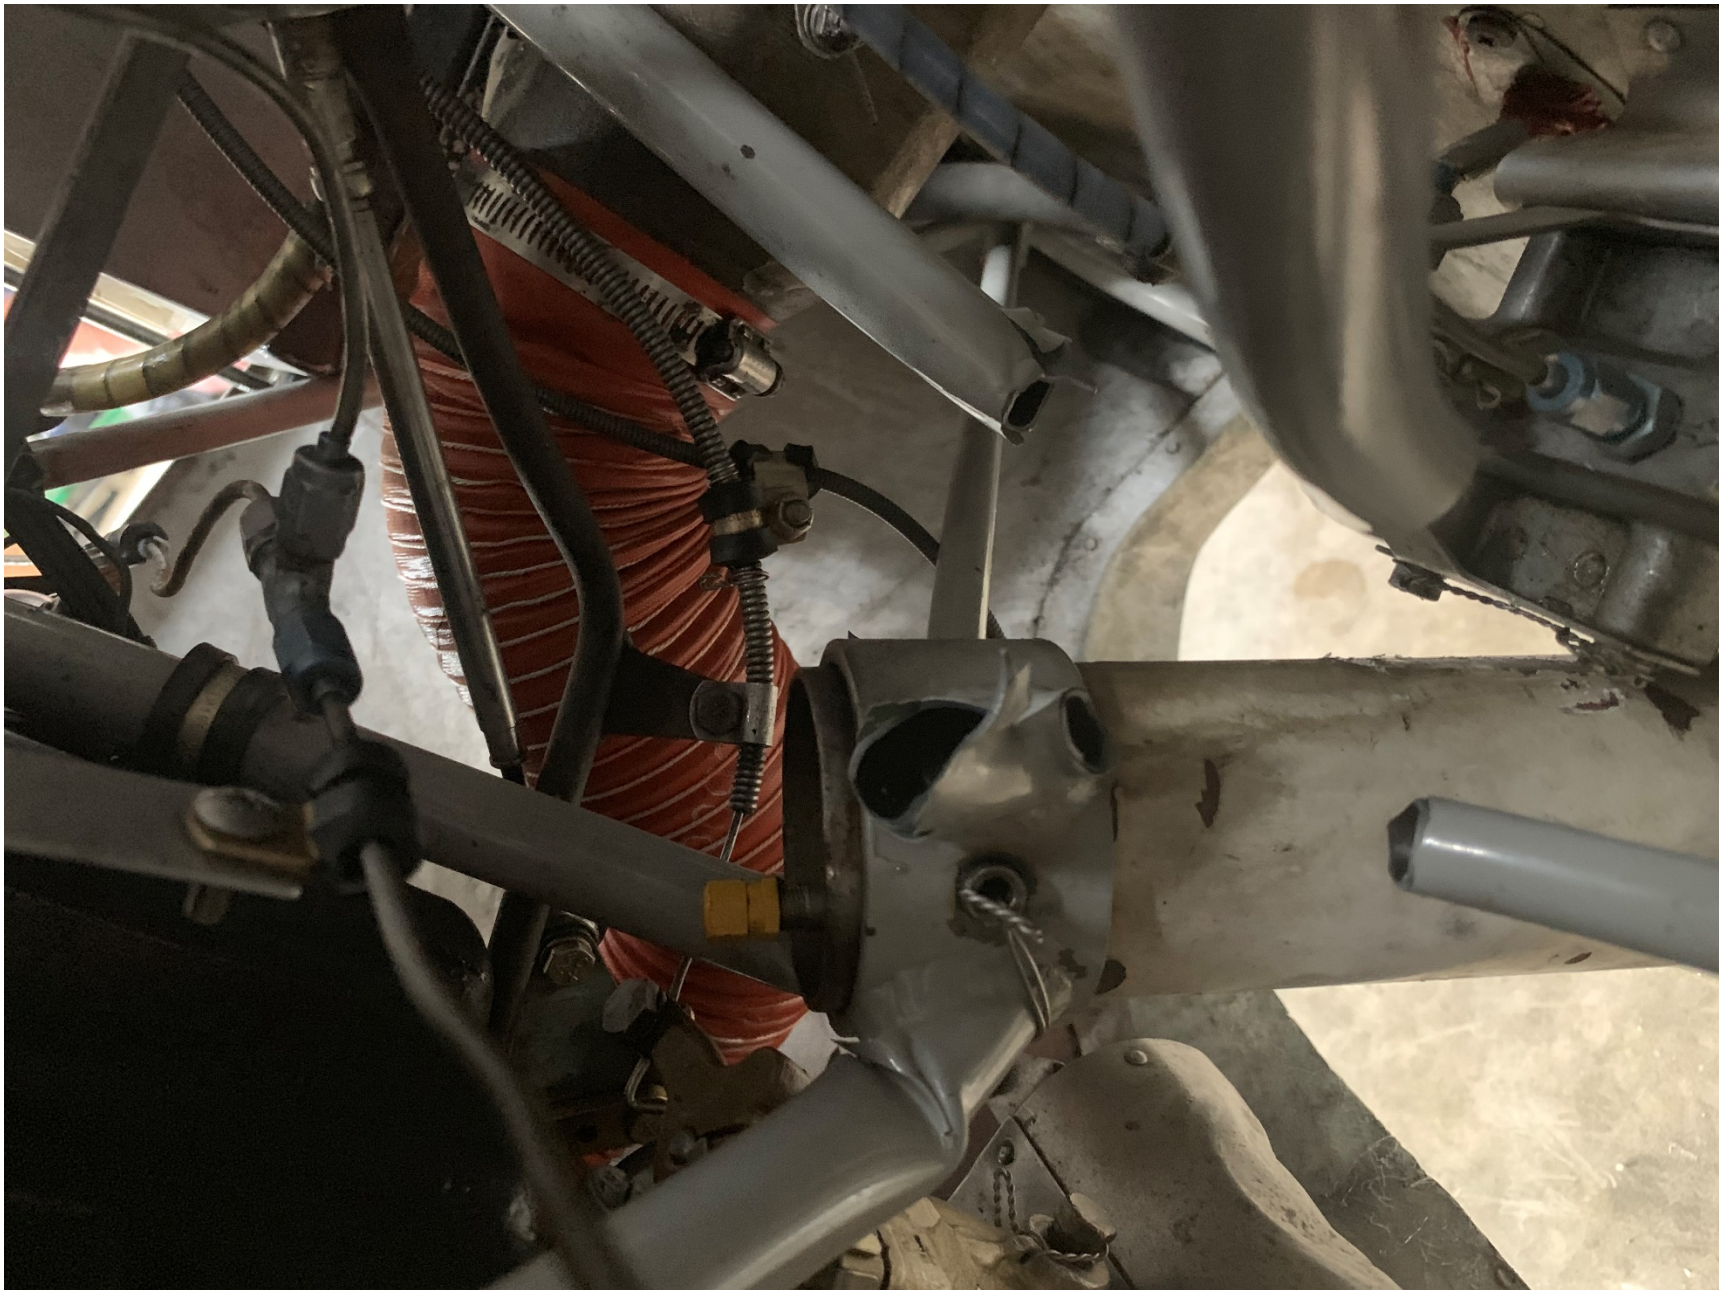
**Photo 1 – View of damaged engine mount (Photo courtesy of the FAA)**
