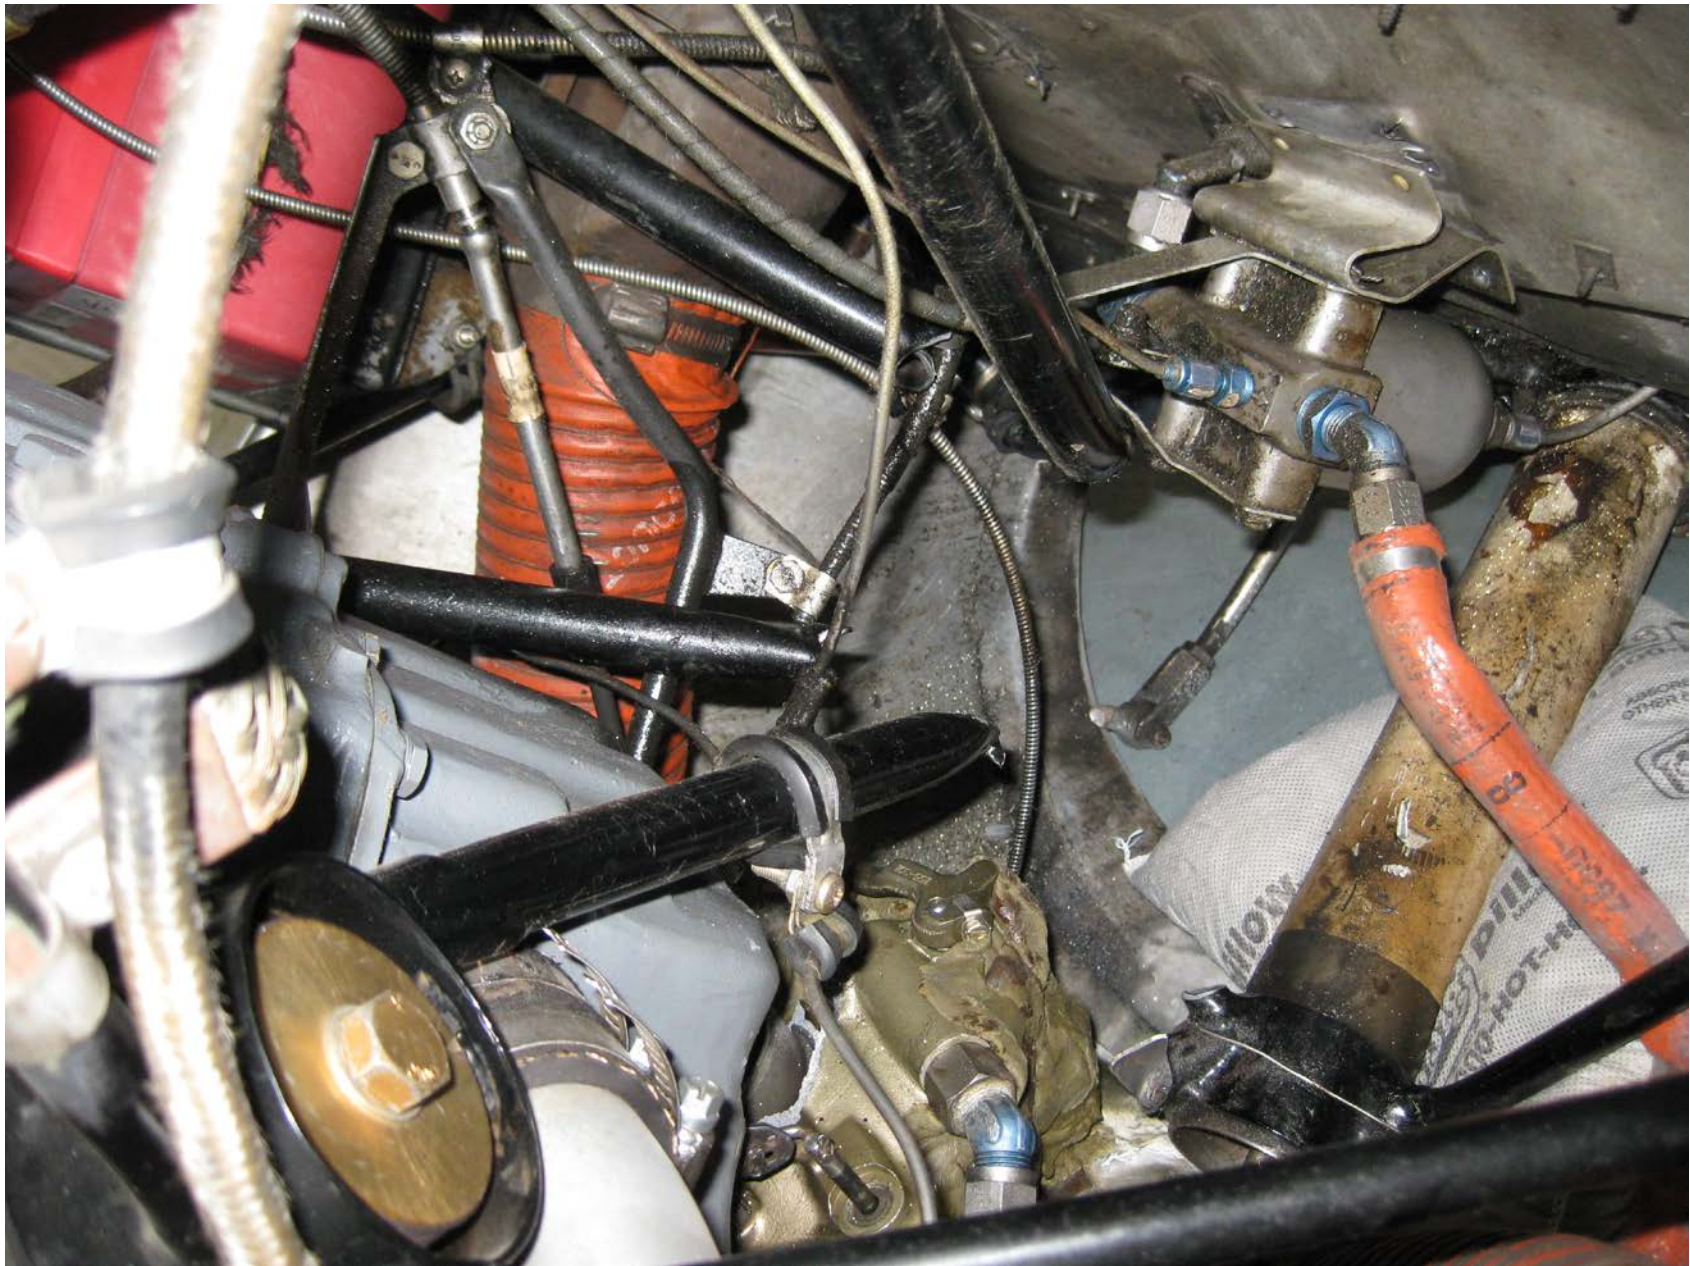
**Photo – View of damaged engine mount and truss (courtesy of the FAA)**
