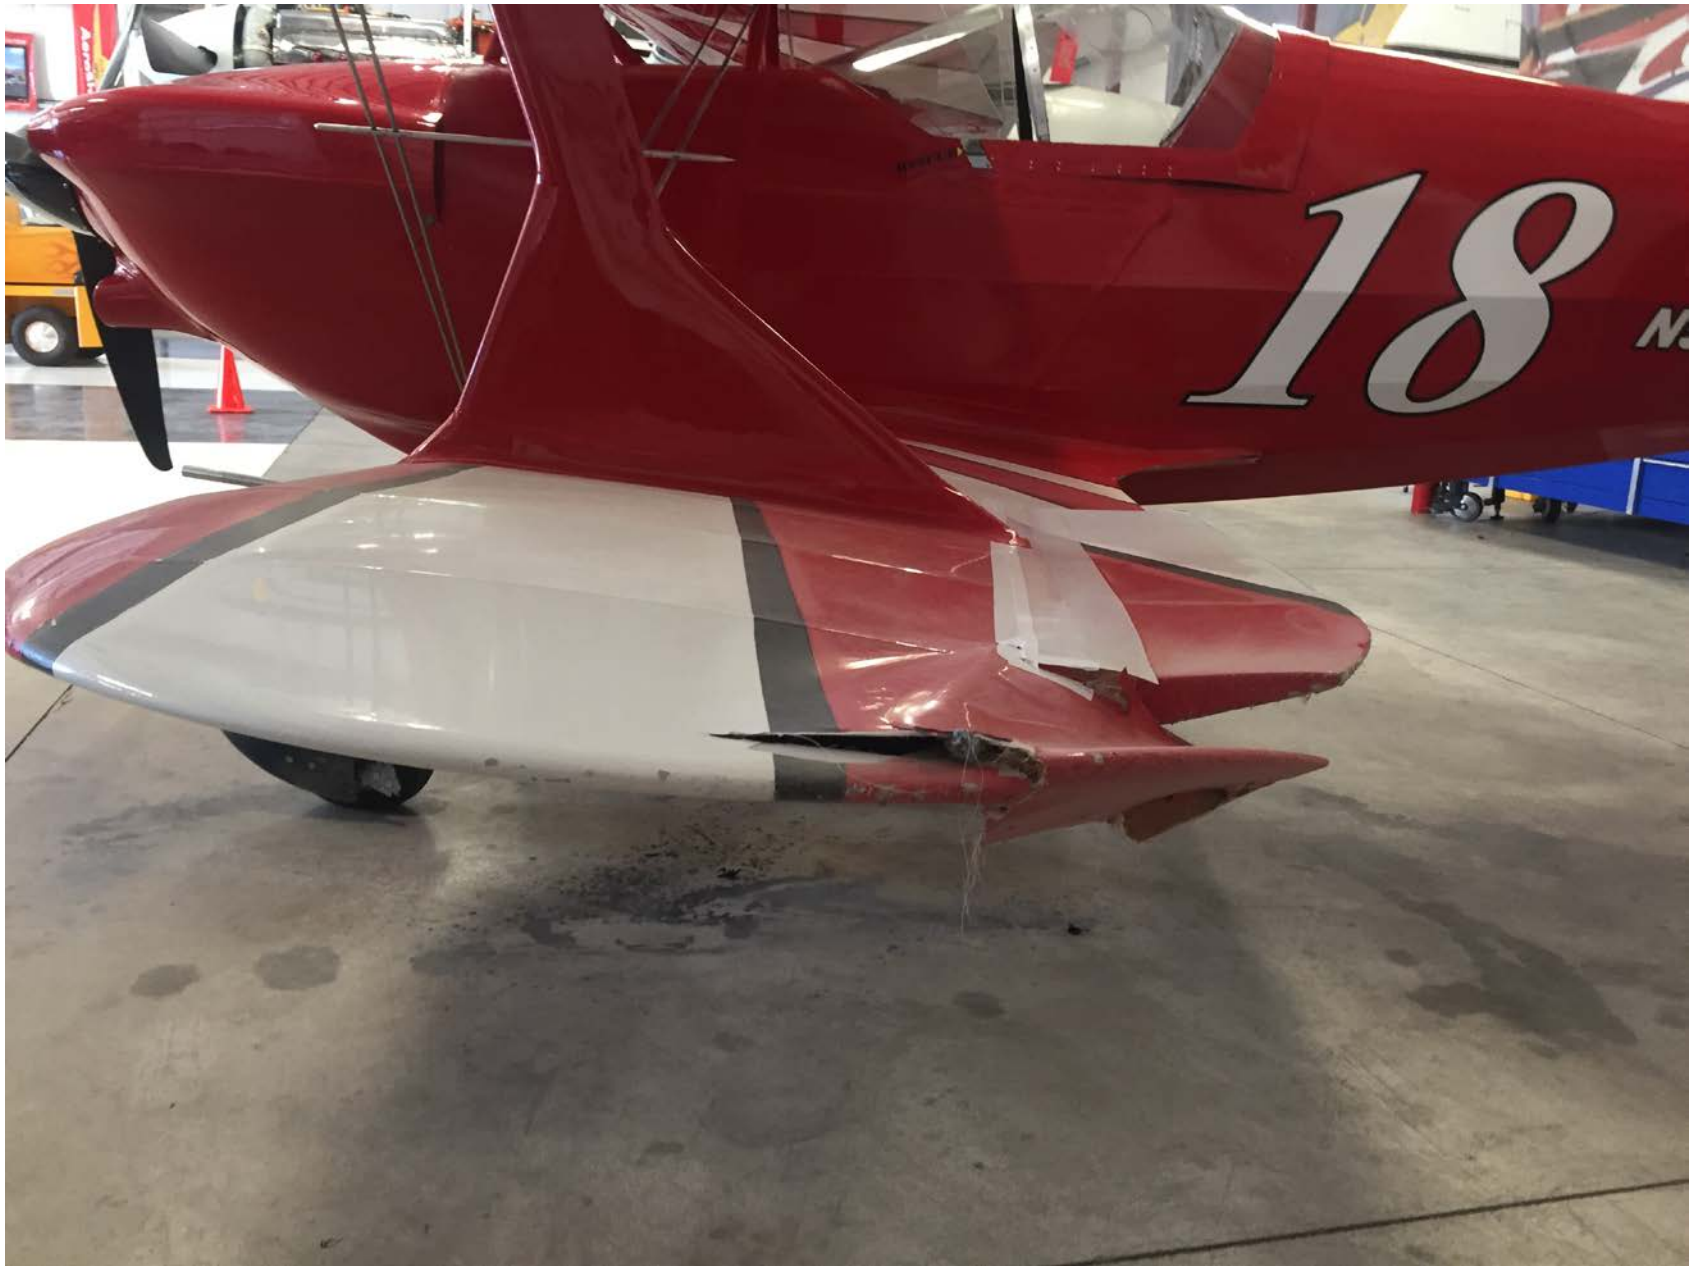
**Photo 1 – View of lower left wing damage (photo courtesy of the FAA)**

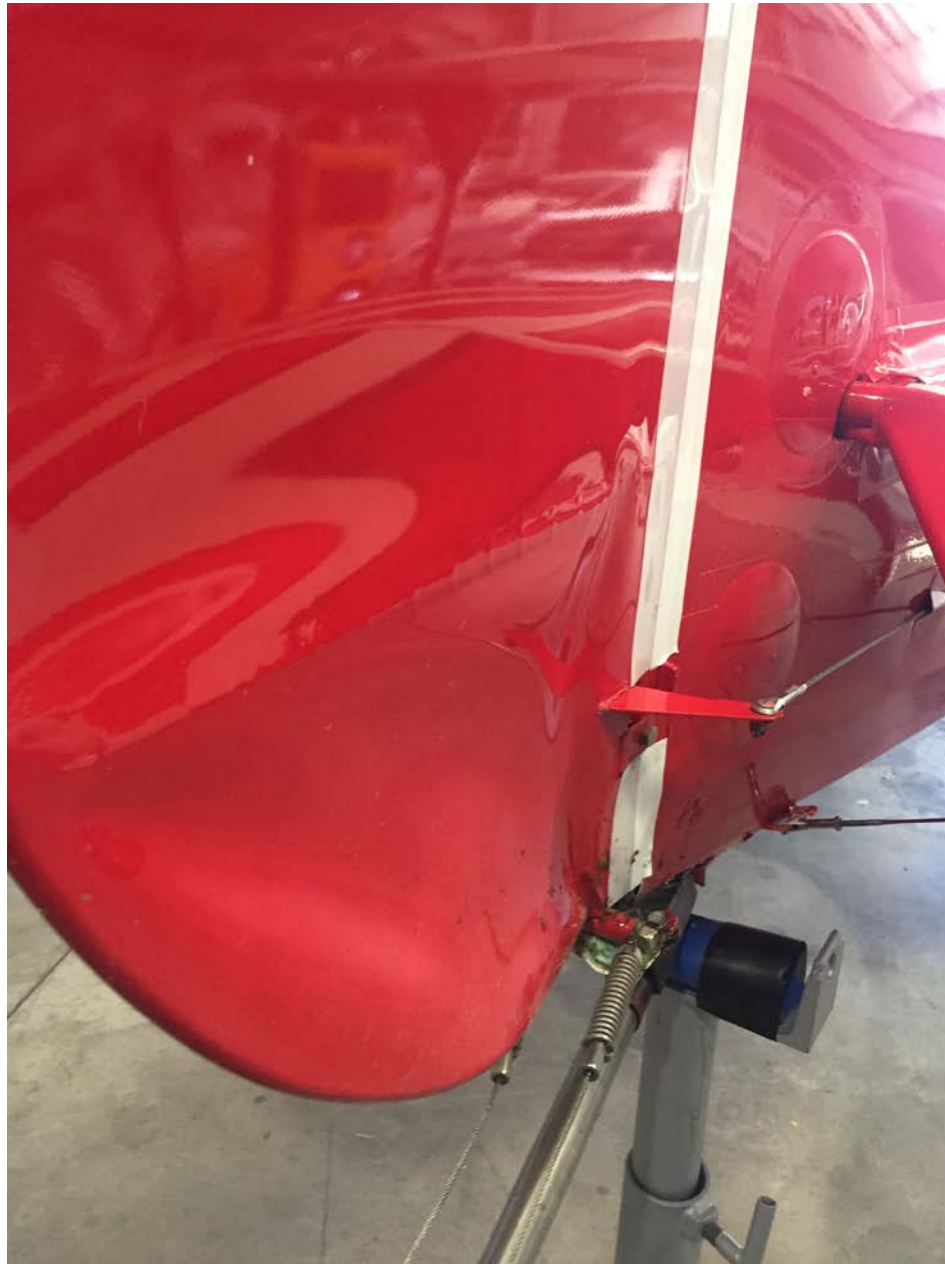
**Photo 2 - View of rudder damage (photo courtesy of the FAA)**
