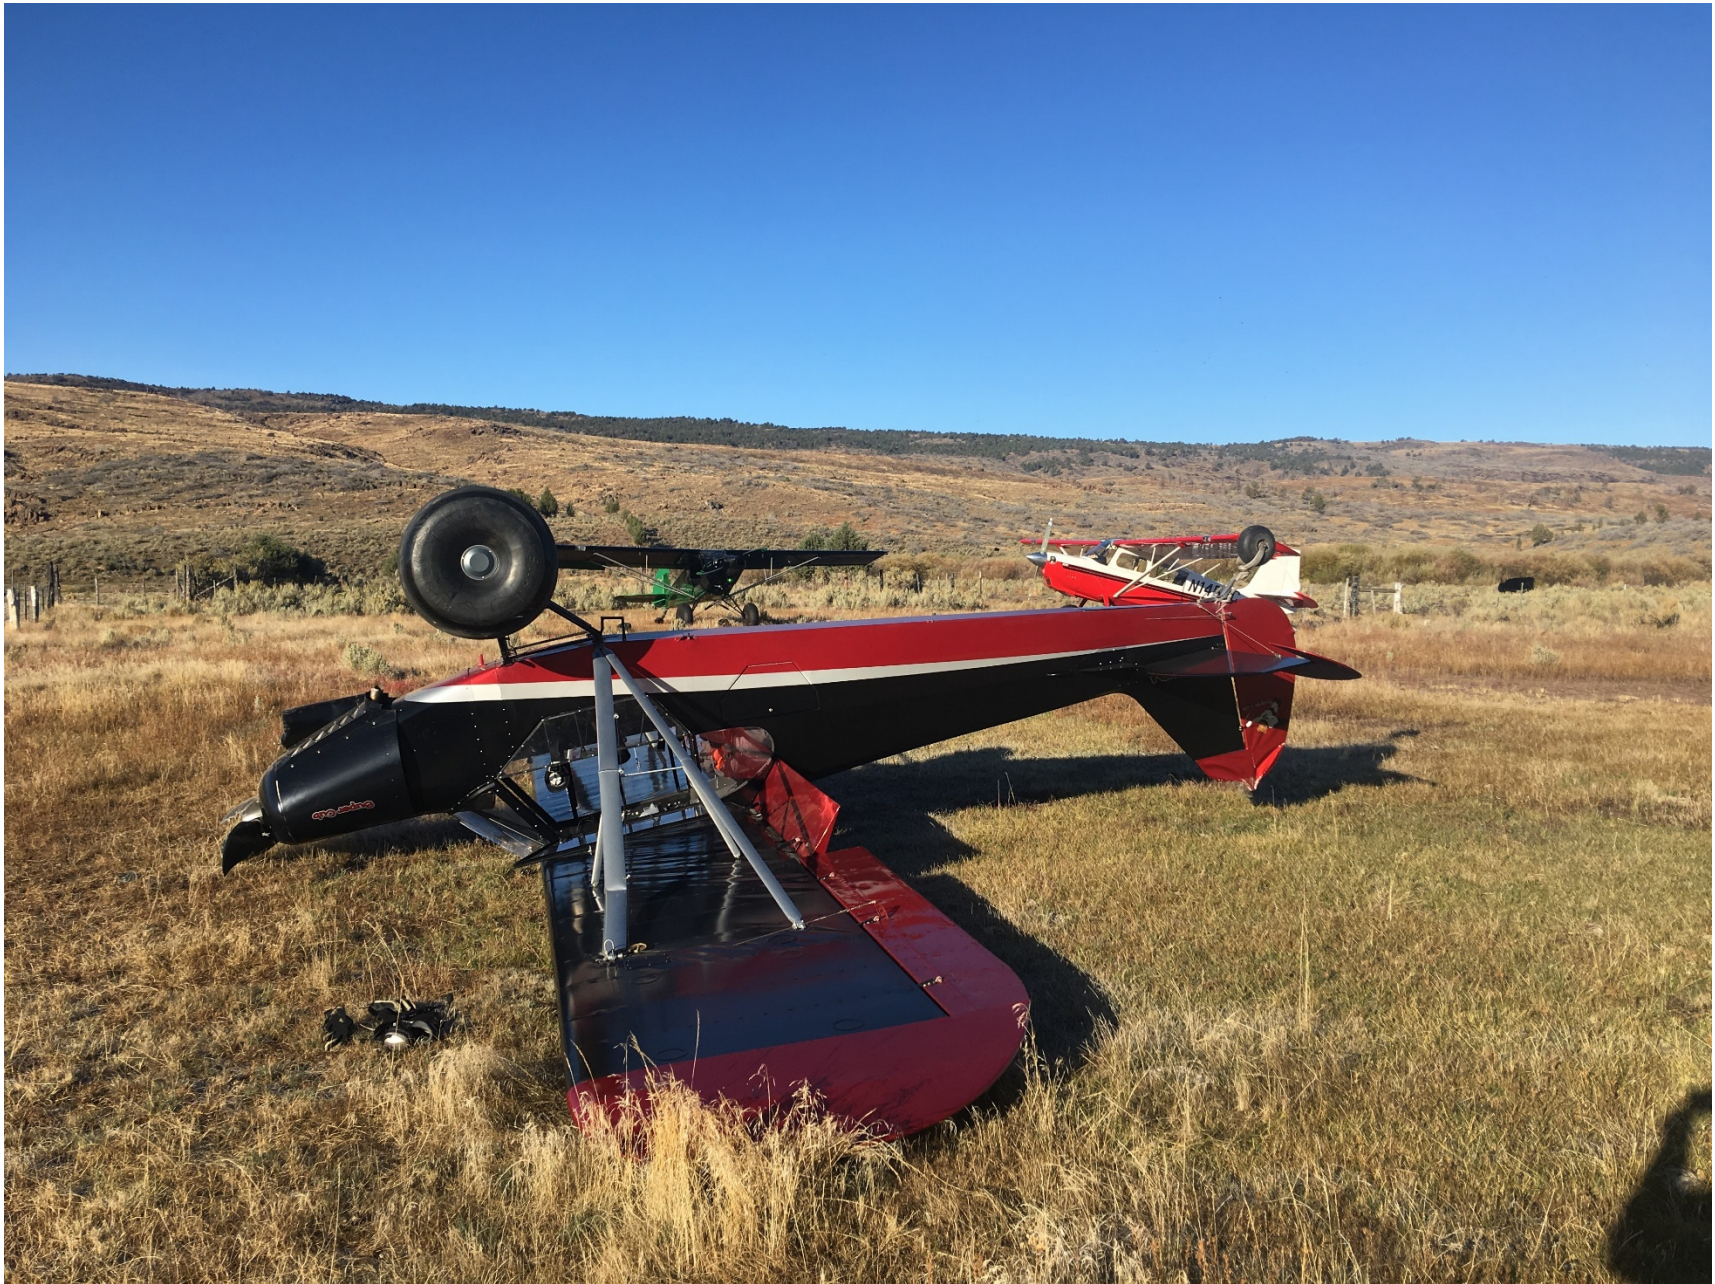
**Photo 1 – View of damaged right wing lift strut and rudder of inverted airplane (Photo courtesy of the pilot)**
