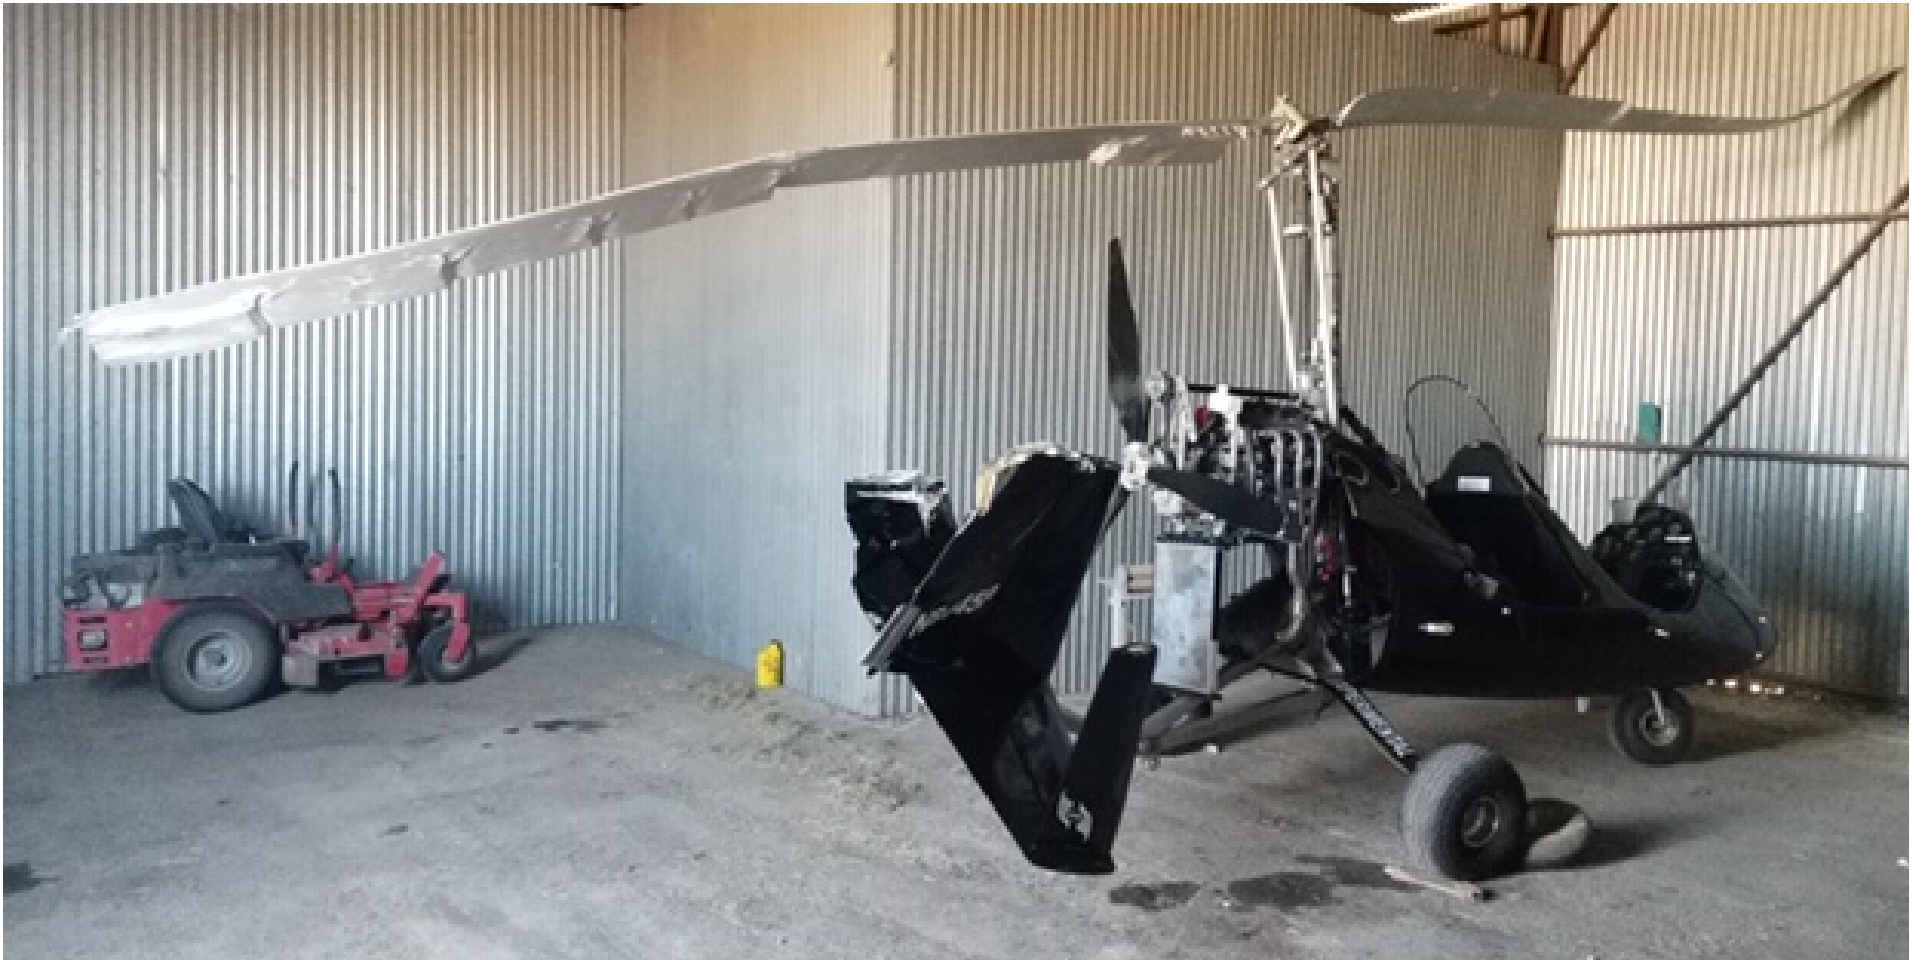
**Photo 1 – View of damage to the main rotor drive system and the empennage (Courtesy of FAA)**
