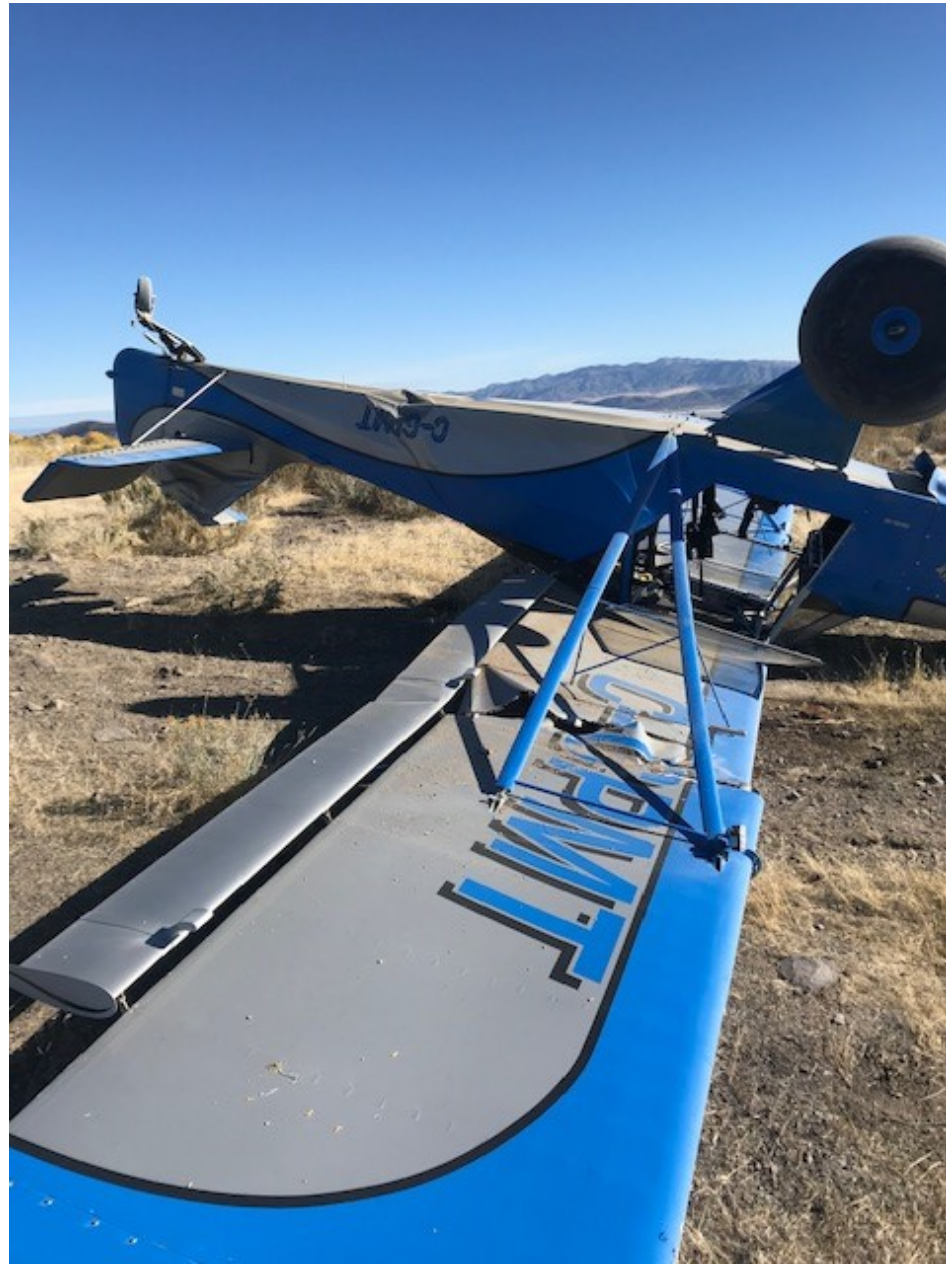
**Photo 1 – View of damaged left wing, tailcone, and rudder (courtesy of the FAA)**
