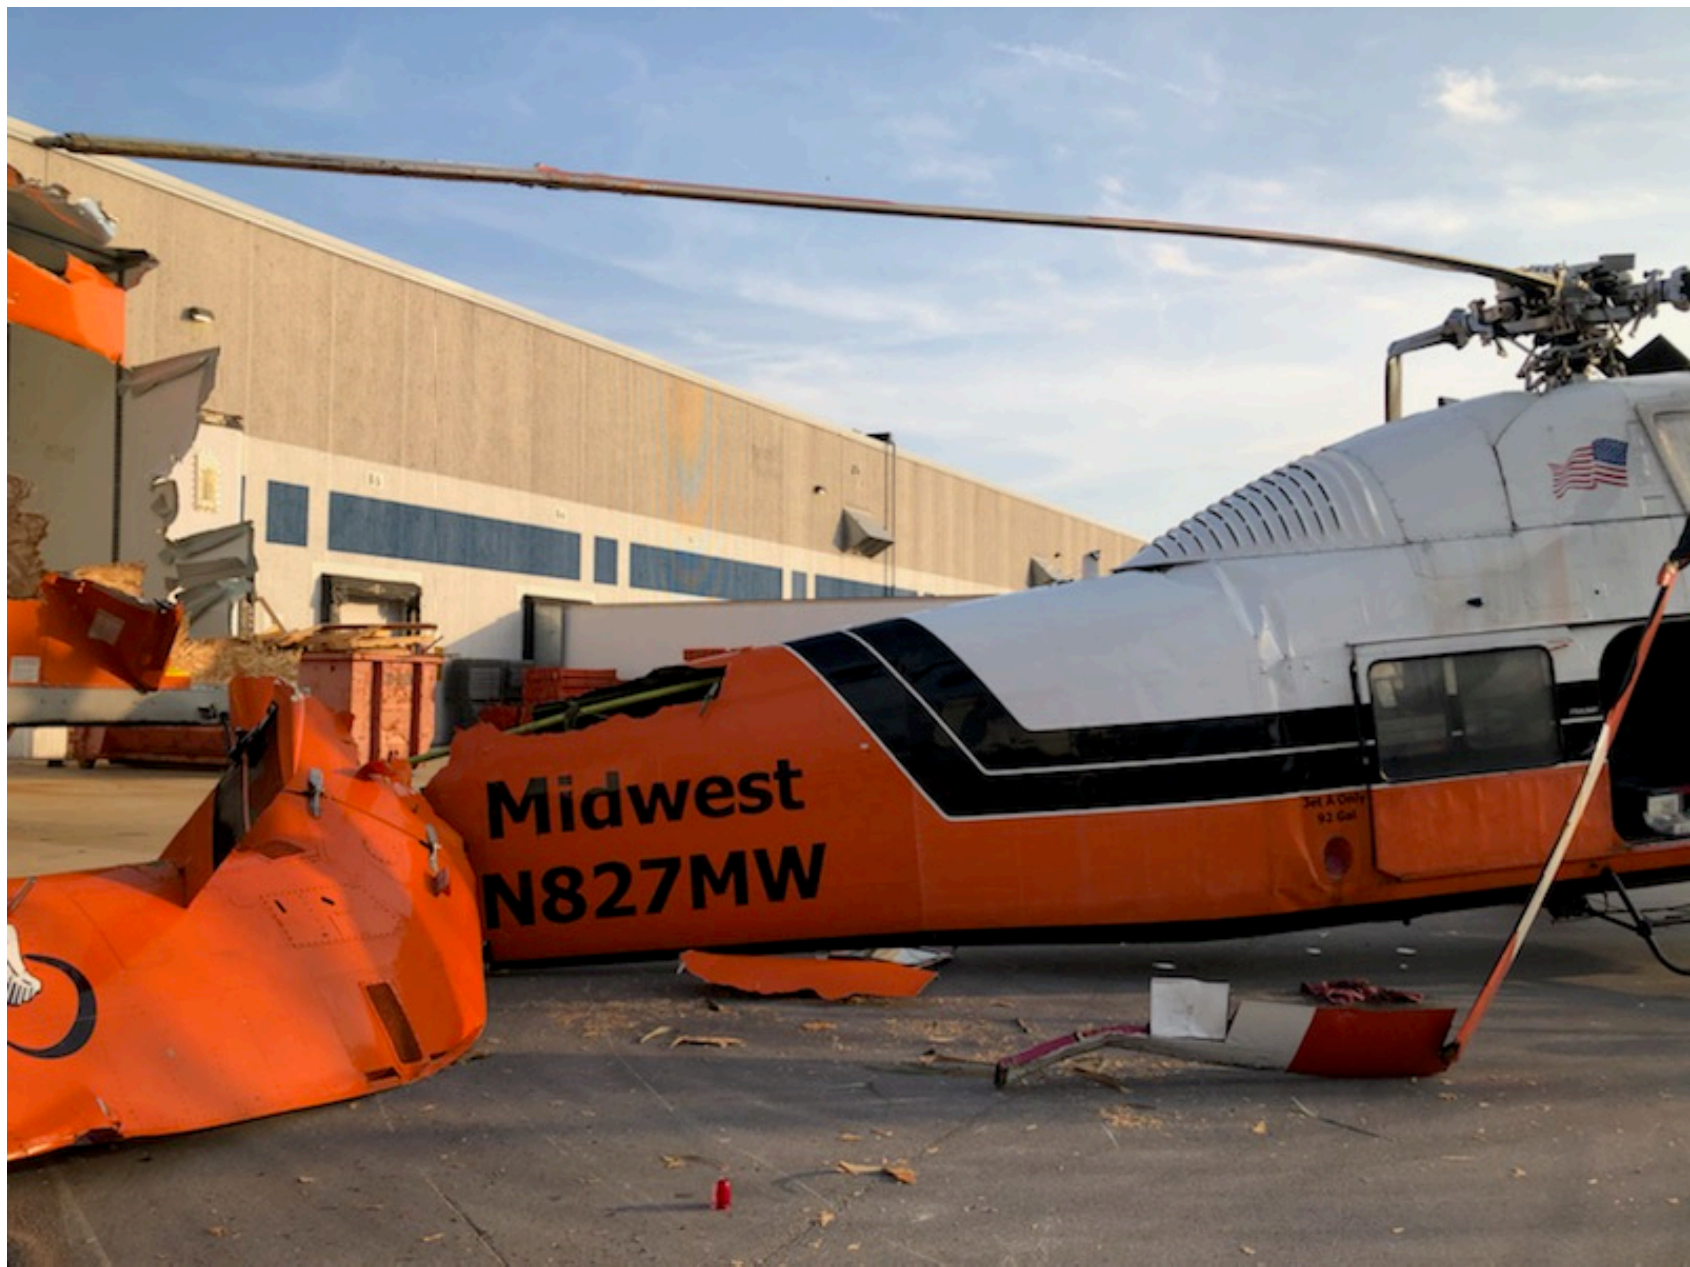
**Photo 1 – View of damaged tailboom and trailer (courtesy of the FAA)**

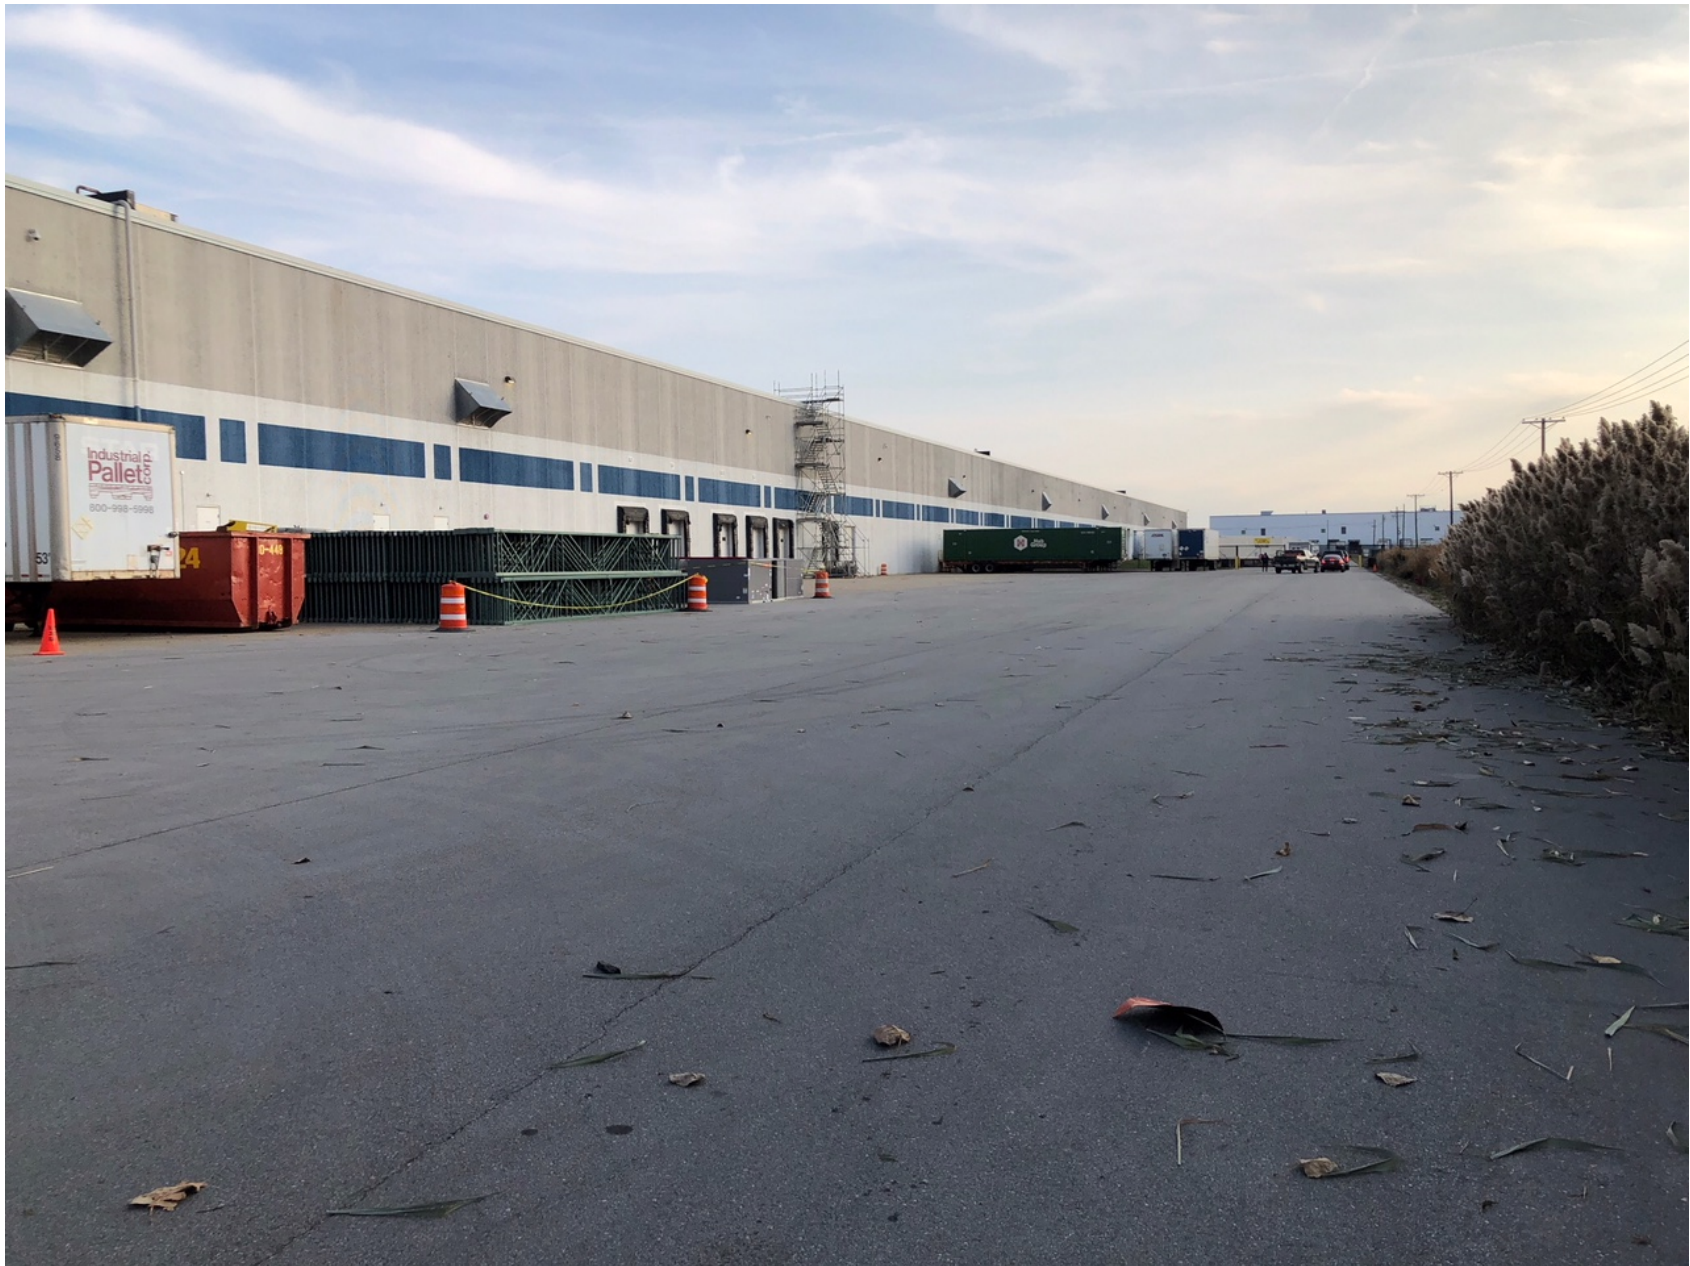
**Photo 2 – View of landing zone (courtesy of the FAA)**
