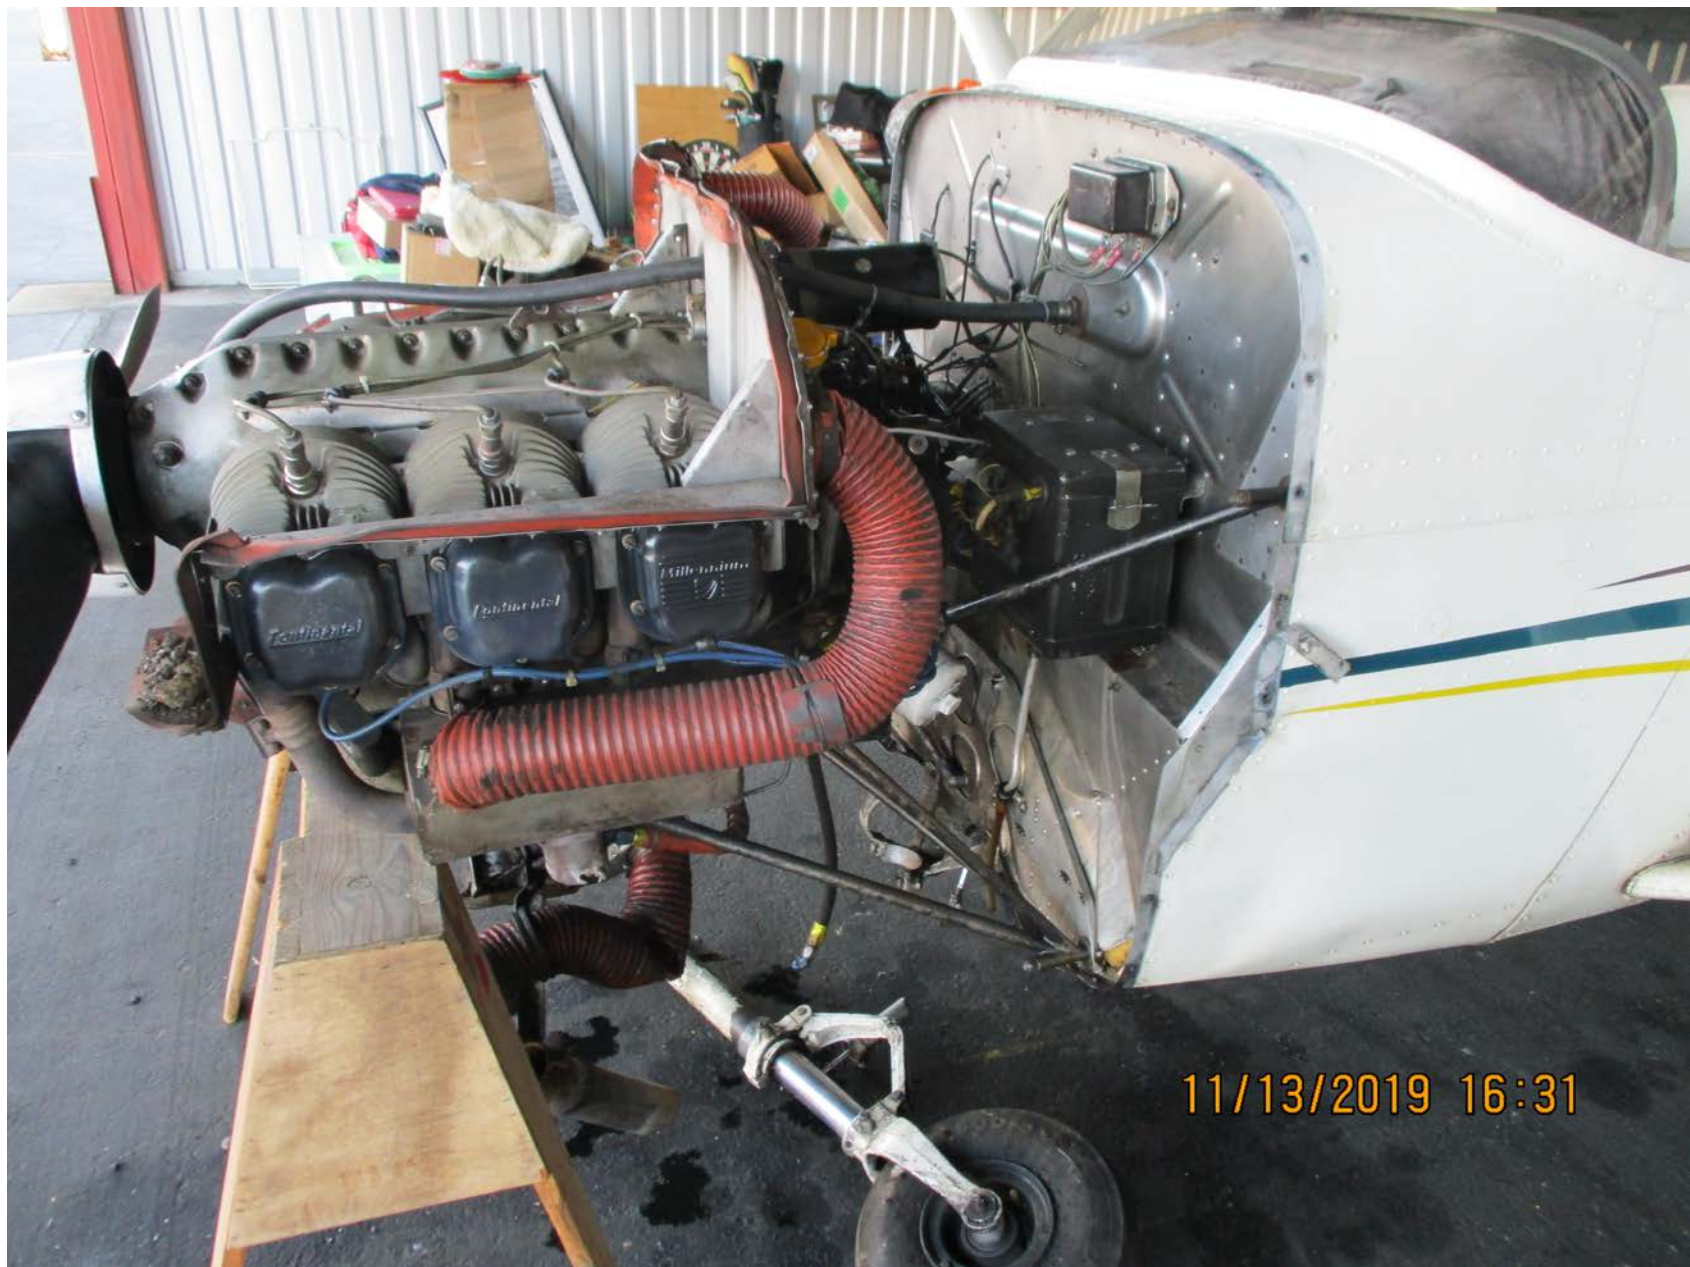
**Photo 1 – View of damage to the lower left engine mount (Courtesy of FAA)**
