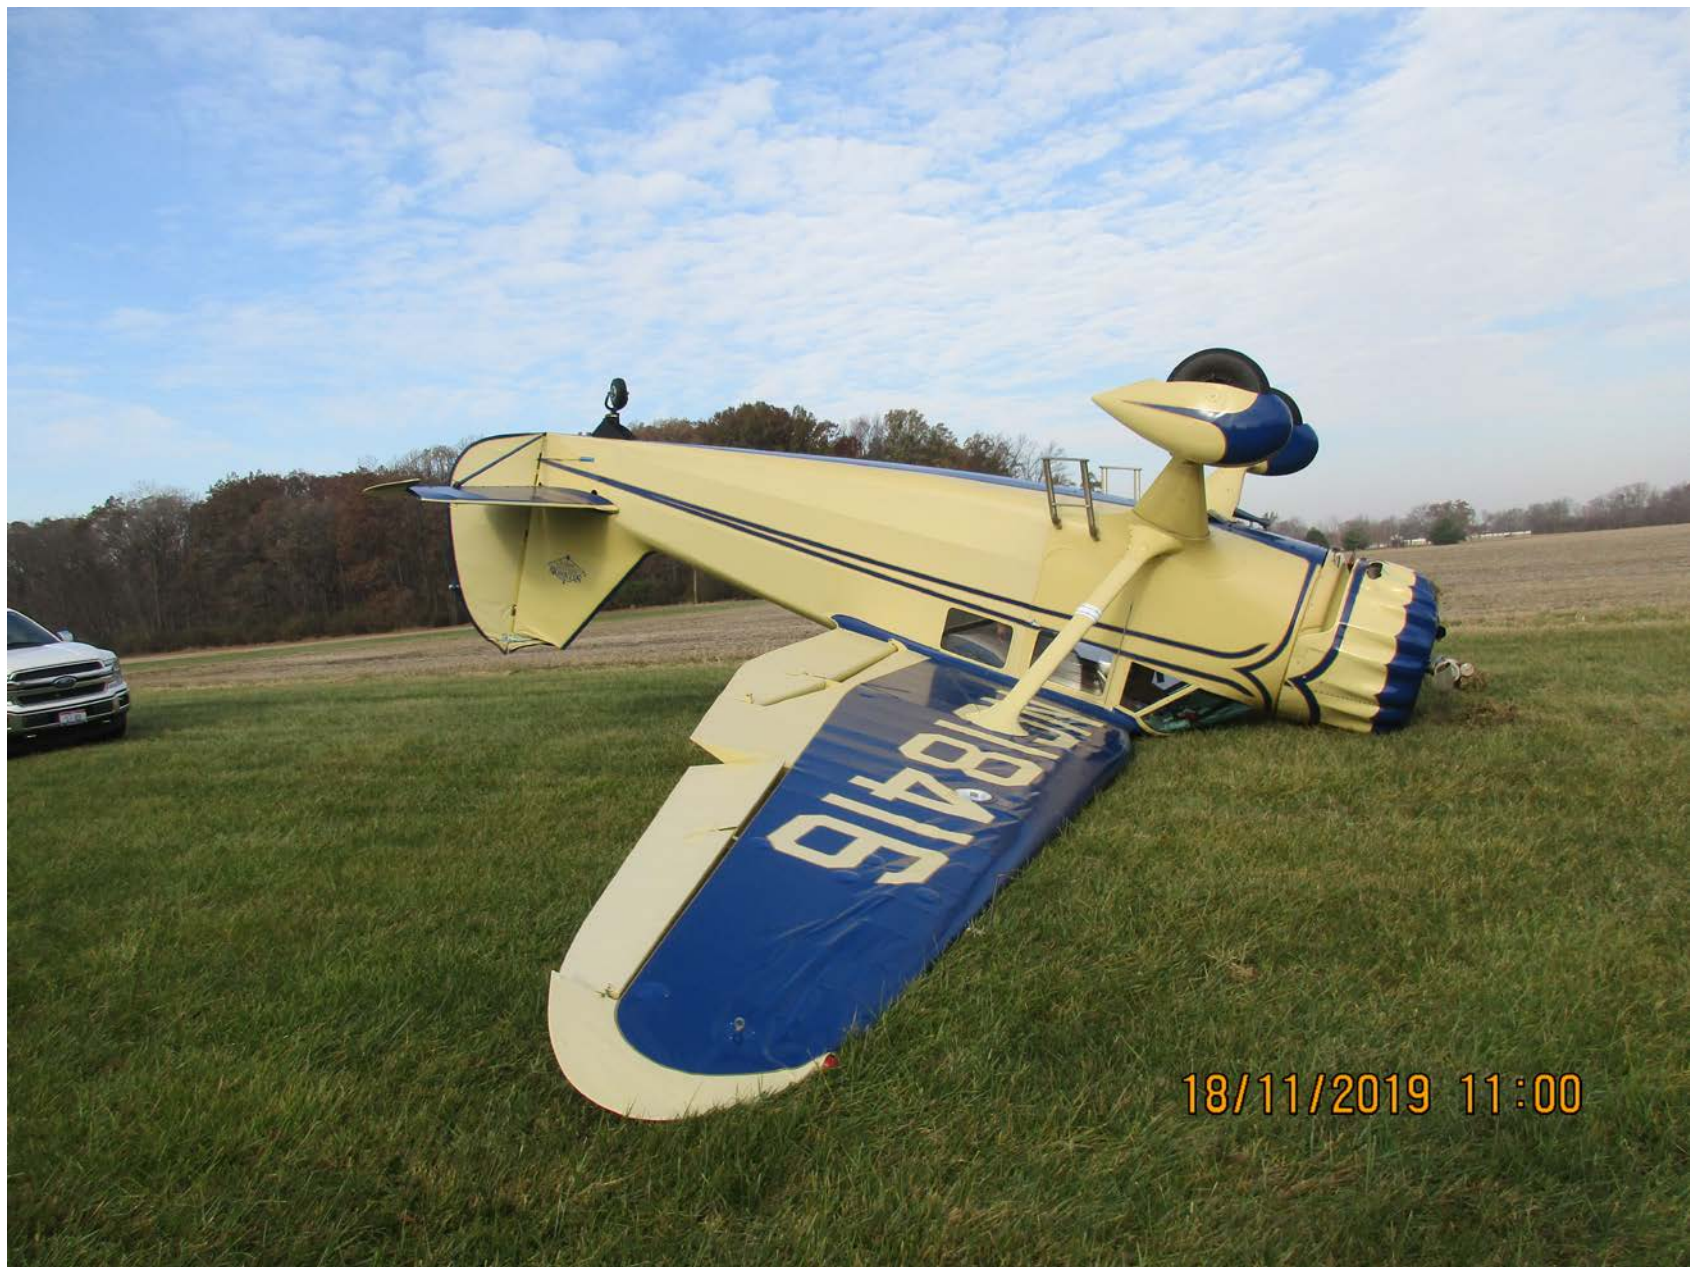
**Photo 1 – View of damaged left wing and empennage (courtesy of the FAA)**
