## **NATIONAL TRANSPORTATION SAFETY BOARD**

### **SUMMARY OF AIRPLANE EXAMINATION**

**(WPR12FA432)**

| Aircraft: | Van's RV-7A |

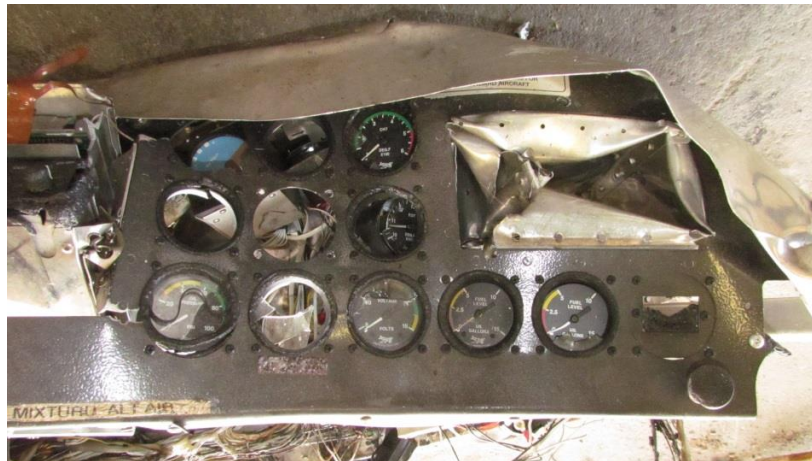
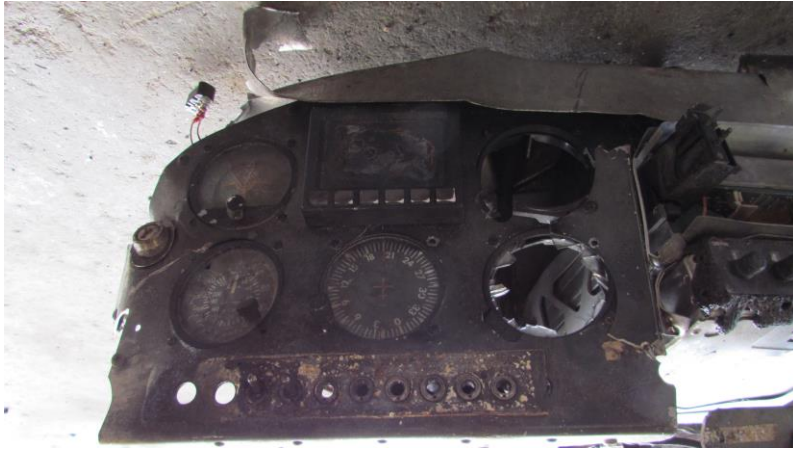
- A. The airplane's instrument panel was observed and provided the following readings/indications:
- The attitude indicator was uncaged and had tumbled.
  - The airspeed indicator read zero knots.
  - The transponder code read 1400.
  - The fact of the comm/nav radio was observed missing.
  - The mounted switch panel had 10 switches, two of which were observed in the "ON" position, #3 and #4 from the left end of the panel.
  - The oil pressure gauge read zero.
  - The oil temperature gauge read zero.
  - The voltmeter read zero volts.
  - The left fuel gauge read zero
  - The right fuel gauge read zero
  - The reading on the Cylinder Head Temperature was not determined
  - The manifold pressure gauge read zero
  - Hobbs reading – no reading available

Photo 1 instrument panel

Photo 2 instrument panel

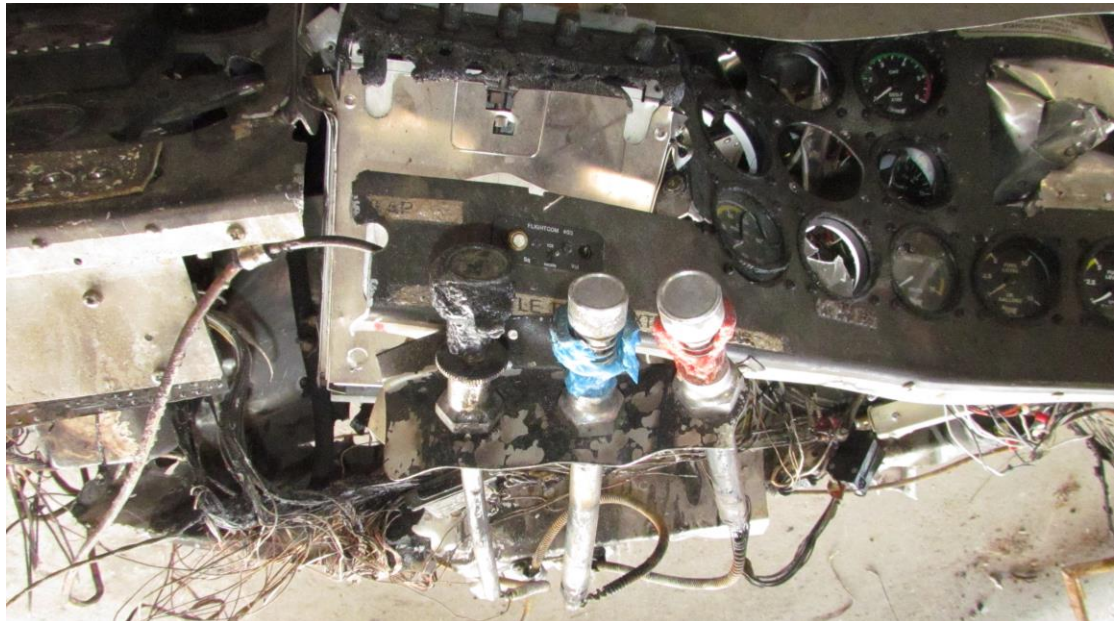
- throttle control – observed in the full forward position
- propeller control – observed in the full forward position
- mixture control – observed in the full forward position

Photo 3 throttle, propeller and mixture controls

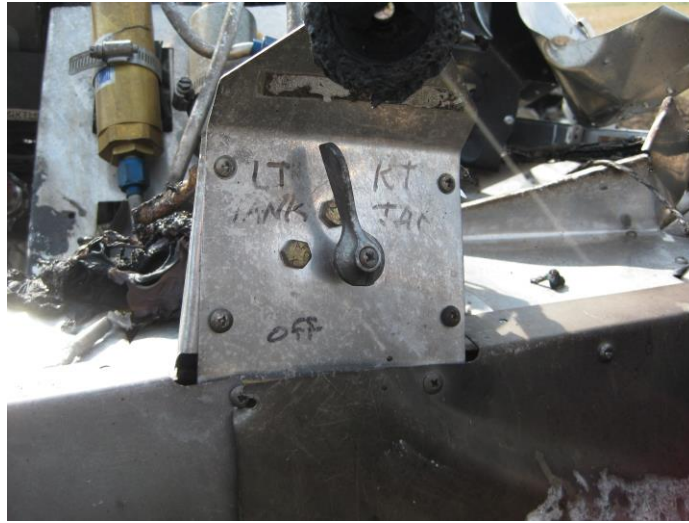
- observed in the Left Tank position

Photo 4 fuel selector

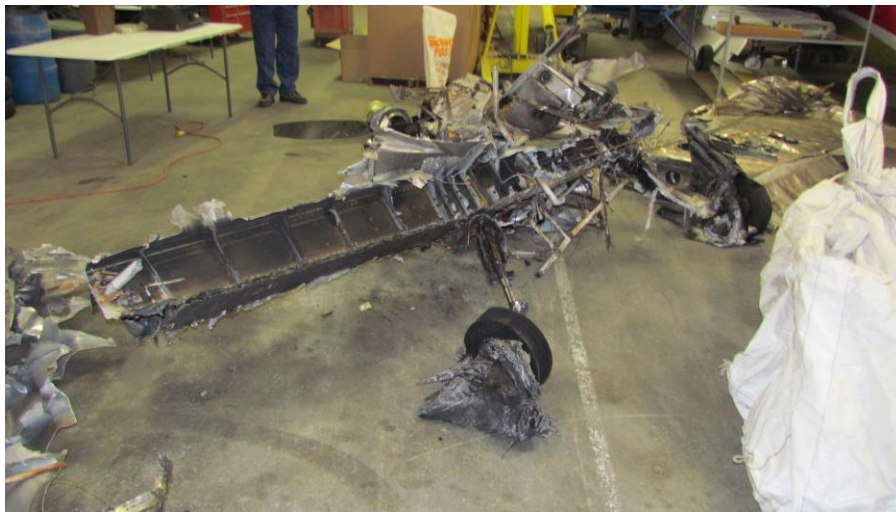
- Both main landing gear were in their normal extended position and attached to the gear box.
- The nose landing gear remained attached to its fuselage attached point and was bent aft

Photo 5 main landing gear

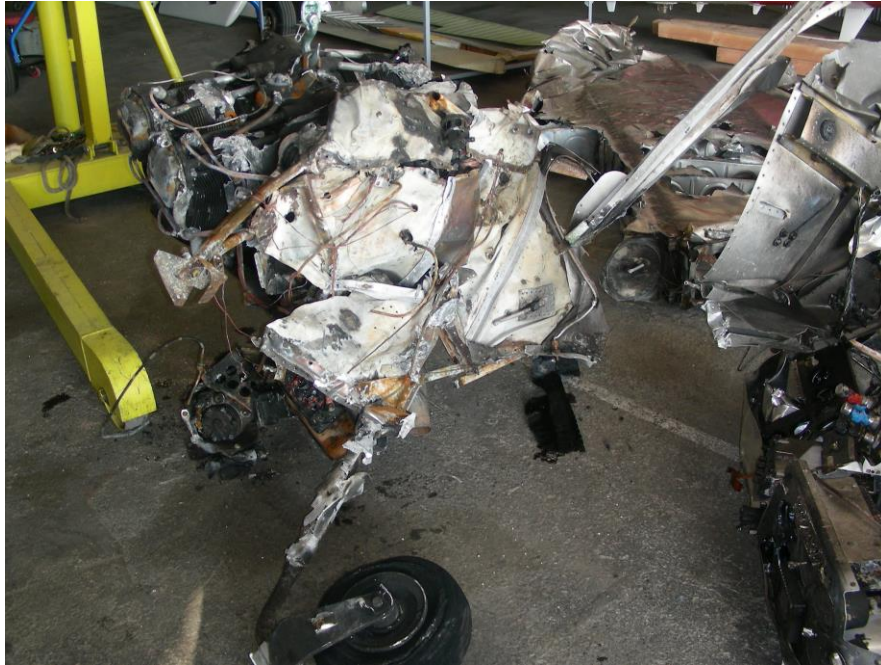
Photo 6 nose landing gear

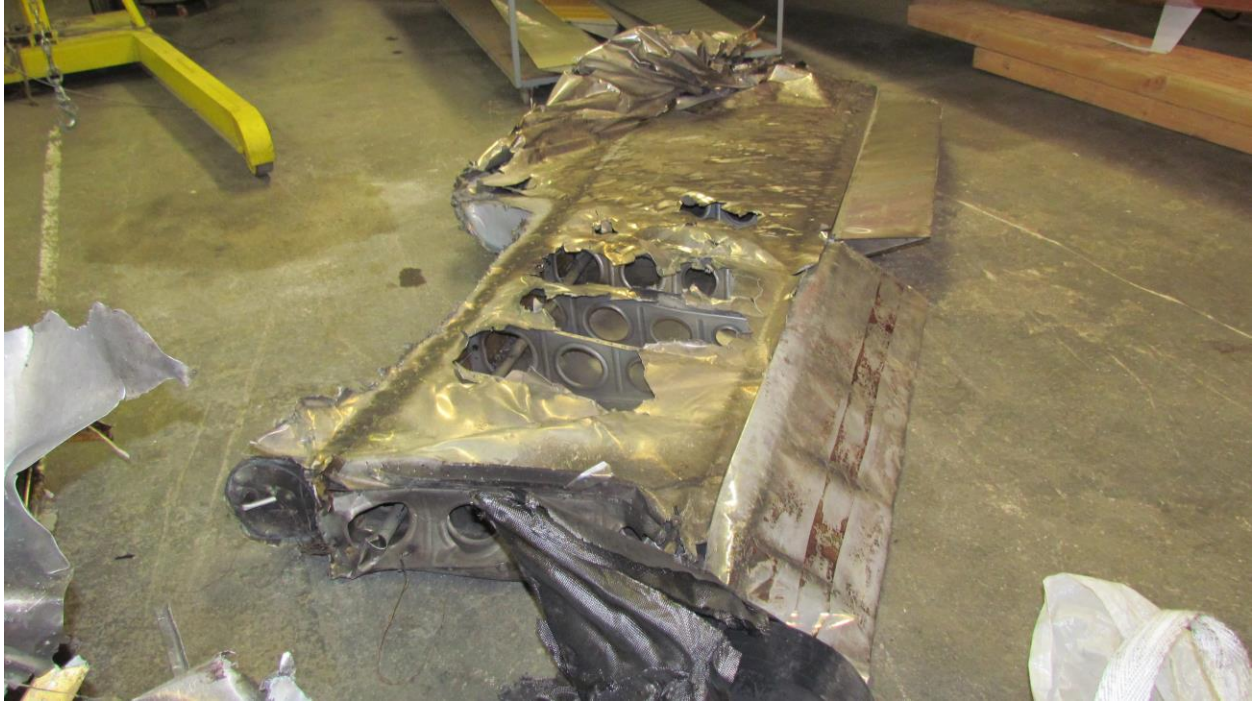
- the wing was observed separated from its fuselage attach points
- the aileron remained attached at all attach points
- the flap remained attached at all attach points. Flap position not determined.
- the wing fuel tank was destroyed by impact and thermal damage
- the outboard one-half of the wing's leading edge sustained aft crushing, consistent with the initial impact with terrain.
- the inboard one-half of the wing was destroyed back to the forward spar
- torque tube and cable continuity was established to the aileron and flaps from the wing root area.
- the entire span of the wing had sustained thermal damage.

Photo 7 right wing

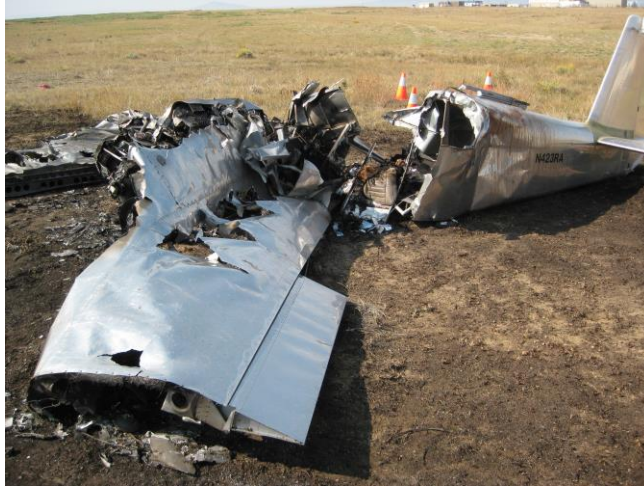
- the wing was observed to have remained partially attached to the airplane's fuselage at its forward attach point.
- the aileron remained attached to the wing's trailing edge at all attach points.
- the entire span of the wing's flap was observed bent under the bottom of the wing. Unable to determine flap position due to destructive impact forces to component.
- control continuity to the associated flap and aileron could not be determined due to the impact and thermal destruction of the wing.
- the wing's fuel tank was destroyed.
- the general condition of the wing was observed to have been bent, twisted, mangled, having sustained severe thermal and impact damage.

Photo 8 left wing

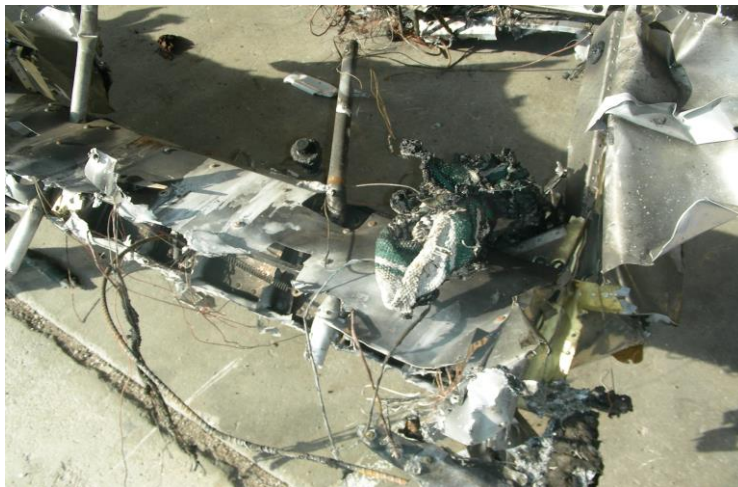
- both control sticks were observed intact and connected to each other via the respective torque tube.

Photo 9 center fuselage (control sticks)

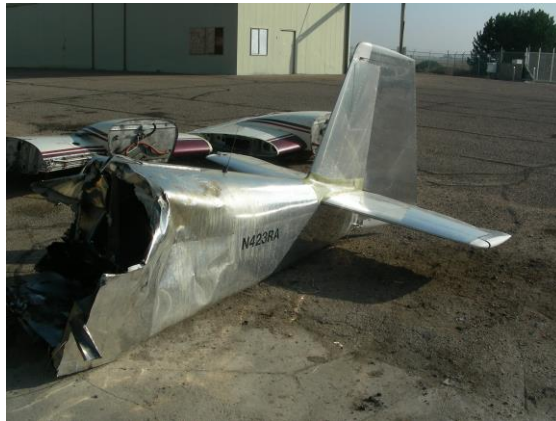
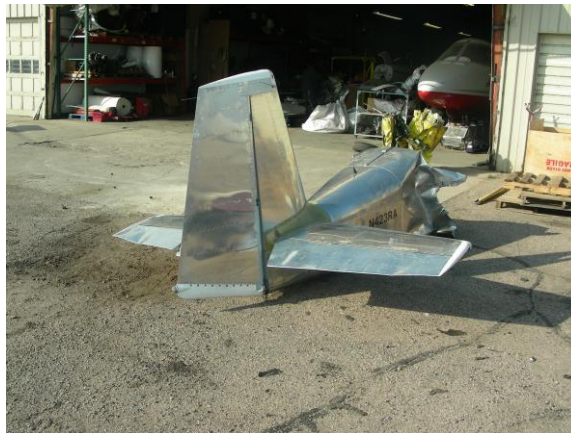
- the empennage was observed separated from the main cabin just forward (about 18 inches) of the aft cabin bulkhead.
- both sides of the fuselage aft of the aft cabin bulkhead were observed compressed inward.

- the horizontal stabilizers, vertical stabilizer, rudder, and both elevators remained attached to the aft fuselage at all attach points.
- no damage was observed to the vertical stabilizer.
- no damage was observed to the rudder.
- the left elevator had sustained a slight crease to its outboard section.
- the right elevator has sustained a slight crease to its outboard section.
- control cable continuity was confirmed from the elevator, rudder and left elevator trim tab up to the aft cabin bulkhead. Cable separation forward from the aft cabin bulkhead area to the forward cabin area was consistent with overload.

Photo 10 empennage

Photo 11 empennage

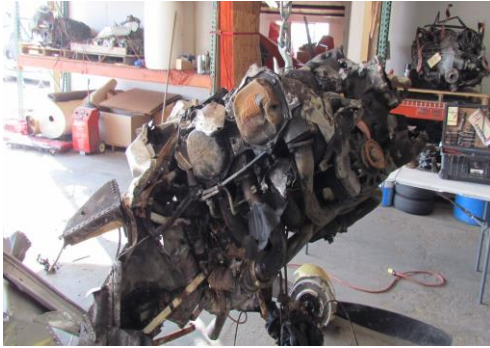
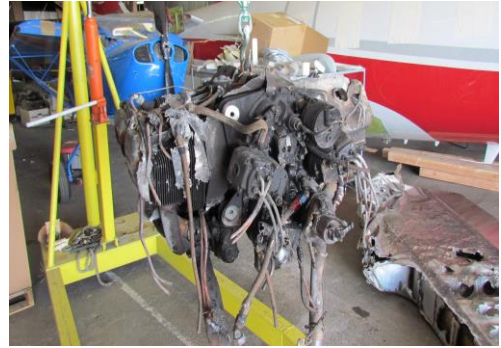
The engine remained attached to the firewall but separated from the fuselage. The propeller and propeller flange was broken free from the crankshaft. The separation was consistent with torsional overload. Both propeller blades were relatively straight and exhibited chordwise scratching and polishing, and minor leading edge damage. One blade was twisted slightly.

Photo 12 engine

Photo 13 engine

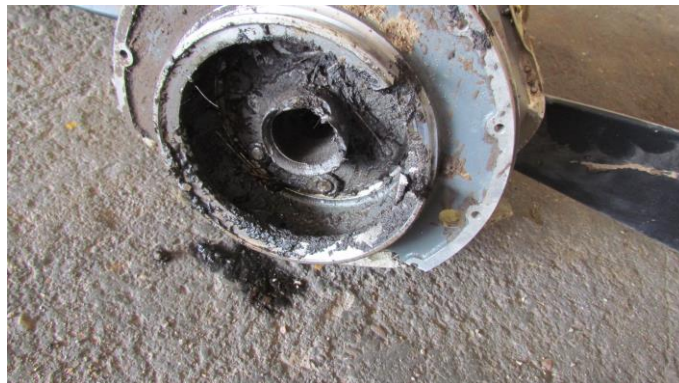
Photo 14 crankshaft separation

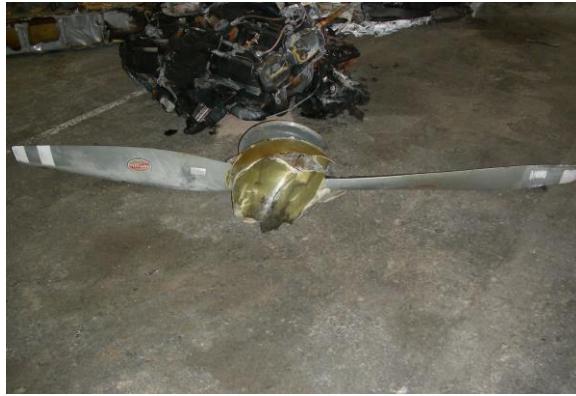
Photo 15 propeller

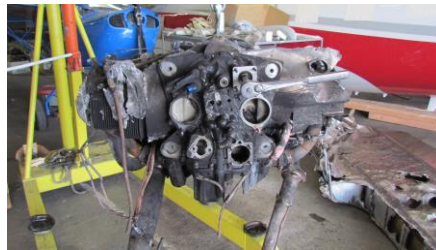
The rear accessories, valve covers, and top sparkplugs were removed to facilitate the engine exam. The cylinders were borescope inspected and no anomalies noted. The crankshaft was rotated via the vacuum pump drive, and thumb compression was established on all cylinders. Engine drive train continuity was established throughout. The spark plugs appeared normal as compared to the Champion Aviation Check a Plug Chart AV-27.

Photo 16 engine rotation confirmed

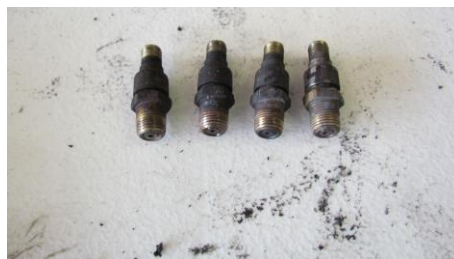
Photo 17 spark plugs

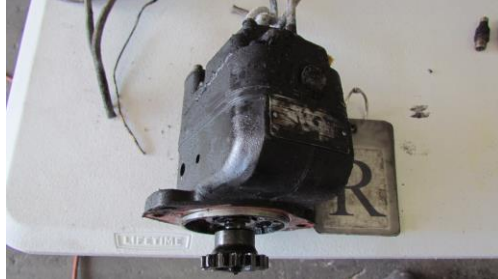
The right magneto was rotated by hand and produced spark at all leads. The left magneto did not produce spark when rotated by hand. Disassembly of the left magneto revealed that a rubber insulator had melted due to the post impact fire and was causing a short to the magneto coil.

Photo 18 right magneto

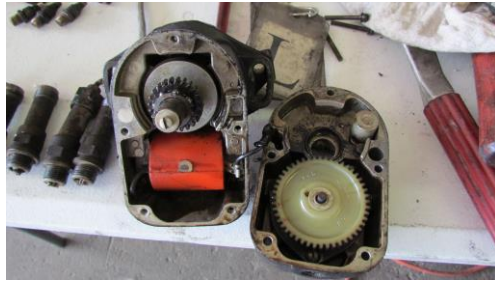
Photo 19 left magneto

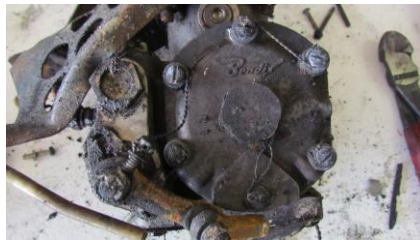
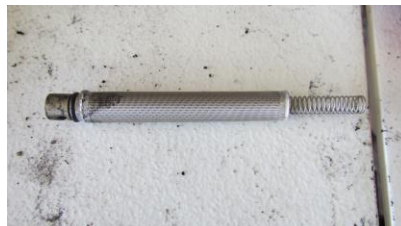
The fuel servo was found broken free from the oil sump. The servo's brass plug was found safety-tied and tight, and the inlet screen was found free of debris.

Photo 20 fuel servo

Photo 21 fuel servo inlet screen

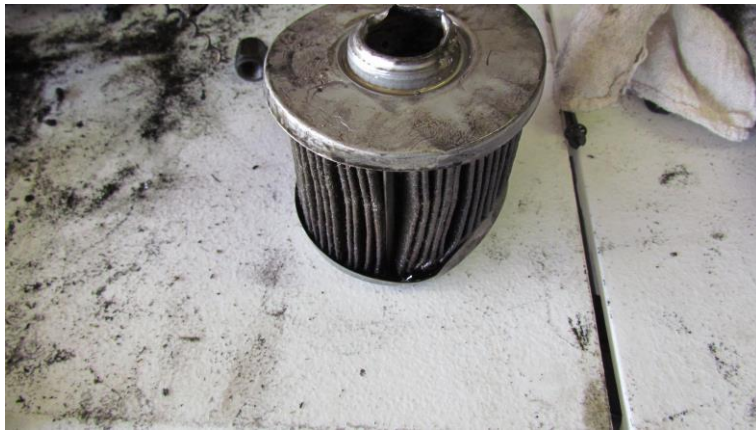
The engine oil filter was examined and found free of contaminants. The engine driven fuel pump was found broken free from its mounting flange.

Photo 22 engine oil filter

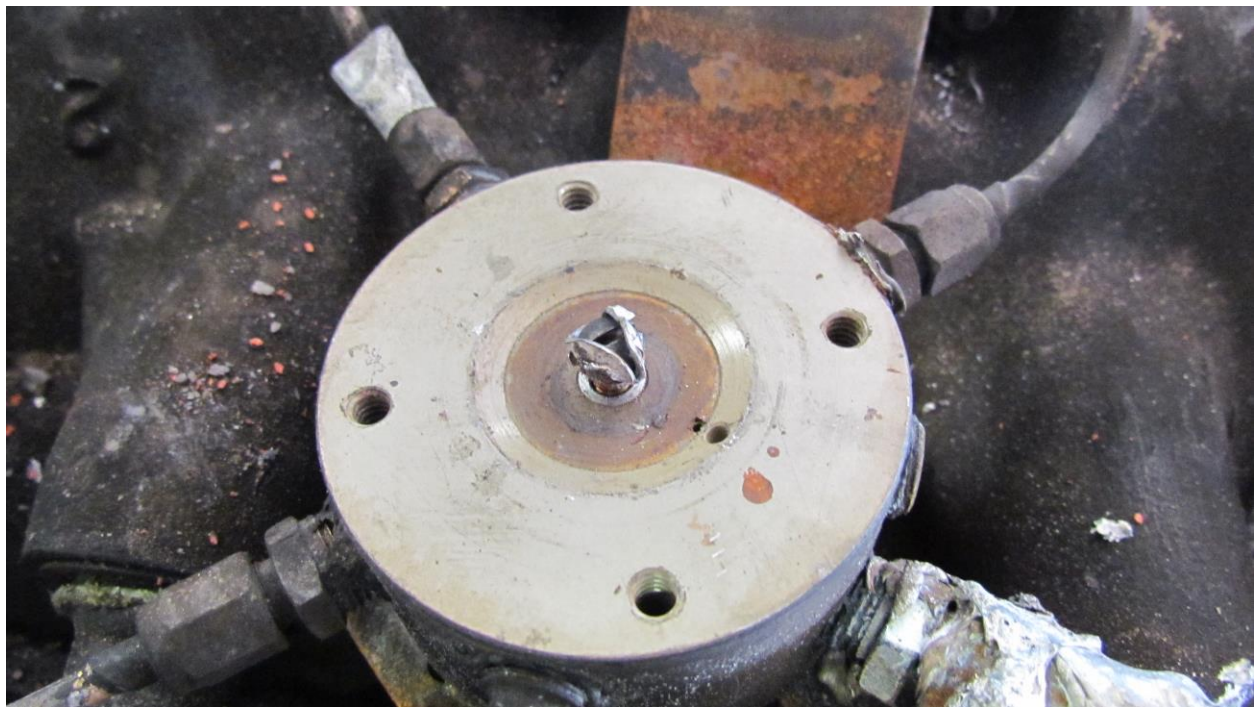
The fuel flow divider cover was removed and the diaphragm was found destroyed by heat and the center plunger was frozen in place. The fuel injectors were all found free of any blockages.

Photo 23 flow divider
