# NATIONAL TRANSPORTATION SAFETY BOARD

## MATERIALS LABORATORY FACTUAL REPORT

Report No. 13-053

Place : Scio, Oregon  
Date : November 26, 2012  
Vehicle : McDaniel RV-6, N424D  
NTSB No. : WPR13FA056  
Investigator : Van McKenny

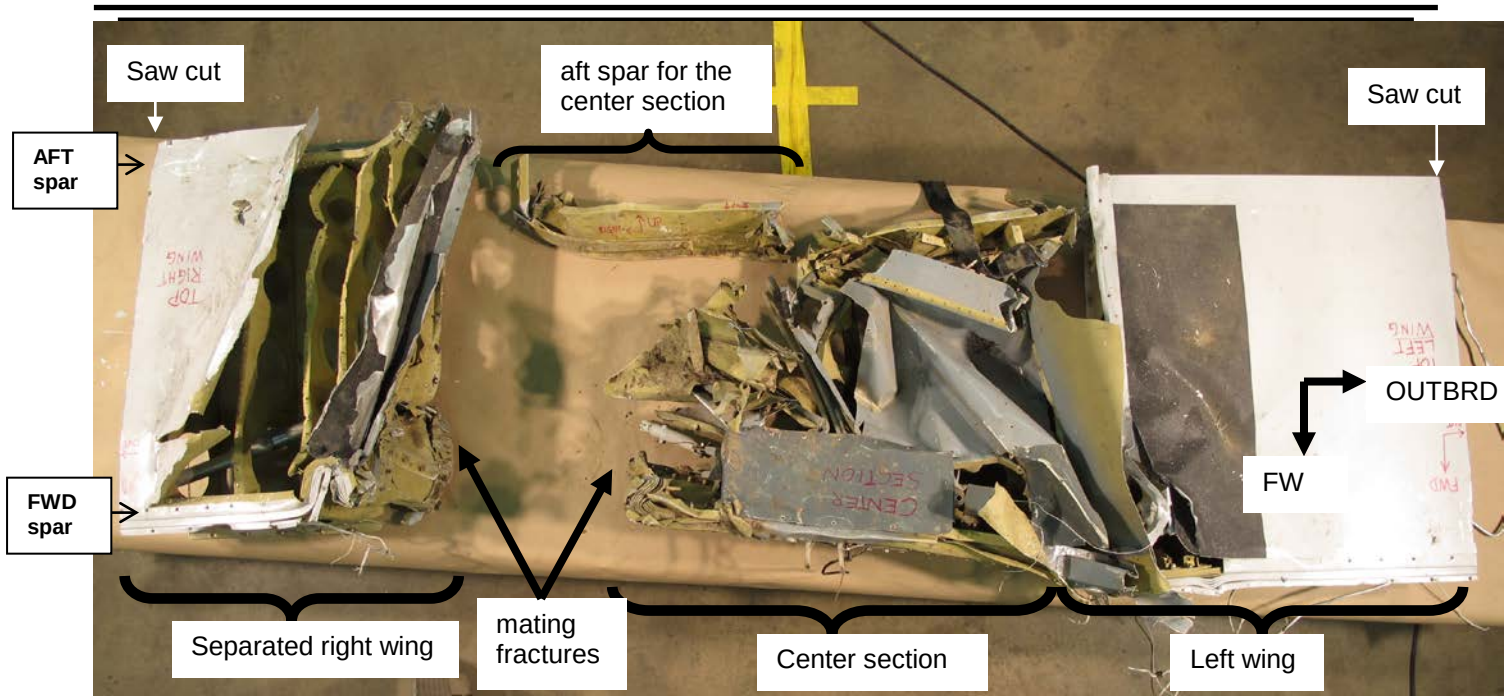
Figure 1 shows a photograph of the as-received wing structure. The right wing separated approximately 1 foot from the centerline of the center section. The left wing remained attached to the center section. The wing structure shown in figure 1 was disassembled in the field (on-site) from the fuselage to facilitate shipping, handling, and examination. The wing contains a forward and aft spar. The forward spar at the fracture location contained a total of 4 reinforcement pieces for the web; 9 reinforcement strips for the upper spar cap; and 9 reinforcement strips for the lower spar cap, as shown in figure 2. Examination of the forward spar revealed the fracture faces of the lower spar cap at the inboard side contained less mechanical damage<sup>1</sup> compared to those on the upper spar cap pieces.

Figure 1. Photograph of the as-received wing structure pieces showing the top surfaces. The right wing separated from the center section. The left wing remained attached to the center section.

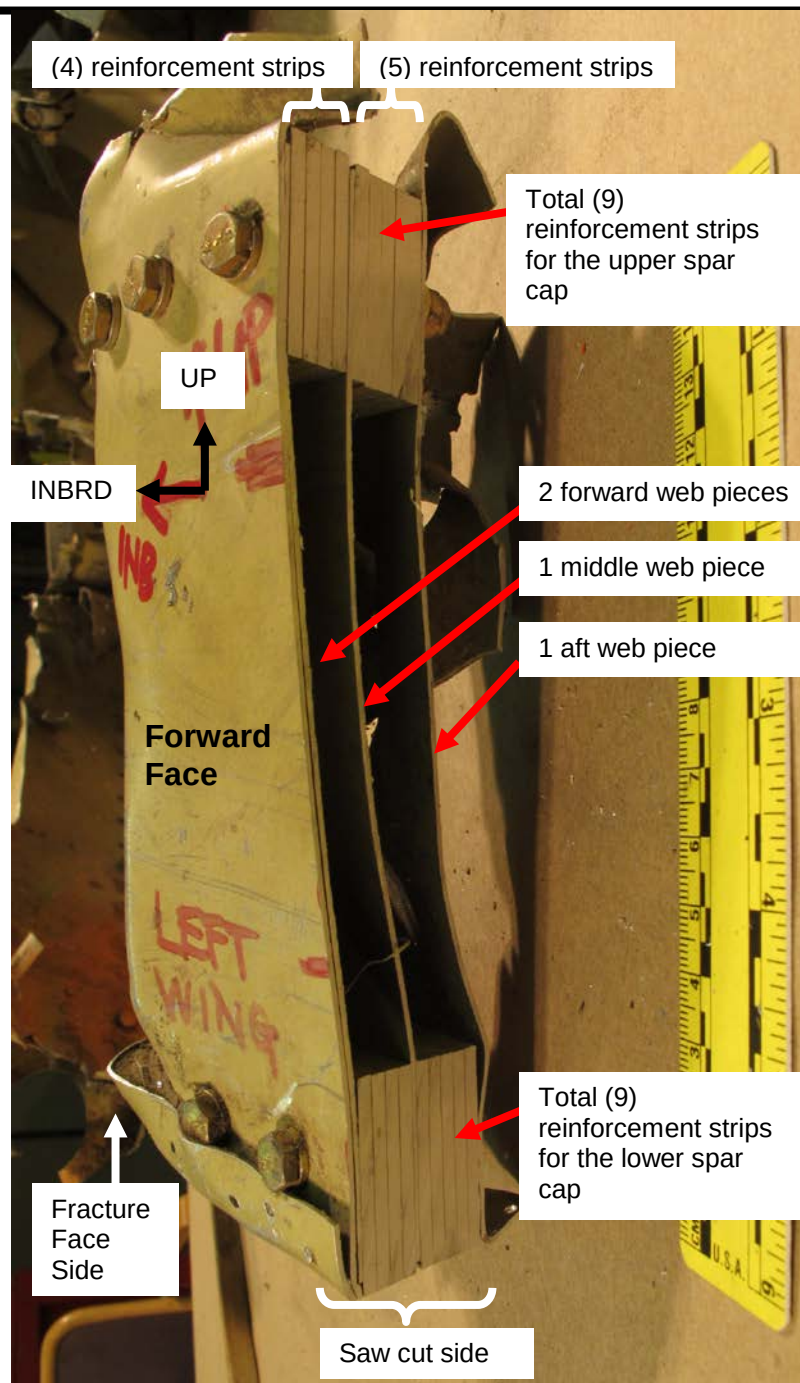
Figure 2. Oblique view of a portion of the forward spar for the left wing. The saw cut was made to show the cross section of the forward spar and to facilitate examination of the fracture faces.

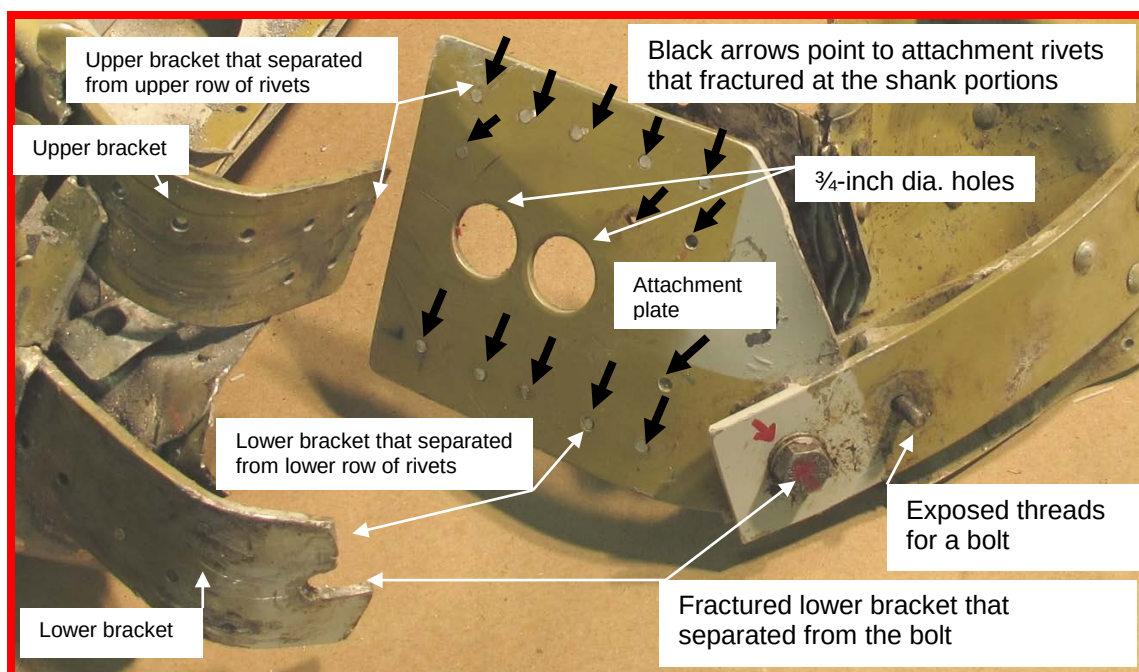
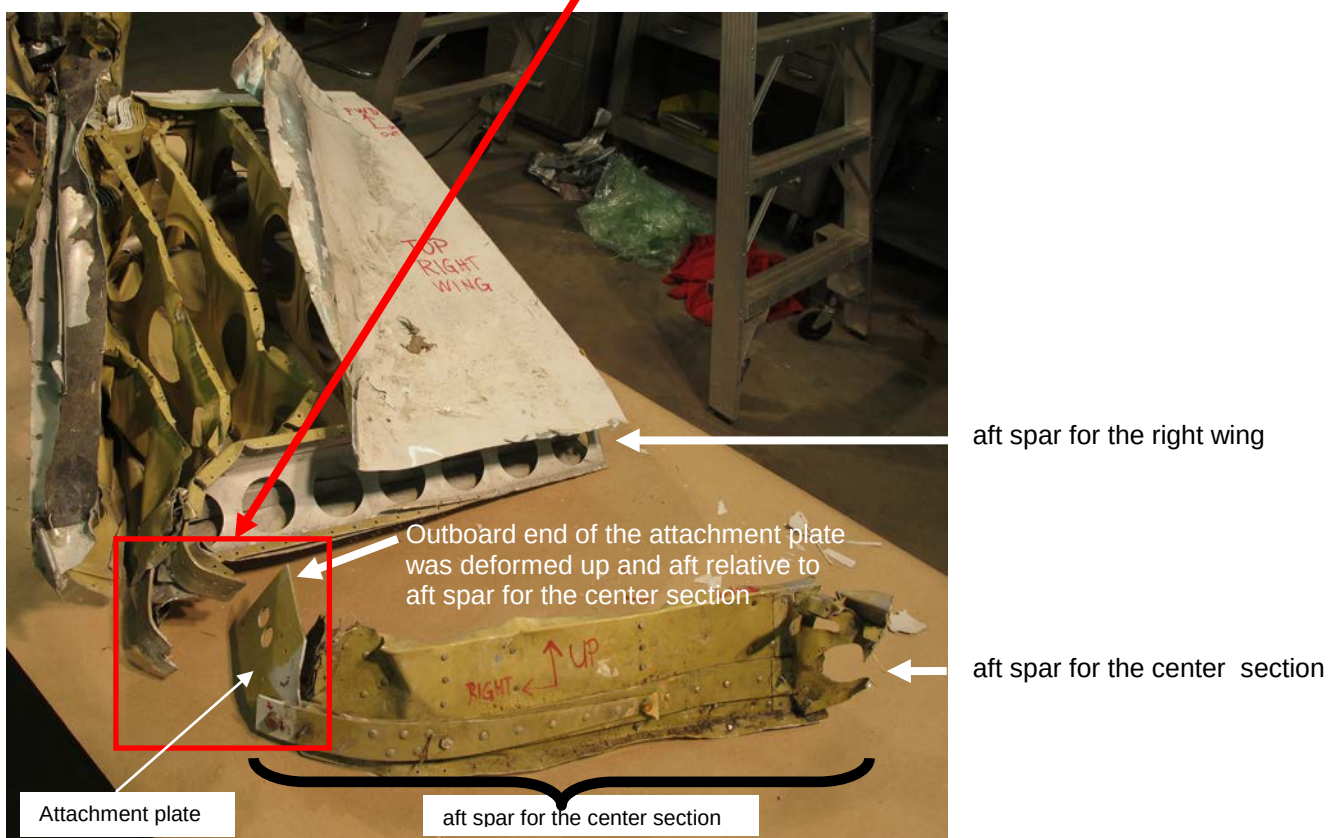
The aft spar contained an attachment plate with two holes (about  $\frac{3}{4}$ -inch diameter, each) as shown in figure 3. When intact, the attachment plate extends between the aft spar for the center section and the aft spar for the right wing. The attachment plate is to be attached by rivets to the upper and lower brackets of the aft spar for the right wing. The inboard end of the plate is to be attached by two bolts and corresponding nuts to the aft spar of the center section. Examination of the attachment plate revealed the attachment rivets between the center section and right wing fractured at the shank portions in the areas indicated by unmarked arrows in figure 3. The fracture faces of the rivets exhibited metal flow consistent with ductile separation in shear mode. The outboard end of the attachment plate was deformed up and aft relative to the aft spar of the center section. The upper and lower brackets remained attached to the aft spar of the right wing.

Figure 3. Overall view of the forward face of the aft spar for the center section relative the aft spar for the right wing (bottom of page) and higher magnification photograph of the attachment plate (top of page).
