# NATIONAL TRANSPORTATION SAFETY BOARD

## MATERIALS LABORATORY FACTUAL REPORT

Report No. 14-015

Place : Burns, Oregon  
Date : August 12, 2013  
Vehicle : McDonnell Douglas 369E, N62PJ  
NTSB No. : WPR13GA374  
Investigator : Joshua Cawthra, ASI-WPR

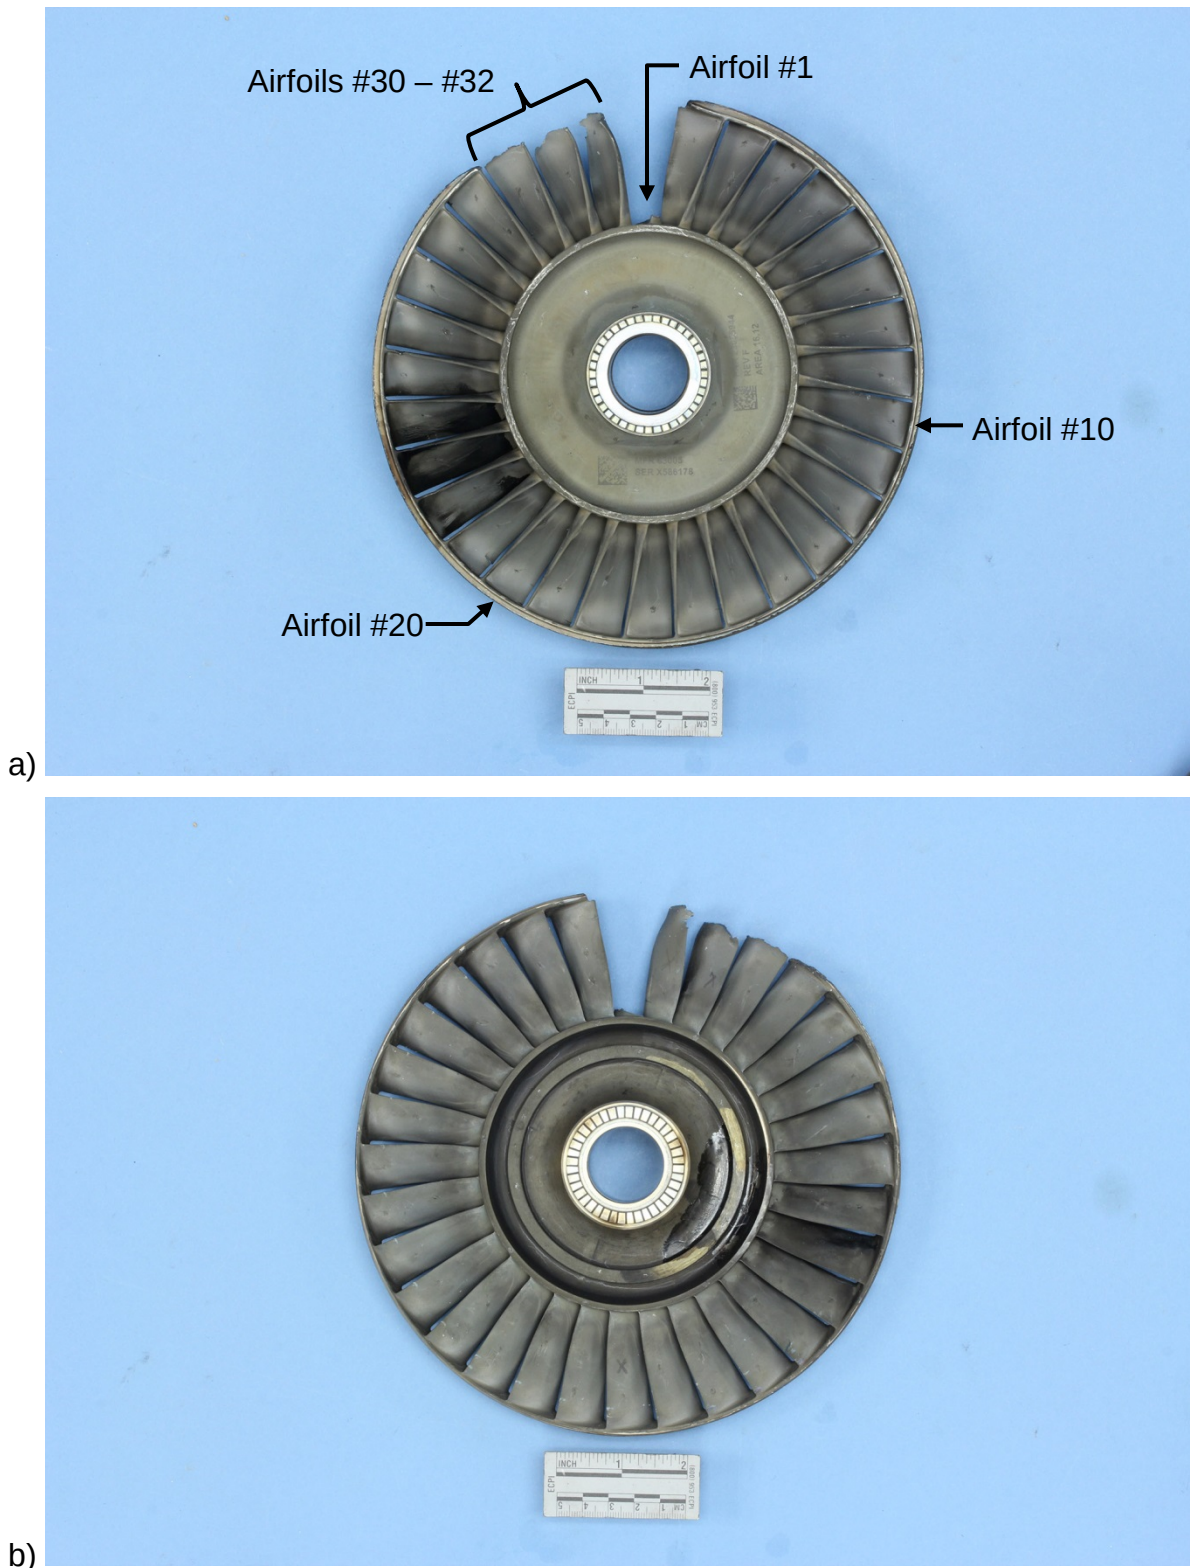
The leading edge and trailing edge sides of the fourth-stage turbine wheel are shown in figures 1a and 1b, respectively. The wheel was originally cast as a single article that contained 32 airfoils; however one of the airfoils was fractured just outboard of the rim of the wheel. For convenience, the fractured airfoil was designated as airfoil #1 and the rest of the airfoils were incrementally numbered proceeding in a clockwise direction when viewing the wheel from the leading edge side, as indicated in figure 1a. The airfoils smoothly transitioned into a continuous outer shroud that ran around the circumference of the wheel. The outer shroud was fractured adjacent to airfoils #29 and #2 and was missing across the intermediate airfoils #30 – #32. The outer shroud fractures had rough appearances that were consistent with overstress fractures.

**Figure 1:** a) Image of the leading edge side of the fourth-stage turbine wheel and b) image of the trailing edge side of the fourth-stage turbine wheel. For convenience, the fractured airfoil was designated as airfoil #1 and the remaining airfoils were incrementally numbered proceeding in a clockwise direction when viewing the wheel from the leading edge side.

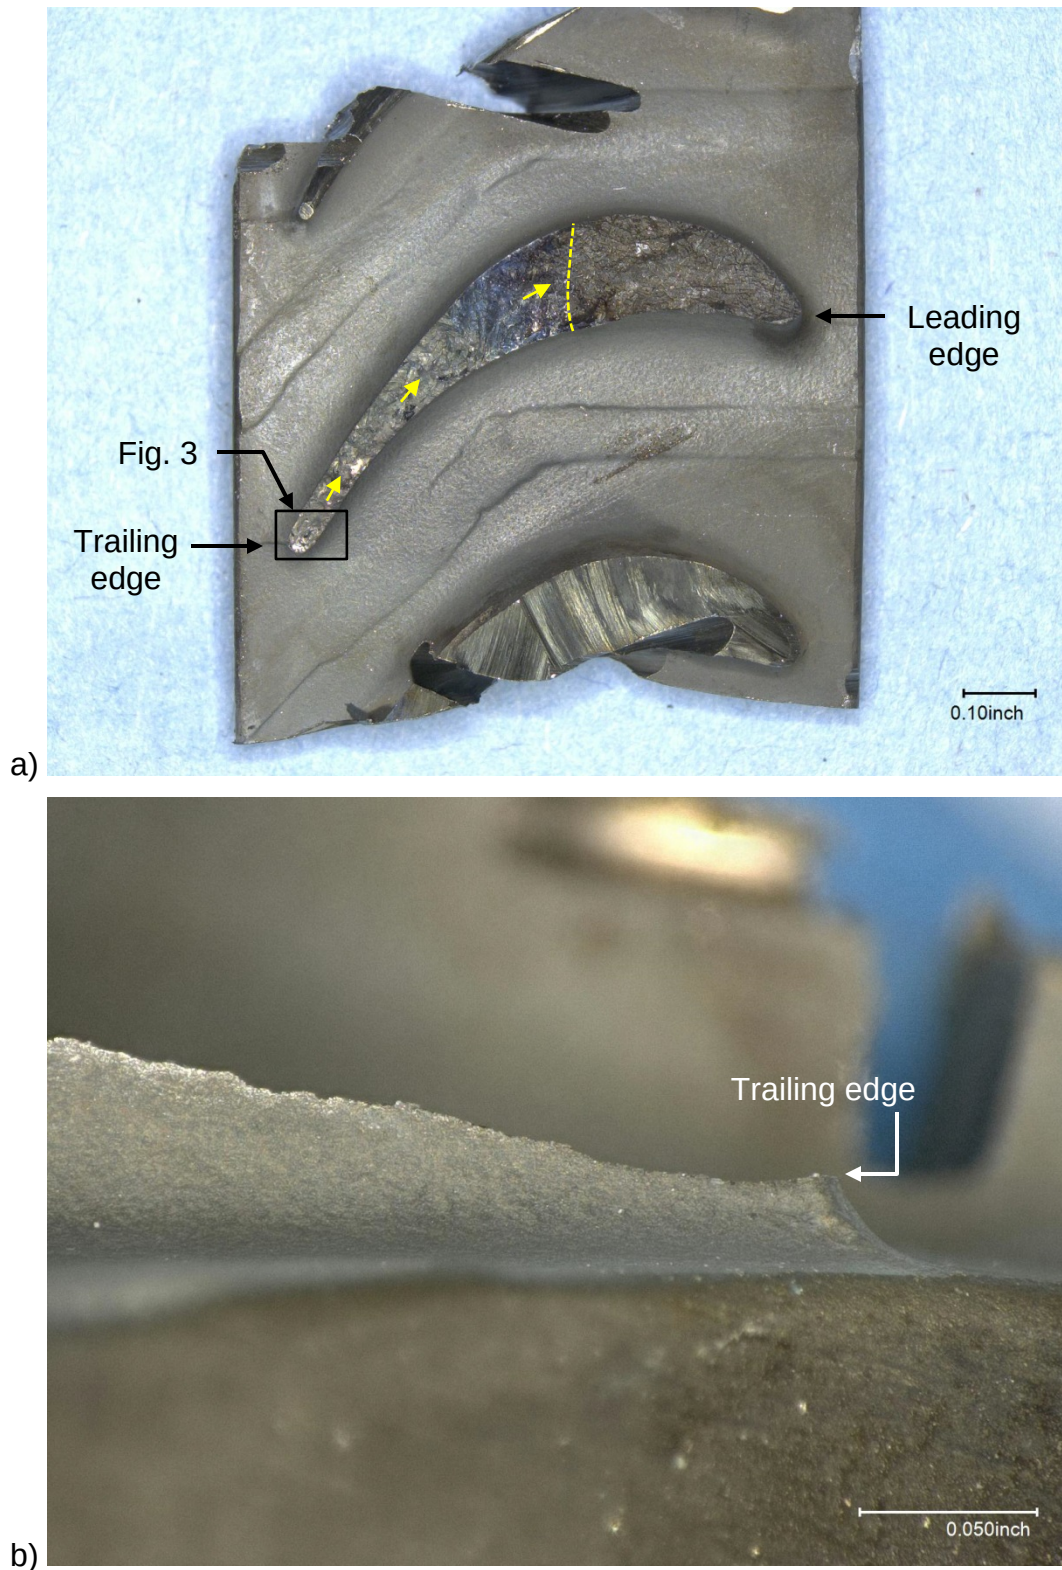
Airfoil #1 was sectioned from the wheel and first examined using an optical microscope. The fracture through airfoil #1 is shown in figure 2a. The fracture, as described below, initiated along the airfoil trailing edge and progressed by fatigue toward the leading edge, nominally following the path indicated by the yellow arrows up to the yellow-dashed line. The length of the fatigue crack, measured from the trailing edge was approximately 0.54 inch. Beyond the yellow-dashed line, the fracture surface exhibited a comparatively rough appearance that was consistent with the remaining ligament failing in overstress. A side view of the fractured airfoil trailing edge is shown in figure 2b. The fracture initiated approximately 0.025 inch above the rim where a fillet radius blended into the airfoil trailing edge. As the crack initially progressed toward the airfoil leading edge it also progressed inward toward the rim. At a distance of 0.028 inch from the trailing edge, the crack began to progress outward away from the rim as it continued its progression toward the leading edge.

**Figure 2:** a) Top down image of the fractured fourth-stage wheel airfoil #1 fracture surface. A rectangle indicates the location of an SEM image shown in figure 3 and b) sideview of the fractured airfoil trailing edge.

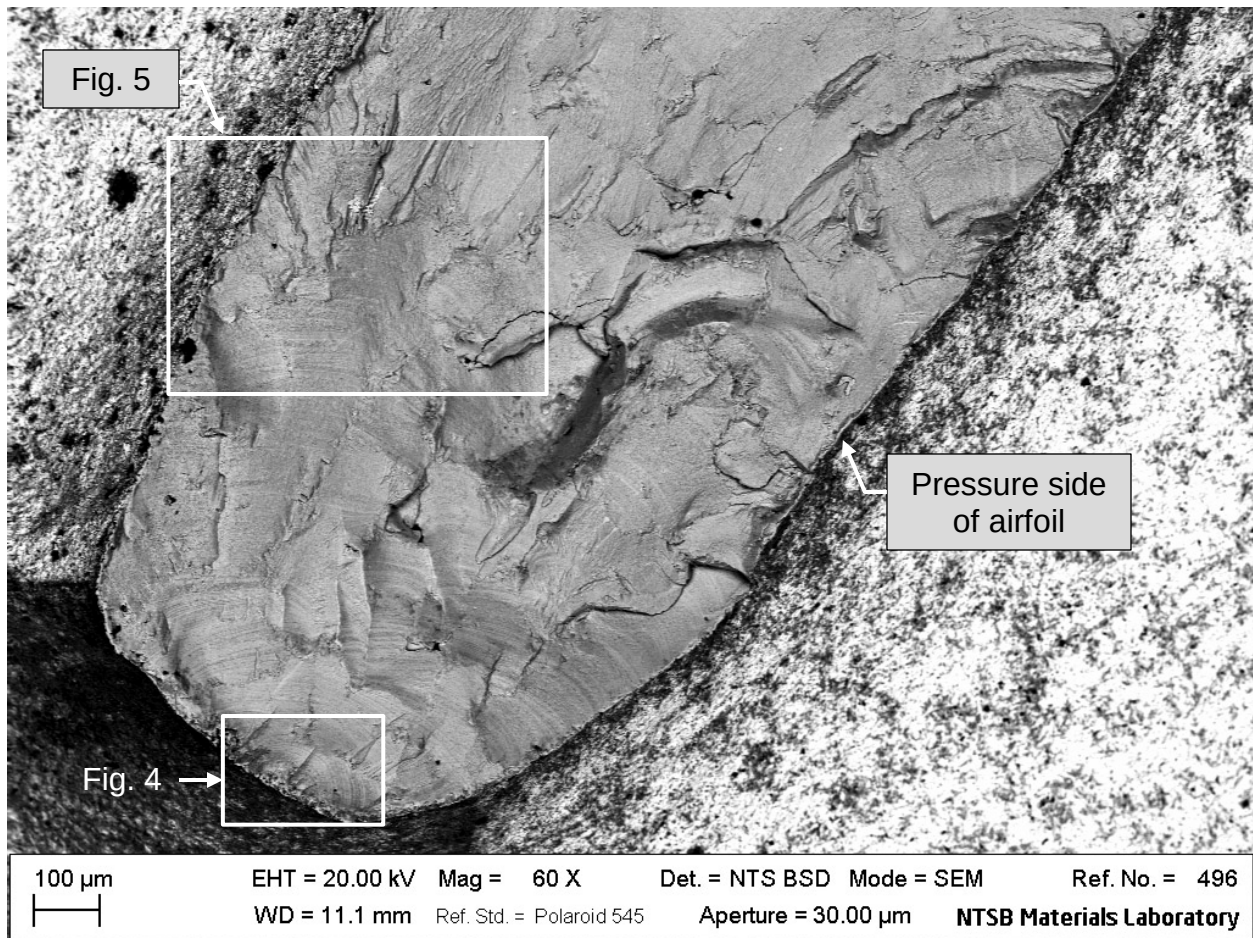
The fracture surface of airfoil 1 was examined using a scanning electron microscope (SEM) and exhibited curved fatigue crack propagation features near the trailing edge as shown in figures 3 through 5. The curvature and orientation of the features were used to trace the crack path back to an initiation site along the airfoil trailing edge. An SEM image of the initiation site is shown in figure 4 and was taken at the location indicated in figure 3. The crack initiated along a straight segment of the airfoil trailing edge approximately 0.0045 inch from a curved segment on the pressure side of the airfoil. The initiation site exhibited features consistent with oxidation and mechanical rubbing/smearing.

**Figure 3:** Overview SEM image of the airfoil #1 trailing edge fracture surface. Rectangles indicate the locations of images shown in figures 4 and 5.

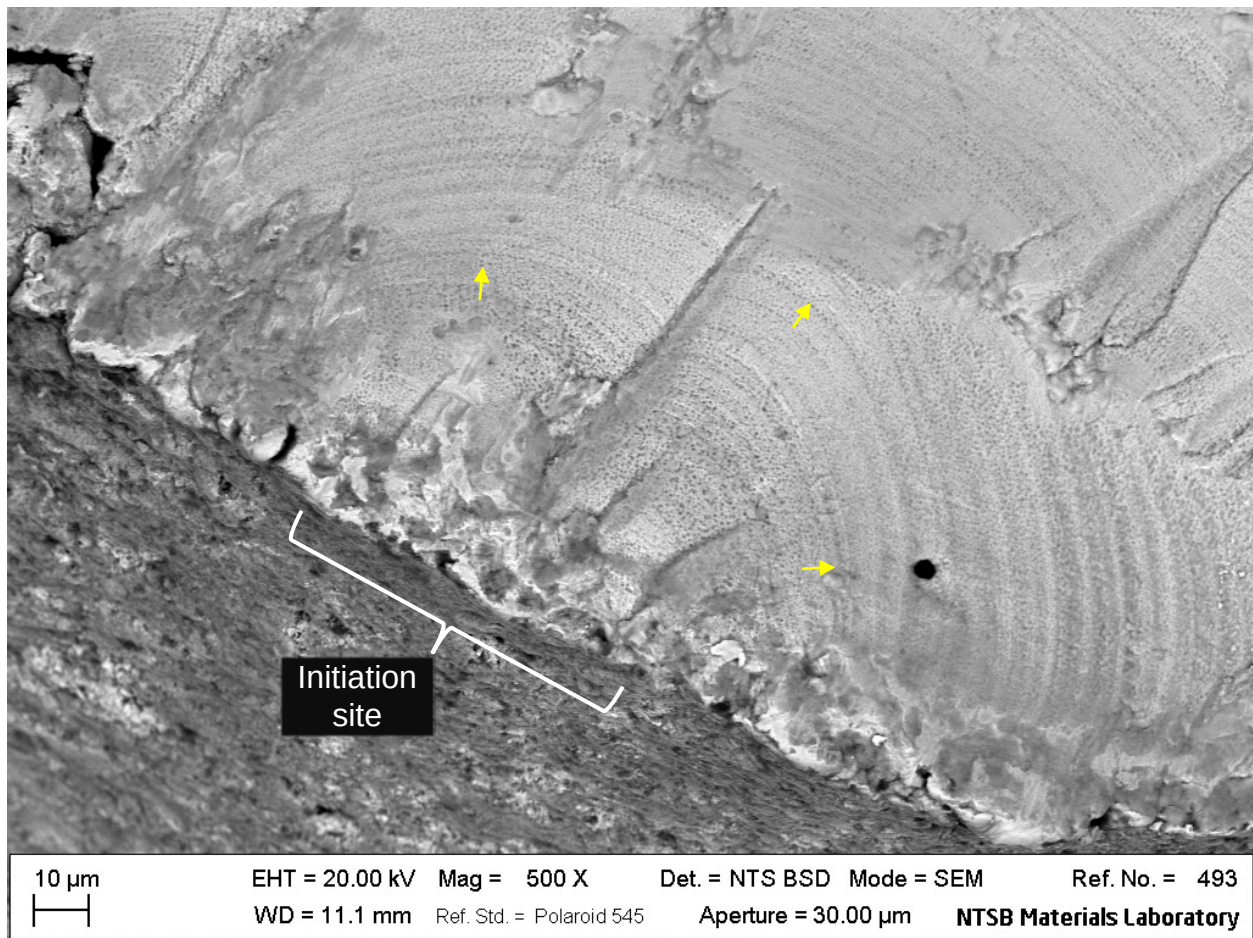
**Figure 4:** SEM image along the trailing edge of the airfoil #1 fracture surface. Fatigue crack propagation features radiated away from a straight segment of the airfoil trailing edge located approximately 0.0045 inch from a curved segment on the pressure side of the airfoil.

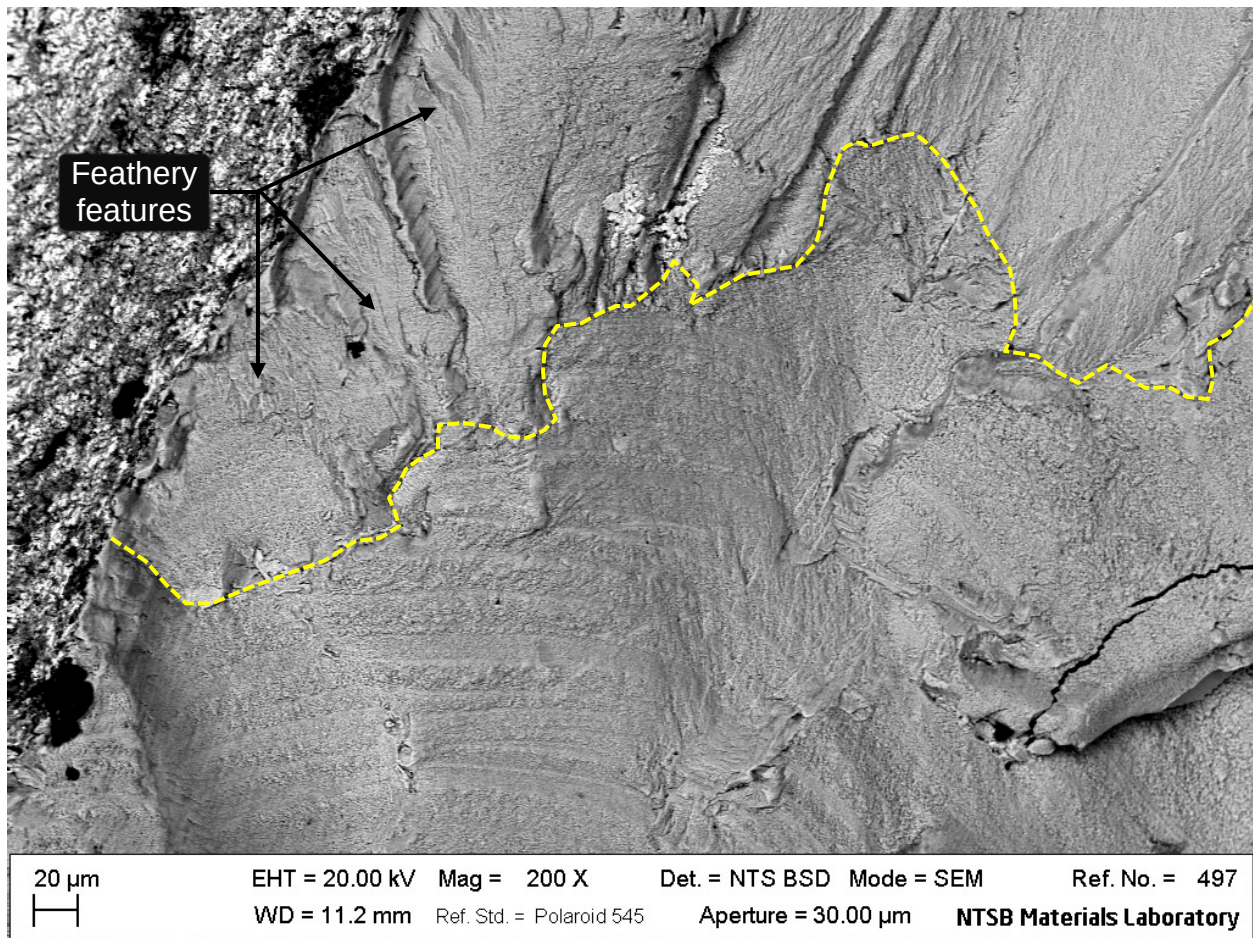
Examination of the fracture surface in the SEM revealed a boundary at which the fatigue fracture morphology changed as the crack progressed toward the airfoil leading edge. An example of the boundary for a portion of the fracture is indicated by a yellow-

dashed line in figure 5. From the initiation site up to the boundary, the fracture surface exhibited the curved fatigue crack progression features described above. Beyond the boundary the curved crack progression features diminished in appearance and the fracture surface began to exhibit feathery features. The transition occurred as far as 0.038 inch from the trailing edge of the airfoil. The feathery features persisted as the fatigue crack progressed toward the leading edge until it reached the overstress region described above.

**Figure 5:** SEM image at the location indicated in figure 3. The yellow-dashed line indicates the boundary where curved fatigue crack propagation marks diminished in appearance and feathery features emerged.

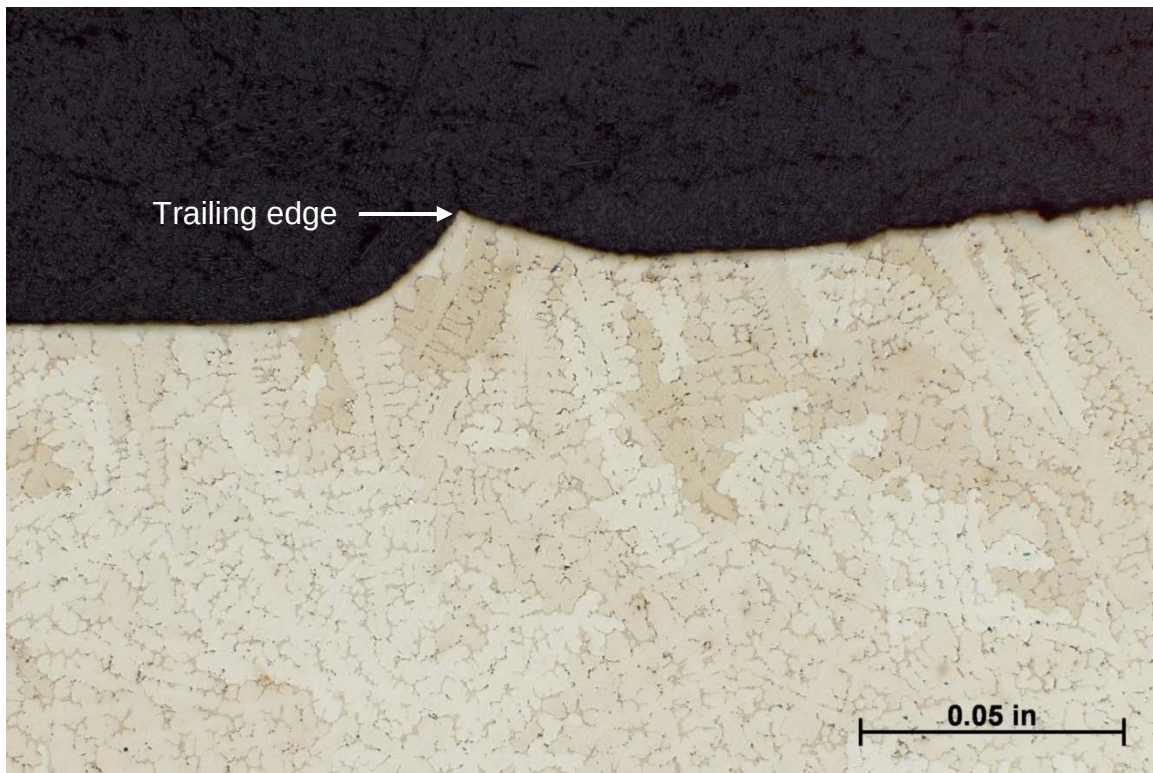
The microstructure of the fractured airfoil was also examined by preparing a metallurgical specimen. The fractured airfoil was cross sectioned, ground, and polished in accordance with ASTM E3. The sample was then etched using a mixture of 33% acetic acid, 33% nitric acid, 33% water, and 1% hydrofluoric acid. The etched cross section is shown in figure 6. The microstructure had an appearance of a typical cast microstructure and there were no apparent microstructural anomalies at or near the trailing edge.

**Figure 6:** Metallographic cross section through the airfoil #1 trailing edge adjacent to the suction side of the airfoil.

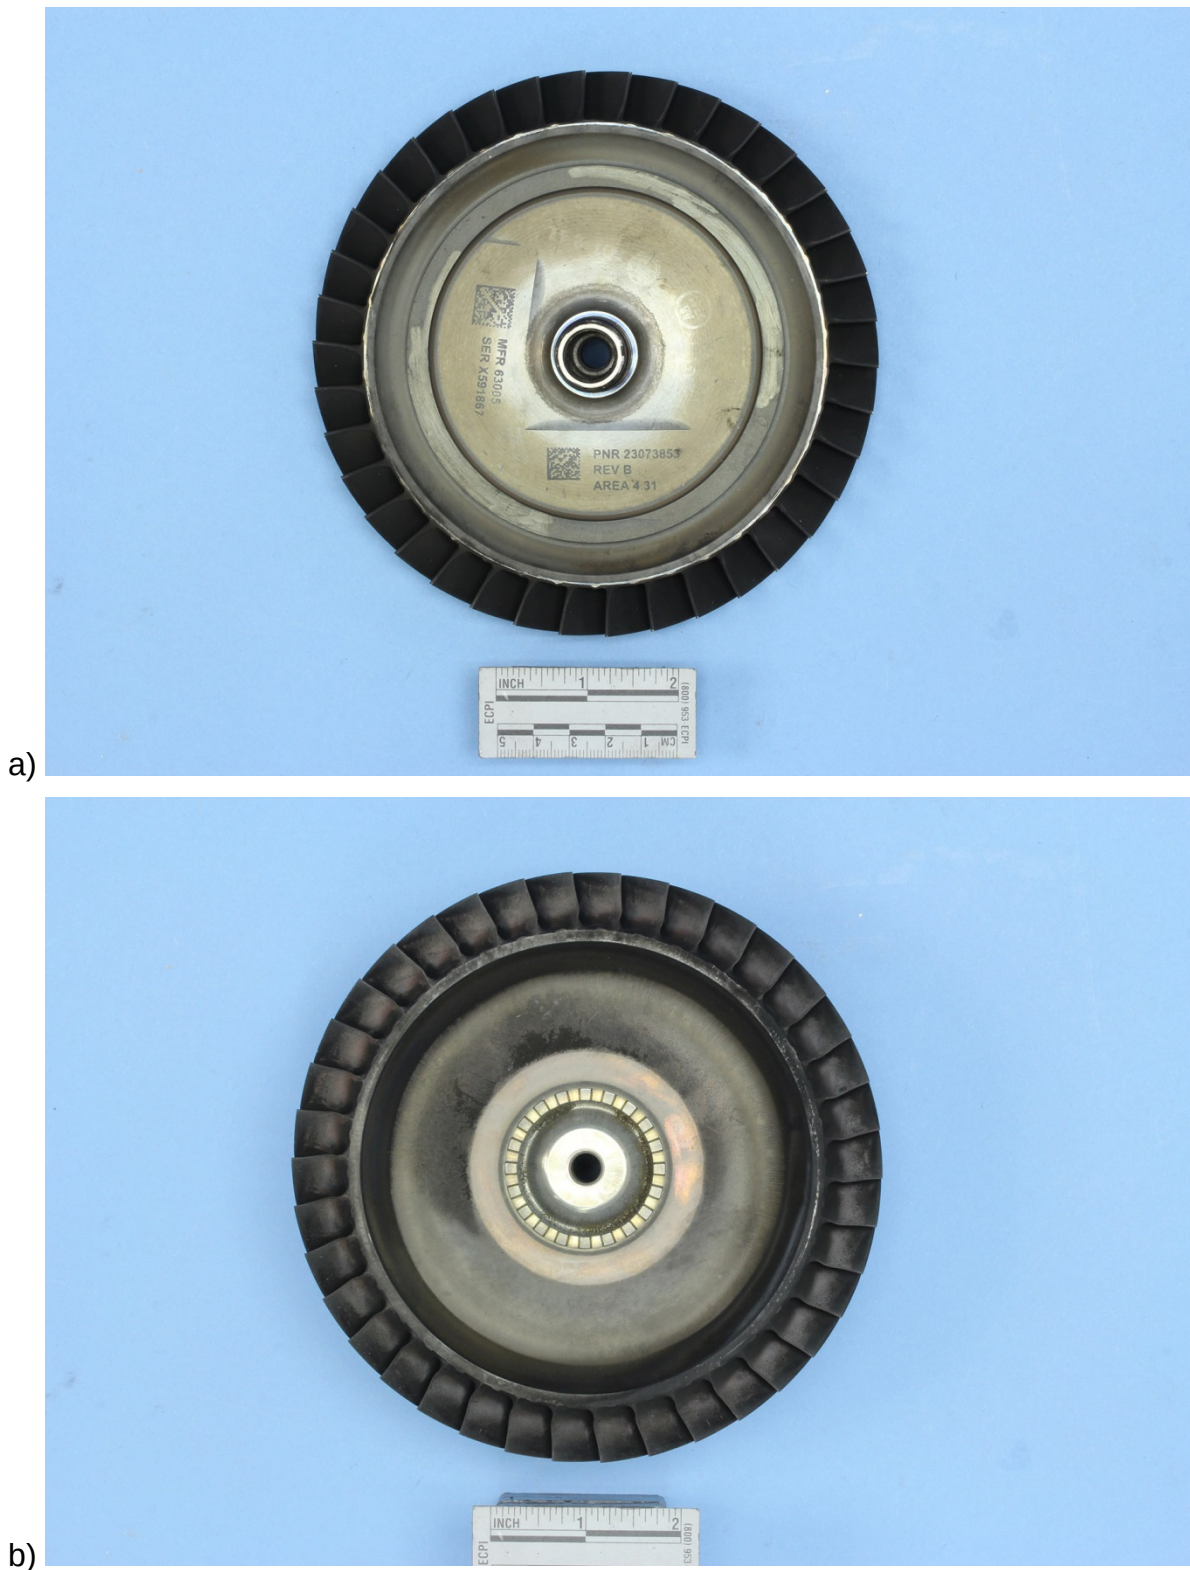
Overview images of the first-stage turbine wheel are shown in figures 7a and 7b. The airfoils on the wheel were black, consistent with a carbon-based deposit. Similar deposits were observed on the rim and as far as 0.3 inch below the rim on the trailing edge side of the wheel.

**Figure 7:** a) Image of the first stage turbine wheel leading edge side and b) image of the first stage turbine wheel trailing edge side.

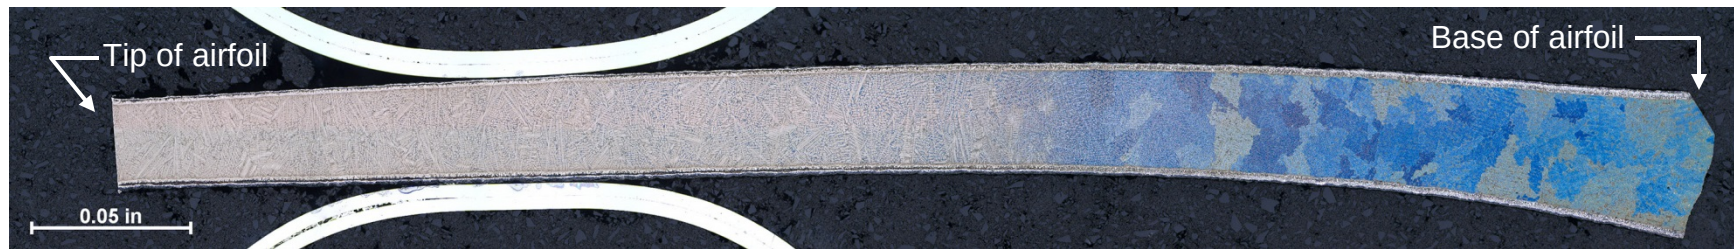
One of the airfoils was cut from the wheel for the purpose of making a metallurgical cross section. A cut was made parallel and adjacent to the trailing edge and the cut face was mounted for viewing. The sample was ground and polished in accordance with ASTM E3 and etched using a mixture of 33% acetic acid, 33% nitric acid, 33% water, and 1% hydrofluoric acid. The etched cross section is shown in figure 8. The outer portion of the airfoil etched white, while the inner portion of the airfoil etched blue.<sup>1</sup>

**Figure 8:** Metallographic cross section of a first-stage turbine wheel airfoil adjacent and parallel to the trailing edge from the base to the tip of the airfoil.

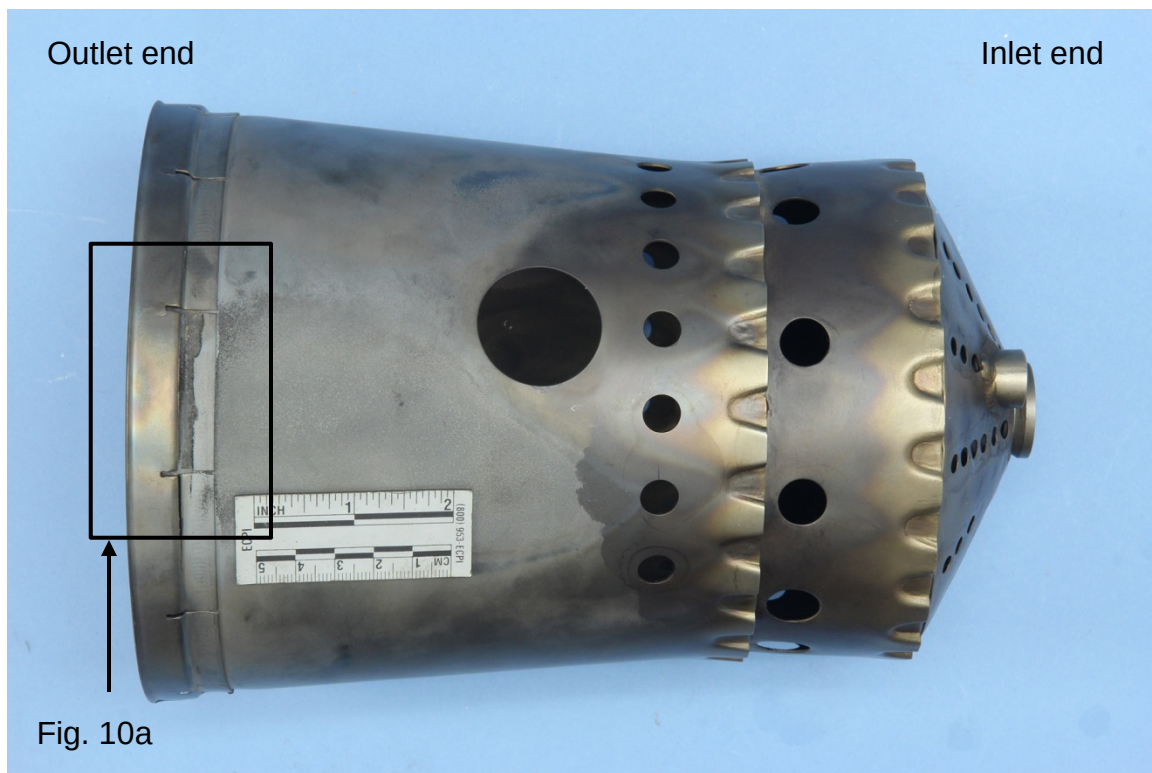
An overview image of the combustion liner is shown in figure 9. At the outlet end of the liner, there was a metal ring that was welded onto the outside of the liner by means of tabs distributed around its circumference. The weld zone on one of the tabs is indicated in figure 10a. The ring-and-tab assembly was formed in such a way that the ring and the liner formed a cylindrical groove. The groove then interfaced with a tongue on the downstream gas producer support (not shown). A piece of one of the tabs had separated from the assembly, as shown in figures 9, 10a, and 10b, and was not recovered.

**Figure 9:** Overview image of the combustion liner.

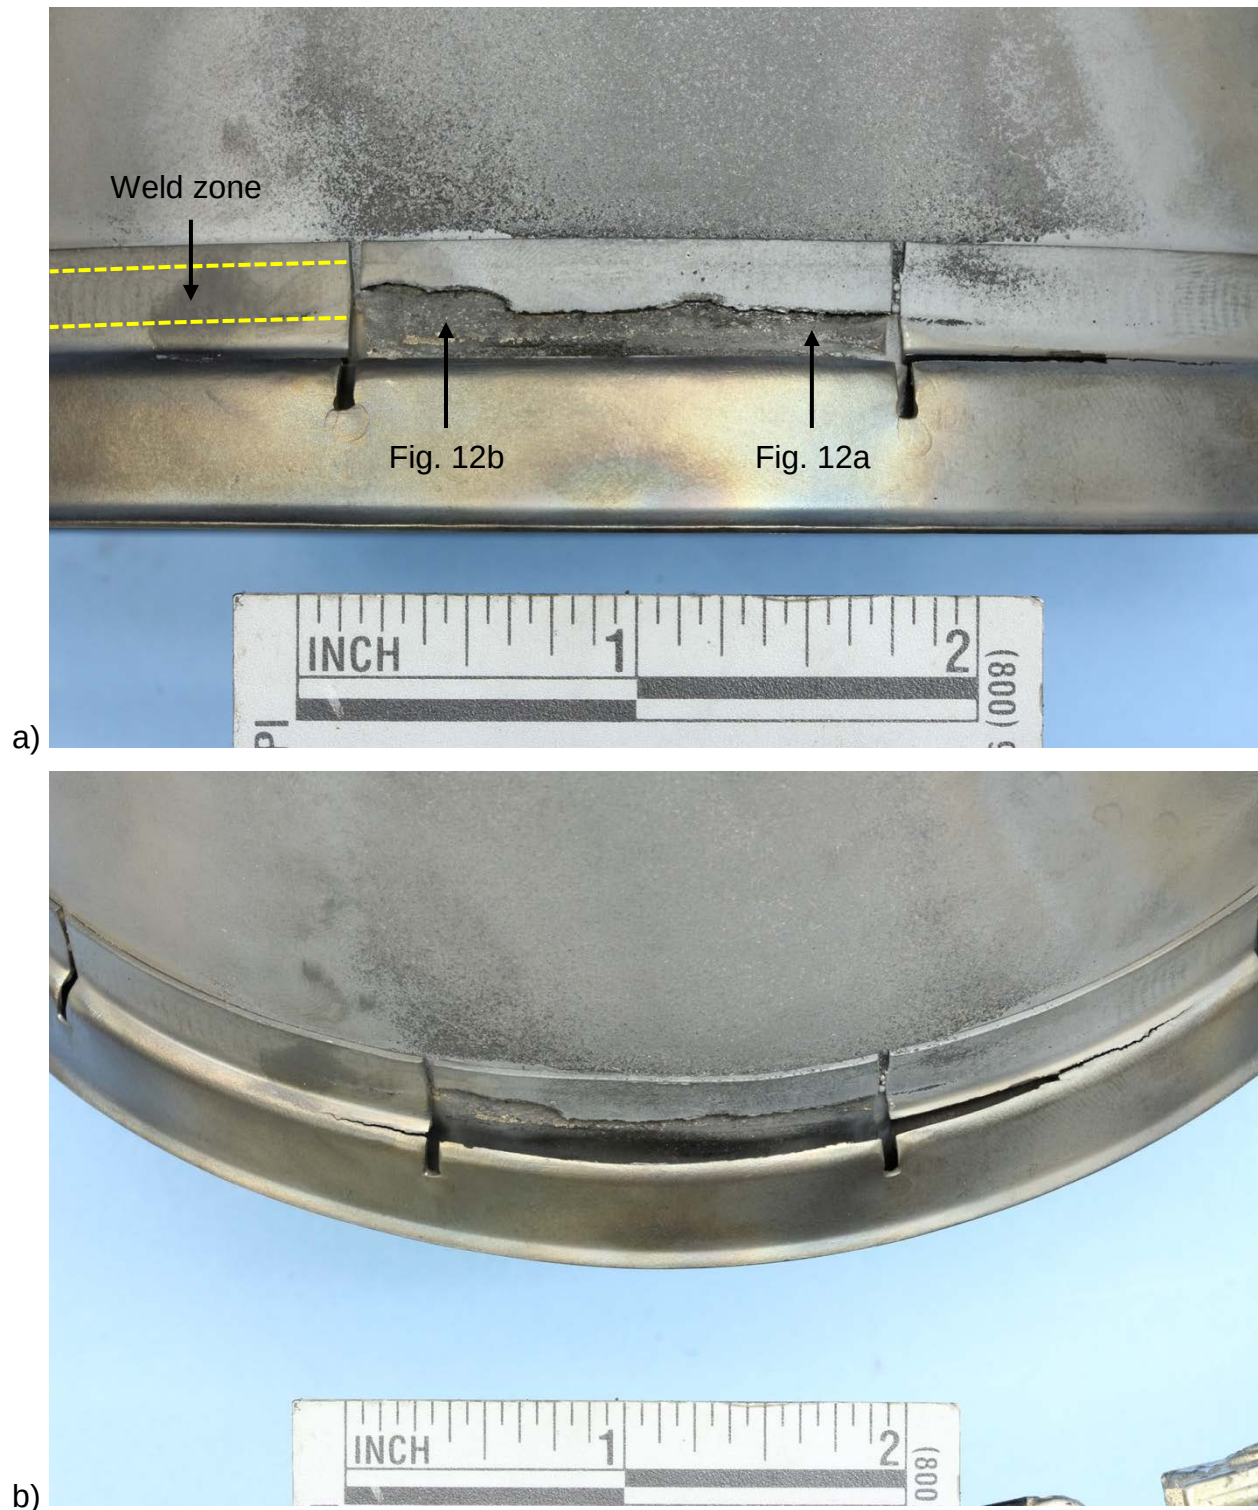
**Figure 10:** a) and b) Images of the combustion liner/ring assembly where a piece of a tab had separated.

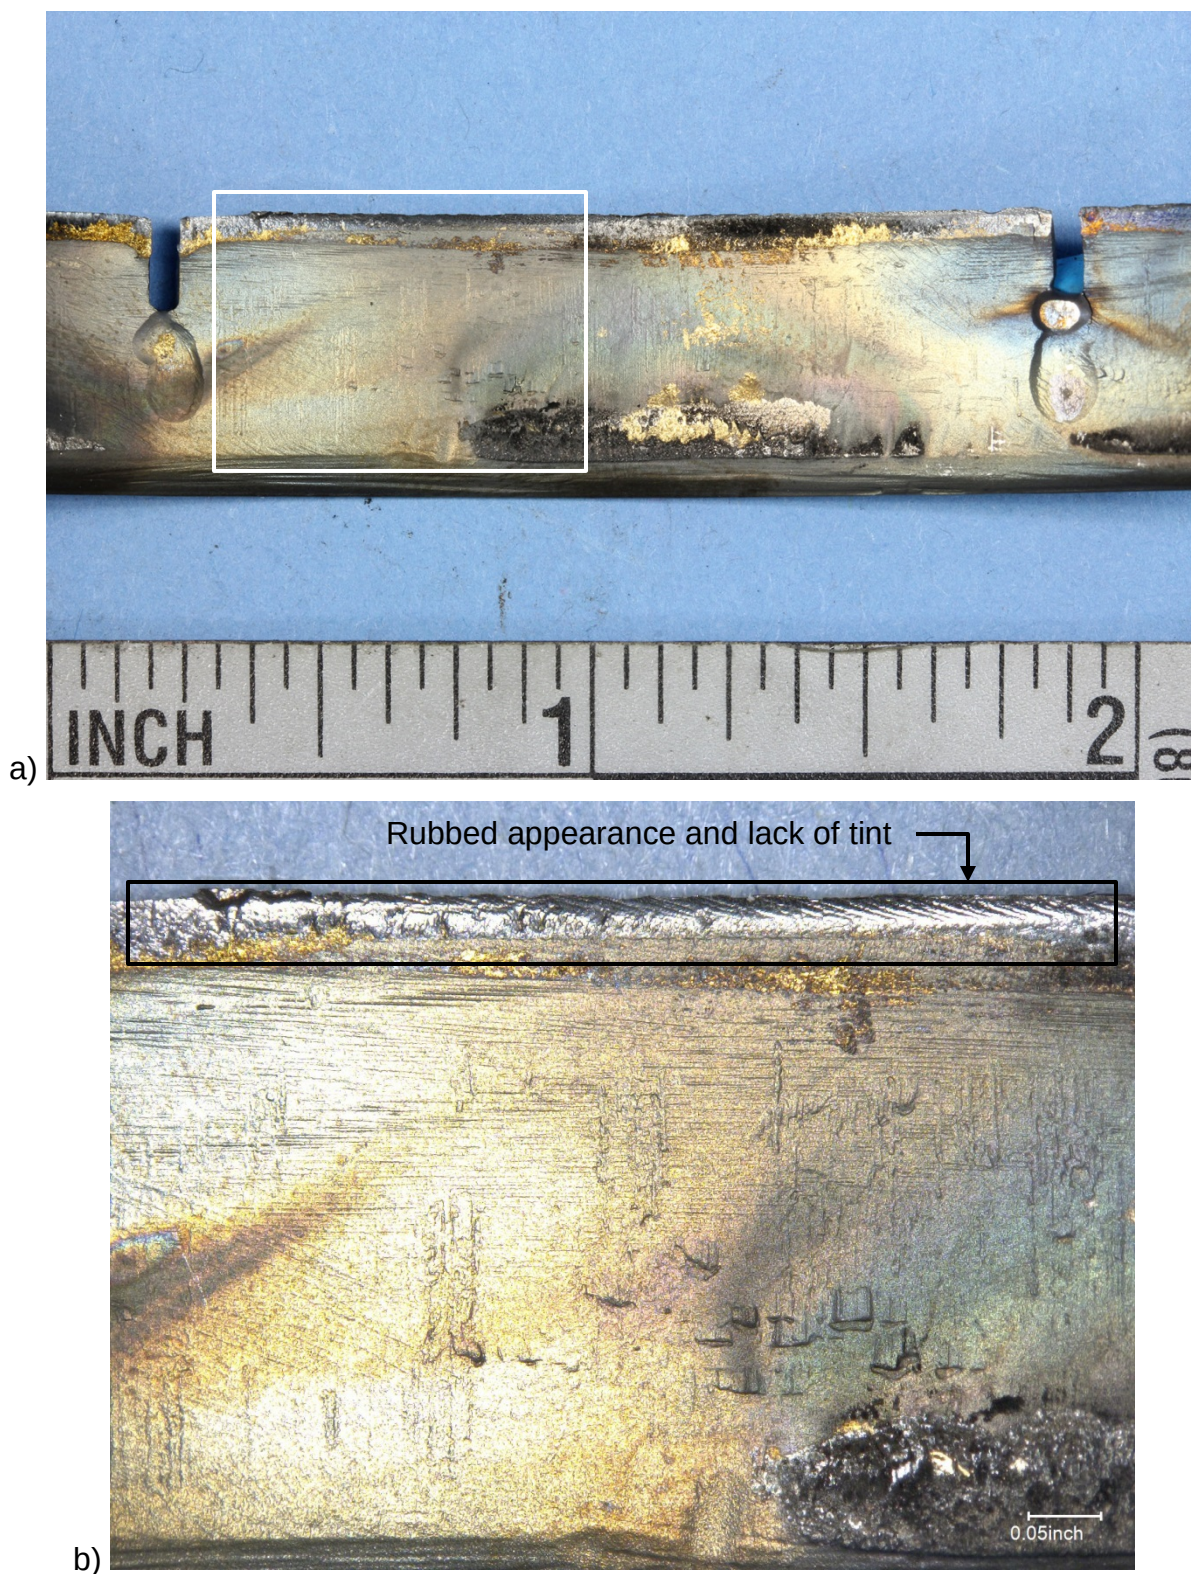
The ring at the separated tab was cut out and the inside surface was visually examined. The majority of the surface exhibited varying shades of a gold or blue tint, as shown in figures 11a and 11b. However along the edge of a manufactured bend, where the base of the tab had separated, the surface had a rubbed appearance and lacked the tint, as indicated in figure 11b. The features were consistent with wear through the metal at the bend.

**Figure 11:** a) The inside surface of the ring section taken from where a piece of a tab had separated from the liner assembly and b) higher magnification image highlighting a location where the material exhibited a rubbed appearance and lack of tint.

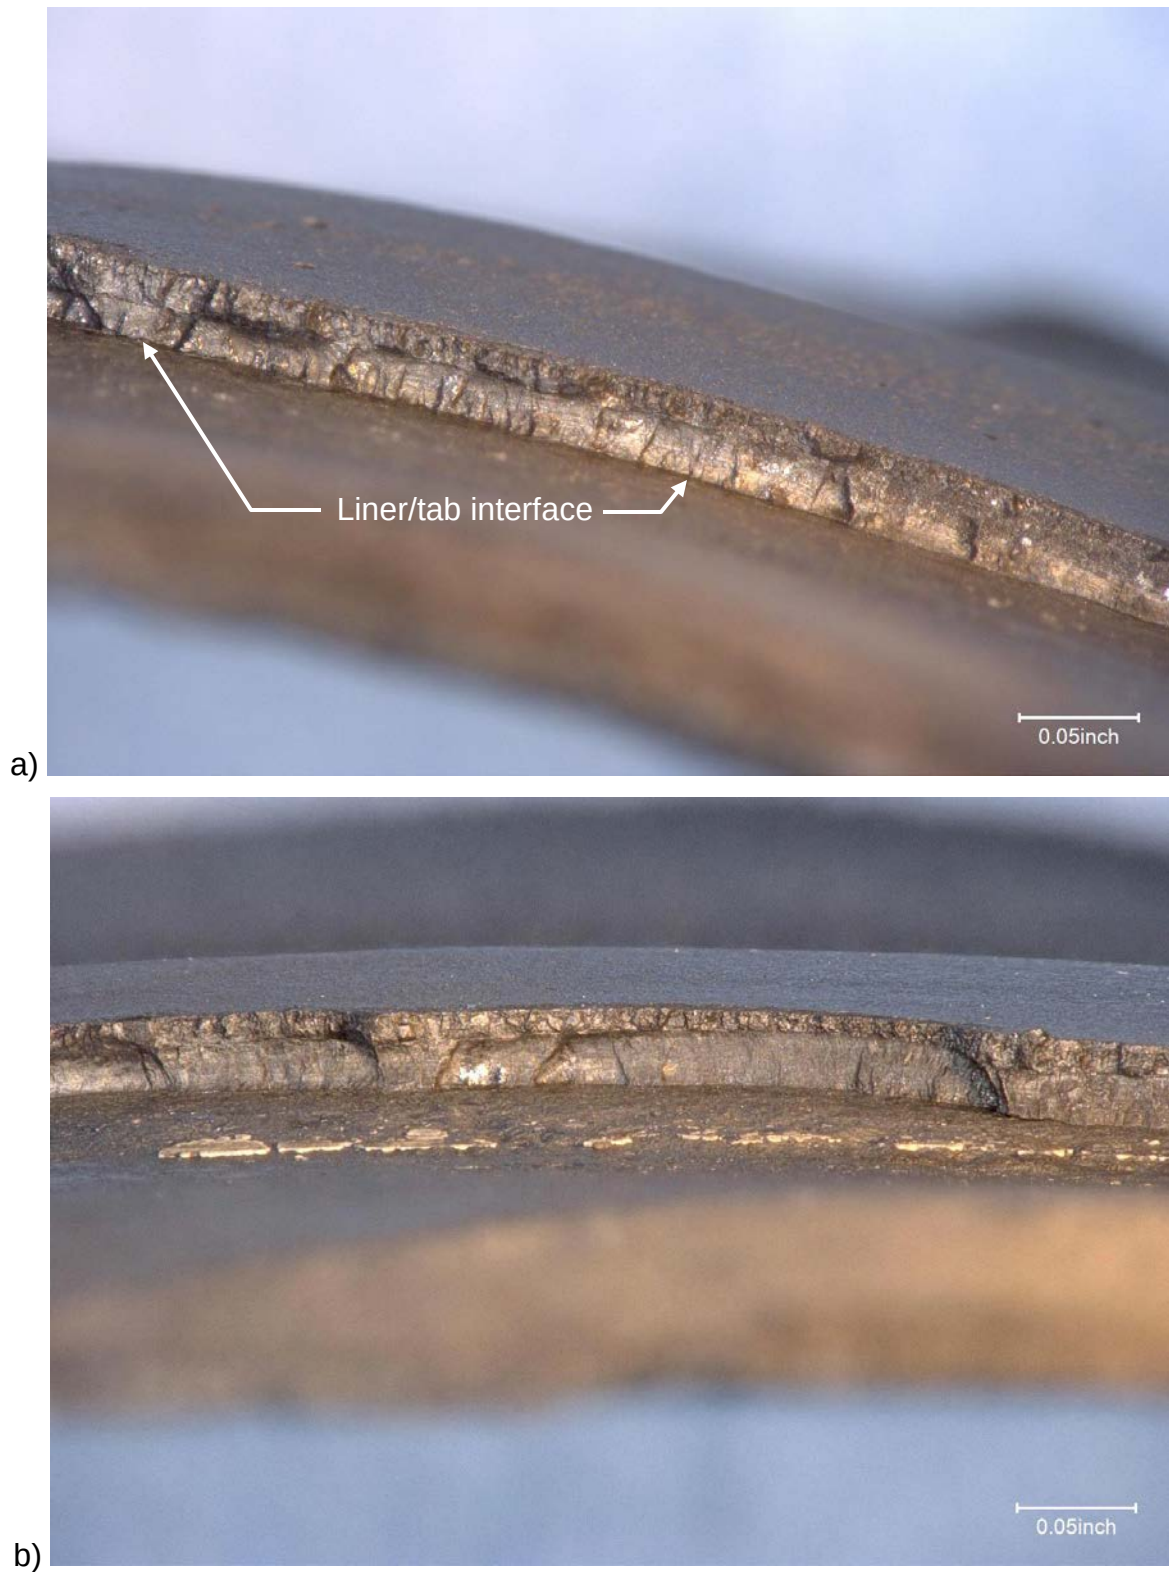
The fragment of the welded tab that remained attached to the liner was examined using a digital optical microscope. Two images of the fracture through the tab are shown in figures 12a and 12b at the locations indicated in figure 10a. The fracture surface radially inward (adjacent to the liner) was comparatively flat and the fracture surface radially outward was comparatively rough. Ratchet marks and thumbnail-shaped features were observed within the flat fracture region that were consistent with multi-site fatigue crack initiation along the welded interface between the liner and the tab. The comparatively rough appearance within the radially outward portion of the fracture surface was consistent with an overstress fracture of the remaining ligament.

**Figure 12:** a) and b) Images of the fracture through the welded tab, taken at the locations indicated in figure 10a.
