**NATIONAL TRANSPORTATION SAFETY BOARD**  
**Office of Aviation Safety**  
**Washington, D.C. 20594**

**POWERPLANT GROUP CHAIRMAN'S FACTUAL REPORT**

**NTSB No: WPR13GA374**

Aircraft: MD Helicopter Inc. (MDHI) 369E Helicopter, Registration Number N62PJ

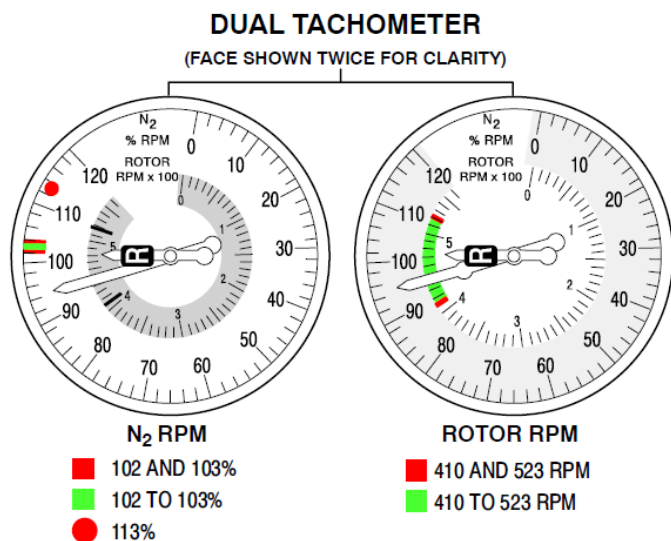
Figure 1 – MDHI Engine- Rotor RPM Gauge

- The MDHI rotor system inertia is lower than the Bell.
- Because of the low rotor system inertia on the MDHI, the control system response is therefore faster than on the Bell. Its throttle damping characteristics are therefore also less, so that the engine can react faster to a low rotor RPM condition.
- MDHI has a higher max speed power-off transmission limit.
- MDHI has a higher max speed power-on transmission limit.
- MDHI has a higher beep check speed.
- MDHI has a higher maximum continuous (Mcont) power (350 SHP Mcont power limitation at 34,289 RPM (103%) versus the Bell installation with 270 SHP Mcont power limitation at 33,290 RPM (100%).
- MDHI FCU maximum fuel flow stop is higher than that on the Bell.
- Gauge markings in the cockpit are different (See [Figure 1](#) & [Figure 2](#))
- Low rotor RPM warning is higher on the MDHI.

In summary, the power turbine speed variation that an engine is subject to on MDHI application was between 98% to 113% RPM while the Bell application was between 90% to 107%.

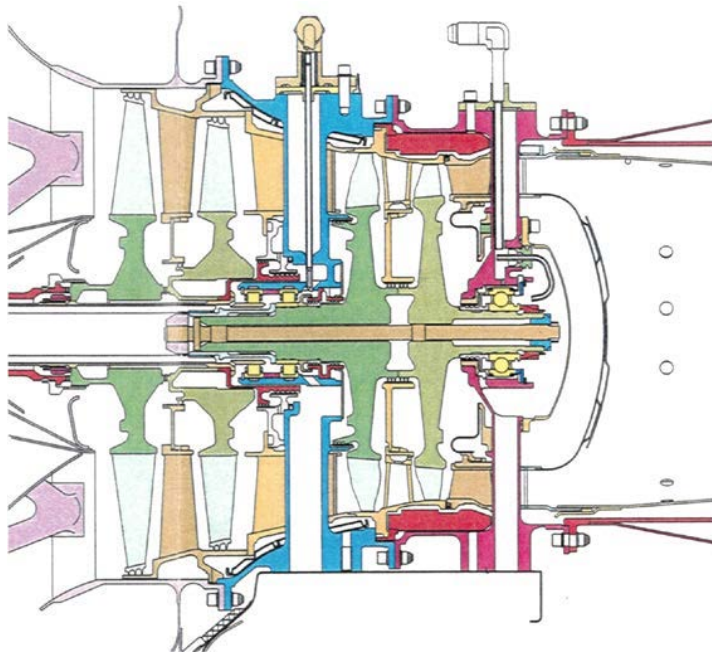
Figure 4 – Engine S/N CAE-836896 – As Received

The engine was in a metal engine container which was opened in the presence of the NTSB ([Figure 4](#)). The engine is of a modular design and a complete engine consists of three serialized major assemblies: the compressor module, the gearbox module, the turbine module.

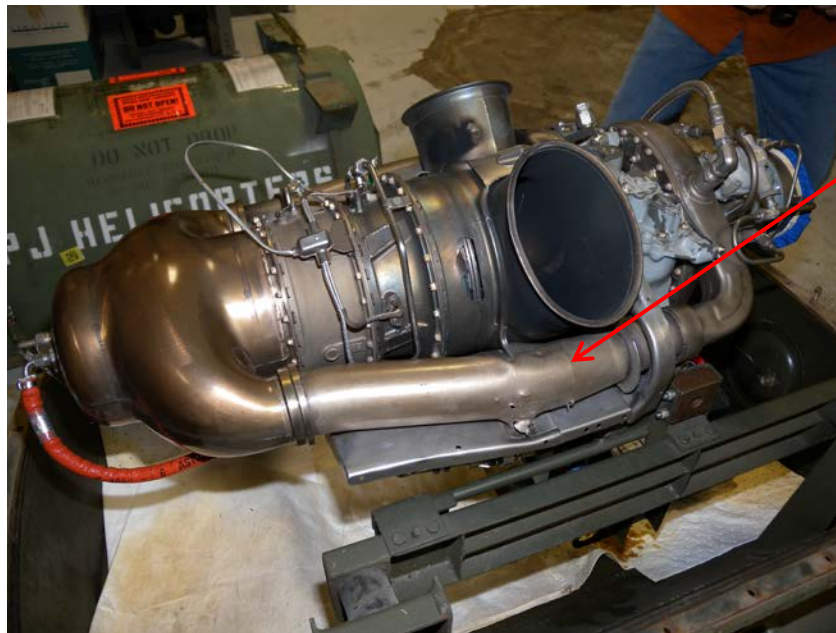
Figure 5 – Gearbox – External View

The gearbox module, S/N CAG 34078 and was intact and appeared to be undamaged ([Figure 5](#)). An examination of the two chip detectors revealed one small shiny flake in the lower chip detector while the upper was clean.

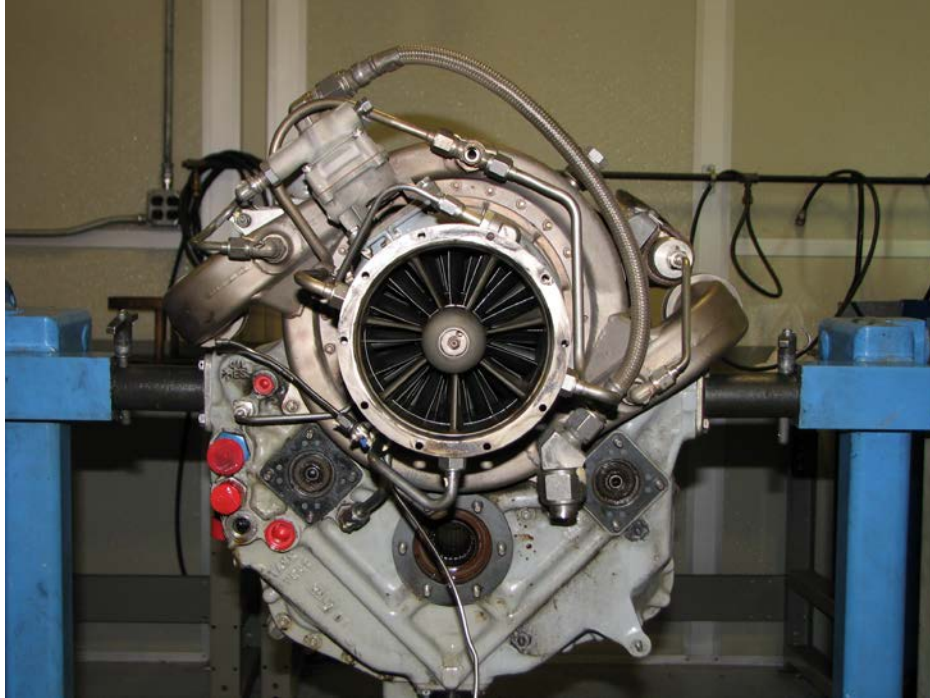
Figure 6 – 1<sup>st</sup> Stage Compressor

The compressor module, S/N CAC 38234F and the diffuser scroll case were intact and appeared to be undamaged. The 1<sup>st</sup> stage compressor blades were intact (Figure 6), complete and undamaged and the compressor rotor could be rotated by hand. The compressor assembly was not disassembled further.

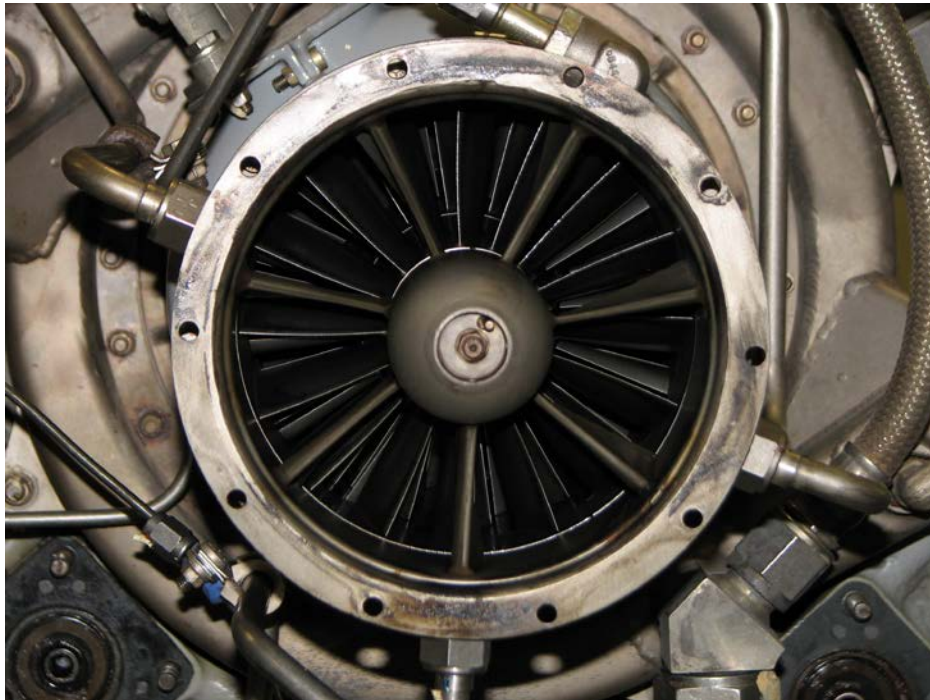
Figure 7 – 1<sup>st</sup> Stage Turbine Nozzle

The 1<sup>st</sup> stage turbine nozzle was intact and undamaged (Figure 7). All the airfoils were coated with a flaky black sooty deposit that was easily removed with finger pressure. The 1<sup>st</sup> stage turbine wheel was intact and undamaged (Figure 8). The curvic coupling was intact and undamaged.

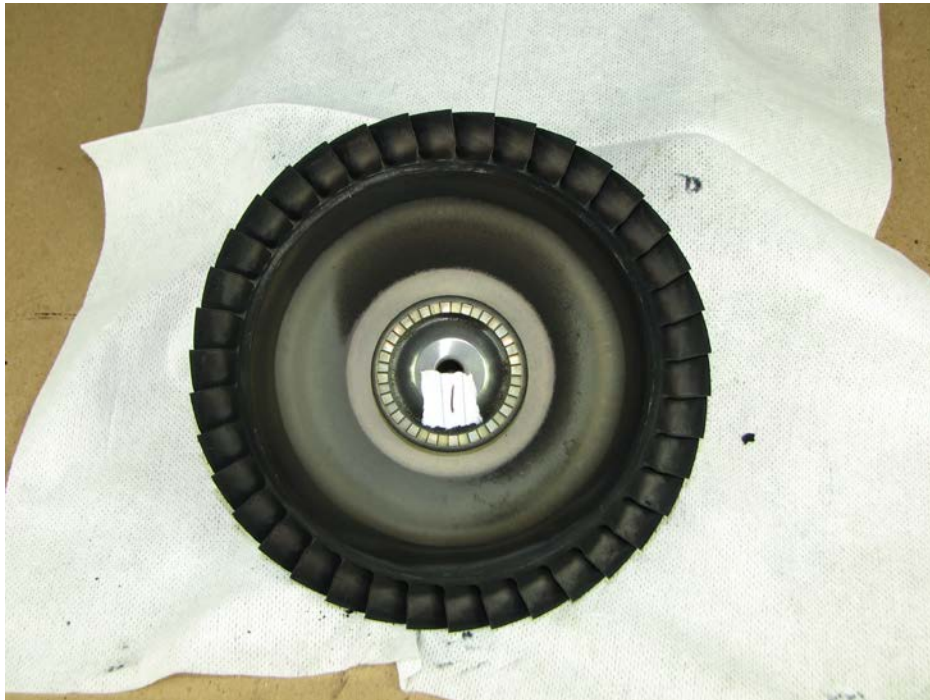
Figure 9 – 2<sup>nd</sup> Stage Turbine Wheel

The 2<sup>nd</sup> stage turbine nozzle was intact and undamaged. The 2<sup>nd</sup> stage turbine wheel and its curvic coupling was intact and undamaged (Figure 9 & Figure 10).

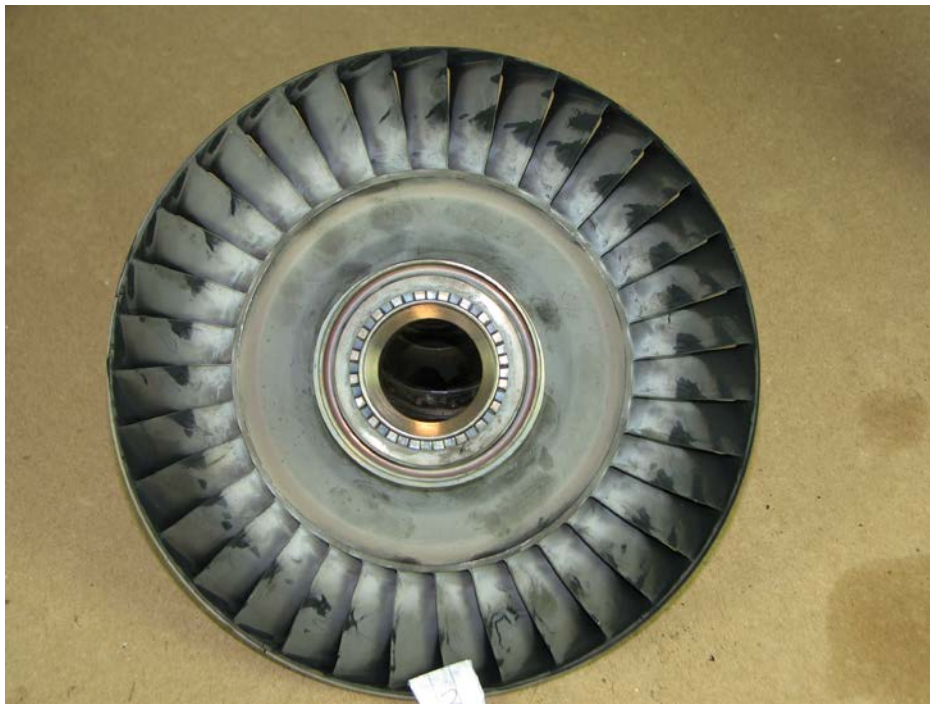
Figure 19 – 4th Stage Turbine Nozzle & Turbine Wheel

The 4<sup>th</sup> stage turbine nozzle was generally intact; however a 190 degree segment of the 4<sup>th</sup> stage turbine blade track was fractured in the plane of the 4<sup>th</sup> stage turbine wheel, consistent in location with the fracture of the exhaust collector housing (Figure 19). The 4<sup>th</sup> stage blade track was heavily rotationally scored. All the nozzle vanes were present and undamaged. The 3<sup>rd</sup> stage turbine blade track was rotationally scored, consistent with contact against the 3<sup>rd</sup> stage turbine wheel labyrinth seals.

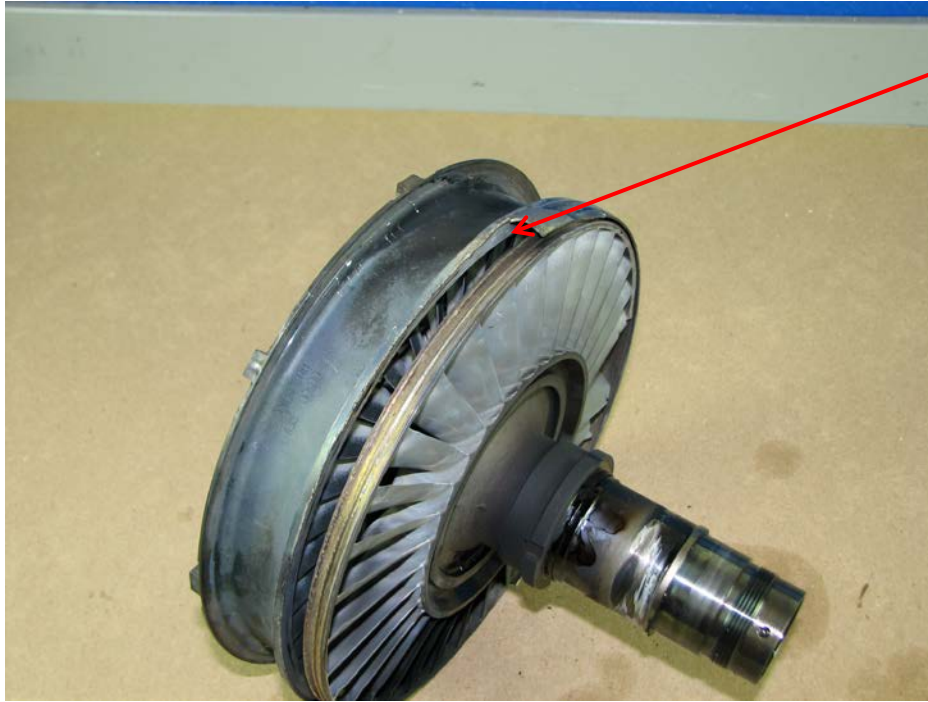
Figure 20 – 4th Stage Turbine Wheel

The 4<sup>th</sup> stage turbine wheel was missing one blade (Figure 20 & Figure 21). The missing blade was fractured near the inner rim (Figure 22). A 4-blade span of the shroud was also missing; it was located outboard of the liberated and three adjacent lagging blades. The three lagging adjacent blades were fractured near the tips, were missing the entire shroud segment and were twisted (Figure 23). The leading and lagging adjacent blades were still attached to the inner platform rim. All the other blades were present and intact however all were dented at the trailing edges approximately ½ inch inwards from the blade shroud. Nine of the curvic coupling teeth which mate to the 3<sup>rd</sup> stage turbine wheel were smeared on their contact faces; however, all were still intact (Figure 24).

190 degree segment  
of the 4th stage  
turbine shroud was  
fractured

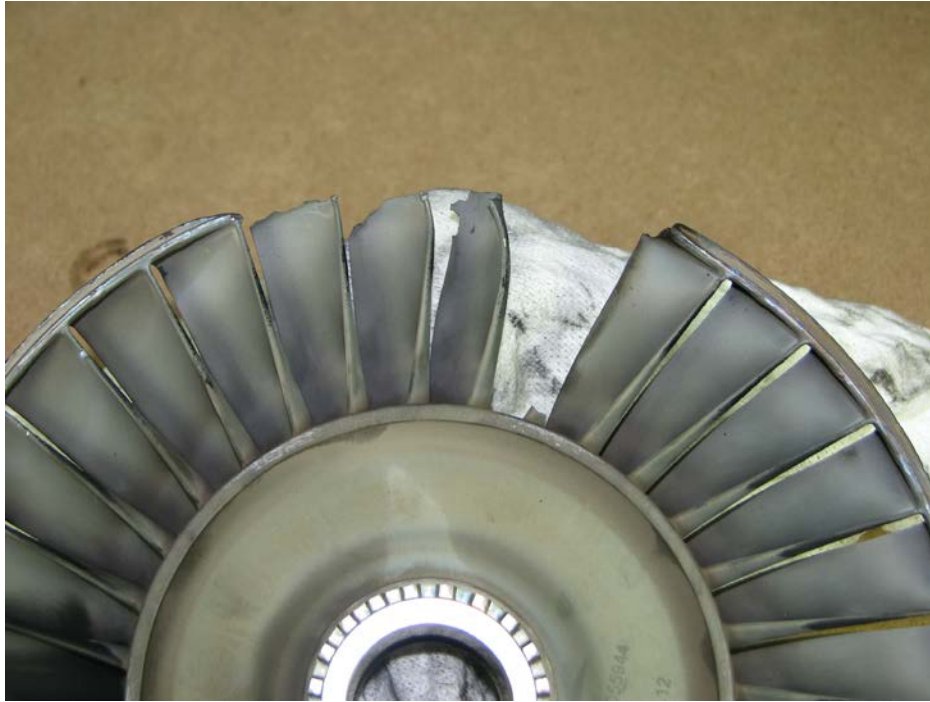
Figure 22 – 4<sup>th</sup> Stage Turbine Wheel - Fractured Near the Inner Platform

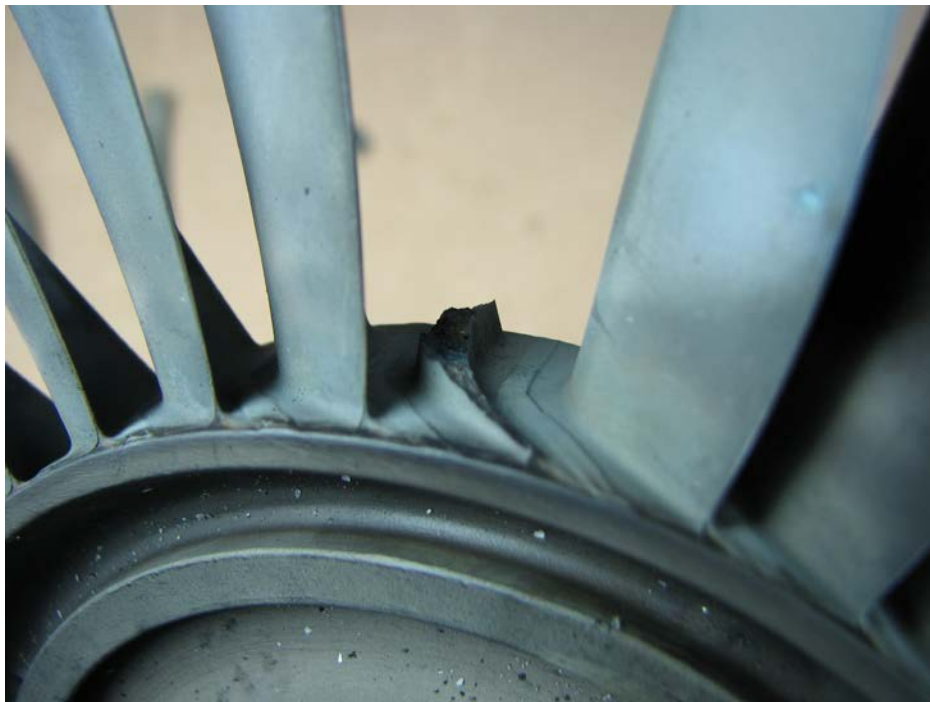
**Figure 23** – 4th Stage Turbine Wheel - Three Lagging Adjacent Blades Were Fractured and Twisted Near the Tips

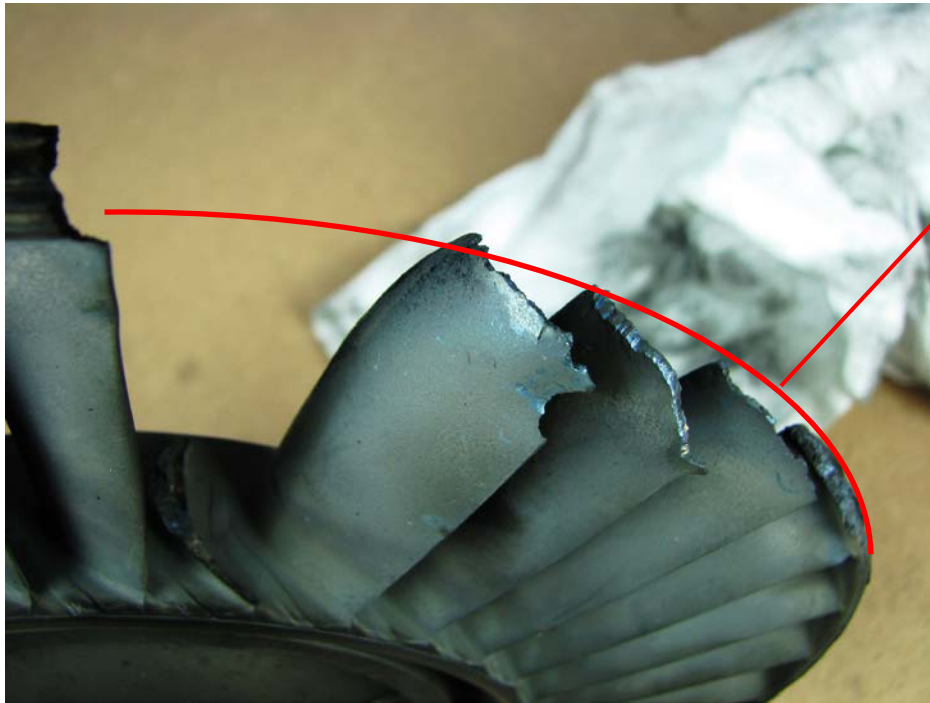
**Figure 24** – 4th Stage Turbine Wheel – Curvic Teeth

the entire rim  
segment of 4 blades  
was missing

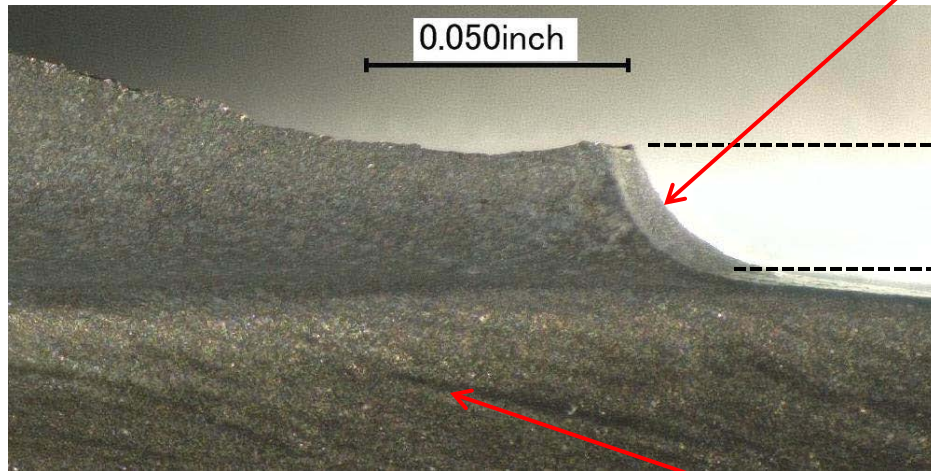
Figure 26 – Fracture Surface on Failed 4<sup>th</sup> Stage Turbine Wheel Blade

- 1) The 4<sup>th</sup> stage turbine wheel was P/N 23055944-F, S/N X586178.
- 2) One 4<sup>th</sup> stage turbine wheel airfoil fractured and separated due to fatigue. The fracture initiated as a low cycle fatigue (LCF) crack at the trailing edge of the airfoil at about 0.025 inch outboard of the hub rim (Figure 25) and propagated forward for 0.035 inch (Figure 26), at which point it transitioned

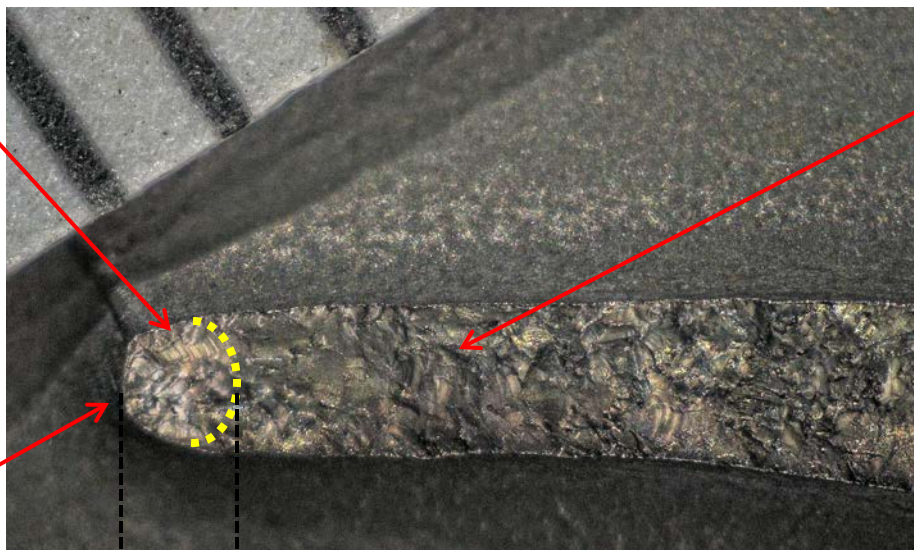
into a high cycle fatigue (HCF) crack, growing approximately 0.494 inches long before the airfoil separated in overload (Figure 27).

Low Cycle  
Fatigue  
(LCF)  
Section

High Cycle  
Fatigue (HCF)  
Section
