**Class A Accident**  
**November 23, 2012**  
**Eurocopter AS-350B3 (2B1) Helicopter**  
**N3984A**  
**Newfield, Arizona**

**Accident Report**  
CBP Case Number 20121124ZC0001  
NTSB Case Number WPR13GA051

**U.S. Customs and  
Border Protection**

## **Aircraft Accident Report**

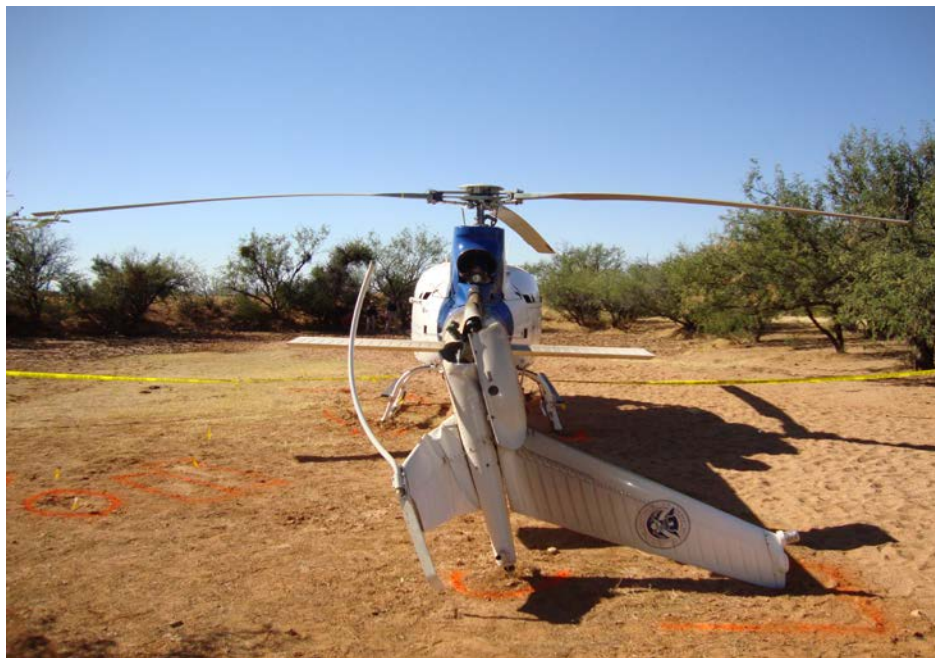
- Tail cone (aft fuselage)- evidence of wrinkles in the skin, tail boom - scrapped,
- Vertical fins- scrapped,
- Tail rotor drive train (entire)- scrapped
- Tail rotor blades and pitch change spider assembly - scrapped
- Right Hand landing gear spring- bent upwards - scrapped,
- Lower wire strike- bent - scrapped
- The engine produces a grinding noise that is heard when the engine is rotated.

Figure 1. Damage to Tail Section (1)

It is recommended the entire airframe, main rotor, and main gearbox (MGB) drive train be subjected to a hard landing inspection. AMM 05-50-00,6-5b.

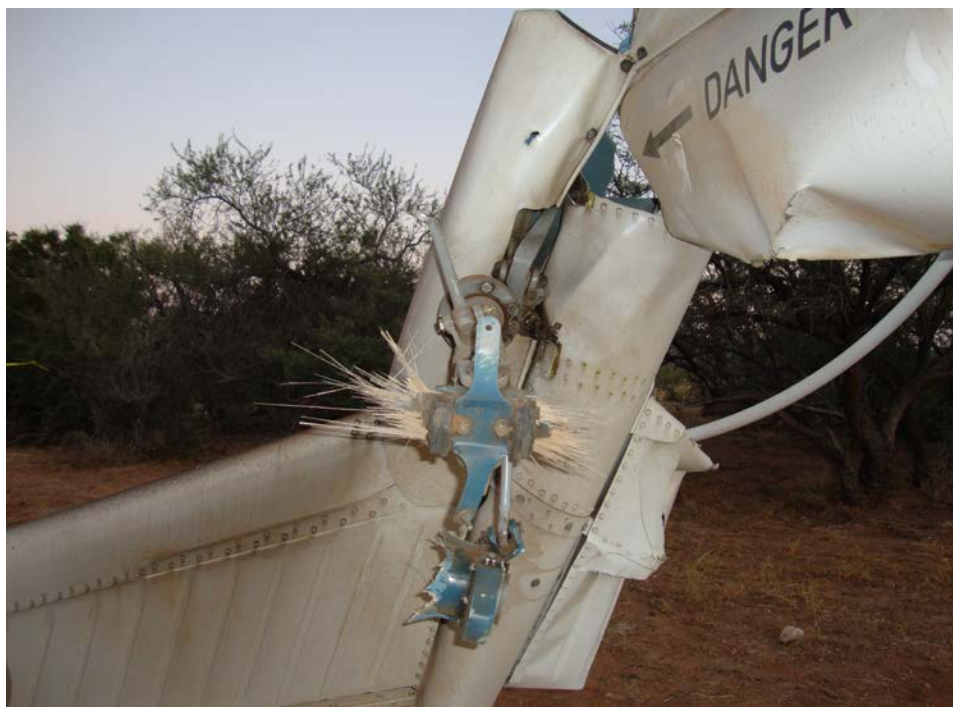
Figure 2. Damage to Tail Section (2)

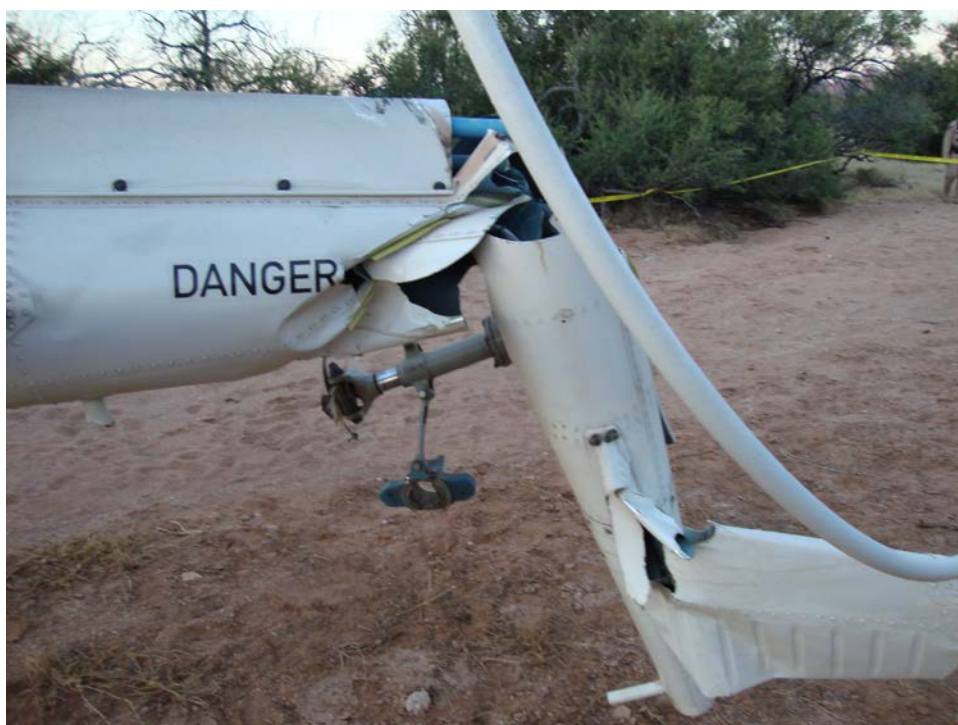
Figure 3. Marks on T/R Drive Shaft Cover from Gearbox deflection upward

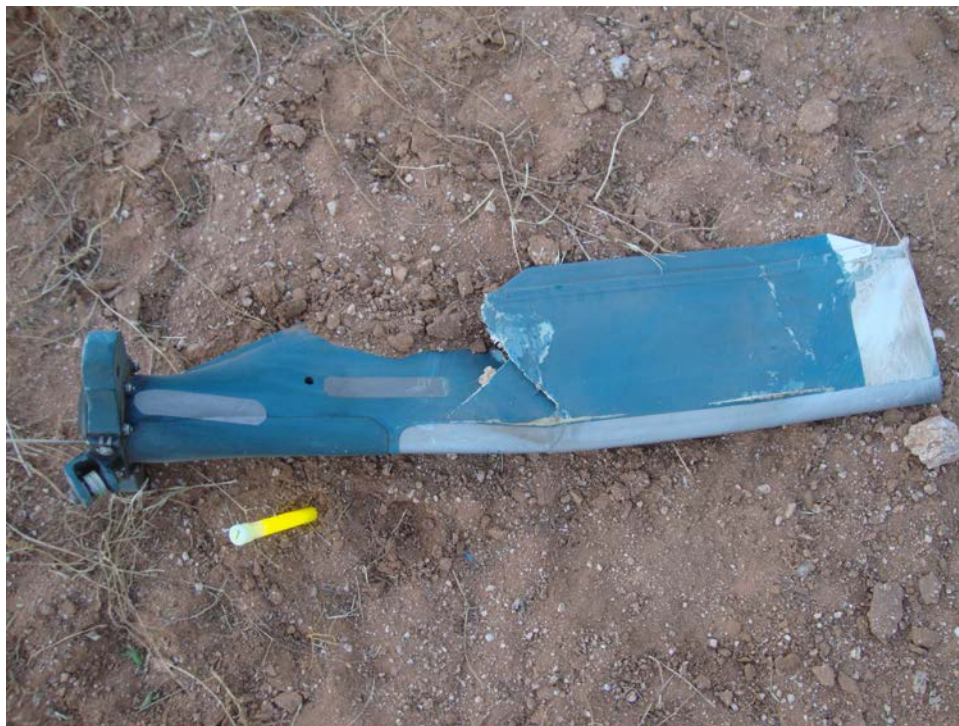
Figure 4. Damage to Tail Rotor (1)

- Optional equipment and components involved in a hard landing. AMM 05-50-00,6-25
- Tail rotor blade impact inspection AMM05-50-00,6-7

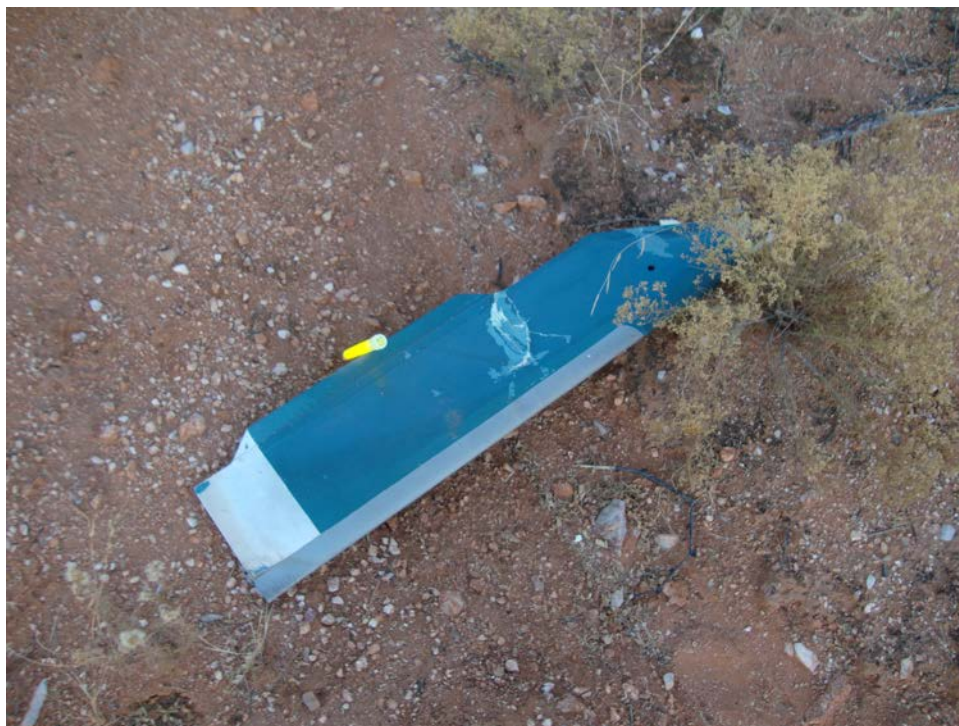
Figure 5. Damage to Tail Rotor (2)

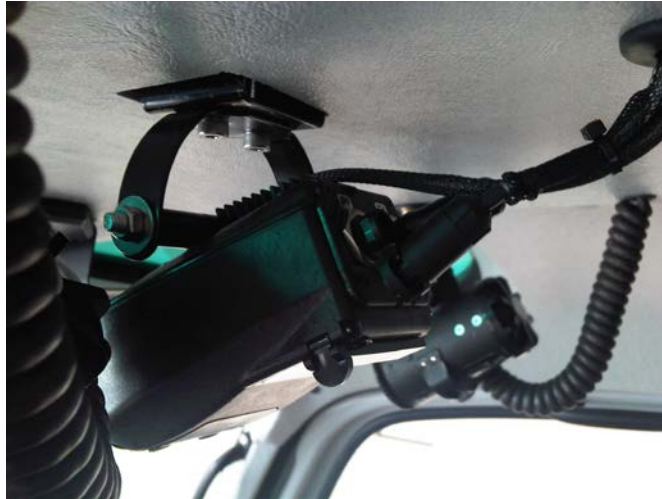
Figure 7. Appareo Vision 1000 Camera

The aircraft Appareo Vision 1000 cockpit camera (Figure 7) was transported to the NTSB lab, Vehicle Recorder Division located at its headquarters in Washington, DC to recover the two non-volatile memory modules, the internal memory component and the removable standard digital card. Those tests returned negative for data associated with this accident. This was due to the camera power cable being disconnected at some point at the end of September (last recording was September 30, 2012).

- The pilots injuries were diagnosed as minor back strain/muscular strain and were not expected to be permanent as a result of the crash sequence.
- Post-accident investigation and NTSB lab results revealed the Appareo Vision 1000 Camera had been disconnected for approximately two months prior to the accident despite internal guidance from the DDAO that anyone found tampering with it would face disciplinary action.

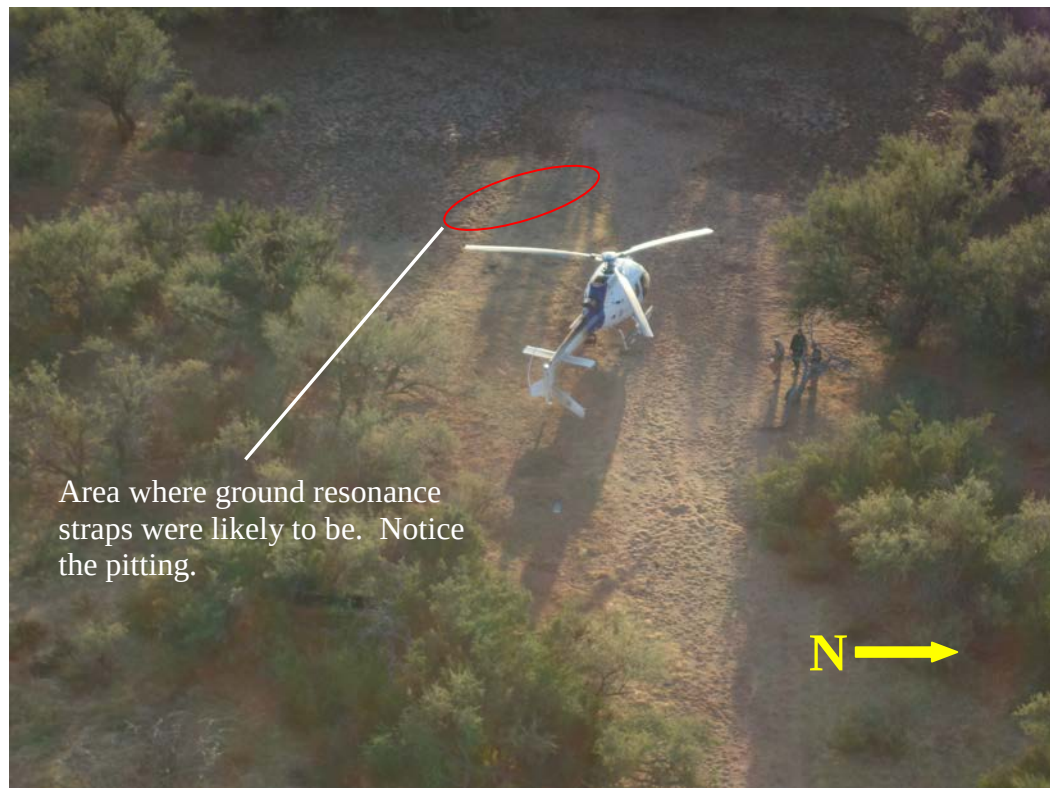
The PIC conducted a high/low recon and based on strength of the winds (approximately 10 knots from the east) executed an approach to a high hover followed by a vertical landing to the confined landing zone without incident. Although the landing zone that was selected was suitable, during the post-accident interviews the pilot could not recall the exact point of landing was in relation to the location of numerous potholes and cattle hoof prints in the dried mud that was hardened like cement (Figure 8). Based on that information and inspection of the landing zone, the Accident Investigation Team could not discern where the original skid marks were (in particular the ground resonance straps) from the original landing location. There were no discernible skid markings or ground scarring due to the hard surface.

Figure 8. Landing Area Selected with aircraft 115 degrees from landing heading
