WPR14FA209 Photographs

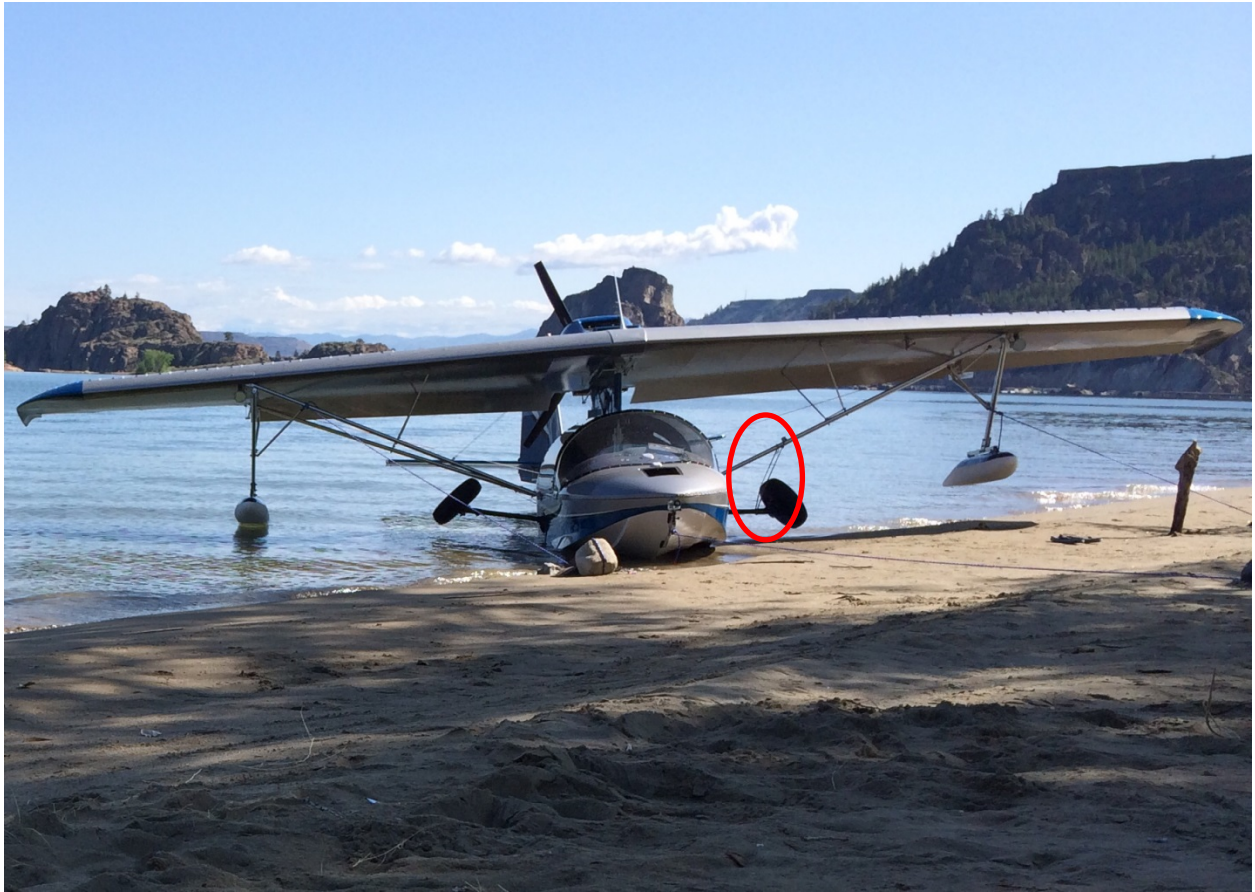
Photo 1. The airplane parked on the beach prior to takeoff, showing the left landing gear tied to the left wing lift-strut. (Courtesy Michael Robbins)

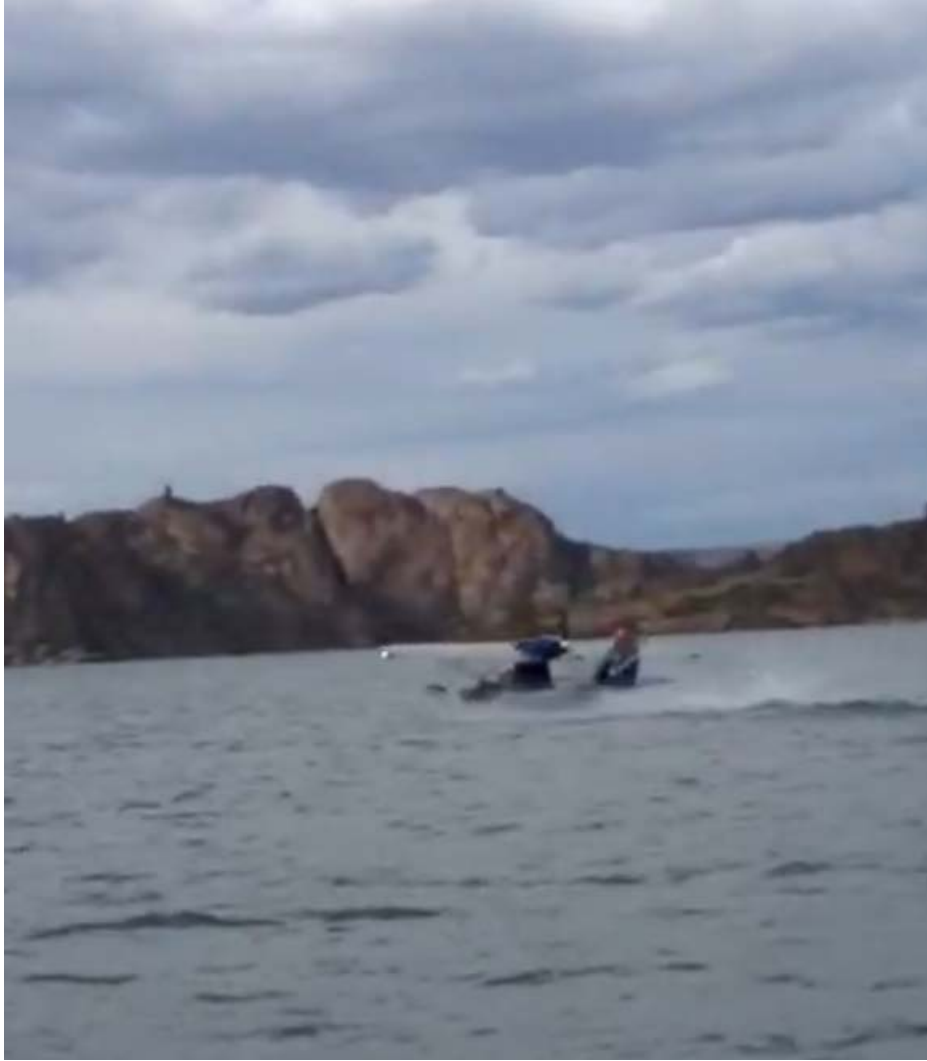
Photo 2. The airplane on the “step” during the final takeoff attempt. (Courtesy Robert Jacobson)

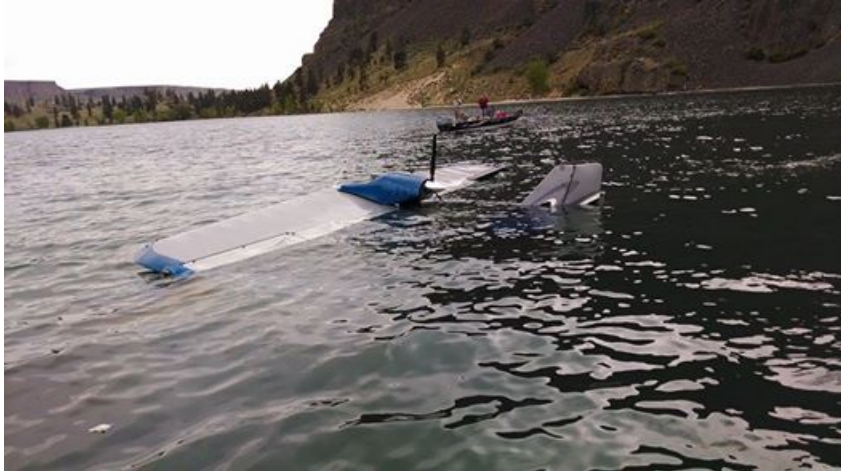
Photo 3. The airplane laying on the surface of the lake following the accident, the cabin is submerged.  
(Courtesy Robert Jacobson)

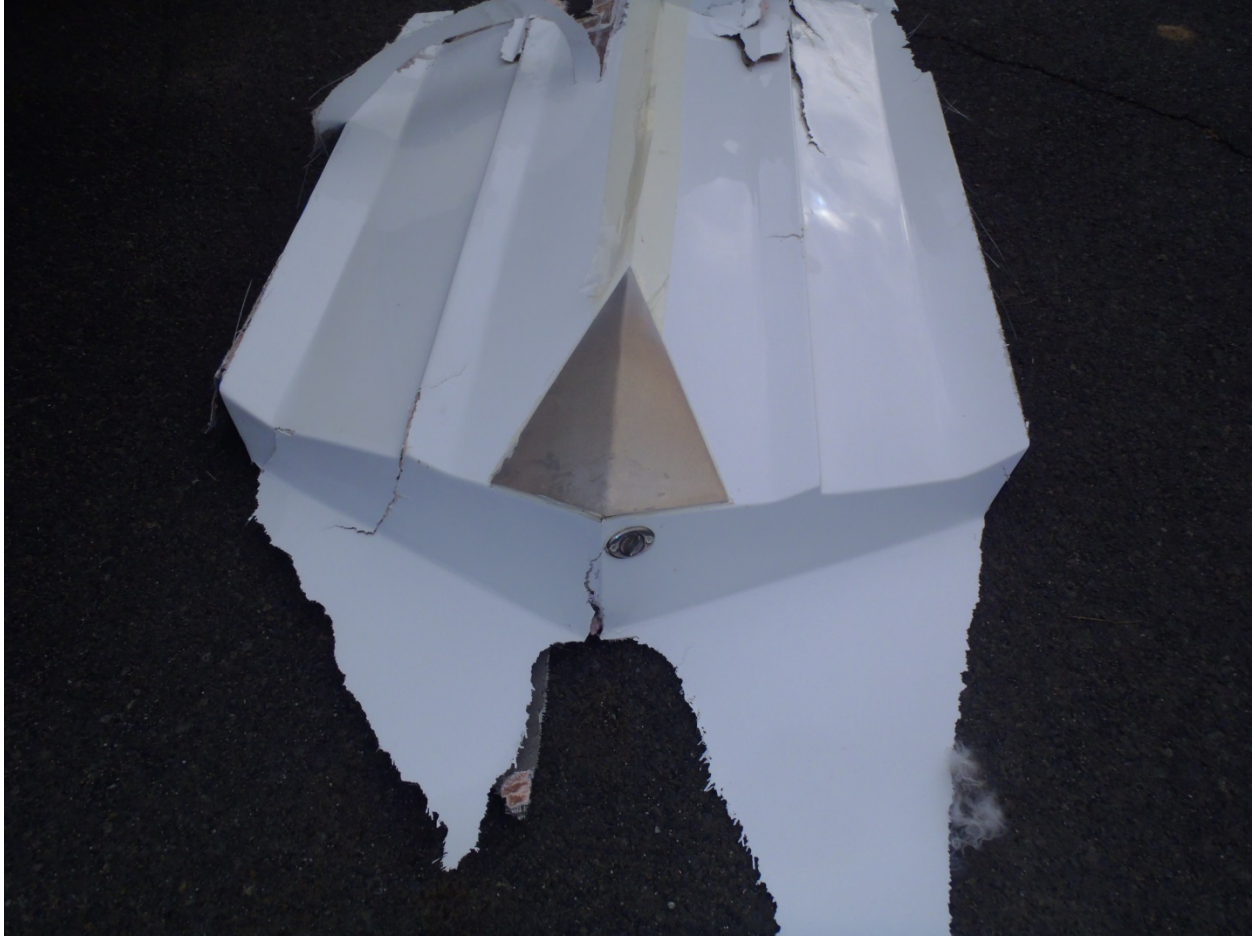
Photo 4. Exterior view of the airplane's hull bottom wreckage, viewed from the aft step forward.

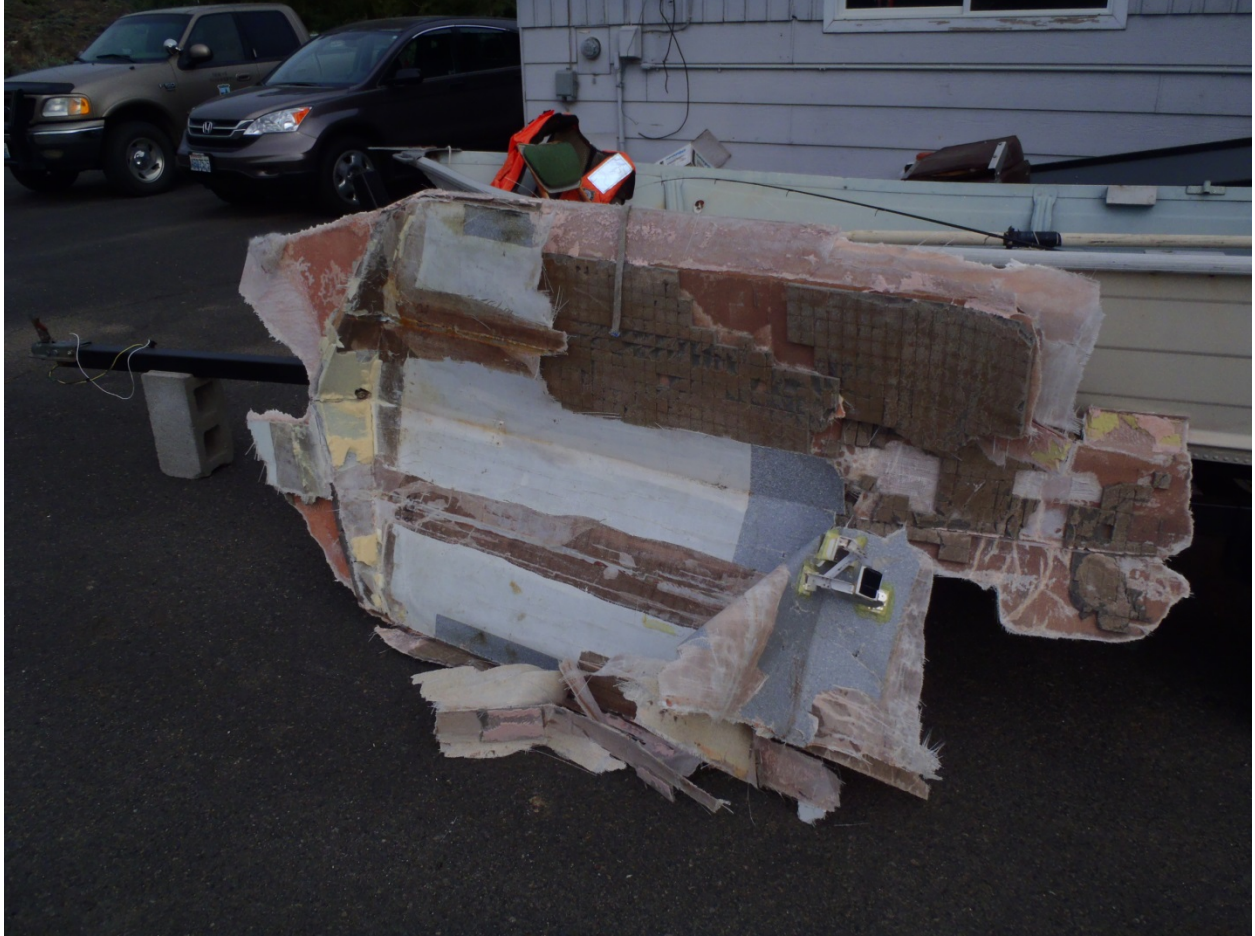
Photo 5. Interior view of the hull bottom wreckage.
