WPR14FA231 Photos

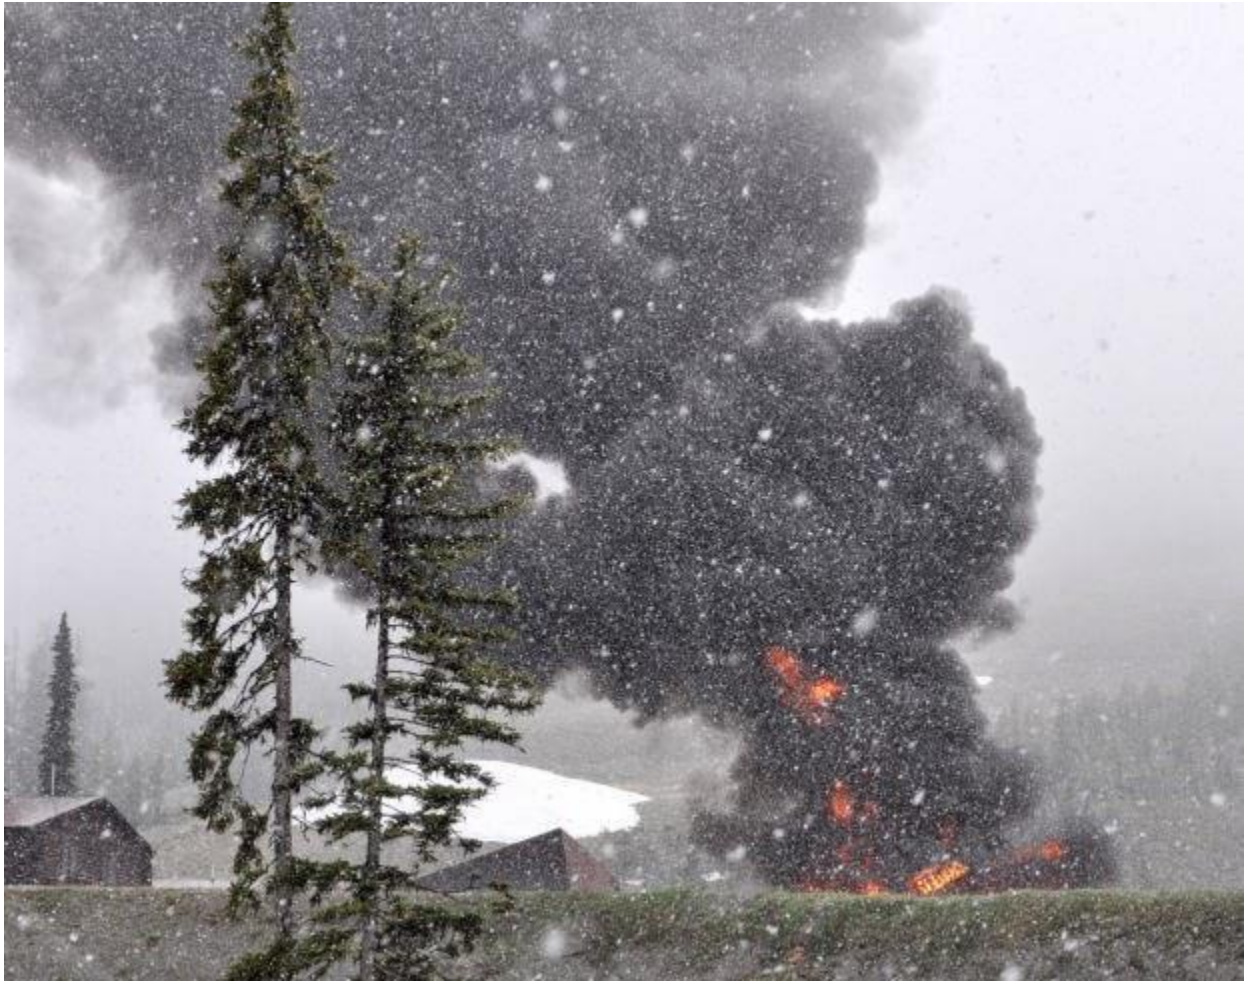
Photo 1. Fire and weather shortly after impact.

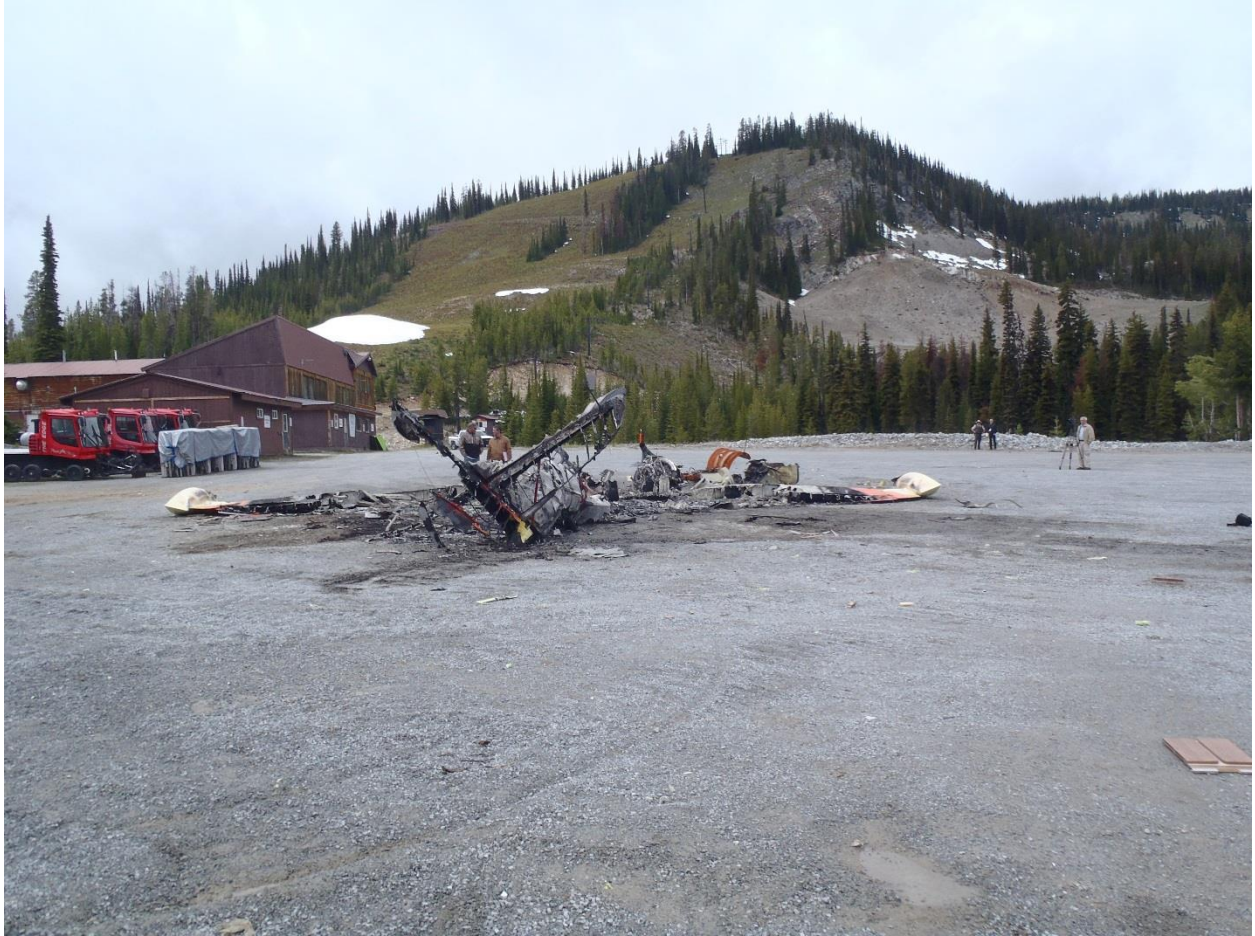
Photo 2. Tail of the airplane looking southwest.

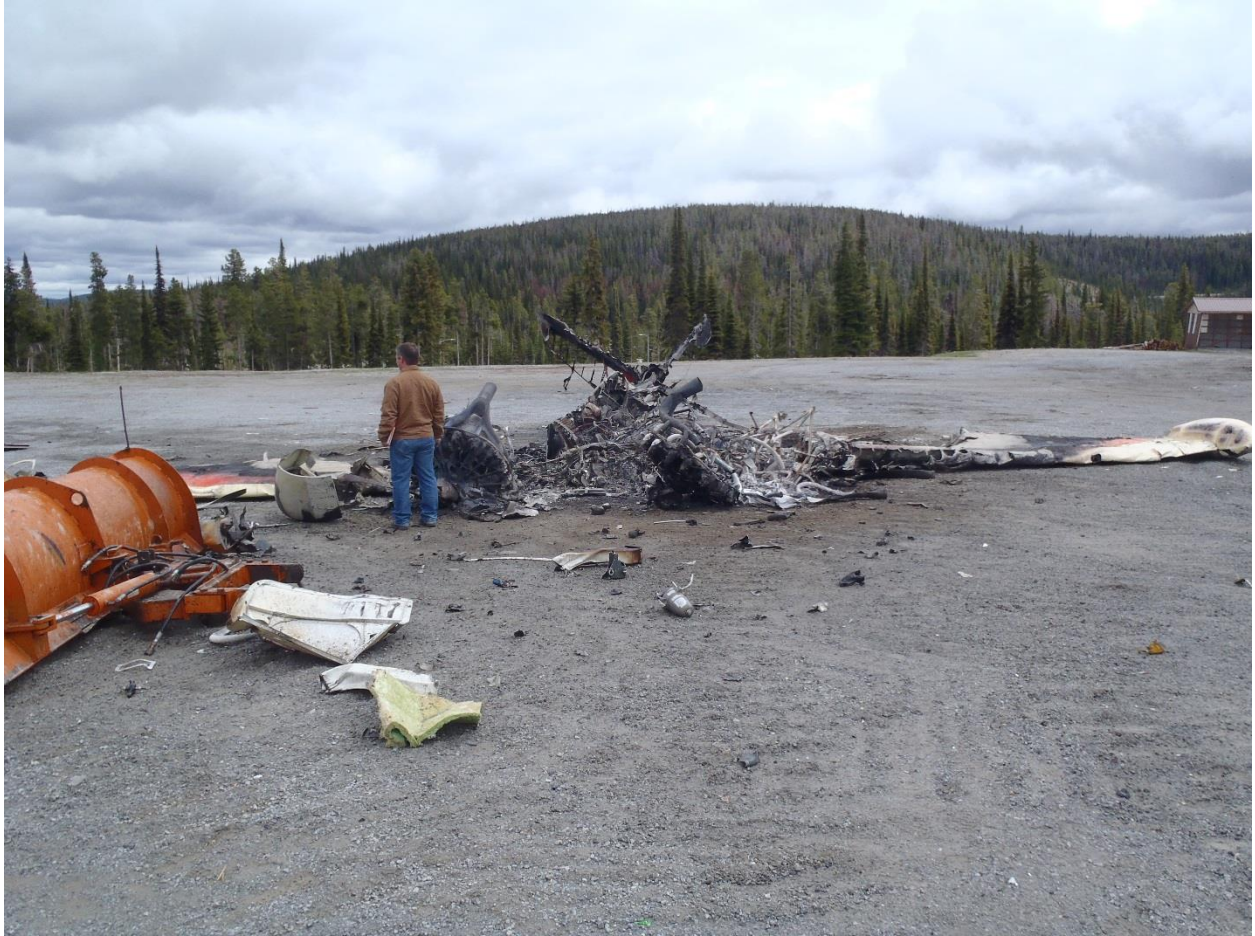
Photo 3. Front of the airplane looking northeast.

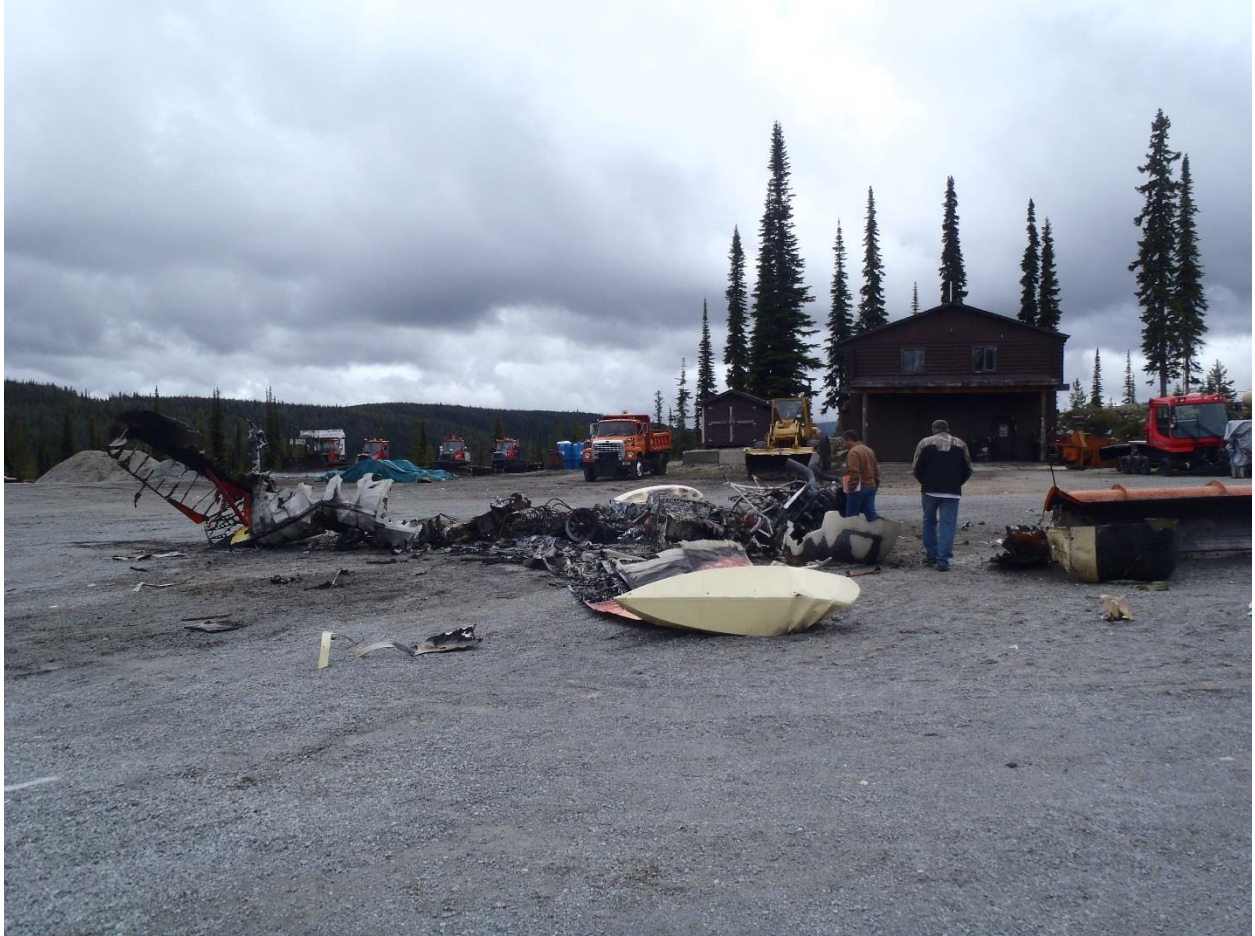
Photo 4. View from the right wingtip looking south.

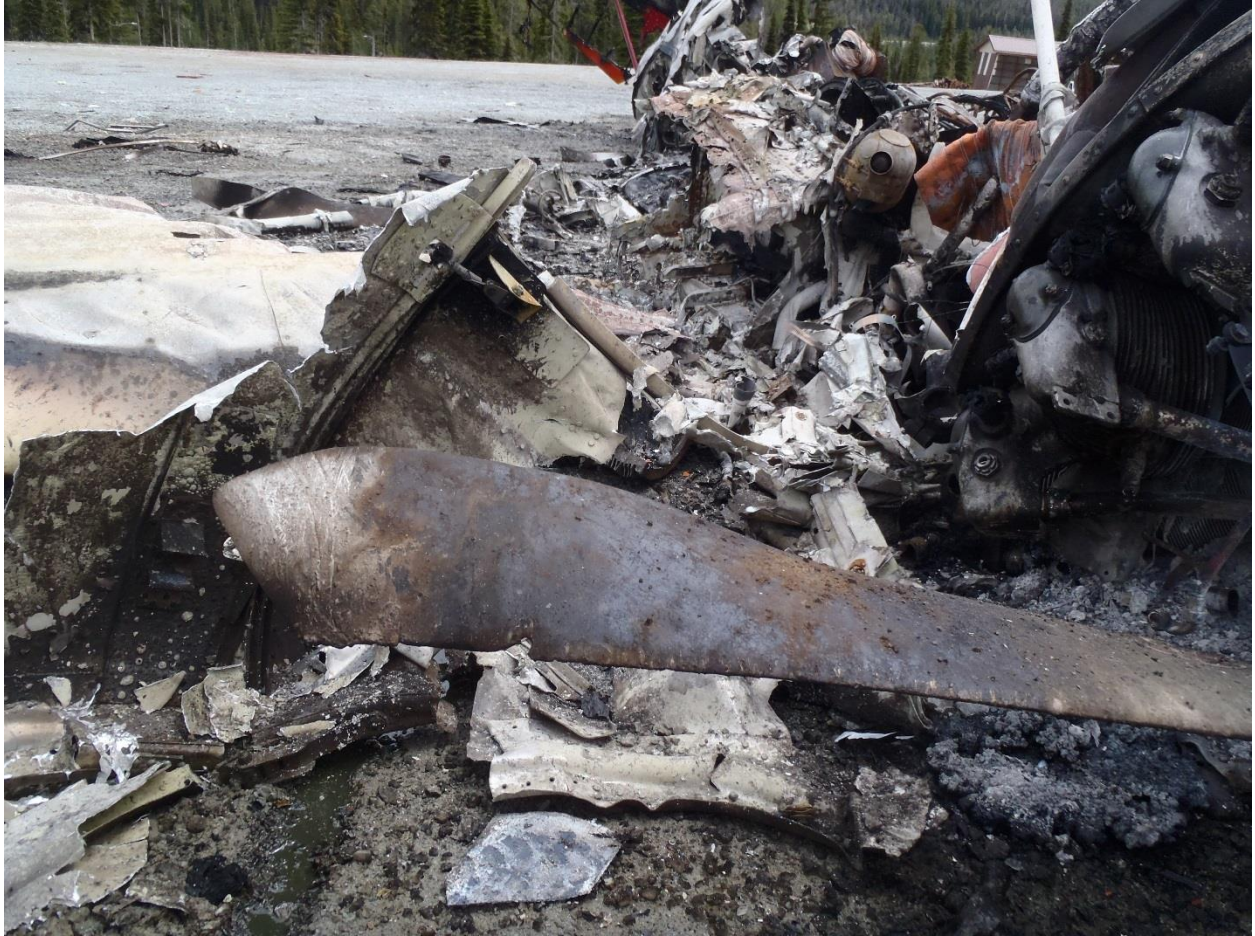
Photo 5. Right engine propeller blade.

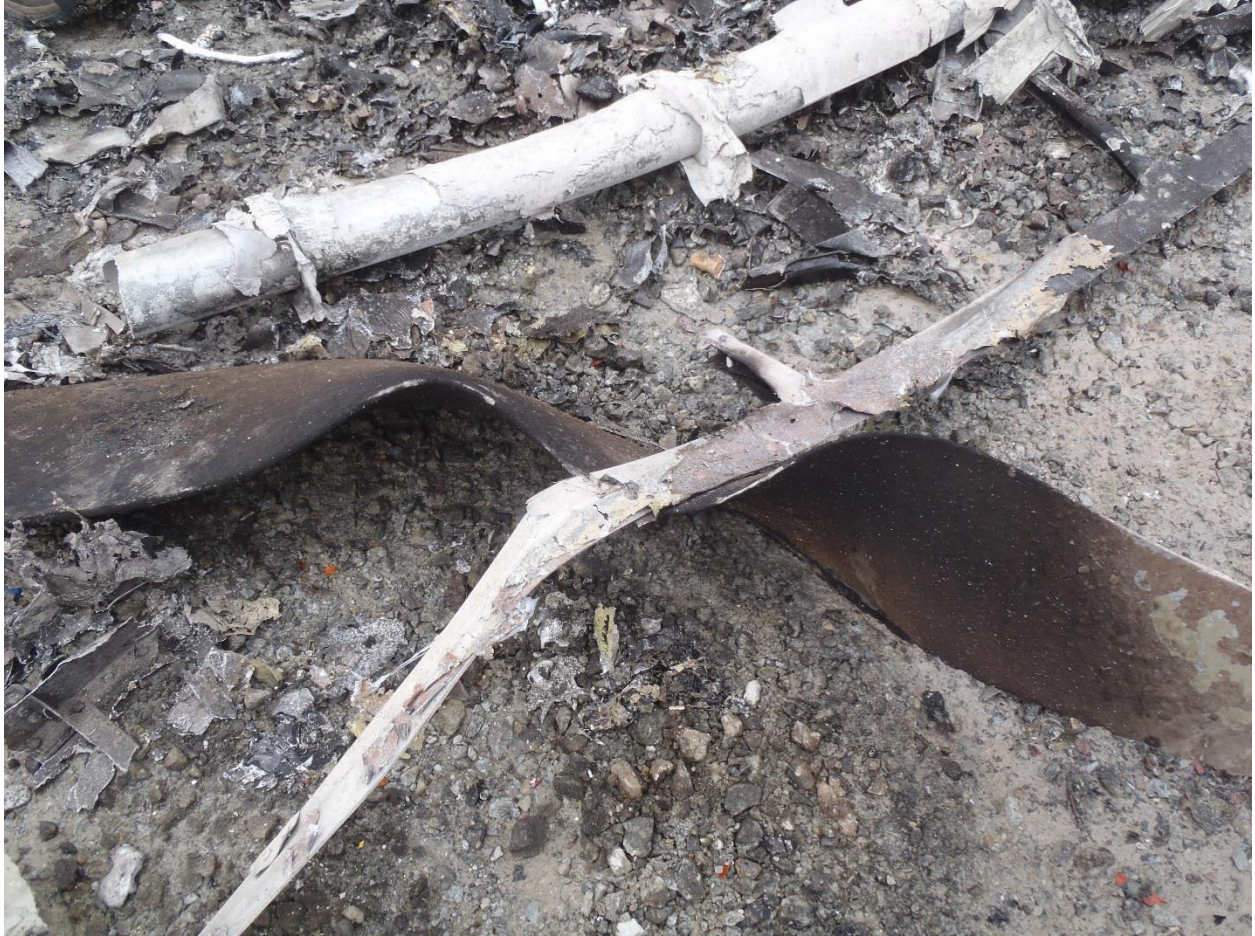
Photo 6. Left engine propeller blade.

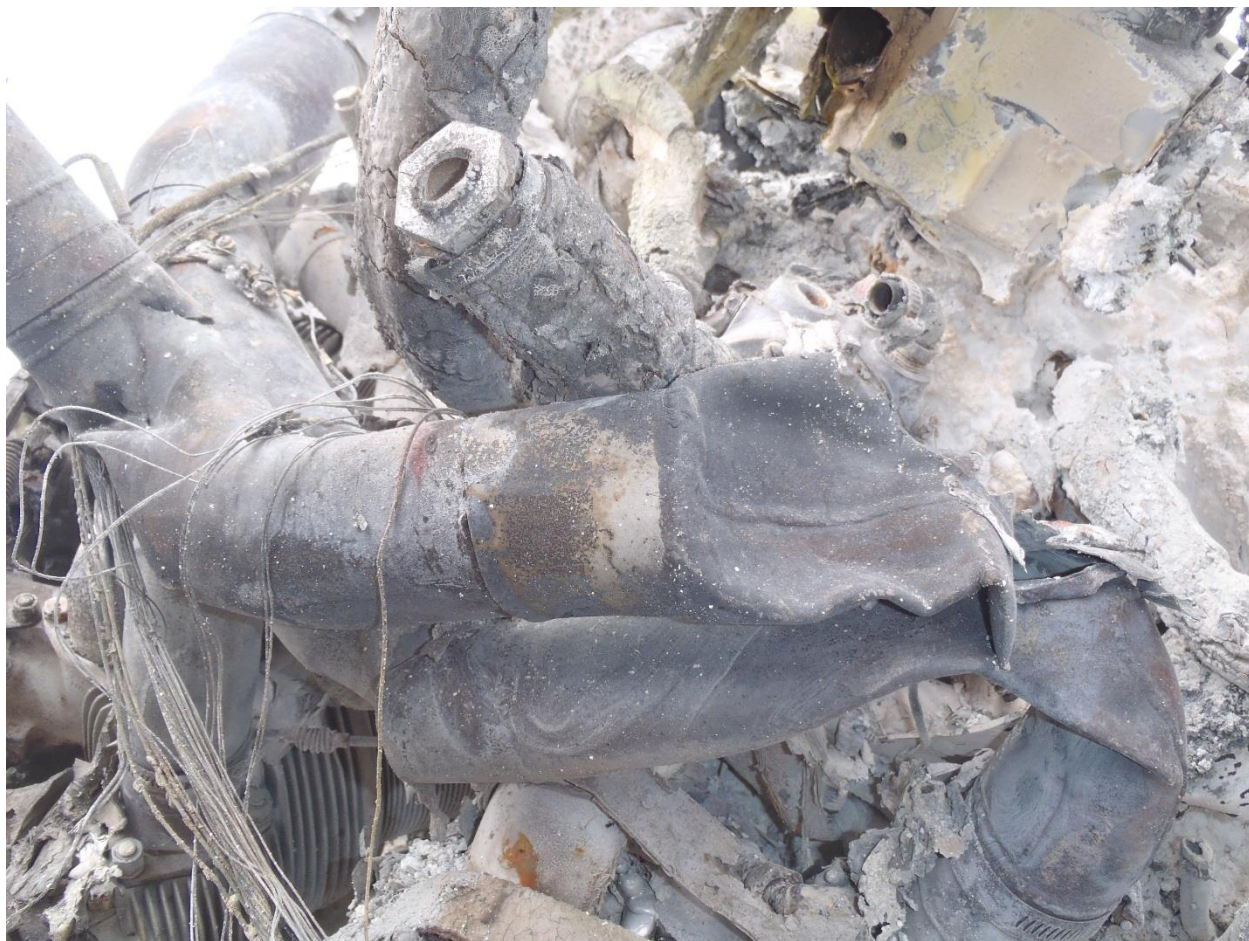
Photo 7. Left engine exhaust manifold.

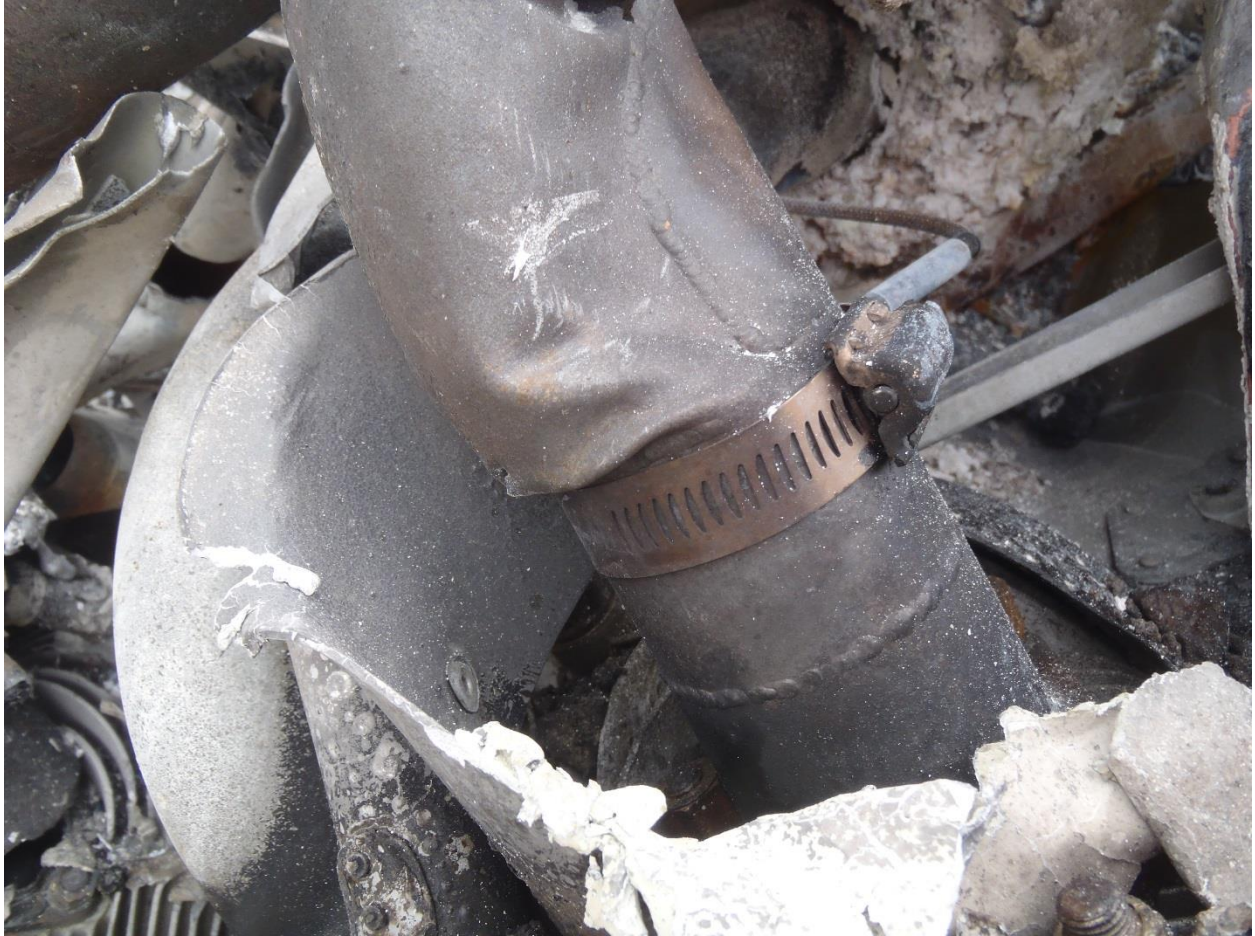
Photo 8. Right engine exhaust manifold.

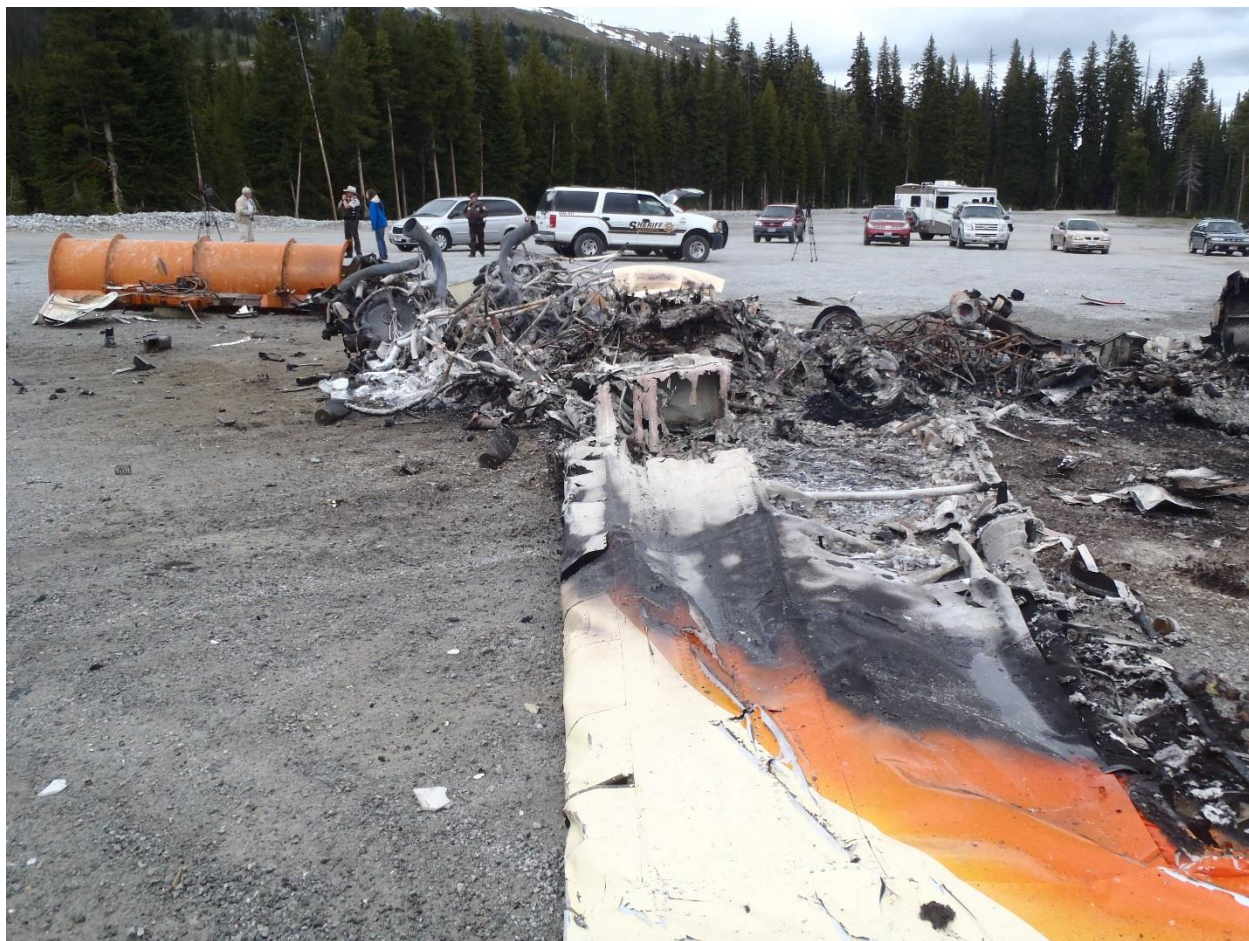
Photo 9. Left wing leading edge.
