## **NATIONAL TRANSPORTATION SAFETY BOARD**

# **AIRFRAME AND ENGINE EXAMINATION**

**WPR14FA234**

Location: Paso Robles, CA  
Date: June 7, 2014  
Aircraft: Piper J3 C-65, Registration Number: N24918, Serial #: 3535  
NTSB IIC: Howard Plagens

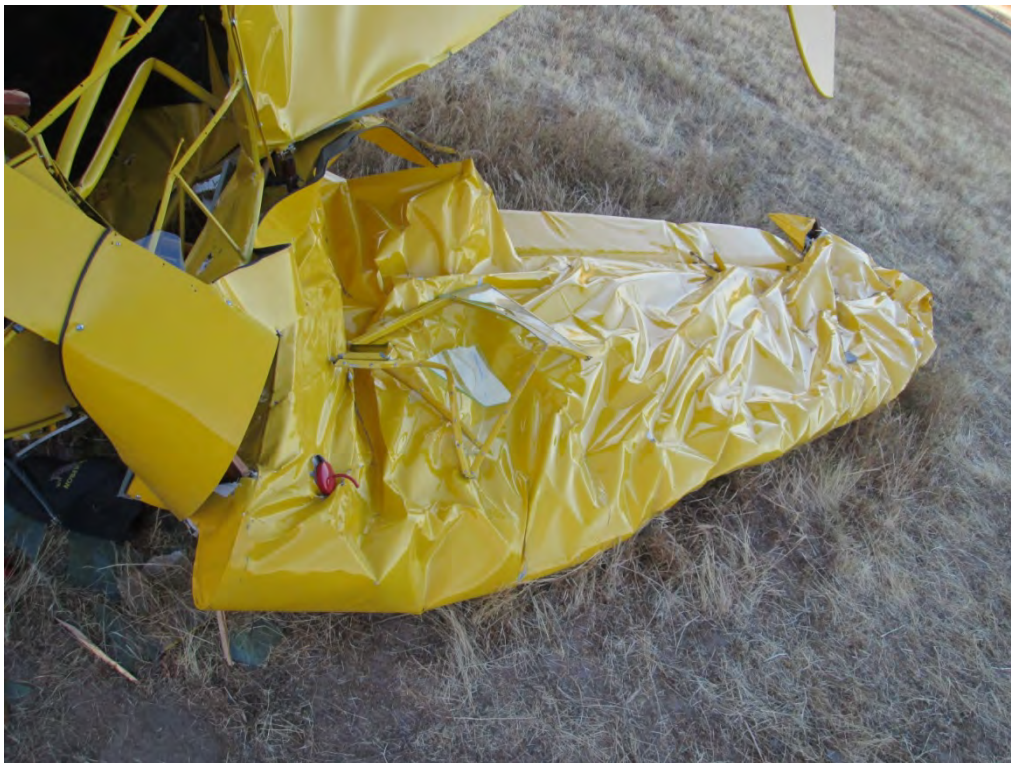
Photo 1 Top of Left Wing

The left wing sustained substantially more damage than the right wing. The front of the right wing exhibited buckling and crush damage inboard of the aileron. The aft strut buckled about 30 degrees, and the wing was displaced forward. The wooden aft spar of the right wing splintered, and separated at the root; the wooden front spar of the right wing cracked, but remained attached. The right aileron was undamaged. The left wing was displaced aft. The left wing was crumpled its entire length with substantial bucking at the wing root. The left aileron was buckled in several places. The cap of the 8-gallon auxiliary fuel tank in the left wing was in place and secure.

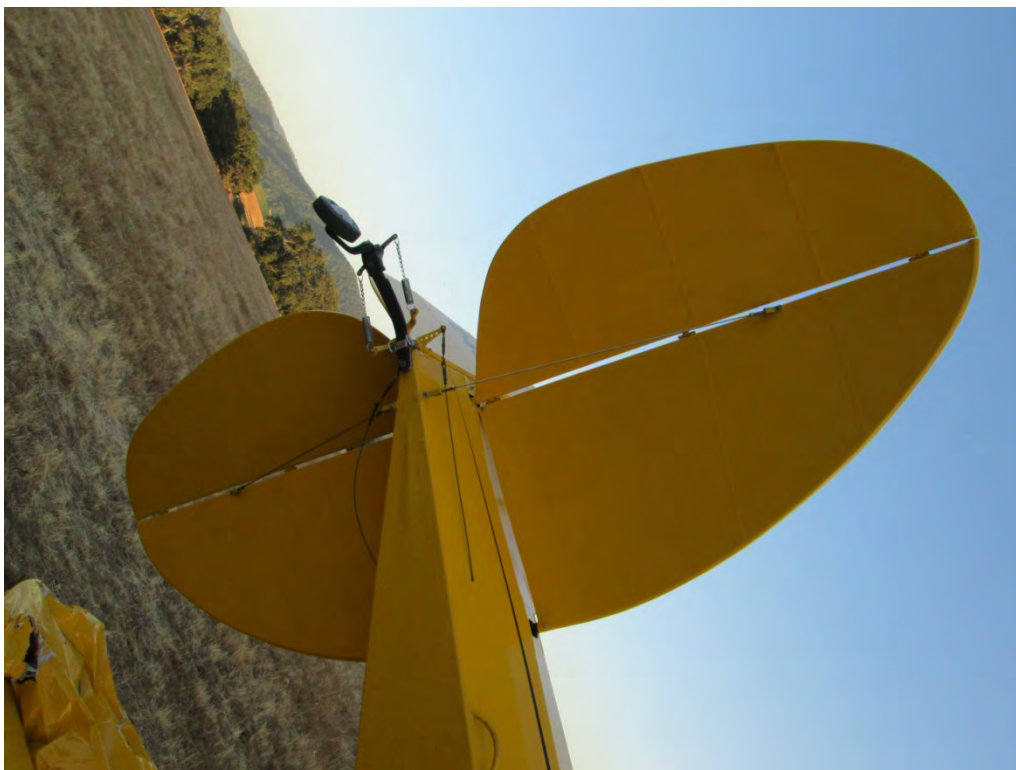
Photo 4 Bottom of the Empennage

Investigators established control continuity for the ailerons, elevators, and rudder.

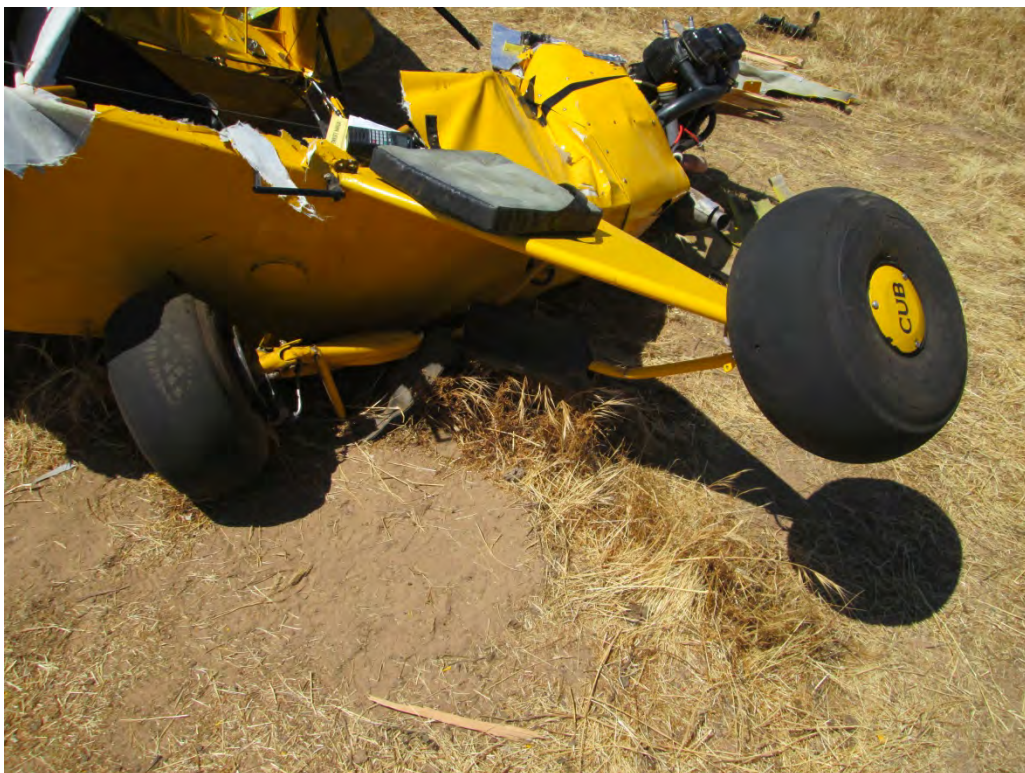
Photo 7 Main Landing Gear

The left main landing gear was crushed under the fuselage; the right main landing gear was intact.

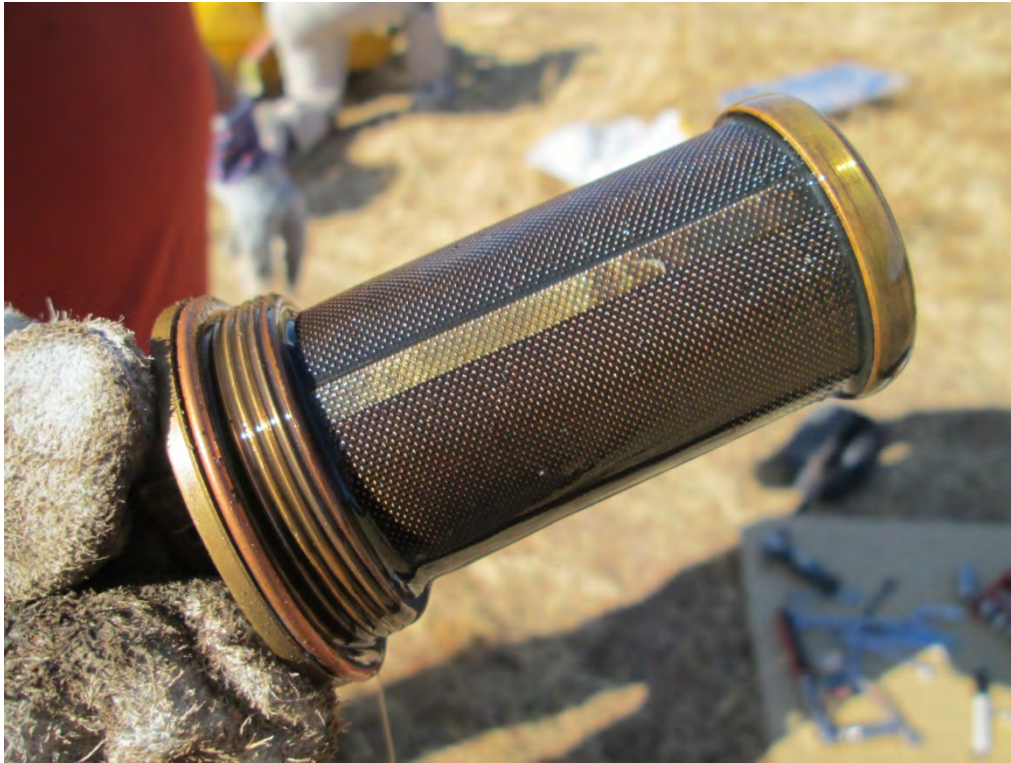
Photo 10 Oil Screen

The oil screen was clean.

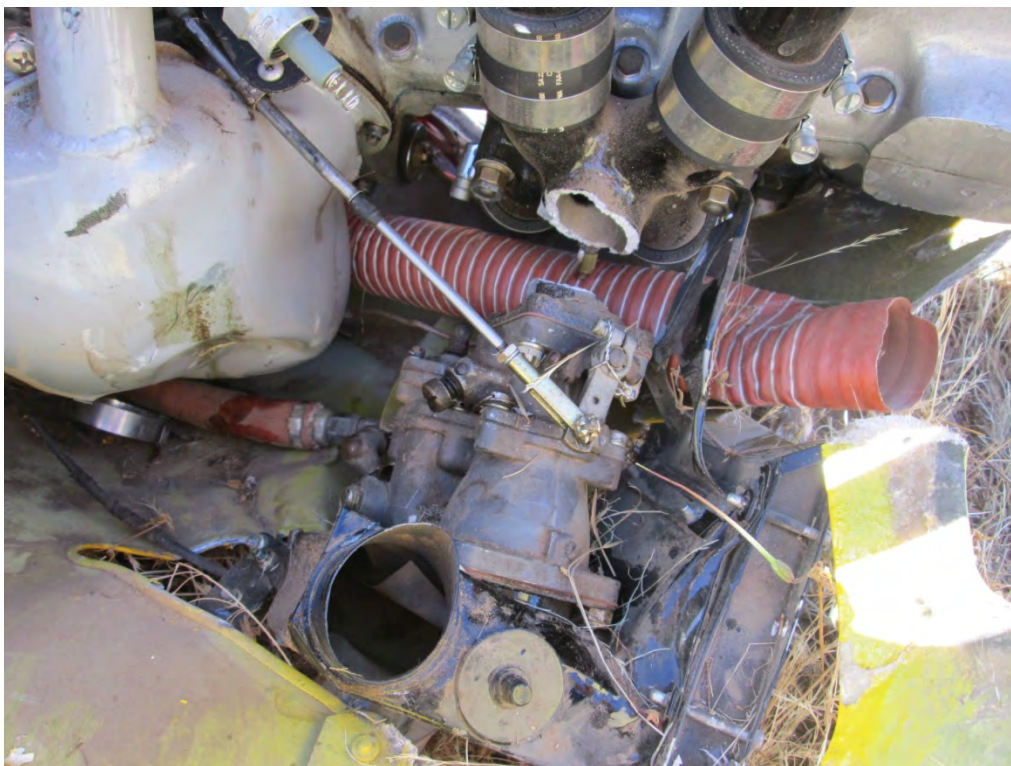
Photo 11 Carburetor

The carburetor was a Stromberg A-18033A-3, serial number 3628. The carburetor separated at the engine connection; the fracture surface was jagged and rough. The throttle and carburetor heat cables remained connected, but the cables were bound by the crush damage to the firewall. With the cables disconnected, the controls on the carburetor moved freely from stop to stop. The mixture was wired in the rich position. The air filter remained attached, but sustained crush damage; the wire mesh screens on the front and back of the filter were partially dislodged. Dirt and grass were imbedded in the front of the filter element, and investigators observed dirt in the back side of the filter after removing it from the carb heat box. The filter element was paper, and appeared old and brittle. The paper element tore out along several edges.

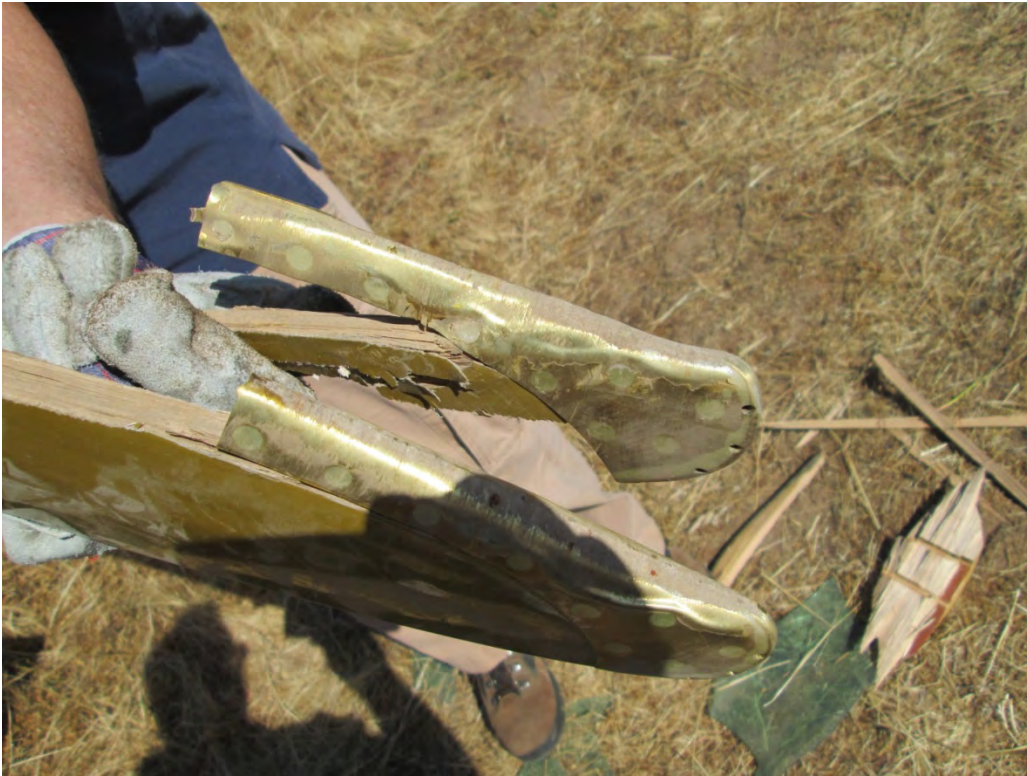
Photo 15 Propeller Blade Tips

Both blades fragmented into numerous pieces. Both blades had metal sleeves on the leading at the tip and around the curve of the tip. Both metal pieces were dented and crushed toward the chord.
