| <b>INVESTIGATION REPORT</b> | <b>Preliminary</b> <input type="checkbox"/><br><b>Final</b> <input checked="" type="checkbox"/> |

| <b>Reference</b> | RA-2013-295 | <b>Commercial File</b> | |
| <b>Accident / Incident report</b> | A-2013-017 / WPR14LA038 | <b>Preliminary Information report A(I)</b> | |

| Data | | | | |
|---|---|---|---|---|
| Eurocopter AS350B3 | 3332 | N985EW | | |

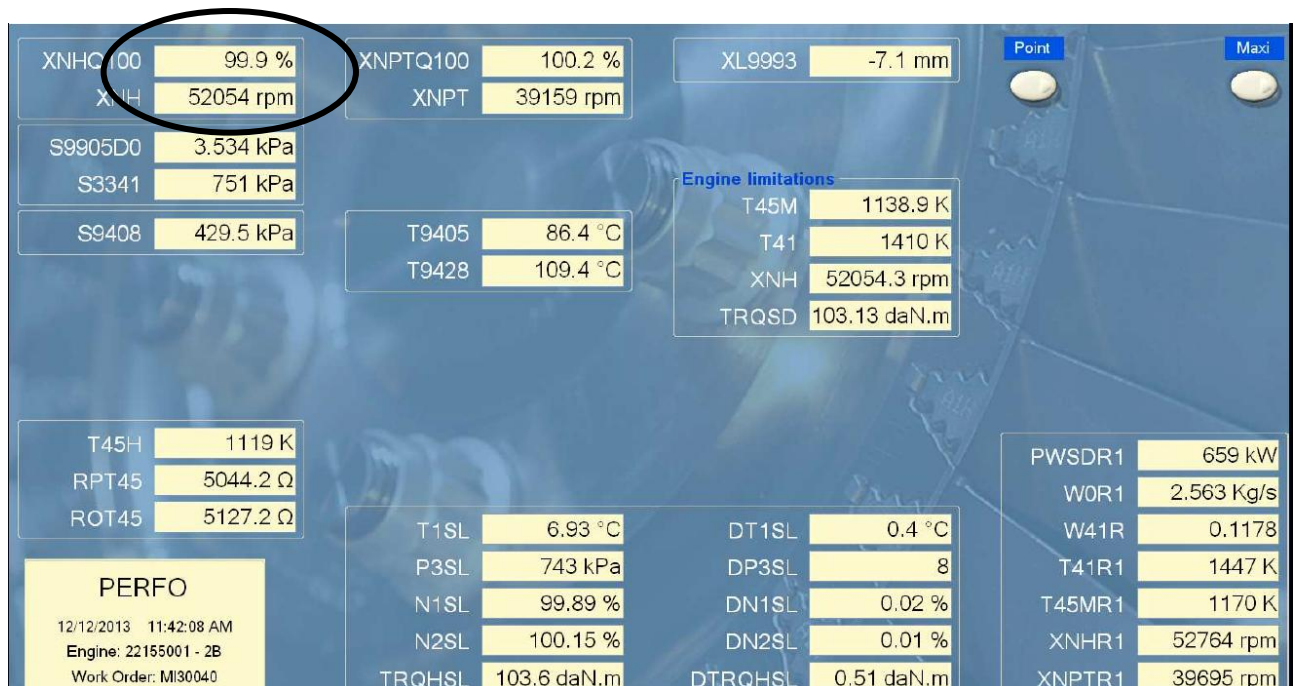
Engine at 99.9% Ng

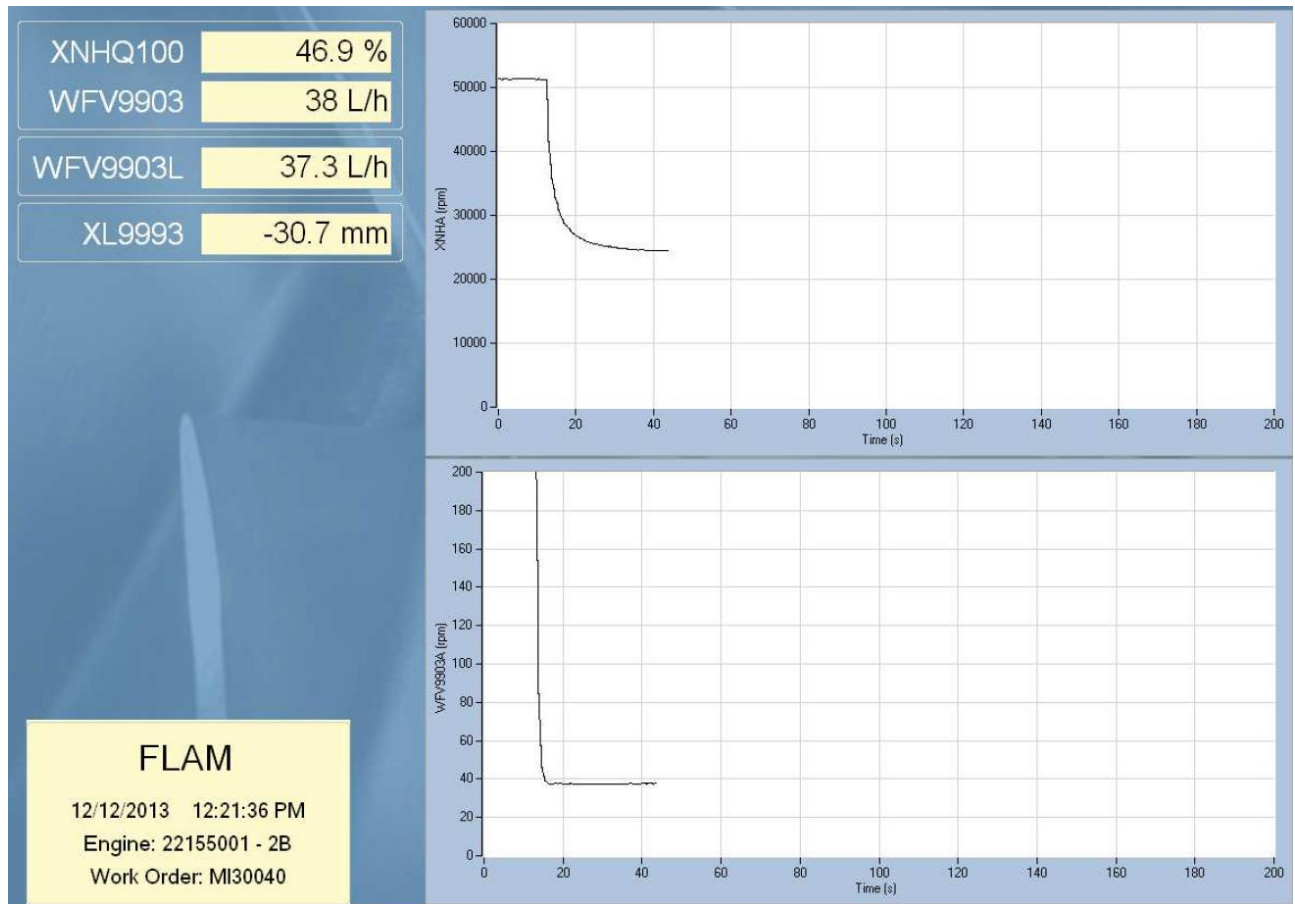
Deceleration from 850°C T45 to minimum fuel flow position in manual mode. Criteria = 32 – 40 l/h no flameout. Results 37.3 l/h no flameout Conforming

Minimum fuel flow. No flameout. (Manual Mode)

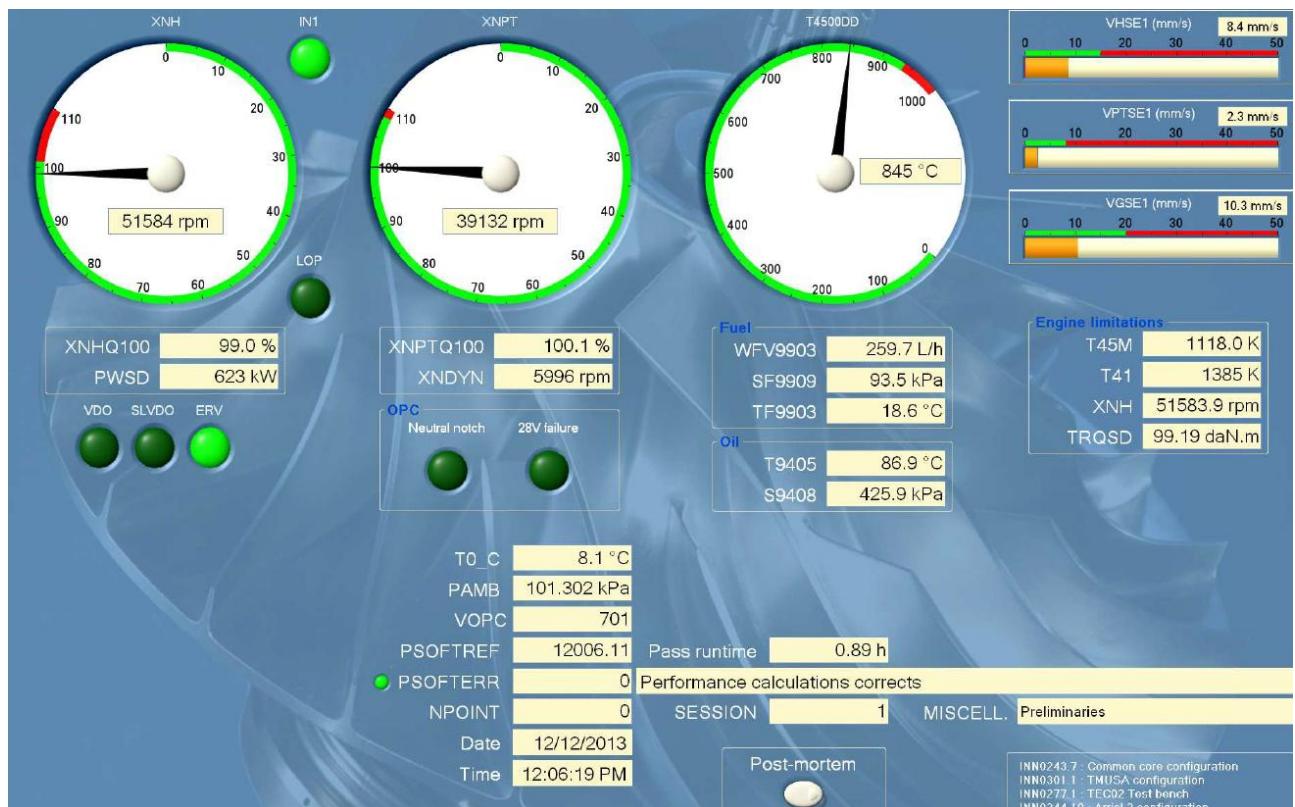
Acceleration from minimum torque (flight idle) to 850°C T45 in manual mode. Criteria = No surging. Results No Surging. Conforming

Point accelerated to from min torque load in < 1 second (Manual Mode)
