## 7745C WRECKAGE OBSERVATION

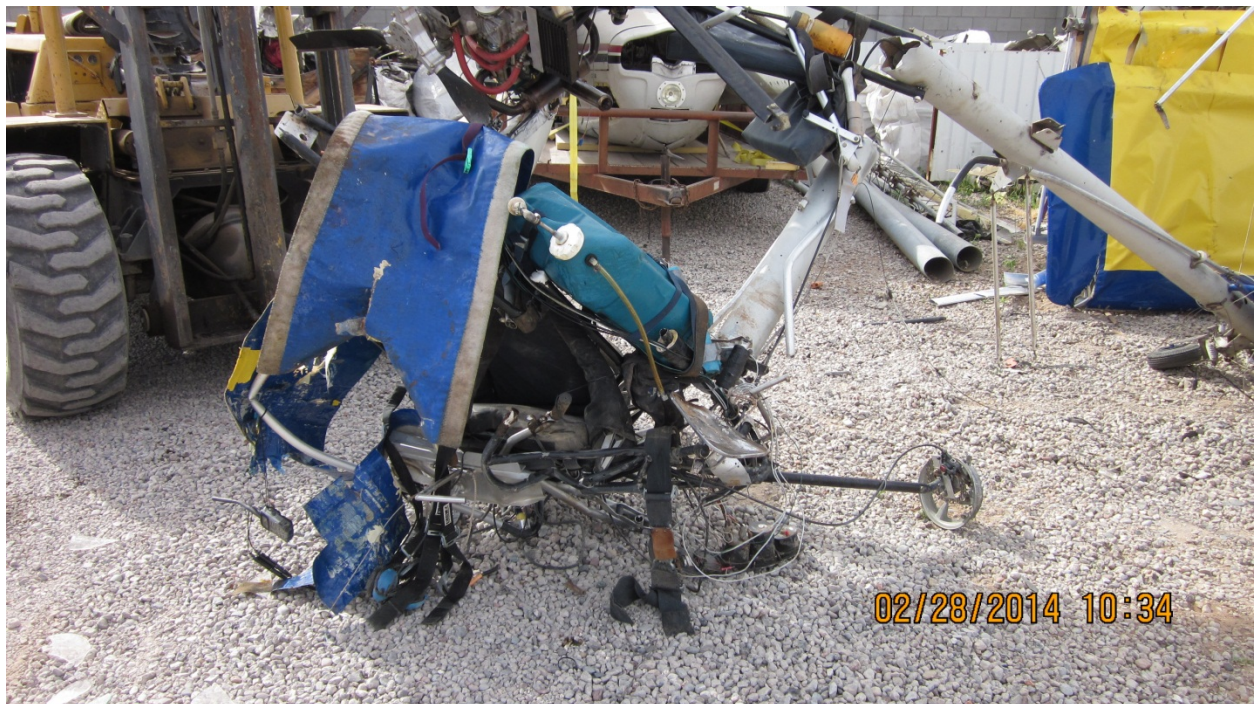
My initial observation was the aircraft was a pile of twisted metal. The main fuselage and engine were in a pile; the wings had been removed and were propped up against the retainer wall at the storage facility.

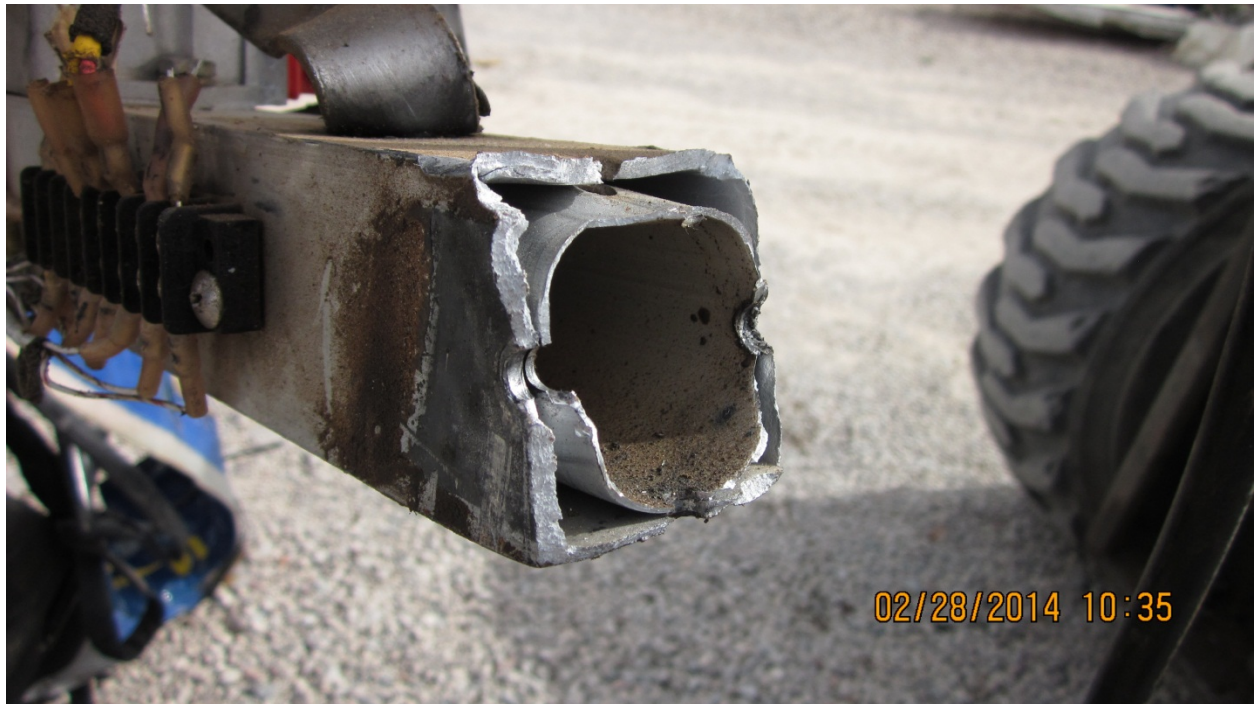
There were numerous broken pieces of various size tubing. All the broken pieces has shear points characteristic with an overload structure failure most likely resulting from the aircraft's impact with the ground. All of the sheared ends were shiny indicating a fresh or recent break.

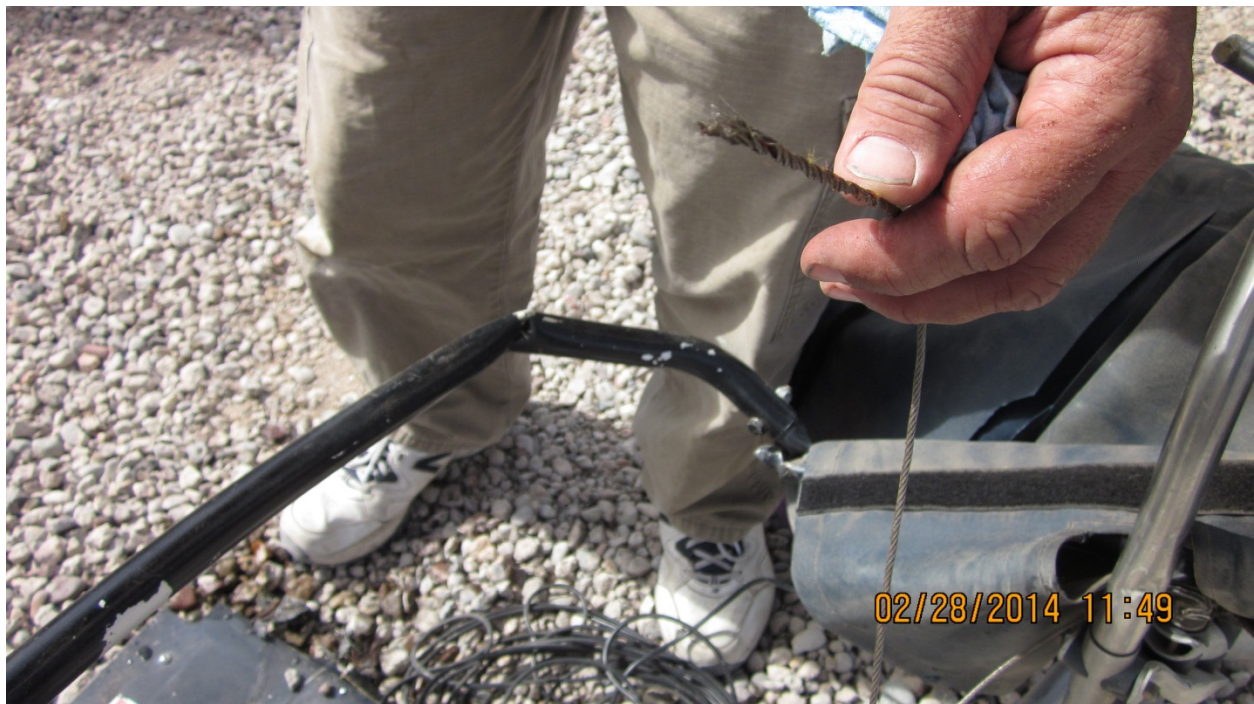
I observed one control cable that had the characteristic broom straw appearance indicating overload failure. The ends of the cable were shiny indicating a fresh break.

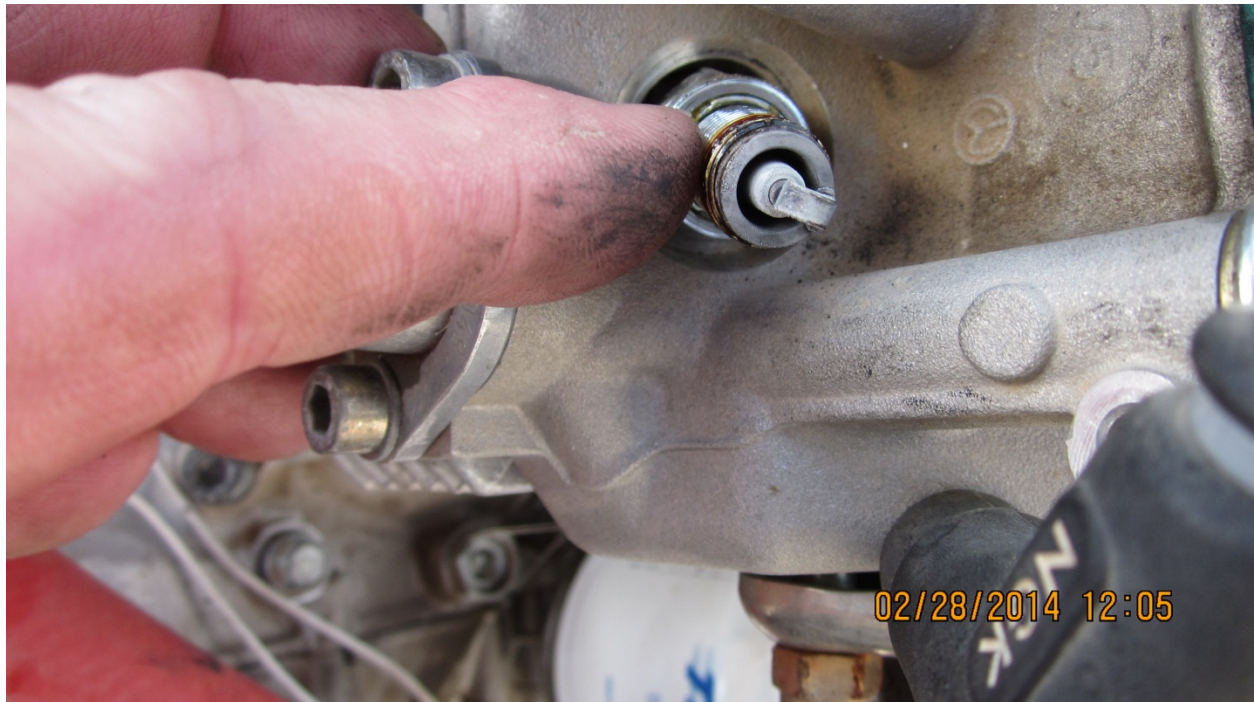
I removed the spark plugs from all the cylinders. One spark plug, #1 cylinder, bottom plug, was finger tight. All other plugs appeared to have been installed correctly. All spark plugs appeared to have been firing normally. All spark plugs have the same appearance. Witness reports stated the engine sounded normal. One propeller blade was broken as a result of the impact. Further engine disassembly was not undertaken past removing the spark plugs and rotating the engine with the propeller. The engine sounded normal and there were no extraneous noises when the engine was rotated.

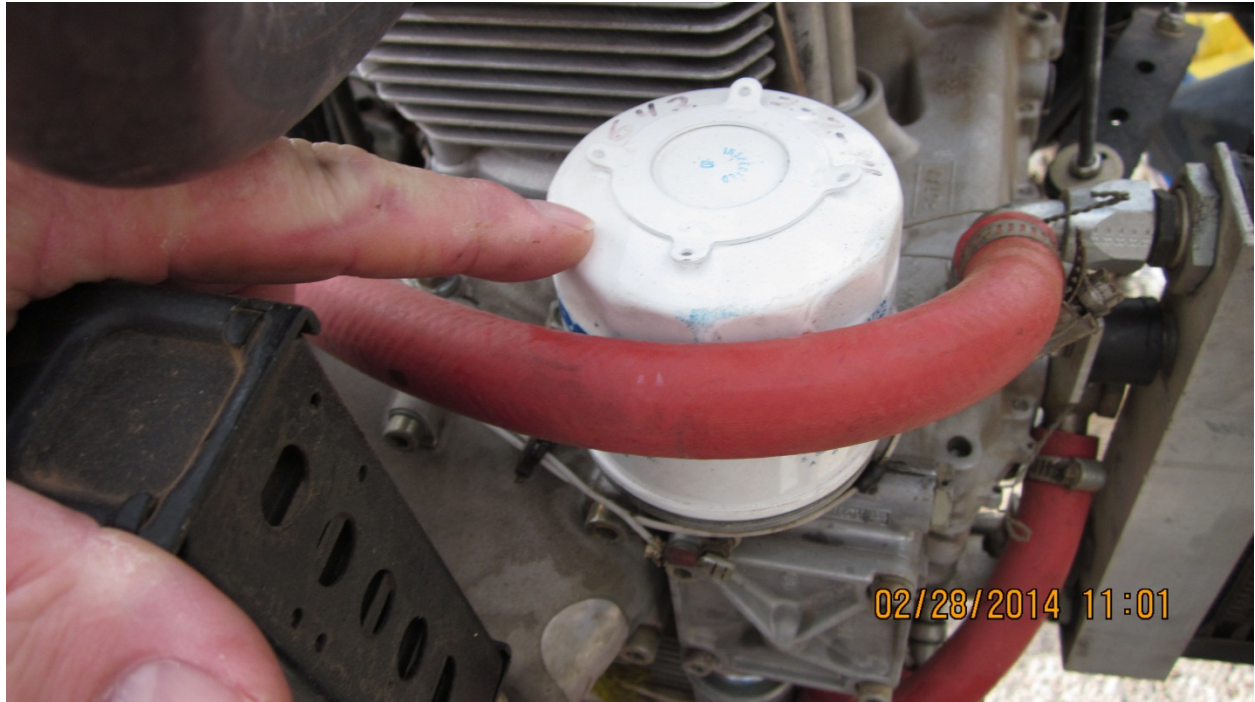
Numerous items observed on the engine. The oil filter was not safetied.

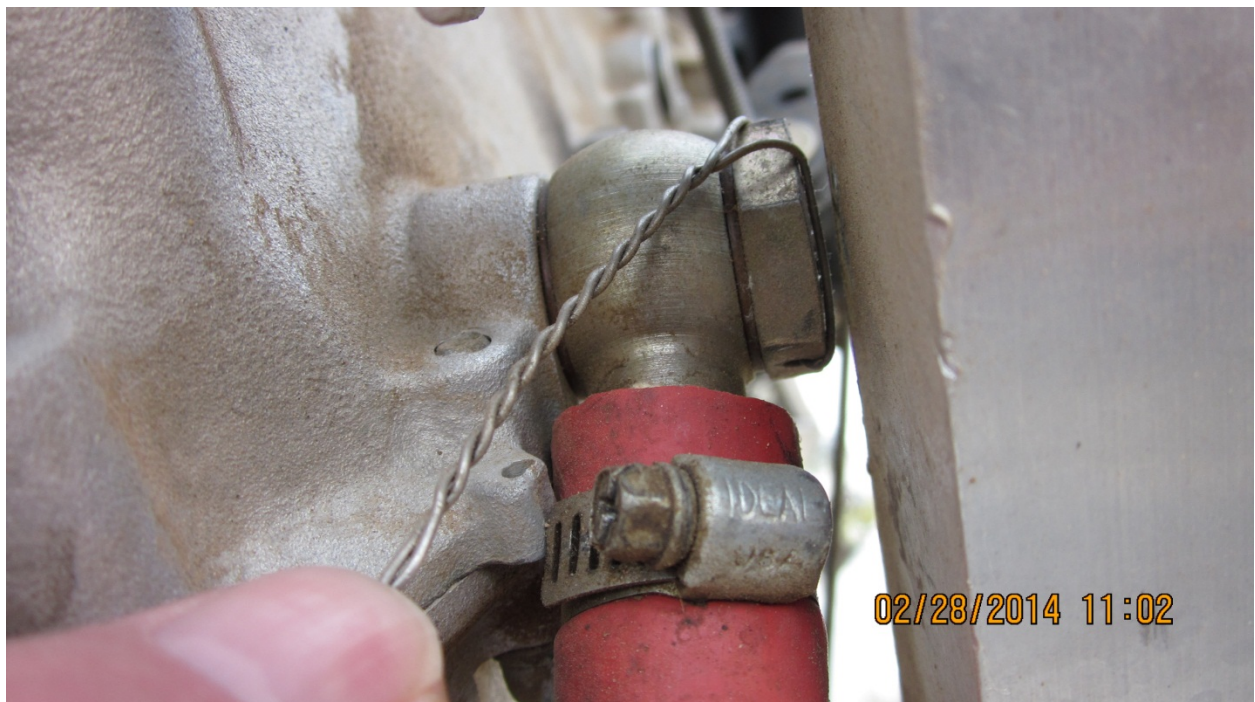
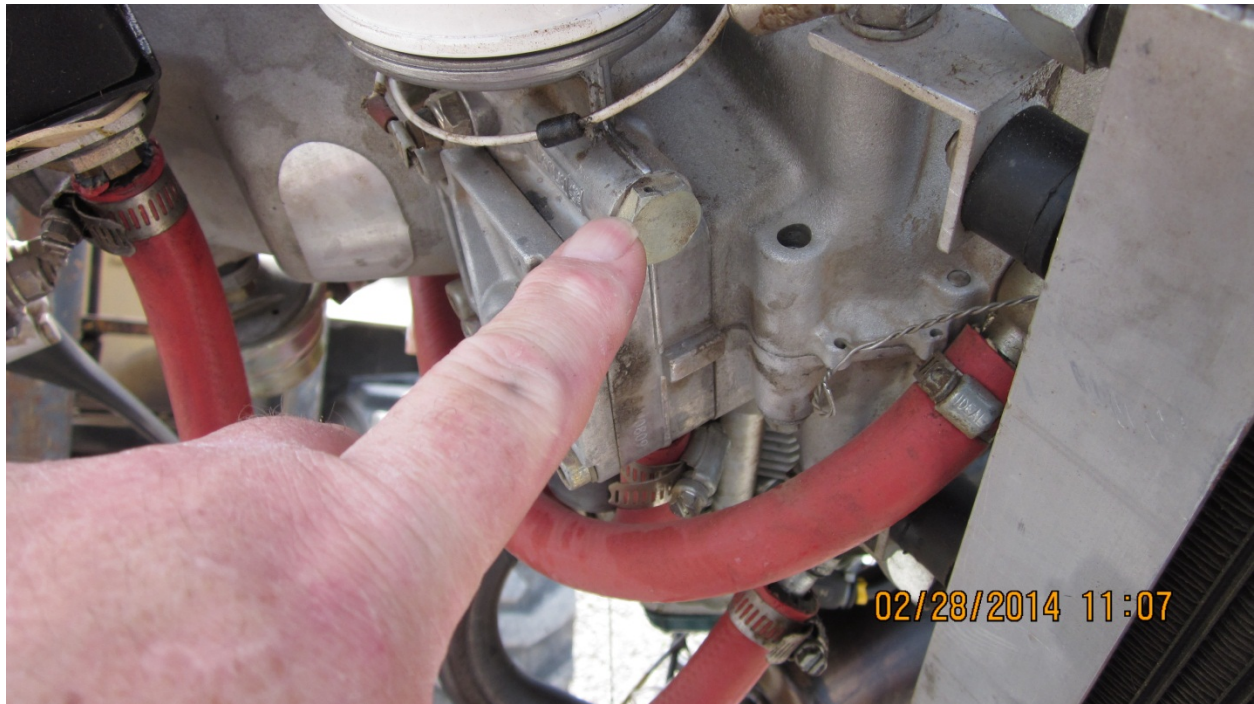
Several fluid fittings adjacent to the oil filter were safetied backwards and not safetied.

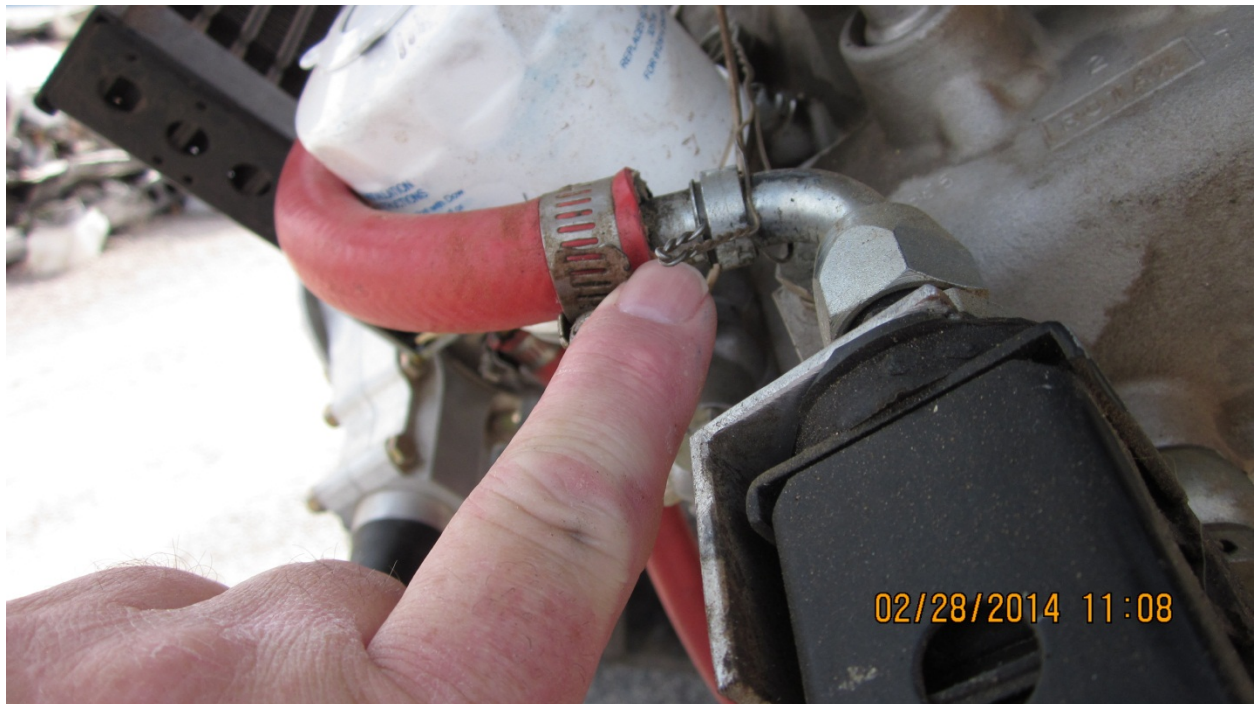
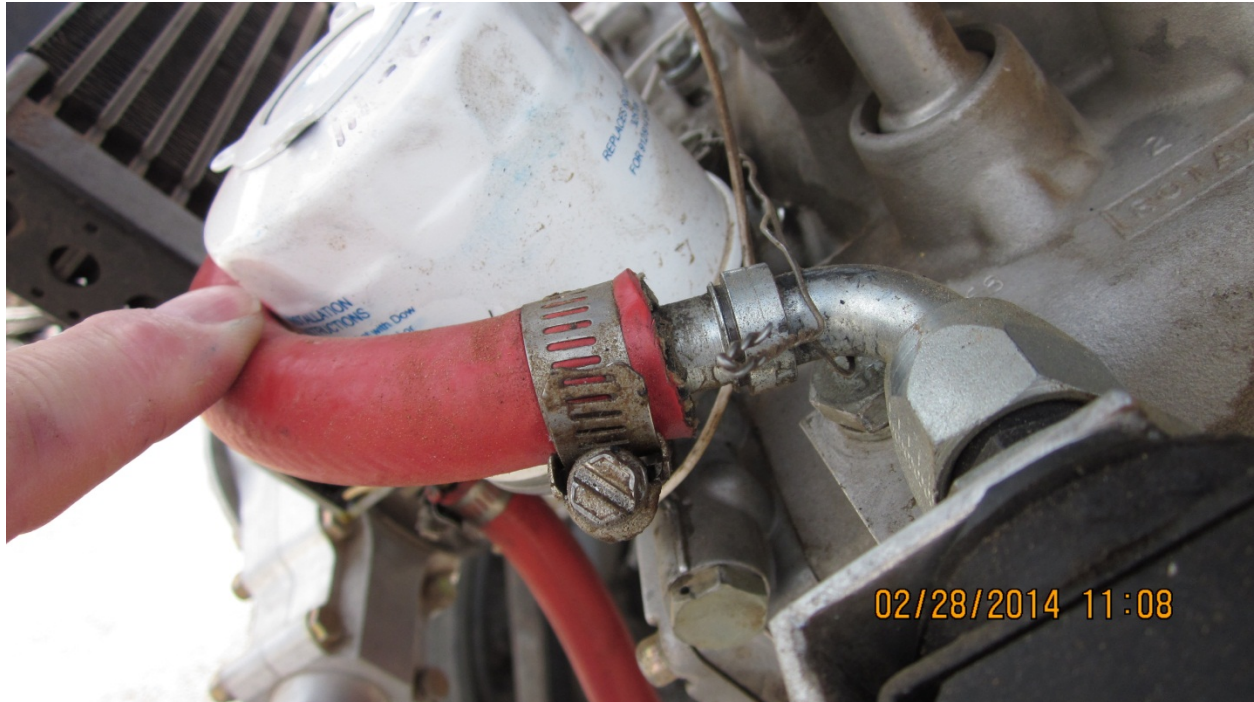
Several liquid lines, (automobile heater hose type) were not properly seated against the fitting and in one case was chaffing against the oil filter.

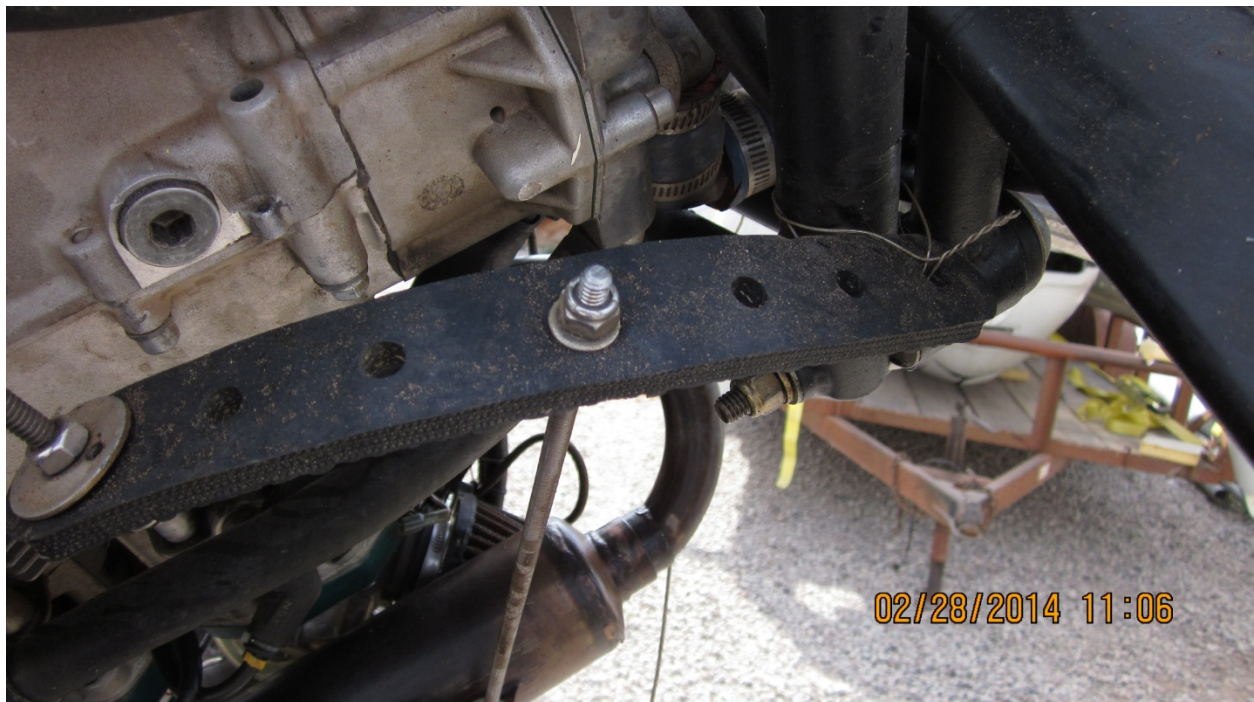
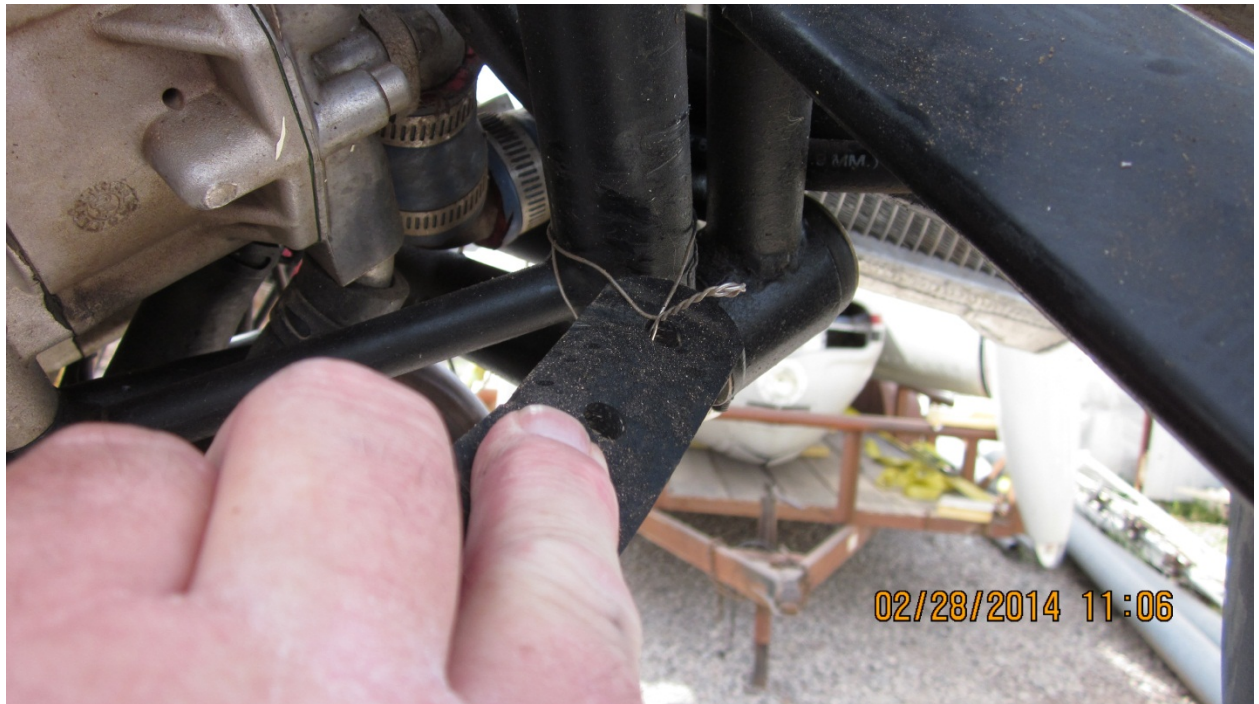
The left and right exhaust manifolds were connected by a pair of straight rods that were attached to a long piece of rubber support material. The rubber support material was very loosely safety wired to the engine support. The entire mechanism did not appear to be supporting anything.

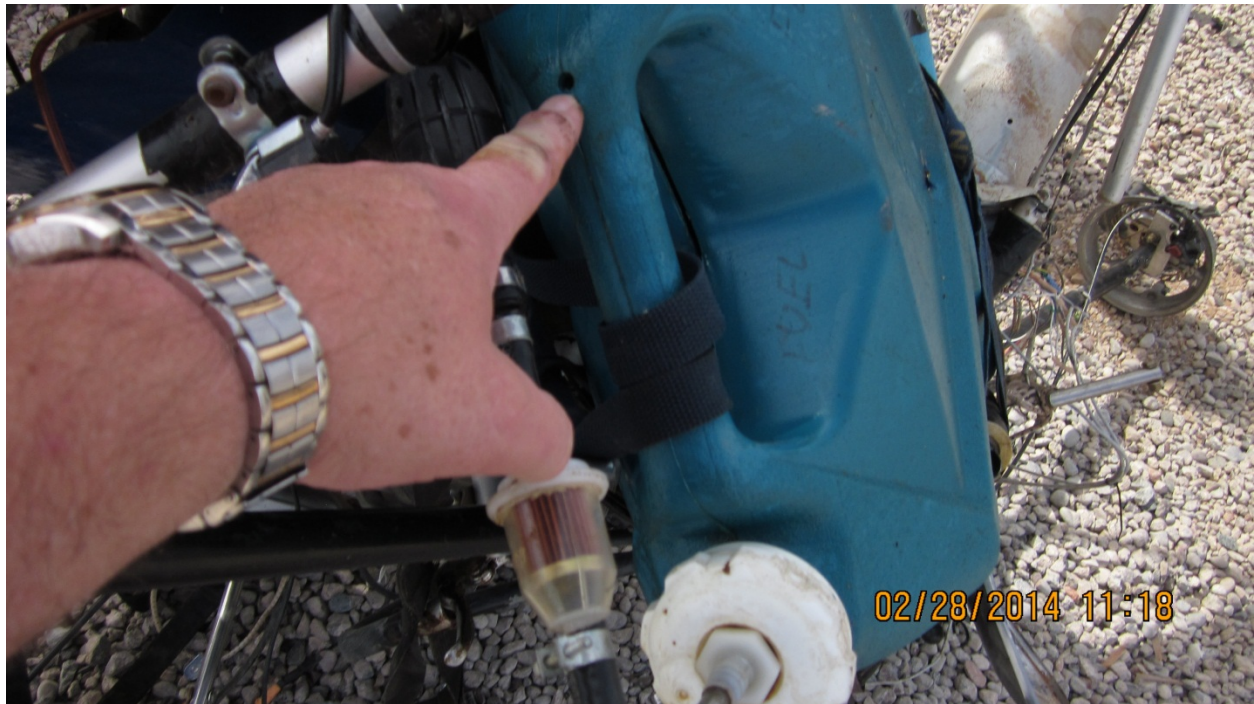
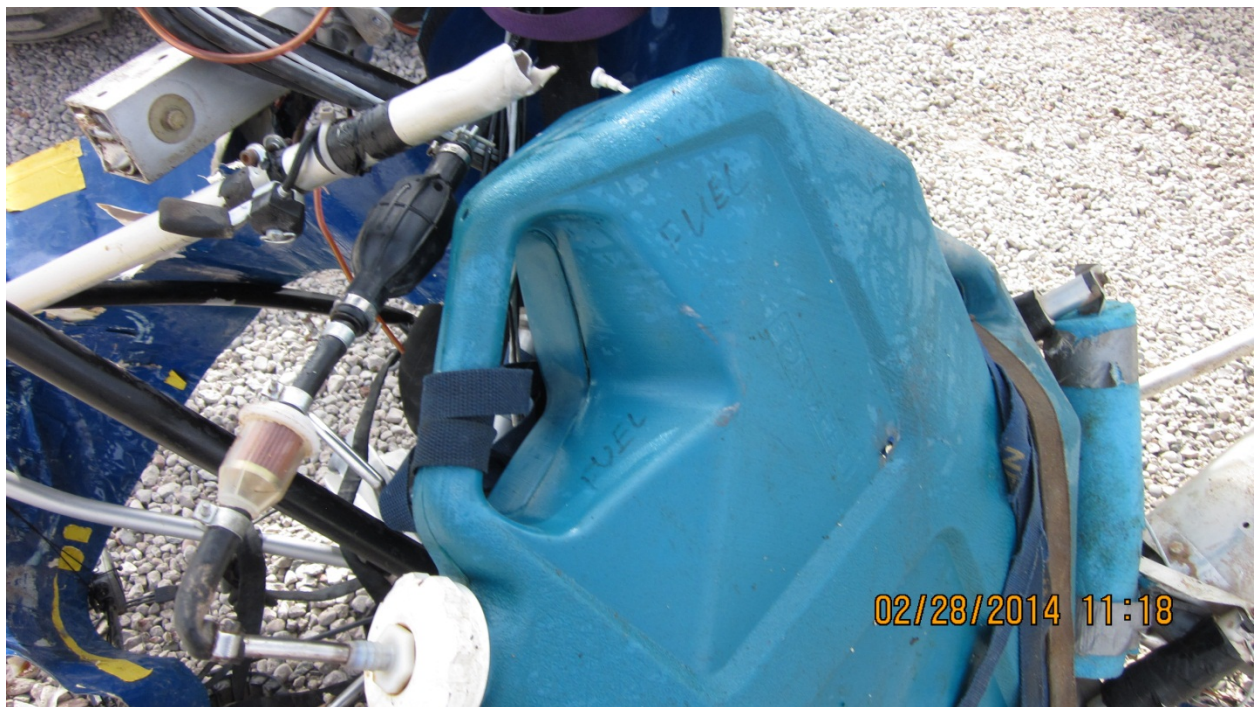
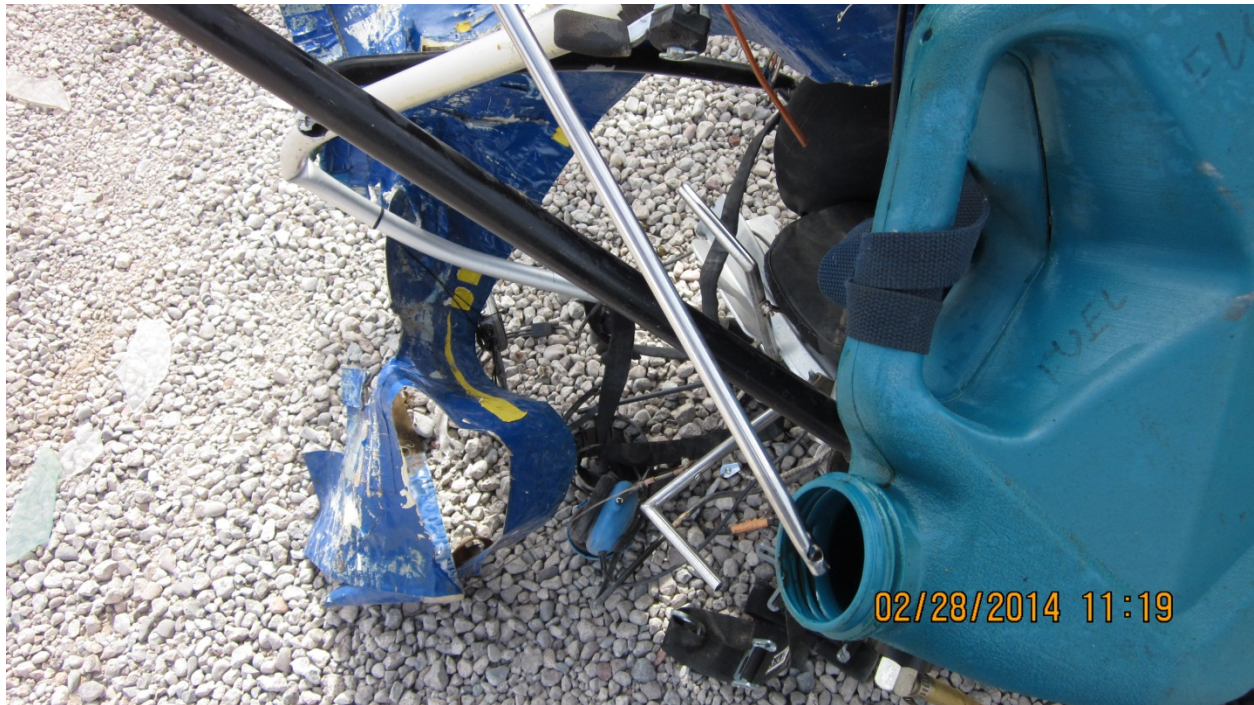
The fuel tank appeared to be a blue, five gallon container. There was a sight gage attached to the side and the tank was held in position by a series of cloth straps. There was a vent hole in the top of the tank that did not have any type of filter in place. A filter may have been installed but was knocked lose by the impact. The amount of fuel in the tank at the time of impact is unknown. The throttle linkage was intact and was operating freely.

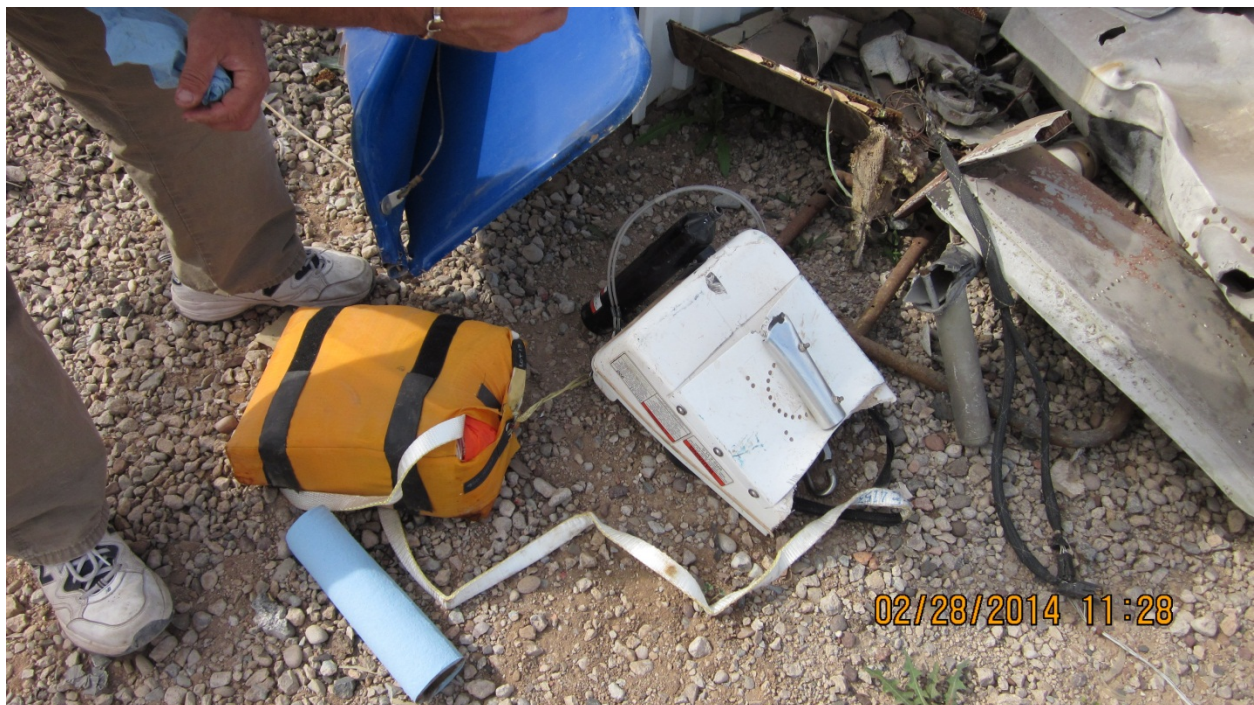
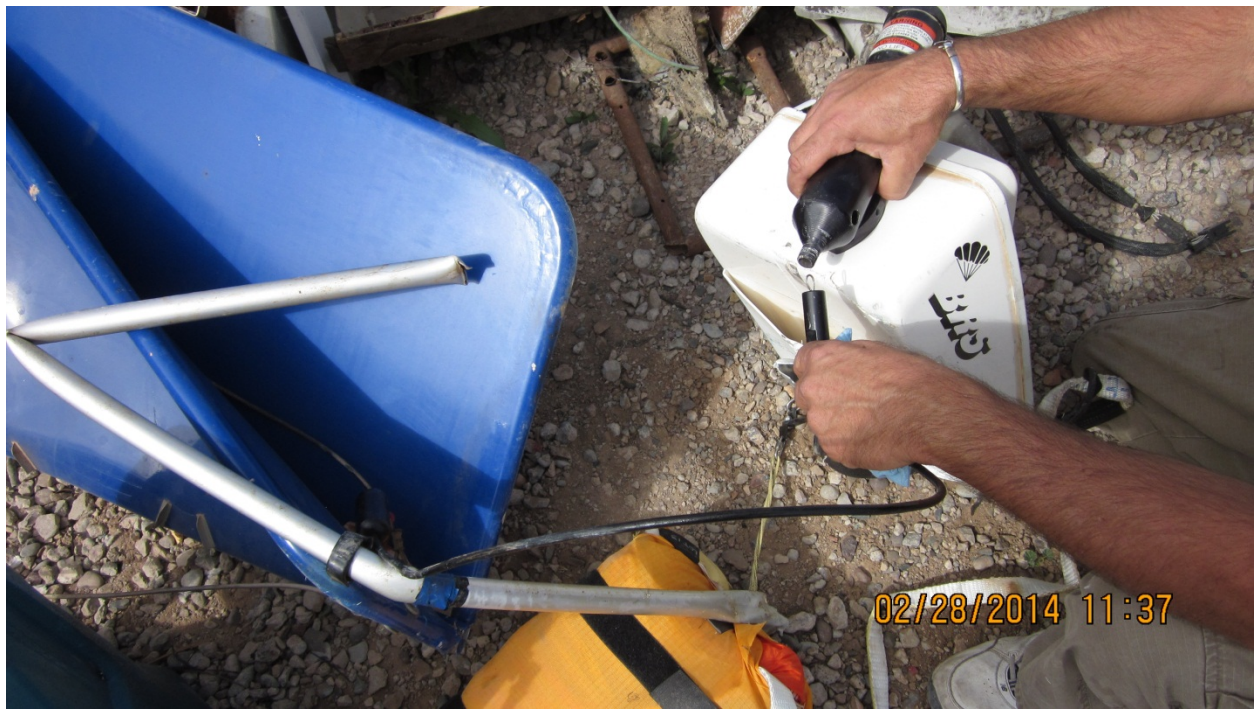
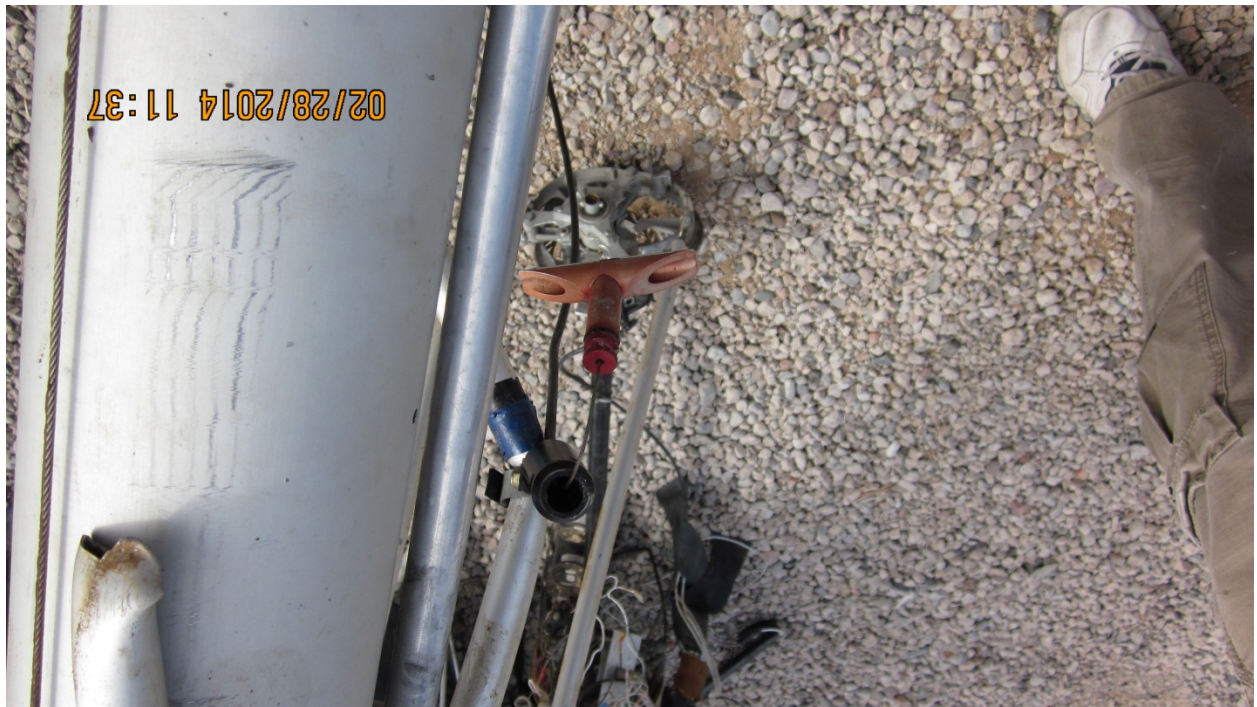
The ballistic recovery parachute system was intact. The handle was partially deployed. We were unable to tell if the pilot attempted to deploy the recovery chute or if it had become dislodged from the holder during transport. The recovery person disabled the system by removing the activation handle. Suggest sending the system to a laboratory to determine if the system is serviceable. The expiration date of the system is July 2014.

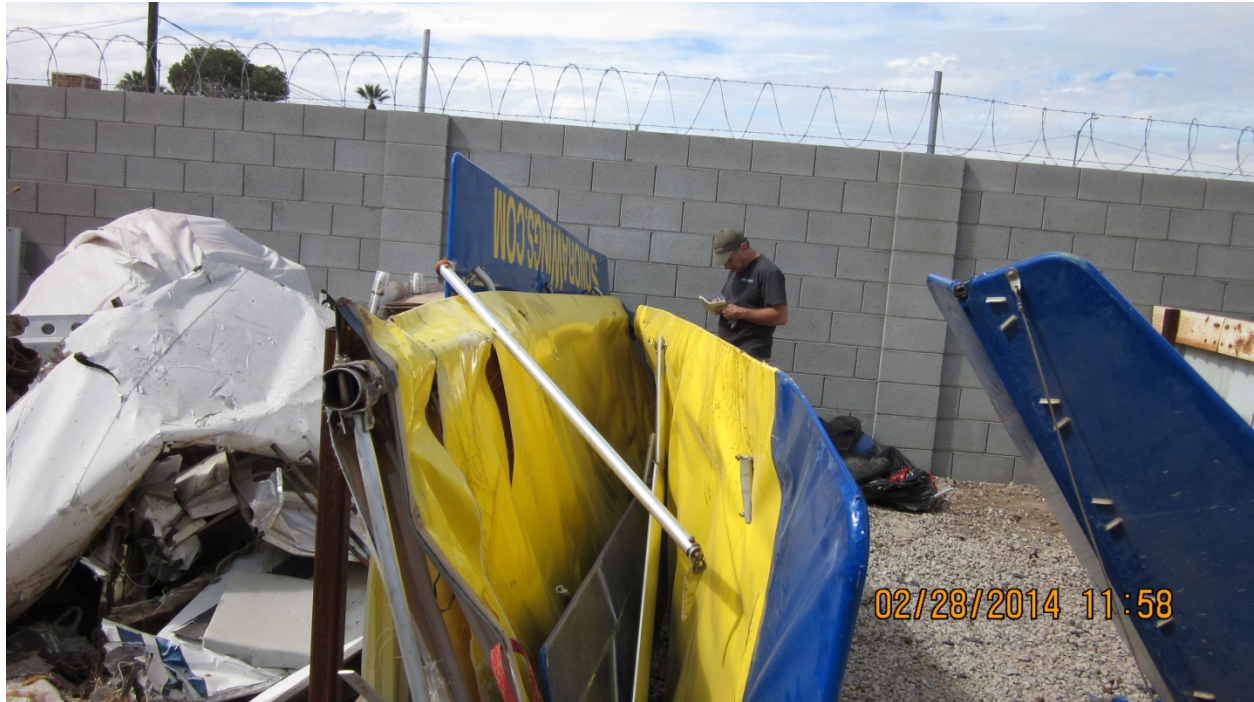
Both wings are relatively intact.

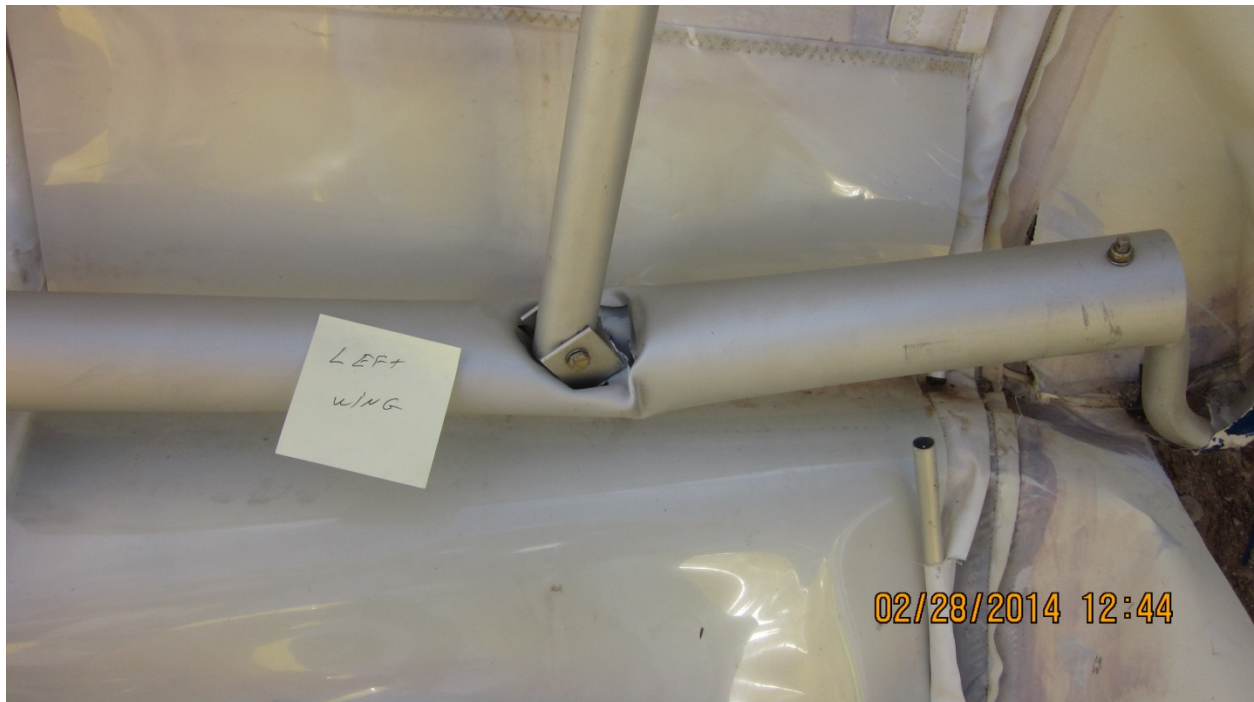
The left wing leading edge near the tip is damaged. This is consistent with witness statements the aircraft impacted on the left wing first.
