# NATIONAL TRANSPORTATION SAFETY BOARD

## MATERIALS LABORATORY FACTUAL REPORT

Report No. 14-033

Place : Fresno, California  
Date : February 28, 2014  
Vehicle : Grumman G-164A Ag Cat, N72ES  
NTSB No. : WPR14LA130  
Investigator : Michael Huhn, AS-WPR

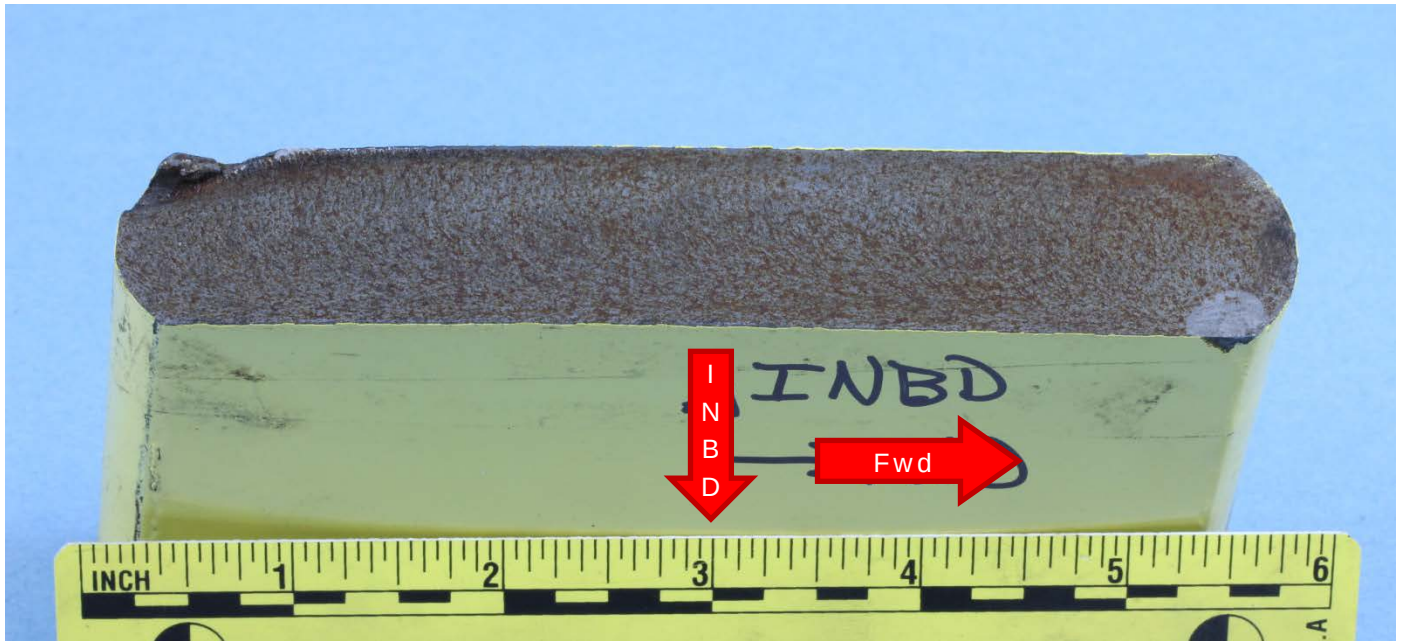
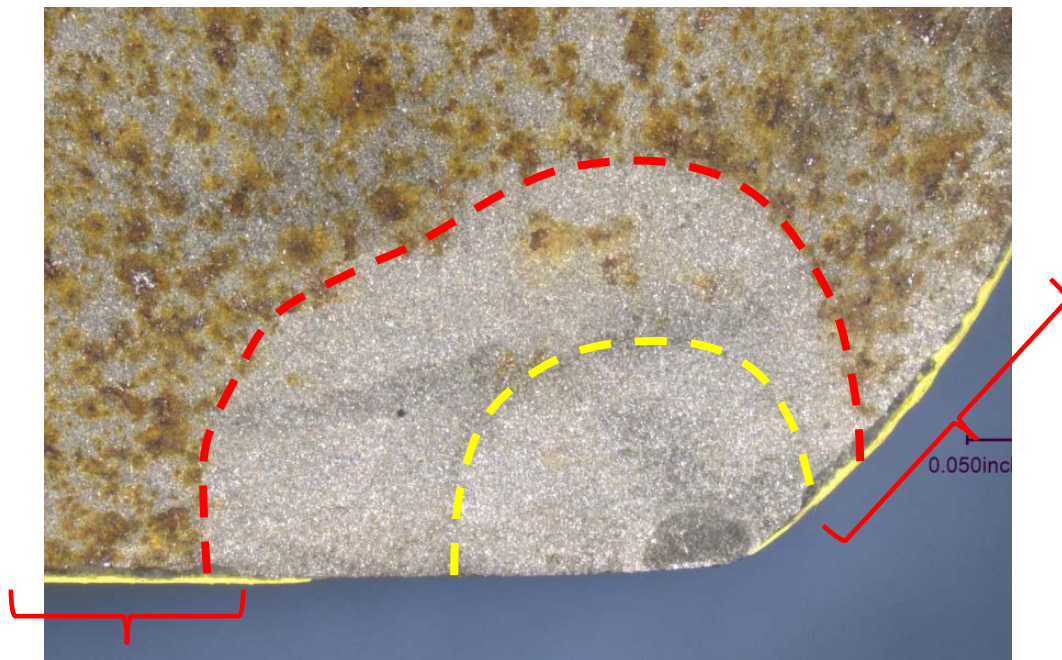
The received inboard half of the fractured right main landing gear spring is displayed in the upper view of figure 1. The spring gear was saw cut about 2  $\frac{3}{4}$  inch inboard of the fracture prior to receipt in the Materials Laboratory. As shown in the lower view of figure 1, the fracture was generally smooth and flat and covered by a speckled pattern of rust products except at the lower forward corner where a semi-elliptical region was nearly rust free.

Visual and magnified examination of the fracture surface revealed fracture traces and marking indicating that the overall fracture initiated in the clean region in the lower forward corner of the gear. Closer optical inspection within the clean area revealed a small (approximate 0.084 Inch wide by 0.040 inch tall) darkly oxidized semi-elliptical region adjacent to the lower gear surface at the forward corner. The oxidized region was then surrounded by a cleaner region measuring about 0.4 inch wide by 0.25 inch high (extent denoted by a red dashed line). One crack arrest band was also apparent in the clean region as indicated by the yellow dashed line. Shear lips (denoted in lower view of figure 1) were evident at the edge of the fracture except adjacent to the oxidized region and at most of the clean area.

Figure 1. Upper view shows the overall fracture of the landing gear spring looking generally inboard. The lower view shows the clean area (dashed red line) with the darker region at the lower forward corner of the gear. Dashed yellow line denotes an arrest line. Bracket indicate shear lips.

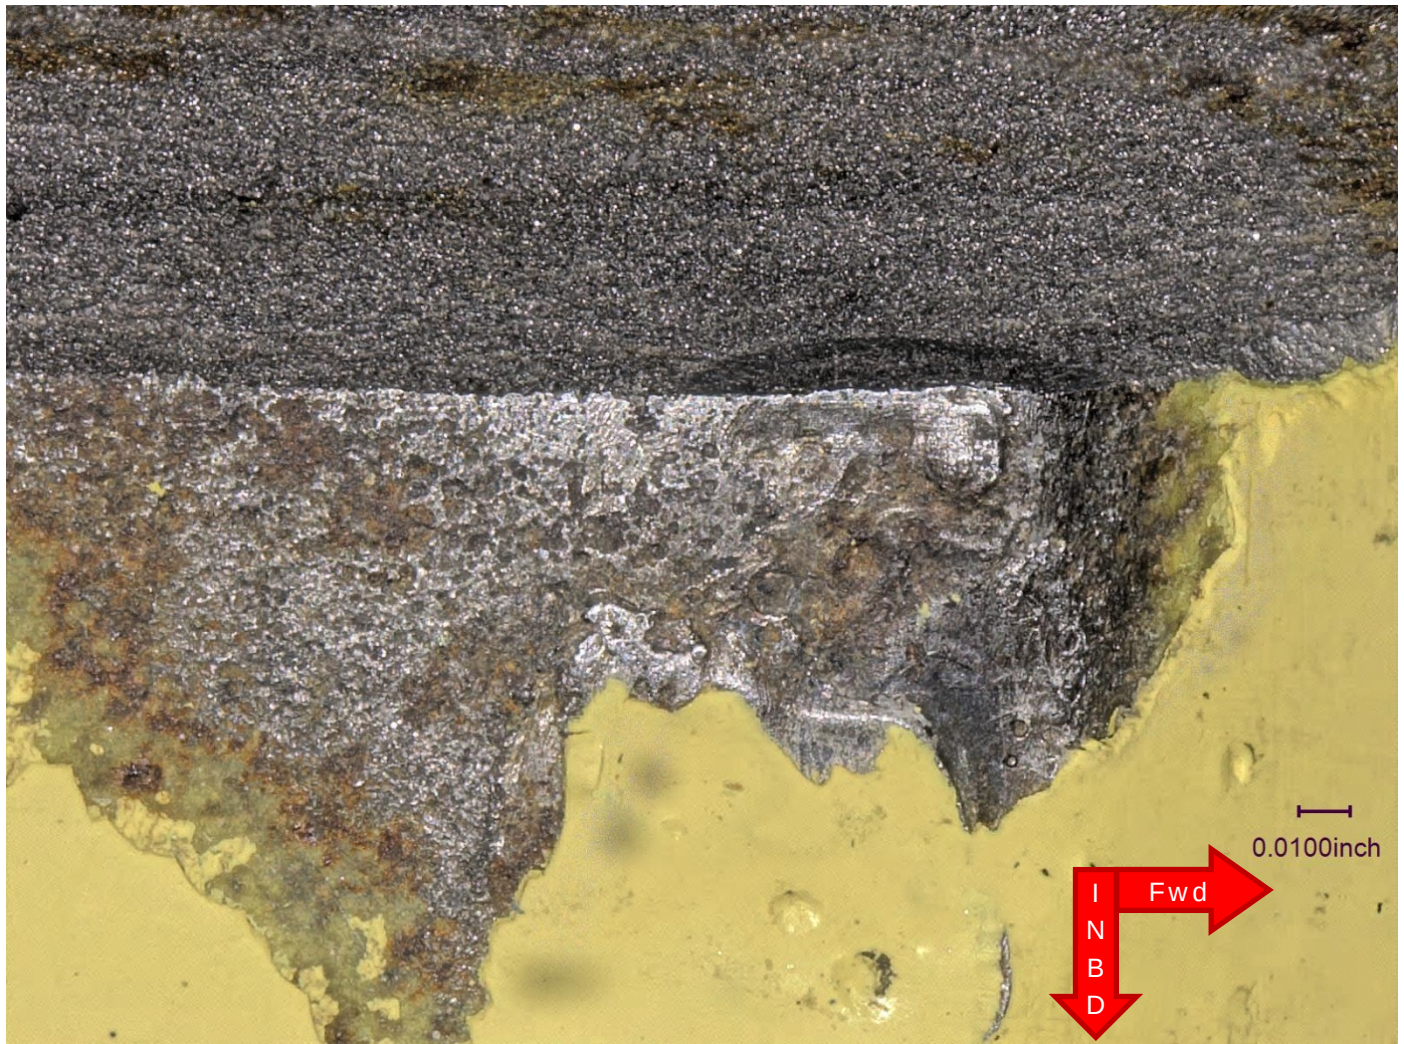
Optical examination of the surface of the spring adjacent to the oxidized region revealed chipped yellow paint with a rough and rusted underlying surface as shown in figure 2. Removal of more paint uncovered the eroded and globular surface shown in figure 3. The features of the surface are consistent with localized melting and resolidification indicative of localized electrical arcing. The damage area measured about 0.15 inch wide by 0.6 inch tall, as shown. X-ray energy dispersive spectroscopy (EDS) of the surface revealed only elements consistent with a plain carbon steel.

Figure 2. As-received oblique view showing the chipped paint and rough corroded surface at the location of the oxidized region on the fracture face (top).

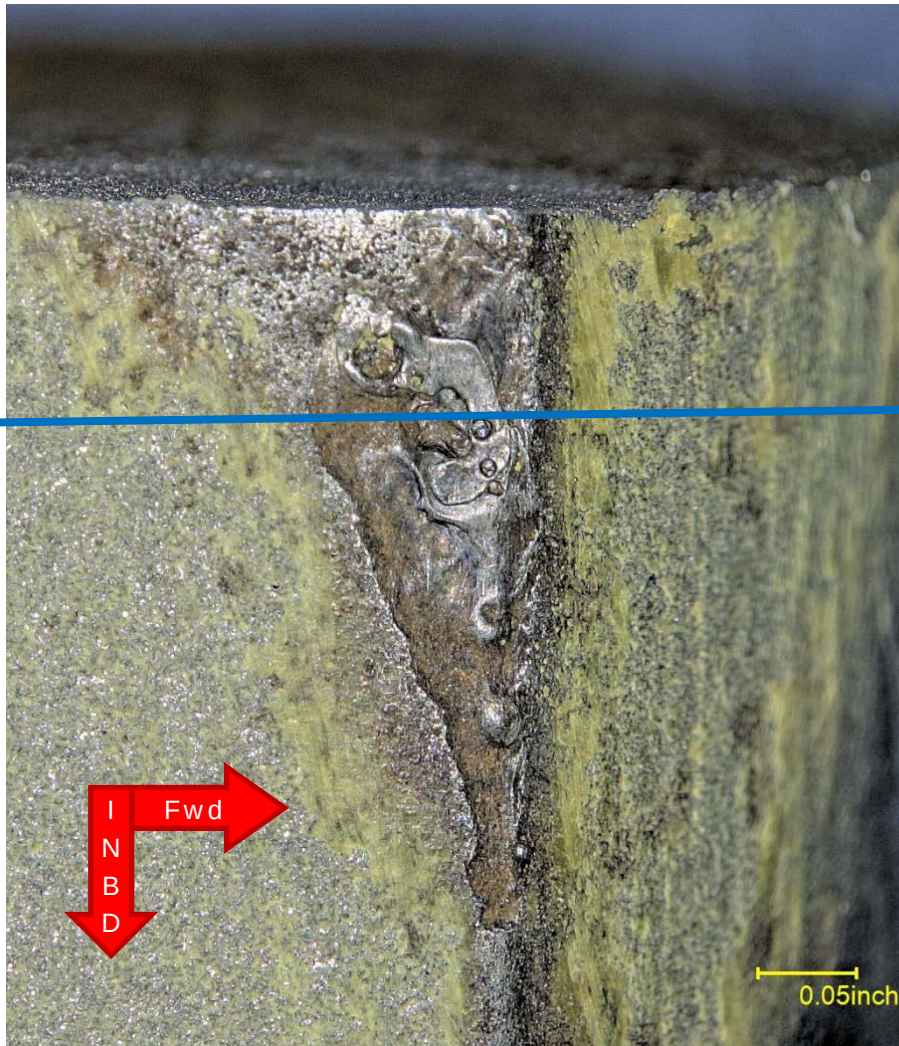
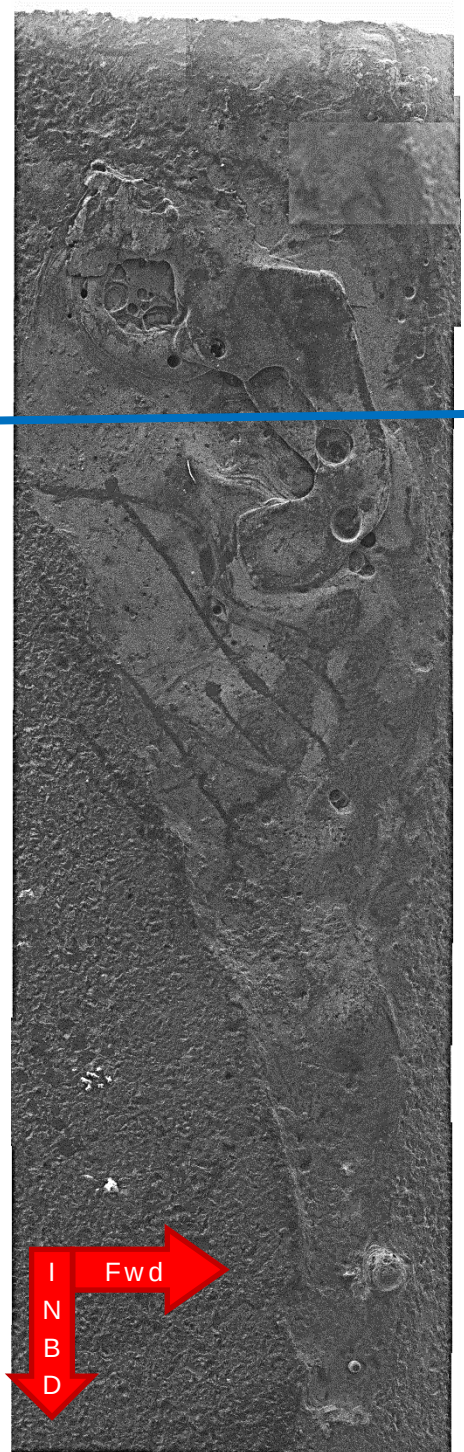
Figure 3. With paint partially removed the resolidified region is apparent in optical (left) and scanning electron (right) images. The blue line indicates the approximate location of the metallographic section.

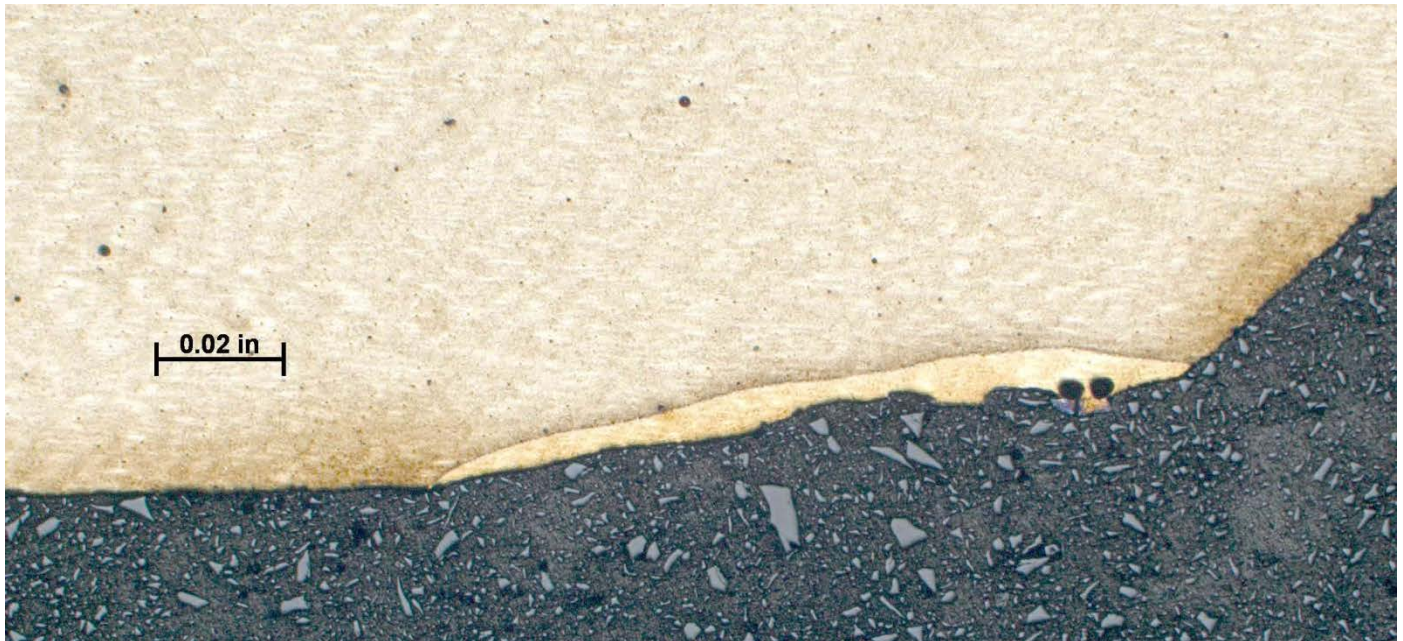
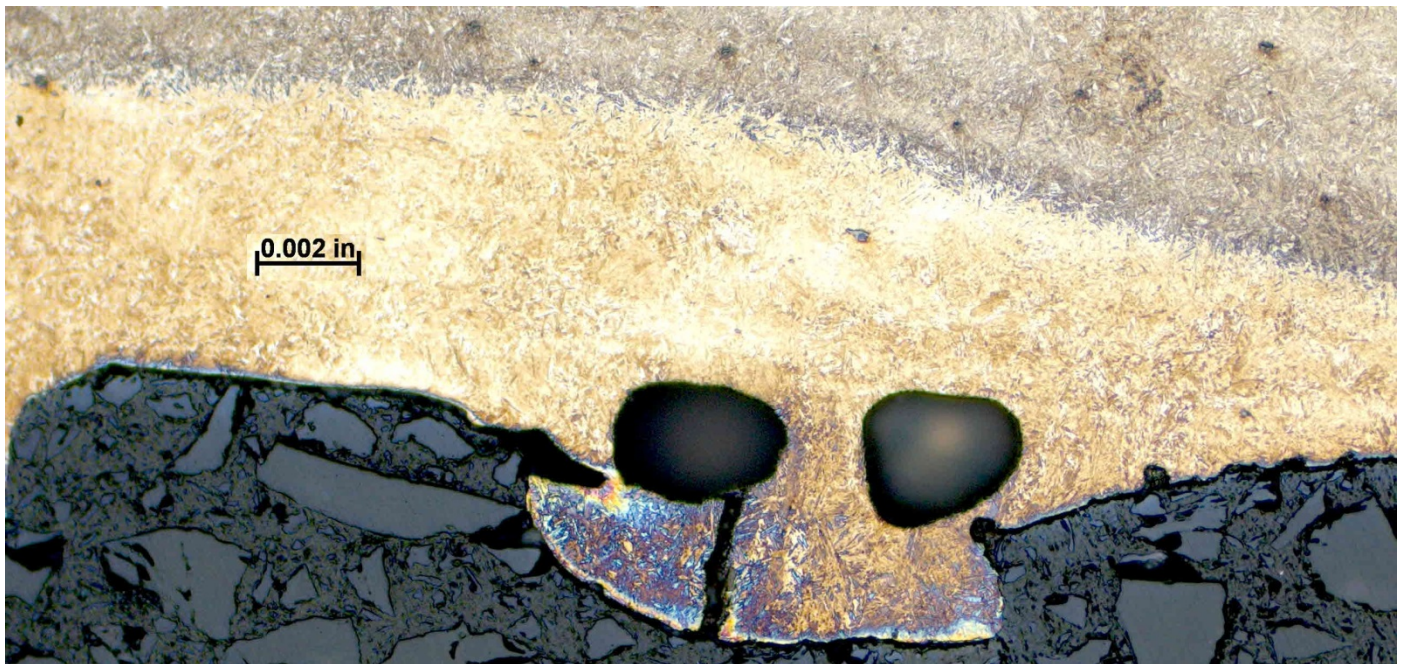
The piece of landing gear was abrasively cut on a parallel plane below the fracture such that a metallographic sample could be prepared through the globular region at the approximate location of the blue line in the left view of figure 3. Etching with 2% Nital<sup>1</sup> reagent revealed the microstructure shown in figure 4. The etched specimen showed a white (lighter etching) zone adjacent to the lower surface corresponding to the location of the oxidized region on the fracture face. At this location the white zone was about 0.012 inch wide and had a maximum thickness of about 0.008 inch. Microhardness measurements determined that the average white zone hardness was HRC<sup>2</sup> 61.5. In comparison, the underlying material had an average hardness of HRC 50. The increased hardness and lighter etching characteristics are consistent with a localized rehardened zone.

Figure 4. Nital etched metallographic section showing the white zone corresponding to the resolidified region and the fracture initiation area.

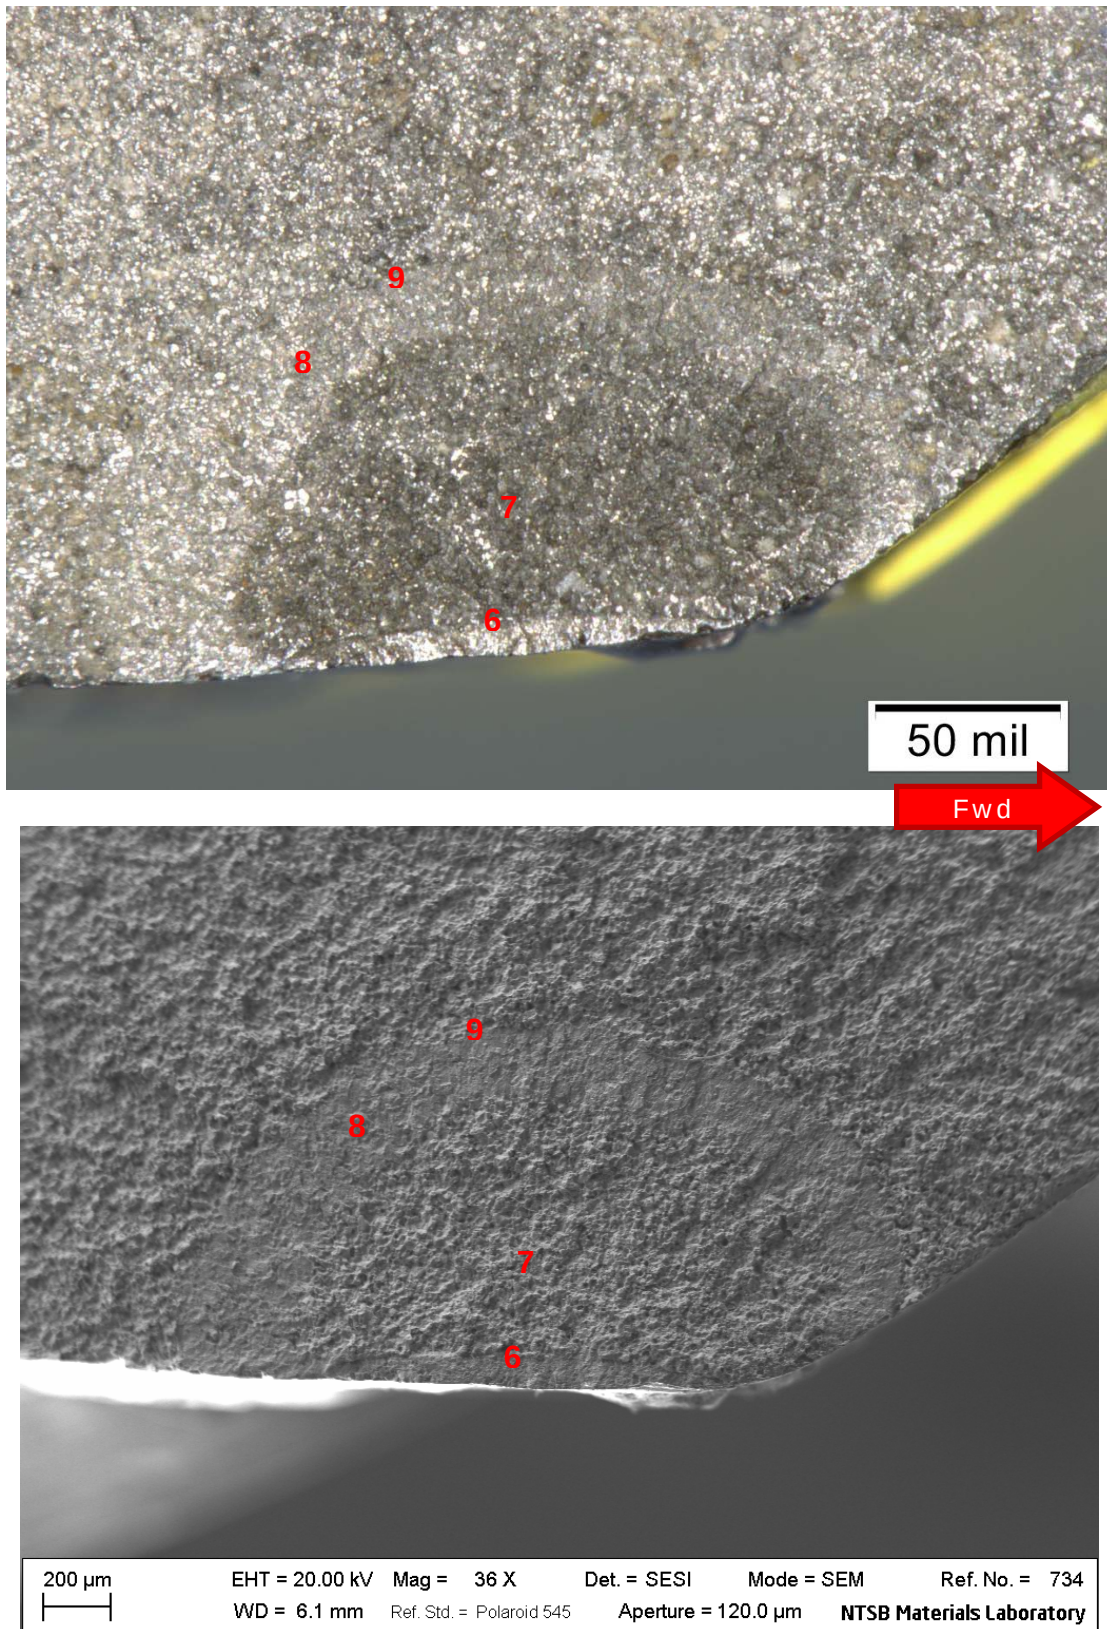
Closer optical and scanning electron microscope examinations in the dark oxidized area revealed additional details as shown in the two views of figure 5. A thin flat lenticular zone was apparent between the surface of the spring and the oxidized region. Fine fracture traces in the oxidized region indicated initiation at the lenticular zone. The lenticular zone had approximately the same shape and size as the white zone.

Figure 5. Optical, top, and scanning electron, below, images of the oxidized and surrounding regions of the fracture. Numbers indicate approximate location of following figures.

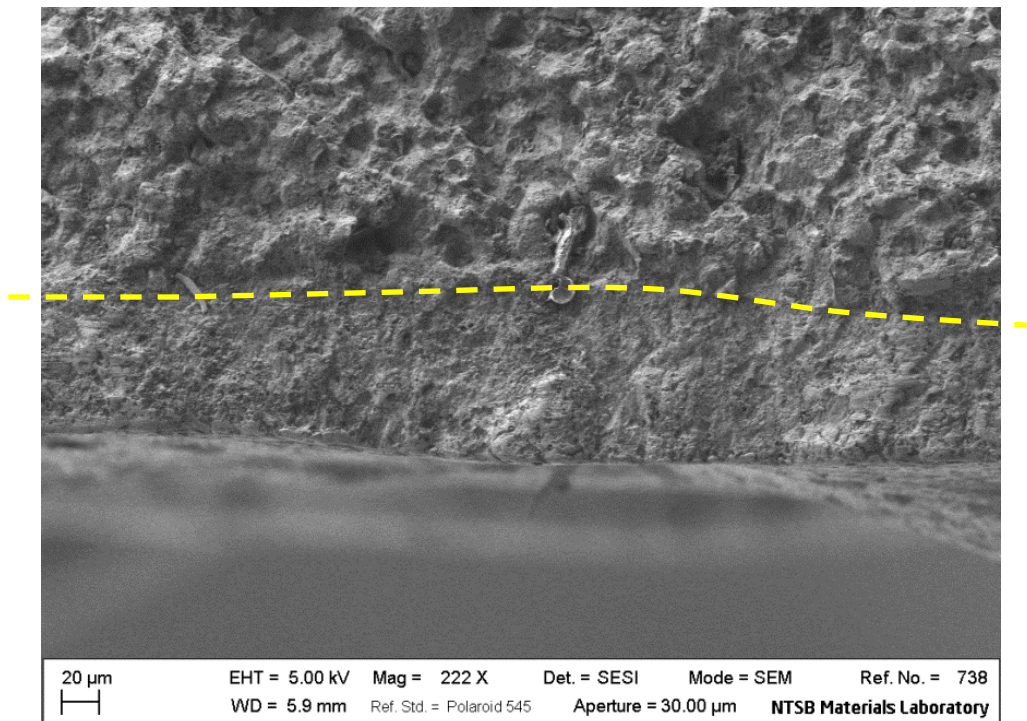
Higher magnification SEM examinations found the surface of the lenticular zone to be relatively smooth and heavily oxidized with no recognizable fracture features. The surface of the adjacent oxidized region also showed heavy oxidations but intergranular fracture features were very apparent, as shown in figure 7. The oxidized region was then surrounded by a 0.010 to 0.015 inch wide band of smoother predominately transgranular features (see figure 8). The remainder of the clean fracture region was again intergranular fracture (see figure 9).

Figure 6. SEM view of the lenticular zone (up to the yellow dashed line) at the initiation of the fracture.

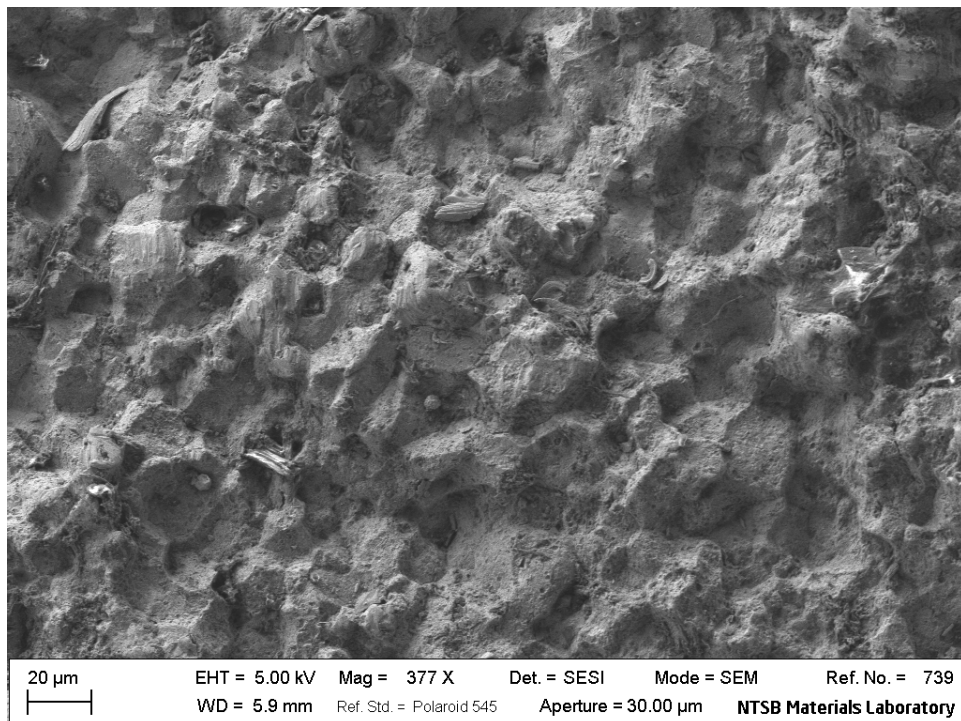
Figure 7. SEM view of the intergranular features in the oxidized region.

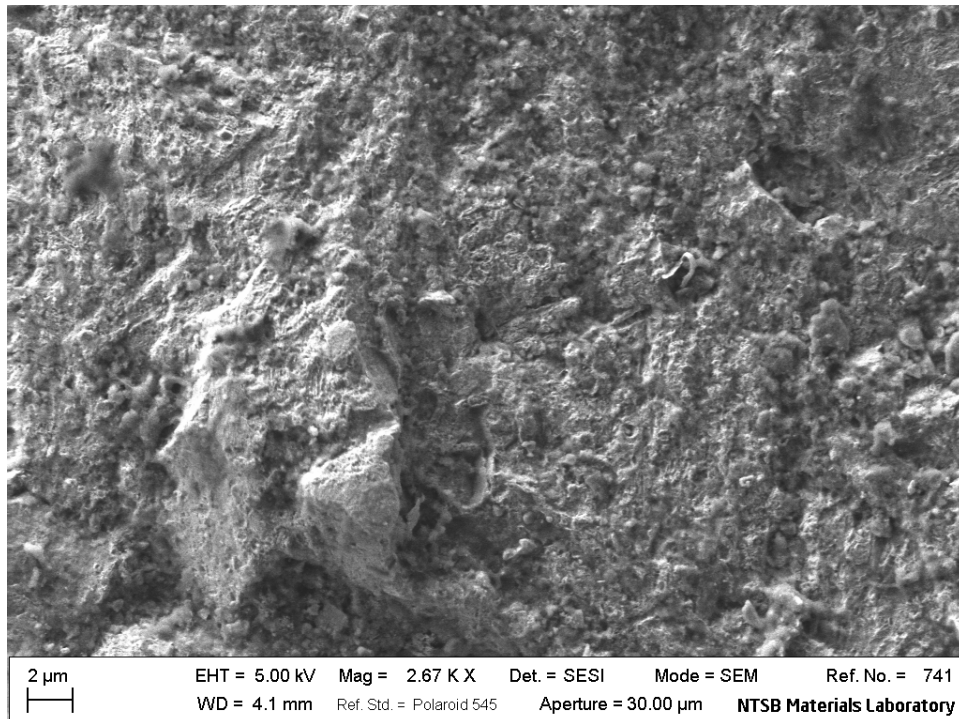
Figure 8. SEM view of the transgranular band between the oxidized region and the clean intergranular region.

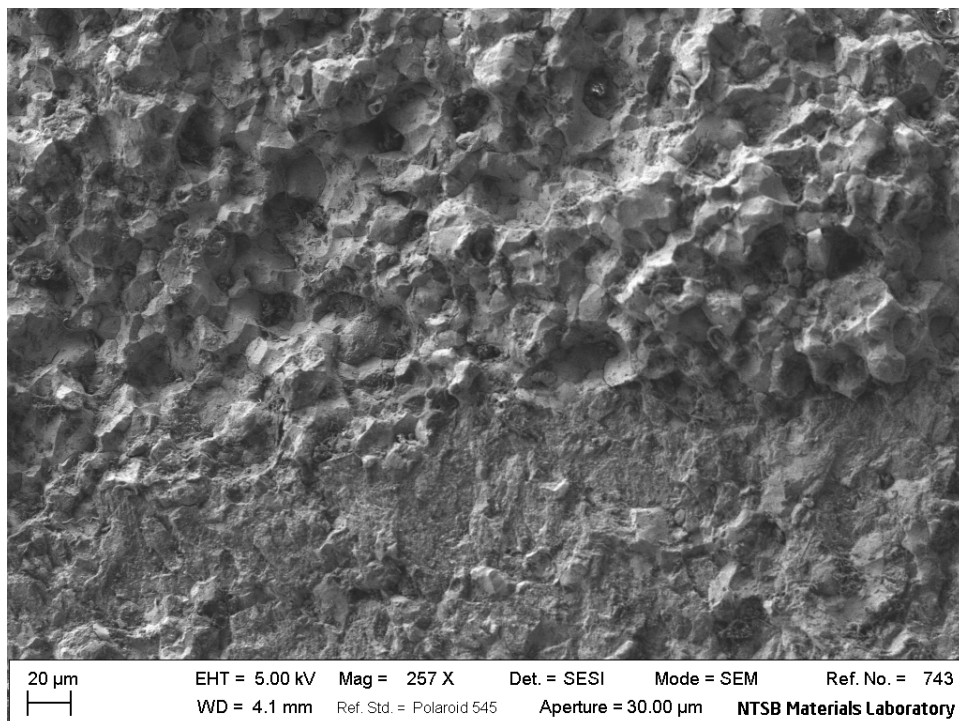
Fig 9

Figure 9. SEM view of the transition from the intergranular band the clean intergranular area.

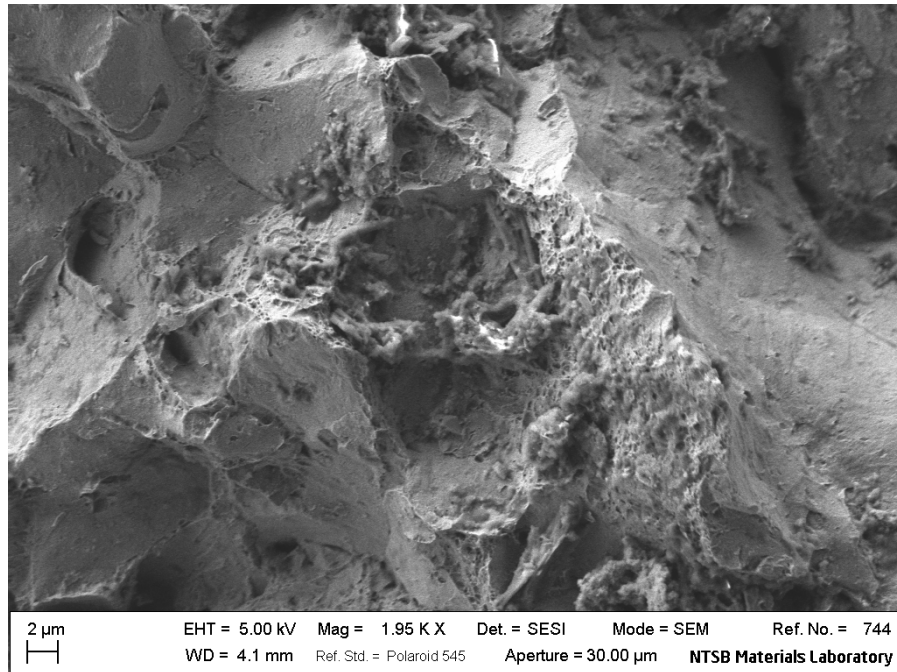
Figure 10. SEM view of the mixed intergranular and ductile dimple features outside of the clean region.

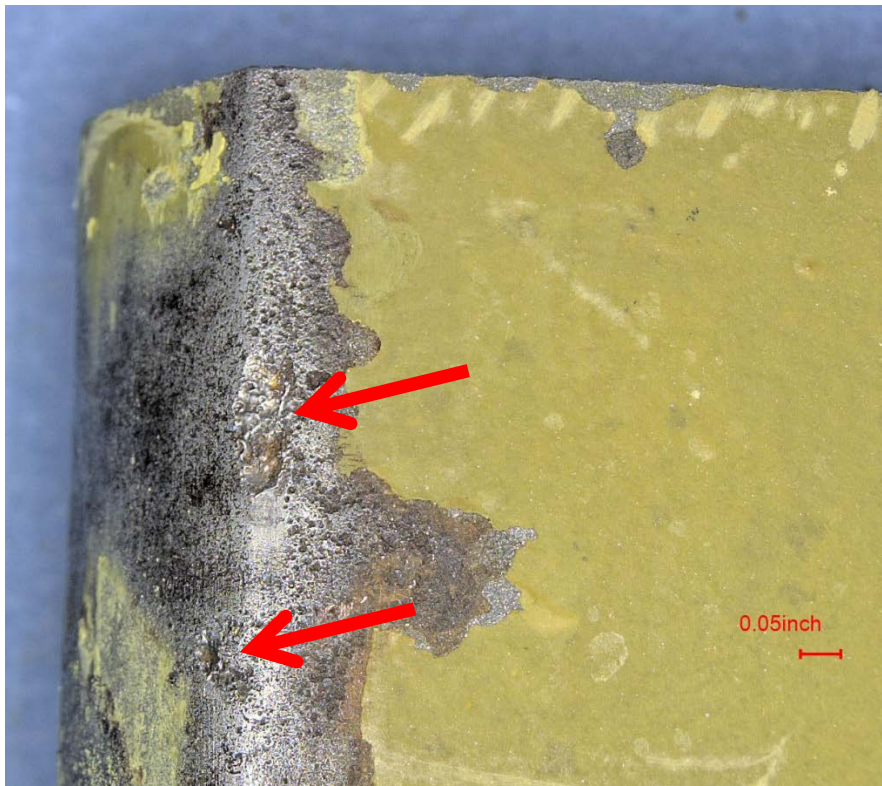
In addition to the arc damage adjacent to the fracture initiation on the lower surface of the gear, two small regions of arc damage were found on the upper forward corner of the gear as shown in figure 11. No cracks were visually apparent at these locations. Similar to the lower surface arc damage, corrosion pitting was apparent to the surfaces surrounding the arc damage.

Figure 11. Arc damage (arrows) on the upper forward corner of the gear.
