# **NATIONAL TRANSPORTATION SAFETY BOARD**

## **AIRPLANE INFORMATION**

**NTSB Accident: WPR14LA179  
Accident Date: April 30, 2014**

Location: Bremerton, WA  
Date: April 30, 2014  
Aircraft: Pulsar XP, N452PC, Serial # 452  
NTSB IIC: Michael Huhn

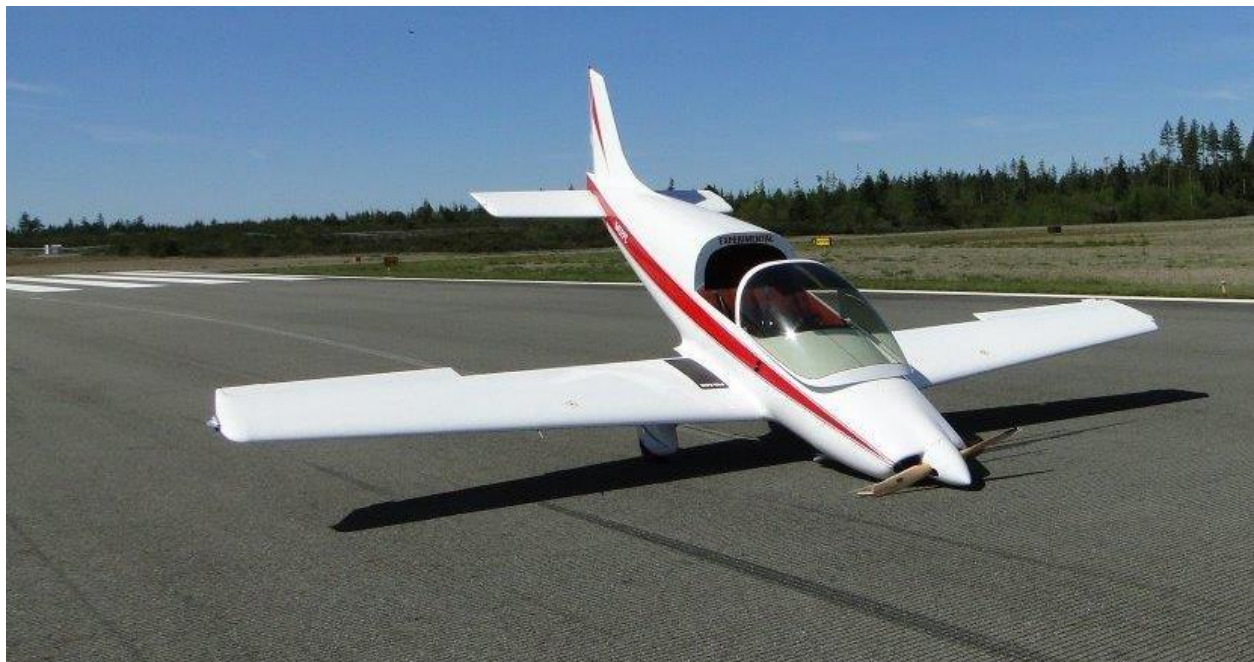
**Figure 1 - Airplane on Runway**

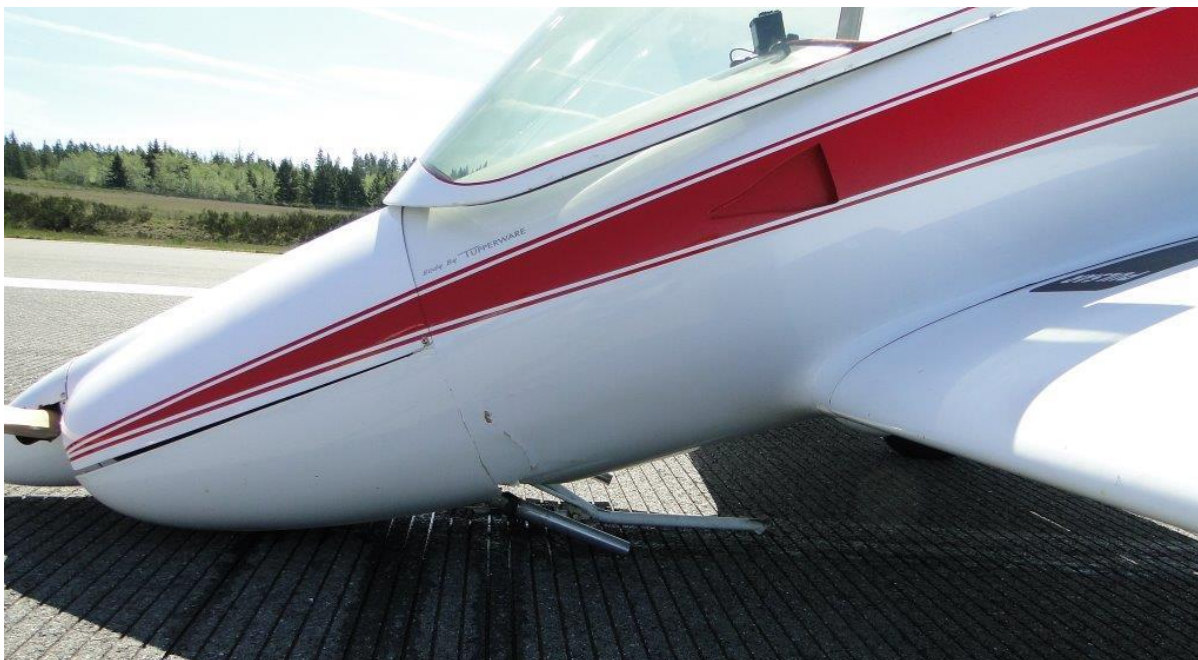
**Figure 2 - Cowl and Nose Gear Leg**

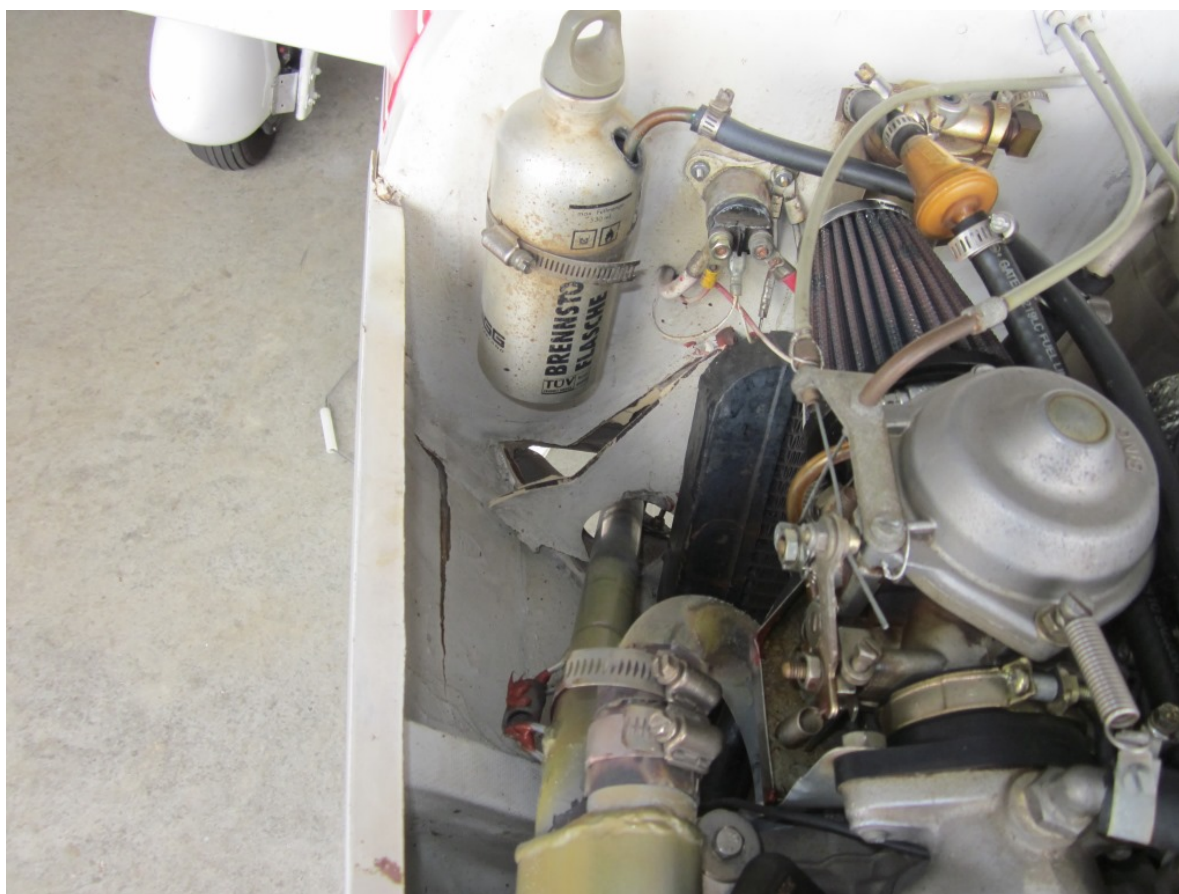
**Figure 3 - Fractured Firewall**

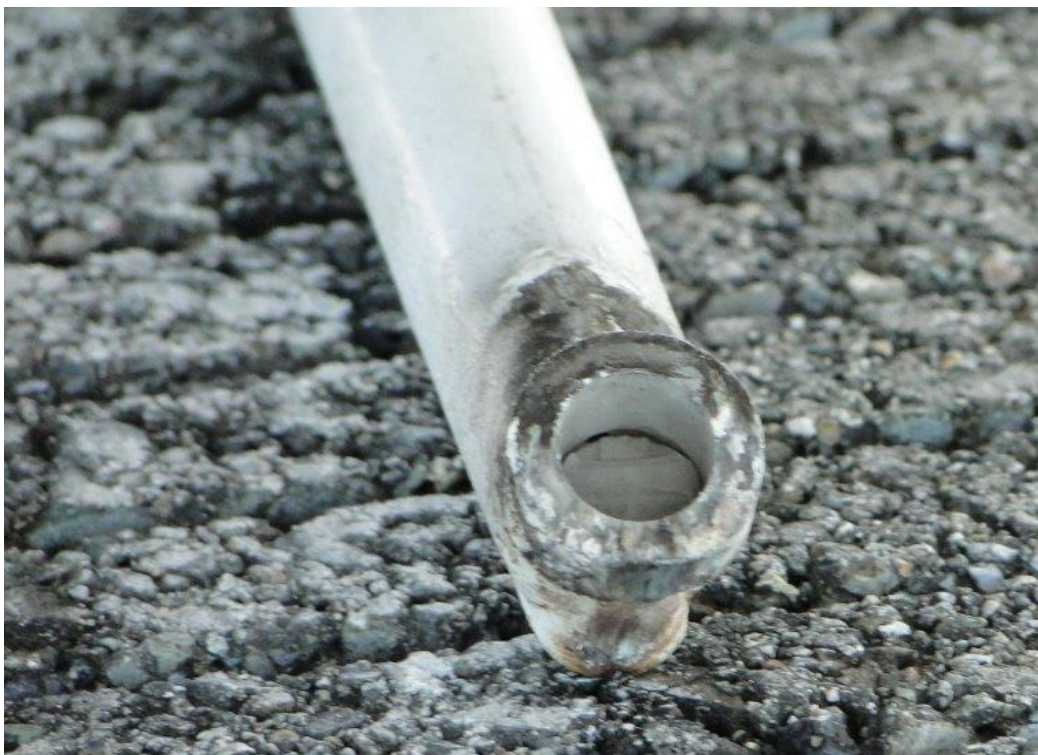
According to the builder/owner/pilot, the shaft was a solid 4130 steel rod that nested in, and was welded to, the tubular steel nose gear leg, and on which the NLG fork assembly pivoted. The shaft fractured just inside the lower end of the NLG leg tube.

Figure 5 - End of Nose Gear Leg

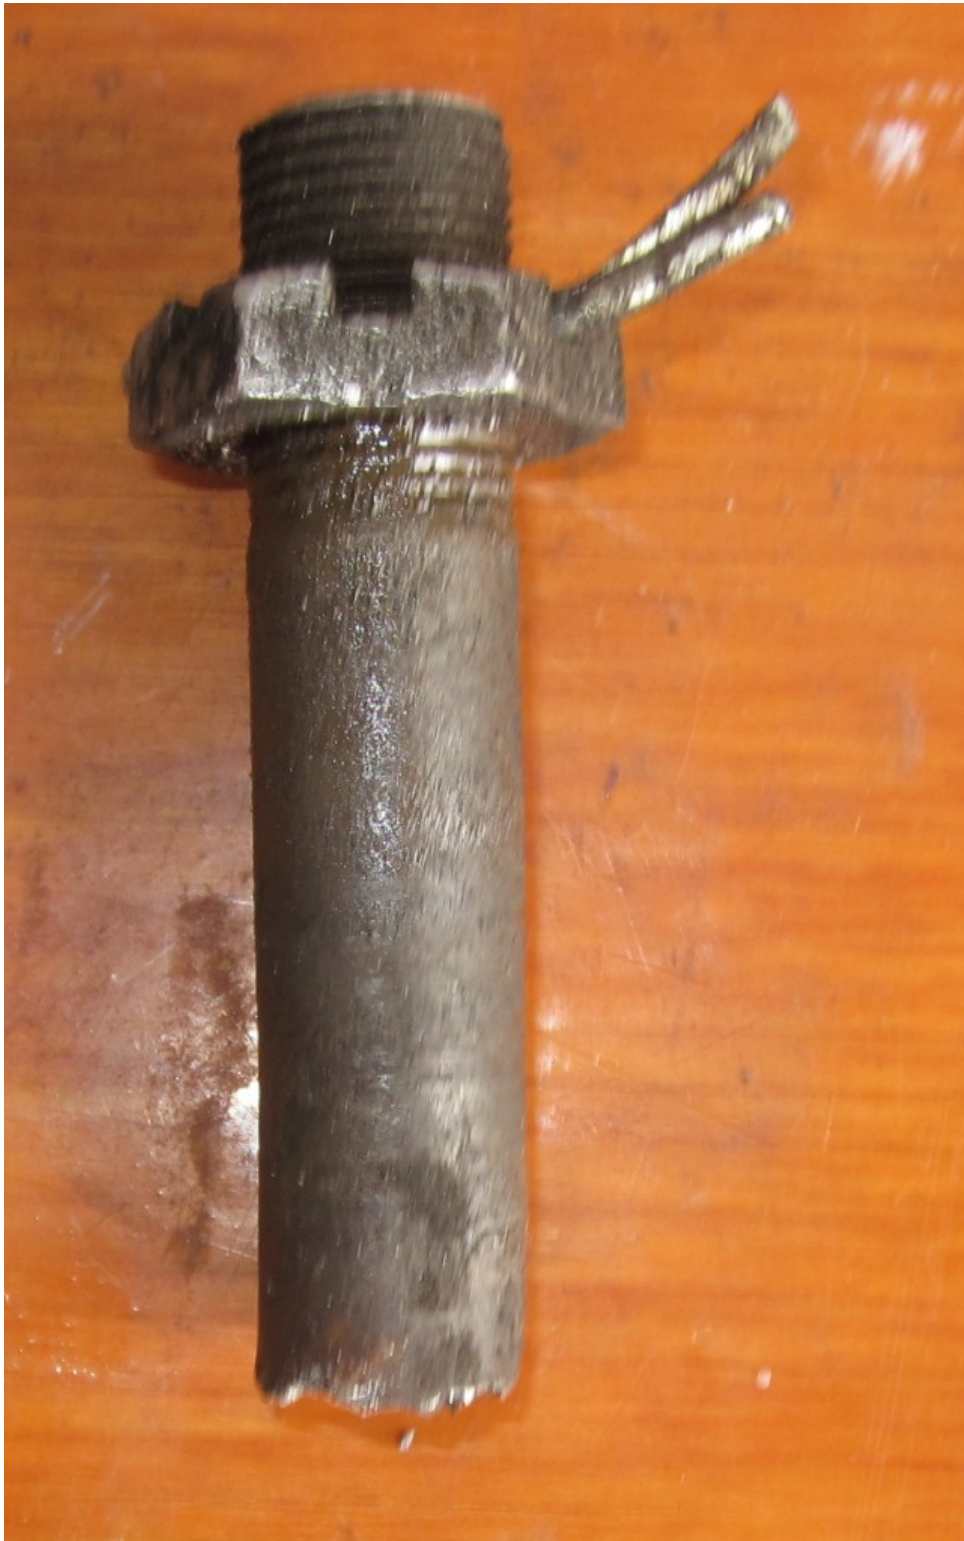
On April 30, 2014, about 1055 Pacific daylight time, an experimental amateur-built Pulsar XP, N452PC, sustained substantial damage on landing at Bremerton National airport (PWT), Bremerton, Washington. Examination of the wreckage by FAA personnel revealed that the pivot shaft that enabled the nose landing gear (NLG) wheel and tire assembly to caster for directional control had fractured, and that fracture allowed the NLG fork to depart the airplane during takeoff. Examination of photographs of the fracture end of the pivot shaft by the investigator in charge and a metallurgist at the NTSB materials laboratory indicated that the fracture patterns were consistent with reversed bending (bi-directional) fatigue.

**Figure 6 - Fractured Shaft**

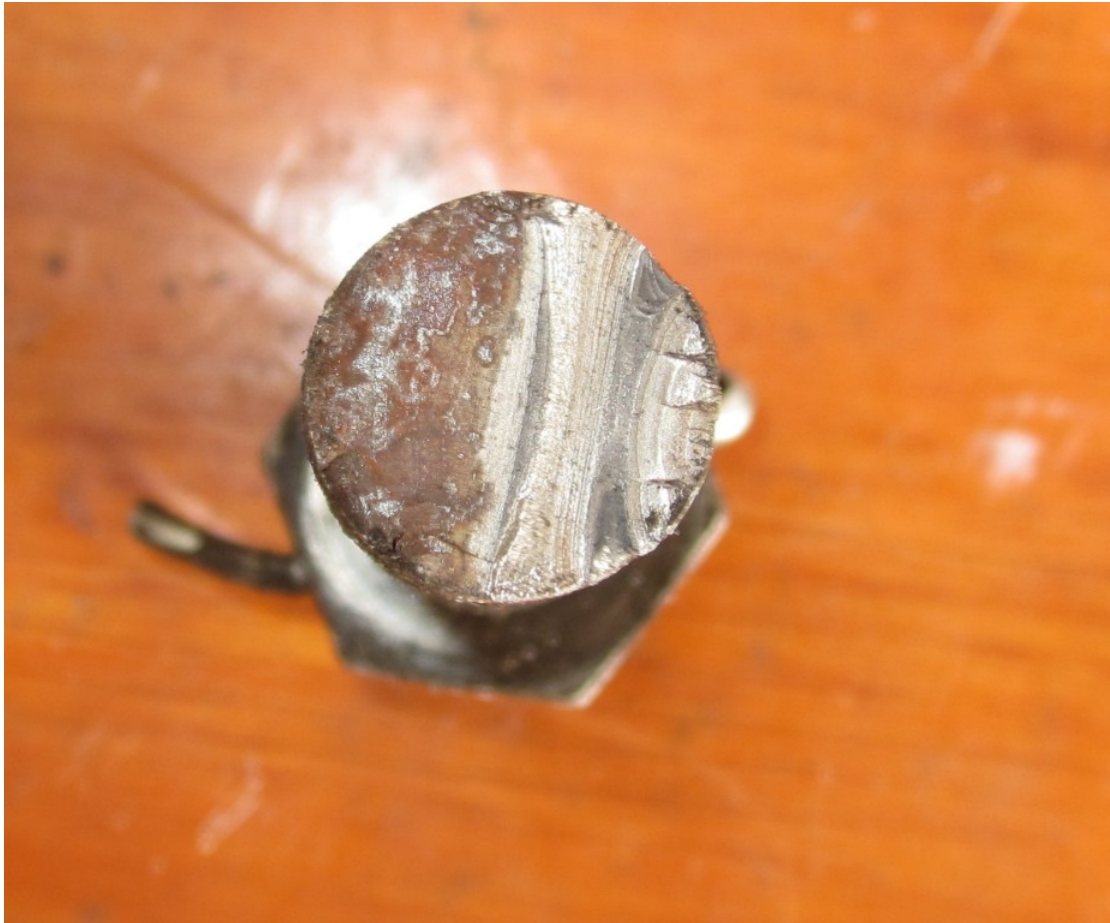
**Figure 7 - Shaft Fracture**

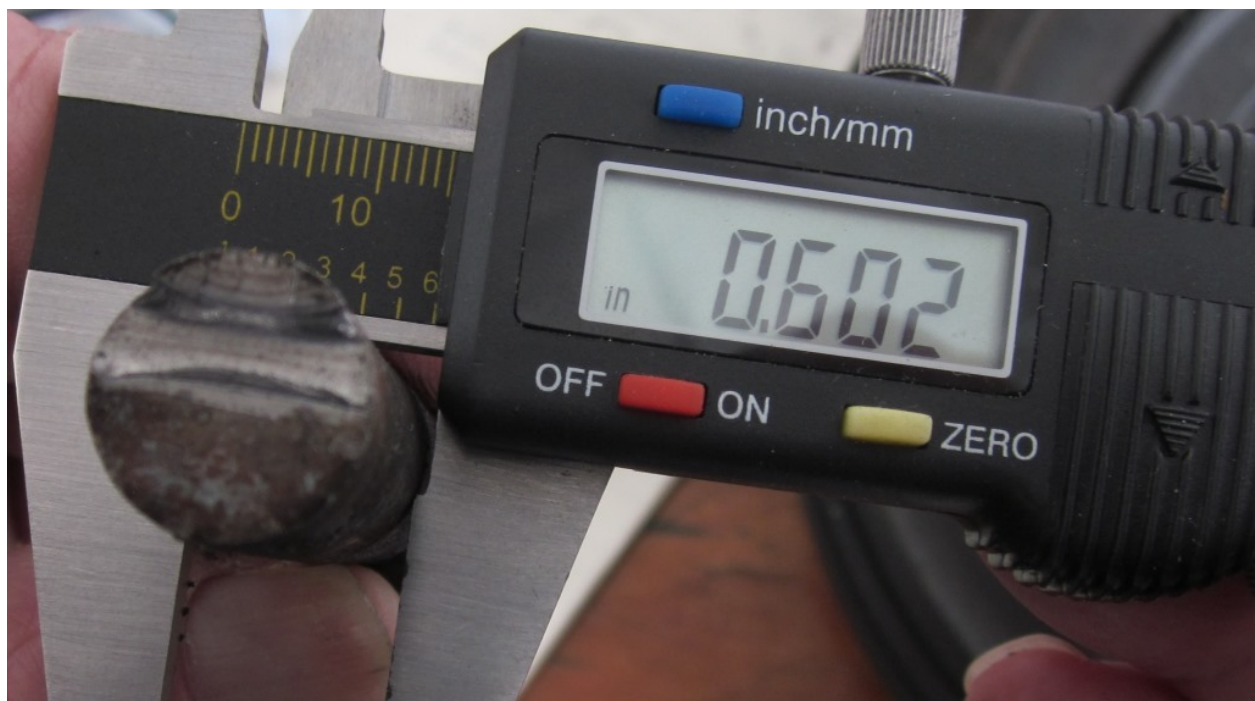
**Figure 8 - Shaft Diameter Measurement (Note incorrect location of shaft in micrometer)**

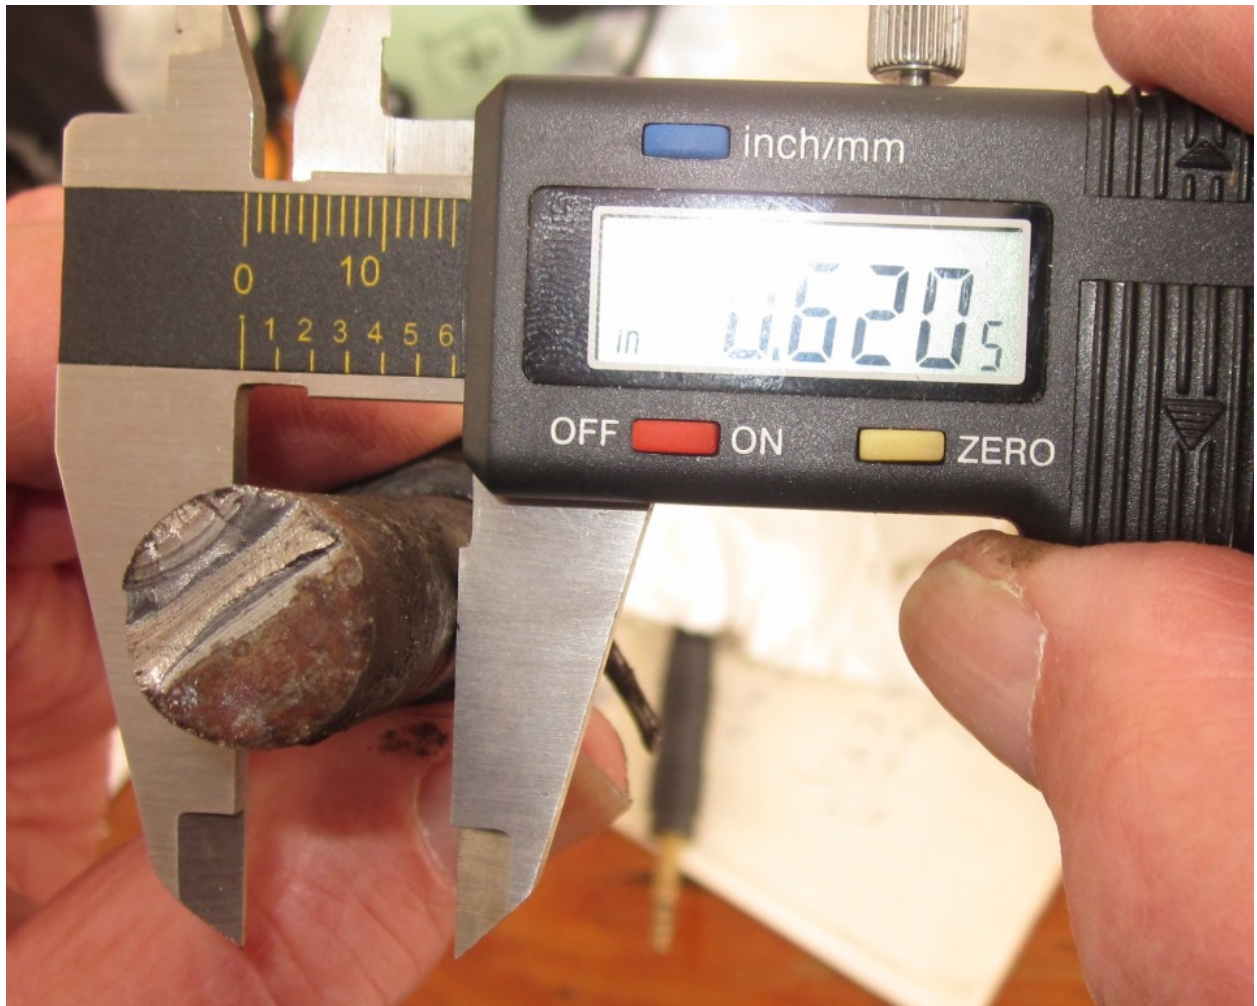
**Figure 9 - Shaft Diameter Measurement (Note incorrect location of shaft in micrometer)**
