## **NATIONAL TRANSPORTATION SAFETY BOARD**

### **NOSE GEAR MODIFICATION INFORMATION**

**NTSB Accident: WPR14LA179  
Accident Date: April 30, 2014**

Location: Bremerton, WA  
Date: April 30, 2014  
Aircraft: Pulsar XP, N452PC, Serial # 452  
NTSB IIC: Michael Huhn

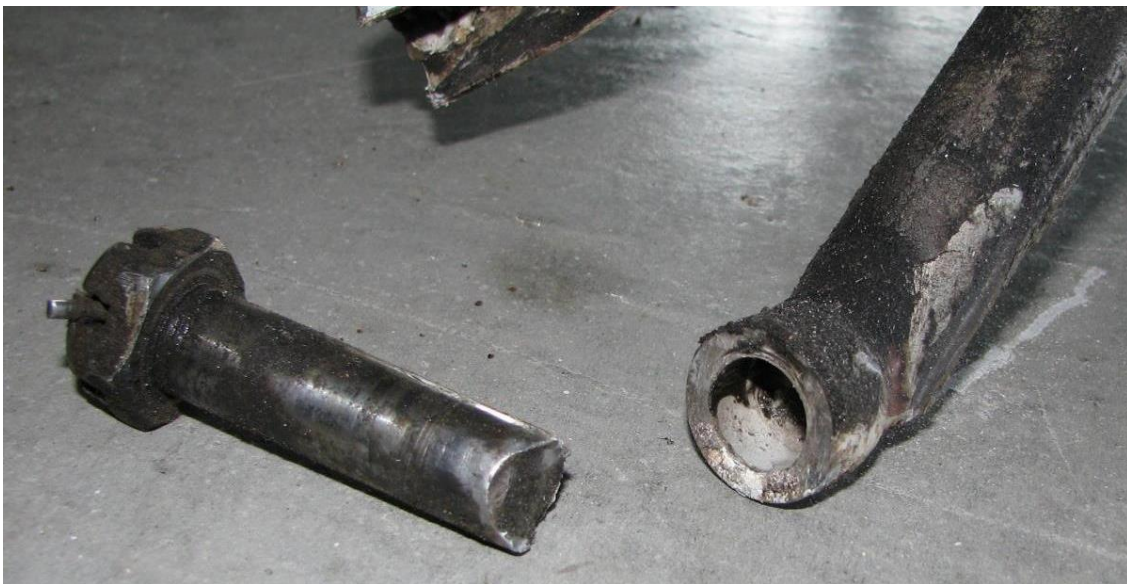
On April 30, 2014, about 1055 Pacific daylight time, an experimental amateur-built Pulsar XP, N452PC, sustained substantial damage on landing at Bremerton National airport (PWT), Bremerton, Washington. Examination revealed that the pivot shaft to enable the nose landing gear (NLG) wheel and tire assembly to caster for directional control had failed in reversed bending fatigue, which allowed the NLG fork to depart the airplane during takeoff.

**Figure 1 - Fractured Shaft**
