# NATIONAL TRANSPORTATION SAFETY BOARD

## MATERIALS LABORATORY FACTUAL REPORT

Report No. 16-074

Place : Williams, California  
Date : August 30, 2014  
Vehicle : Travel Air C-4000 (N9952)  
NTSB No. : WPR14LA361  
Investigator : Howard Plagens (AS-WPR)

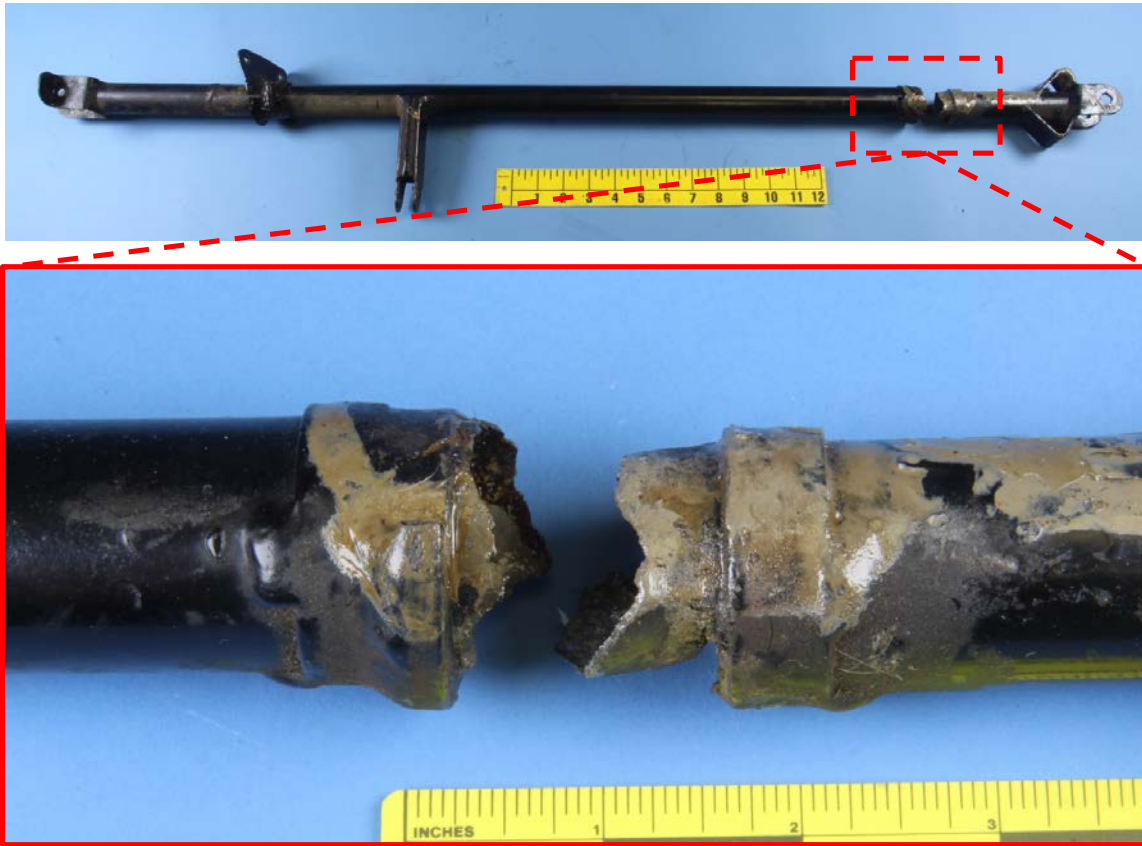
The control tube had separated between two collars, approximately 7 inches from one end, as shown in Figure 1.

**Figure 1:** An overall photo of the separated control tube is shown in the top photo. The bottom photo shows a close-up photo of the separation in the control tube.

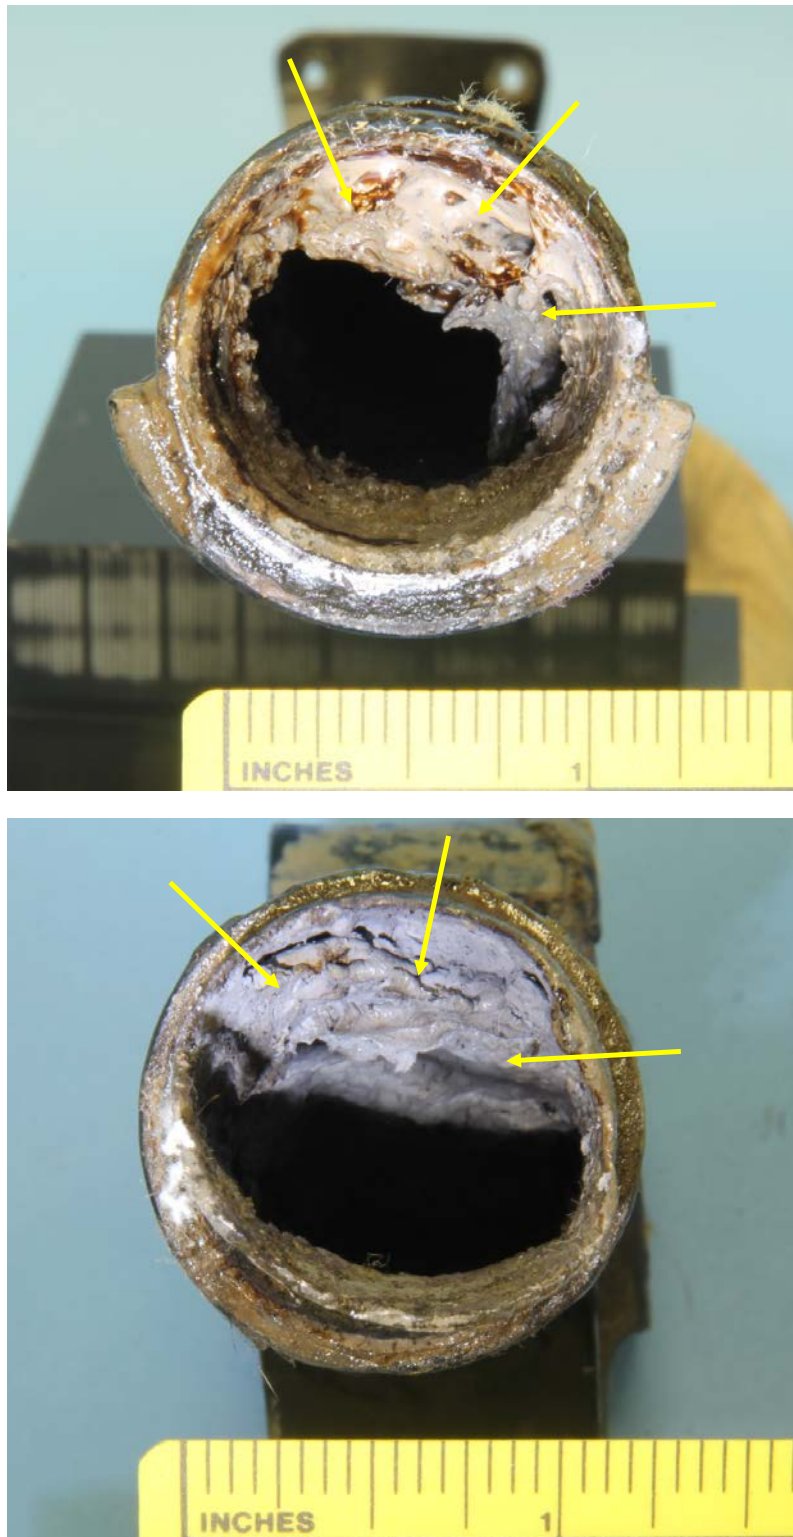
The control tube fracture surfaces are shown in Figure 2. The fracture surfaces were heavily smeared, and the majority was covered with the same glossy, hard substance that coated the inside of the control tube (yellow arrows, Figure 2). Per an internal NTSB Materials Lab email report dated November 13, 2015, this substance was determined via Fourier Transform Infrared (FTIR) spectroscopy to be an organic compound likely consisting of solidified corrosion inhibiting compound.

The areas of the fracture surfaces minimally covered in the hardened substance and largely undamaged had features consistent with overstress. The fracture occurred in a spiral along an approximately 45 degree angle, which is consistent with torsional overstress.

**Figure 2:** Close-up photos of the fracture surfaces on the separated control tube. The yellow arrows point to the hardened substance observed inside the control tube.

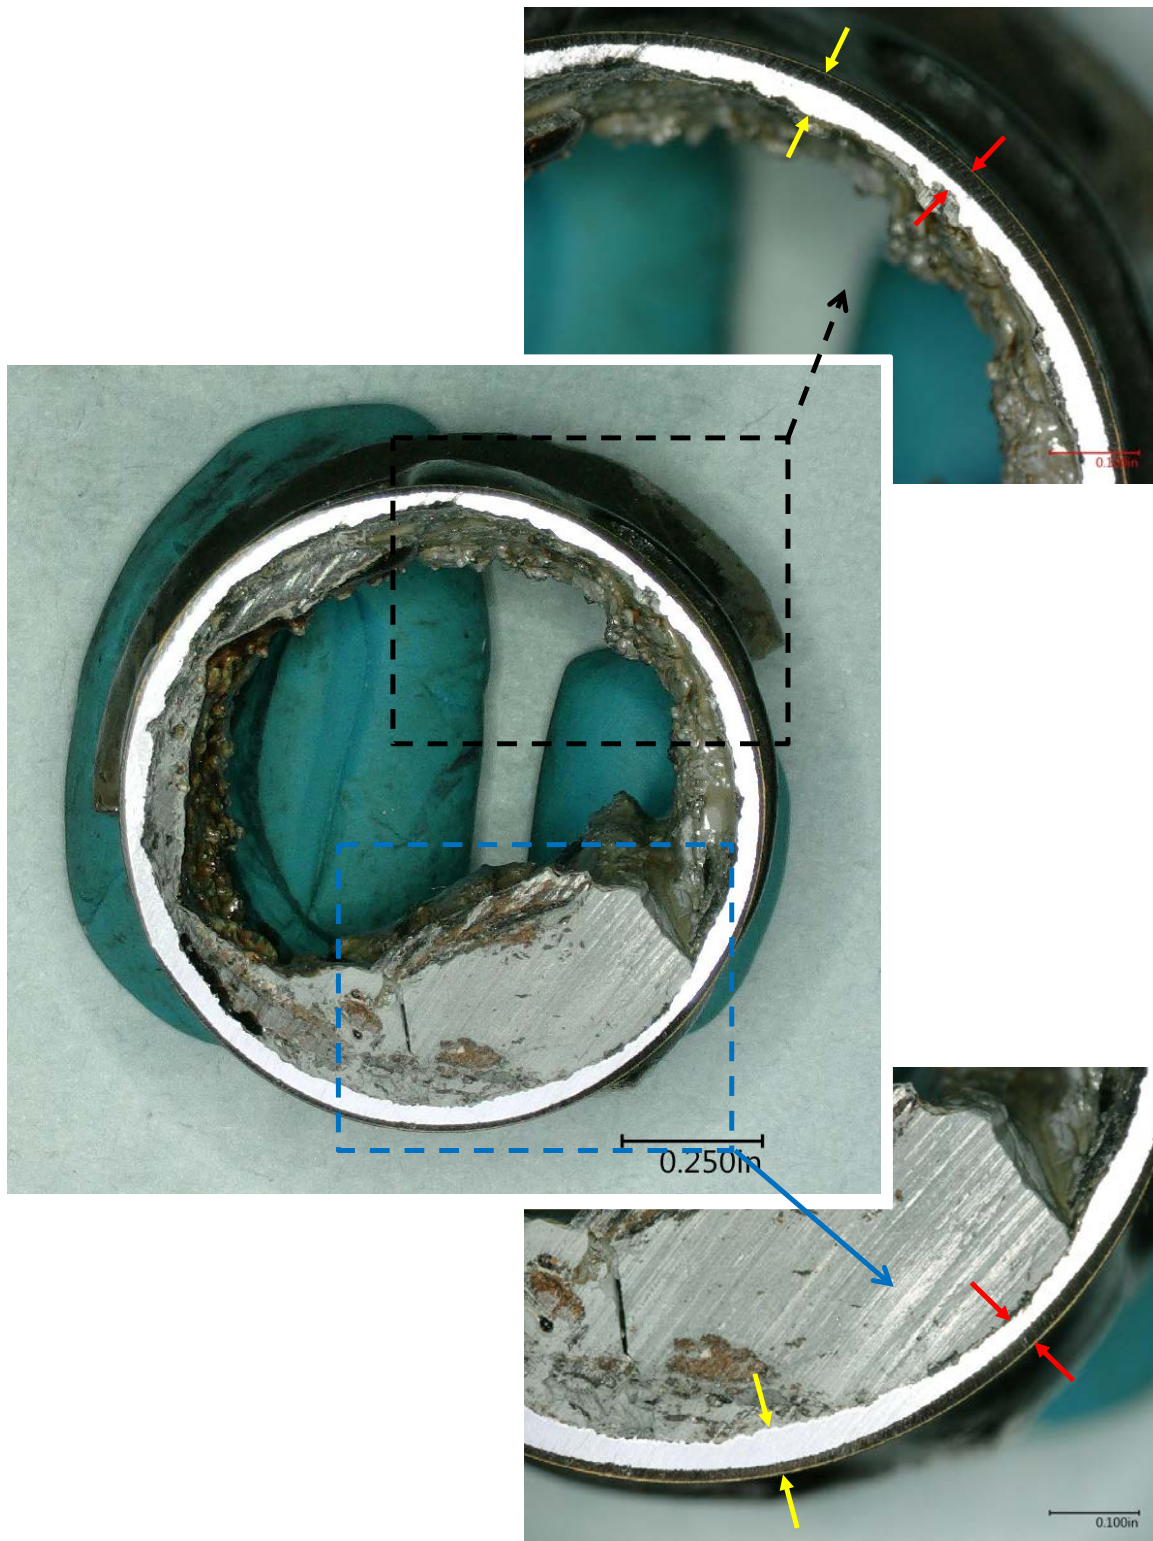
A cross-section was prepared through the control tube away from the fracture. Corrosion was observed on the inner surfaces of the control tube. Significant thinning of the control tube wall thickness was visible, with the most corroded sections retaining roughly half to two-thirds of the wall thickness of the least corroded sections. The thinner wall thickness is shown in Figure 3. The thinner wall thickness resulting from the corrosion likely could not support the same loading conditions as the full wall thickness, and could have contributed to the overstress separation of the control tube.

**Figure 3:** Digital microscope images of the cross-section prepared through the control tube. The red arrows indicate locations where the wall thickness had thinned due to corrosion, as compared to other less corroded areas indicated by yellow arrows.
