# NATIONAL TRANSPORTATION SAFETY BOARD

MATERIALS LABORATORY FACTUAL REPORT

Report No. 15-082

Place : North Salt Lake, Utah  
Date : December 2, 2014  
Vehicle : Robinson R44 II  
NTSB No. : WPR15FA051  
Investigator : Andrew Swick, AS-WPR

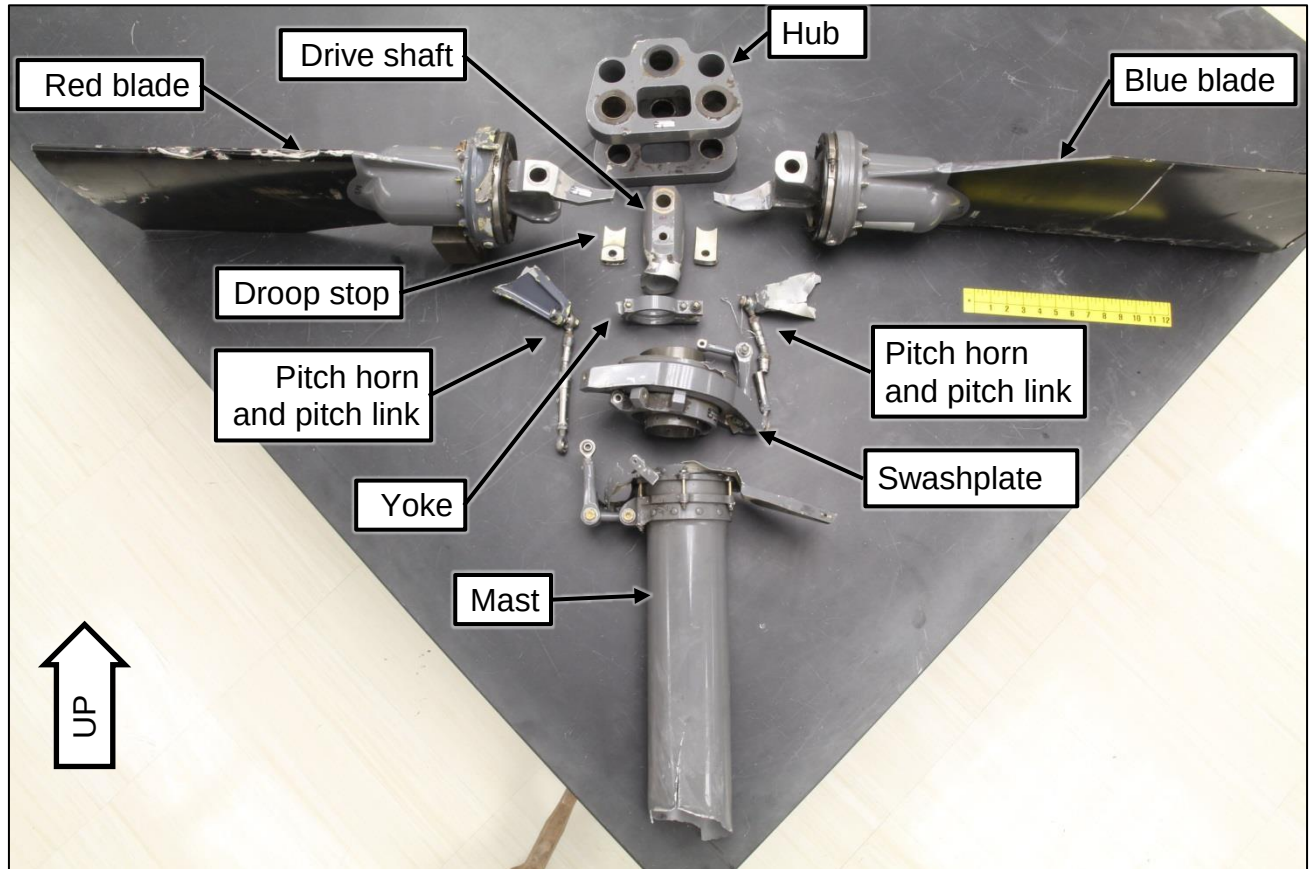
An overall view of the submitted components is shown in figure 1 as placed on the corner of a black table with the components shown in their approximate positions relative to each other. The droop stops were fractured from the main rotor drive shaft. However, the original positions of the droop stops was determined using distinguishing witness marks around the attachment hole on the main rotor shaft with corresponding deformation of the red blade droop stop. Relative positions for the remaining components were determined based on blade labels, mating fractures, and/or witness marks.

Figure 1. Overall view of the submitted components.

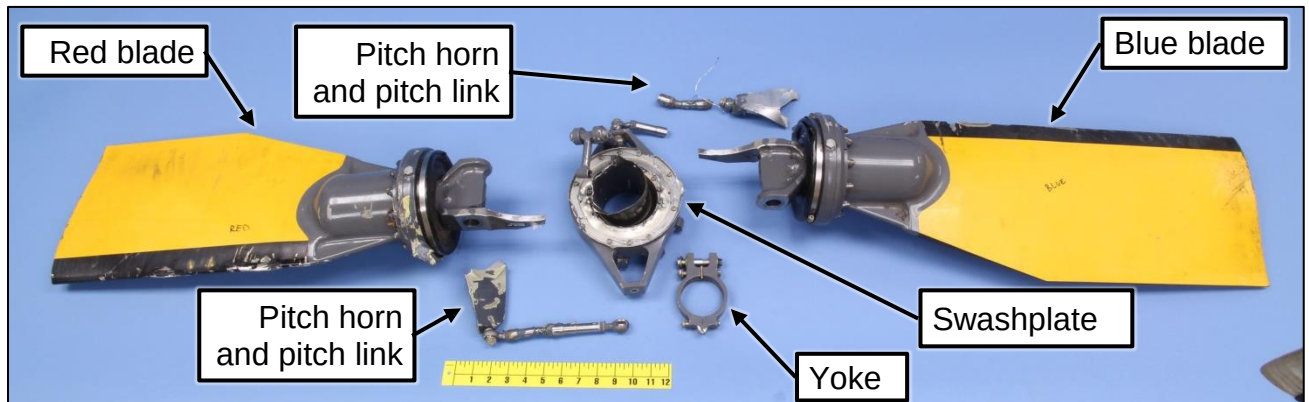
The main rotor blades, pitch change links, yoke, and swashplate assembly as viewed from above is shown in figure 2. The pitch horns for the red and blue blades were fractured from the rest of the blade, and fracture features in both cases were matte gray and rough consistent with overstress fracture. The yoke was fractured through the arms at the counterweight side of the yoke, and the counterweights were missing. Fracture features in the yoke also showed rough matte gray features consistent with overstress fracture.

Figure 2. Overall view of the main rotor blade and swashplate assemblies with pitch links and counterweight yoke assembly.

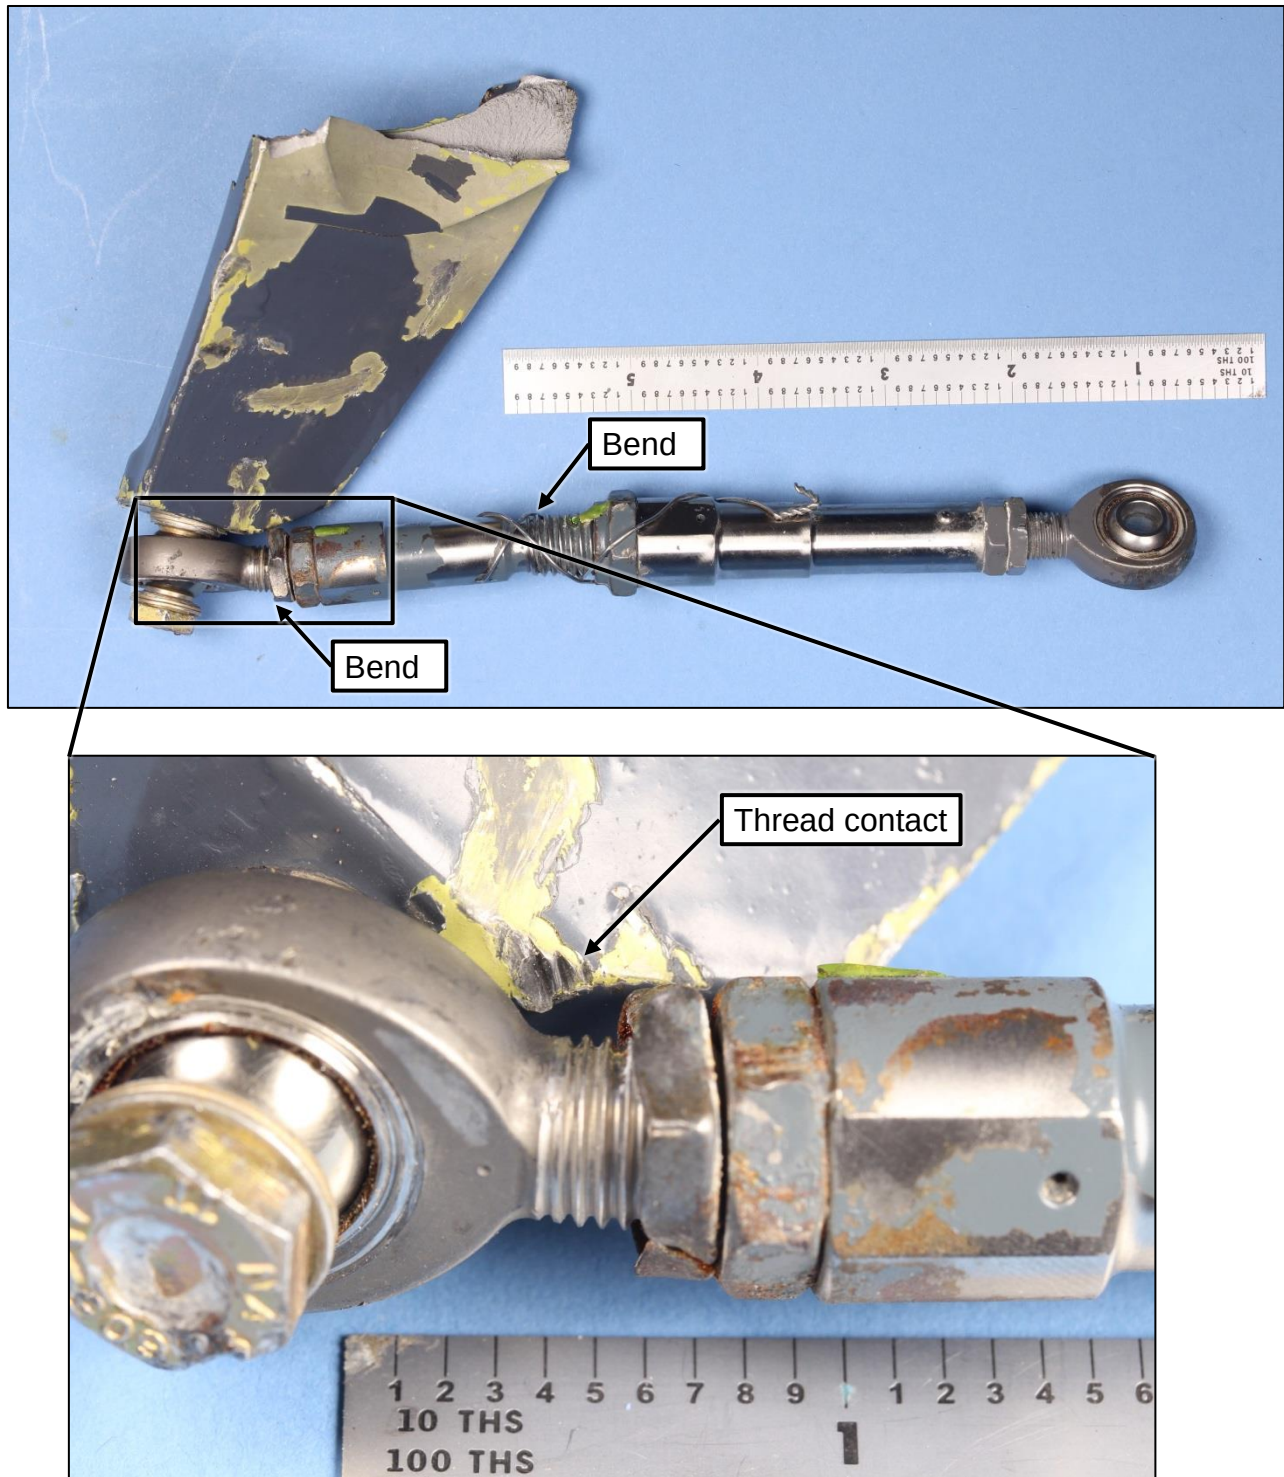
The pitch change link for the red blade was intact and remained attached to the red blade pitch horn as shown in figure 3. The lower end of the pitch change link was separated from the attachment point on the swashplate, and the attachment hardware was missing. The red blade pitch change link was bent slightly at two locations as indicated in figure 3; in the threads for of the upper end fitting and in the area of the length adjustment threads in the middle of the link. Thread impressions corresponding

to contact with the end fitting threads on the inside of the bend at the upper end of the pitch change link were observed as shown in the lower image in figure 3.

Figure 3. Views of the red blade pitch horn and pitch change link with a closer view of damage on the pitch horn corresponding to contact with the pitch change link end fitting threads.

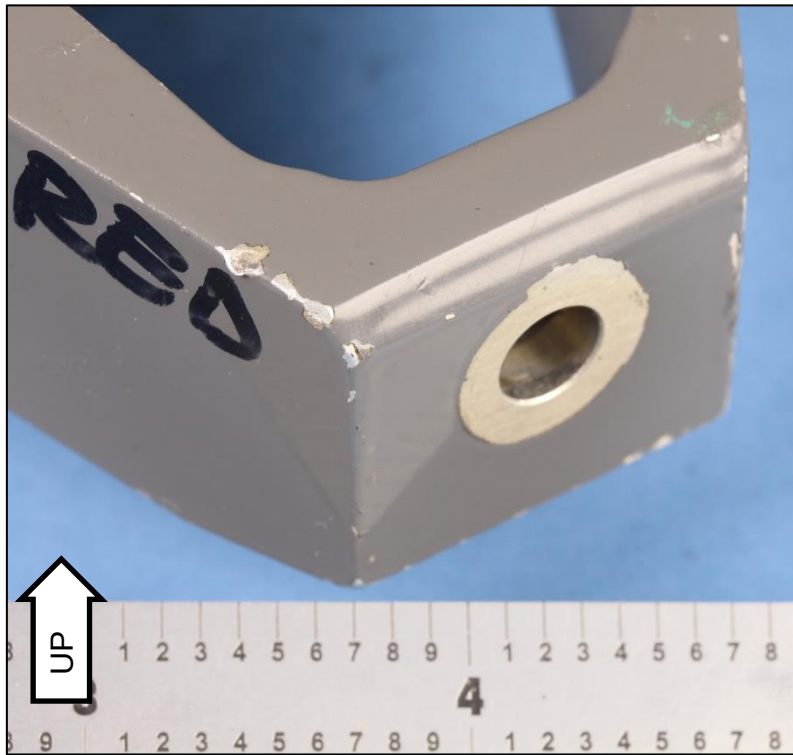
Figure 4. Swashplate showing the attachment location for the red blade pitch change link.

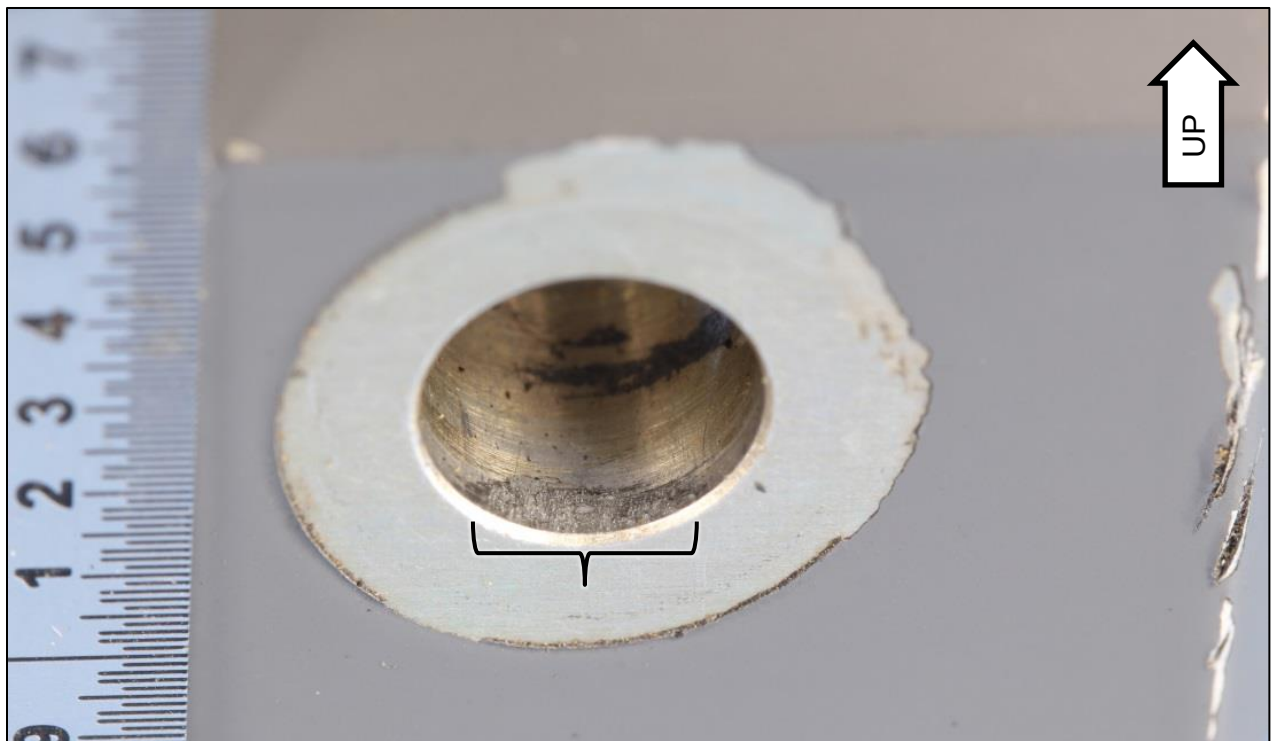
A close view of the swashplate at the red blade pitch change link attachment location is shown in figure 4. The attachment hole in the swashplate was intact and the surrounding area was generally free from contact damage. Closer views of the hole interior are shown in figures 5 and 6. At the outboard end of the hole as shown in figure 5, a discolored area with longitudinally-oriented sliding contact marks was observed on the lower side of the hole bore adjacent to the outboard edge (see unlabeled bracket in figure 5). The circumferential machining marks were disturbed or covered by material transfer in the area of sliding contact. At the inboard end of the hole, a series of parallel impressions oriented at a slight angle relative to the circumferential plane of the hole was observed adjacent to the inboard face on the upper side of the hole (see unlabeled bracket in figure 6). A lip of deformed material was present at the inboard edge of the series of parallel impressions, also indicated in figure 6.

Figure 5. Close view of the hole in the swashplate for the red blade pitch change link attachment bolt. An unlabeled bracket indicates a discolored area where machining marks were disturbed and longitudinal sliding contact marks were observed.

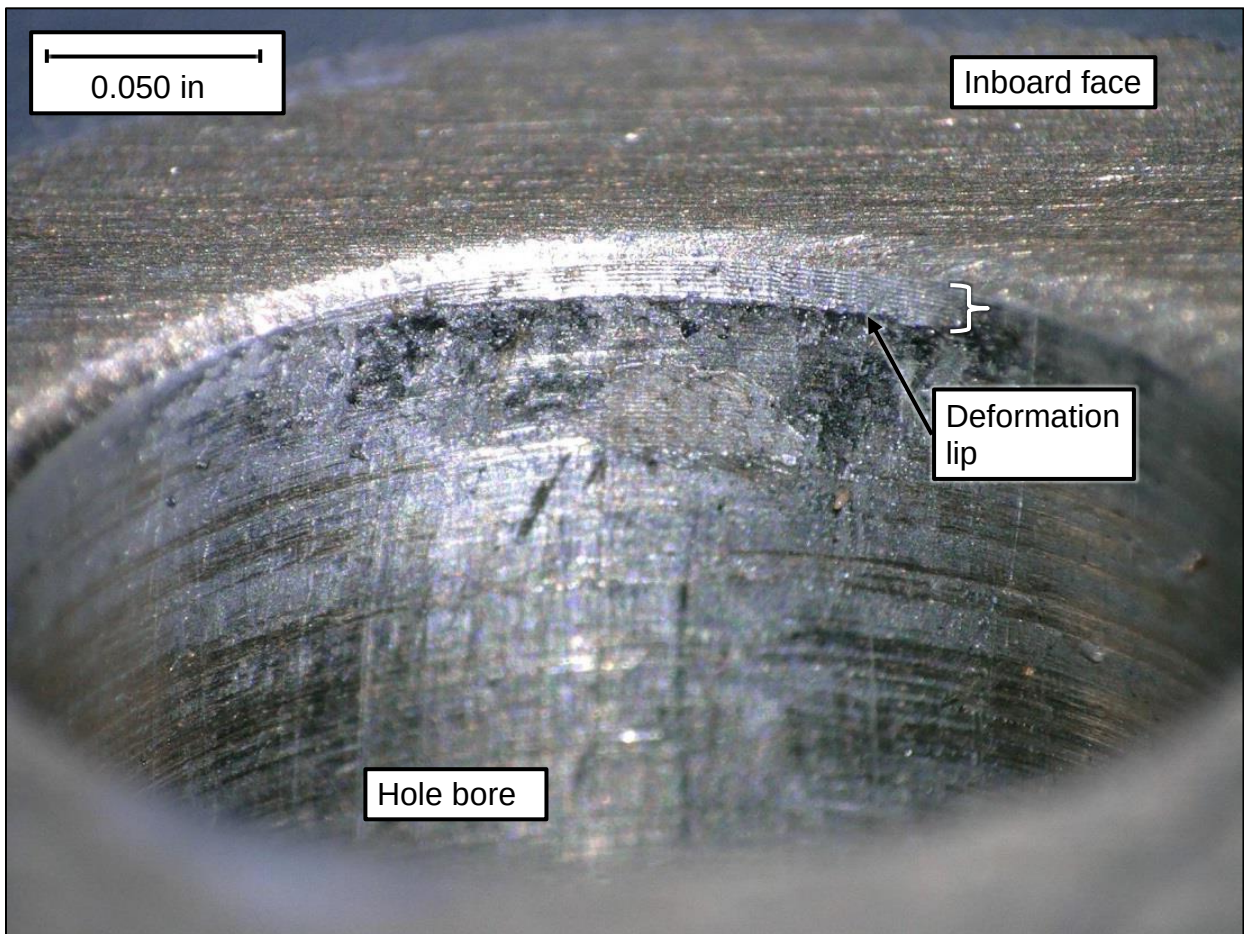
As assembled, the attachment location for the red blade includes a NAS6605-31 attachment bolt that is installed through two counterweights, washers, a pitch change link rod end fitting, and the attachment hole in the swashplate all clamped together with a lock nut backed by a palnut. One counterweight is located at the inboard side of the swashplate attachment location, and the other counterweight and the rod end fitting are located at the outboard side of the swashplate attachment location. Therefore as installed, the hole bore at the attachment location in the swashplate should contact the grip (smooth portion) of the attachment bolt shank.

Figure 6. Image of the inboard end of the hole in the swashplate for the red blade pitch change link attachment bolt as viewed looking upward. An unlabeled bracket indicates a series of parallel impressions in the hole bore adjacent to the inboard face of the red blade pitch change link attachment location on the swashplate.

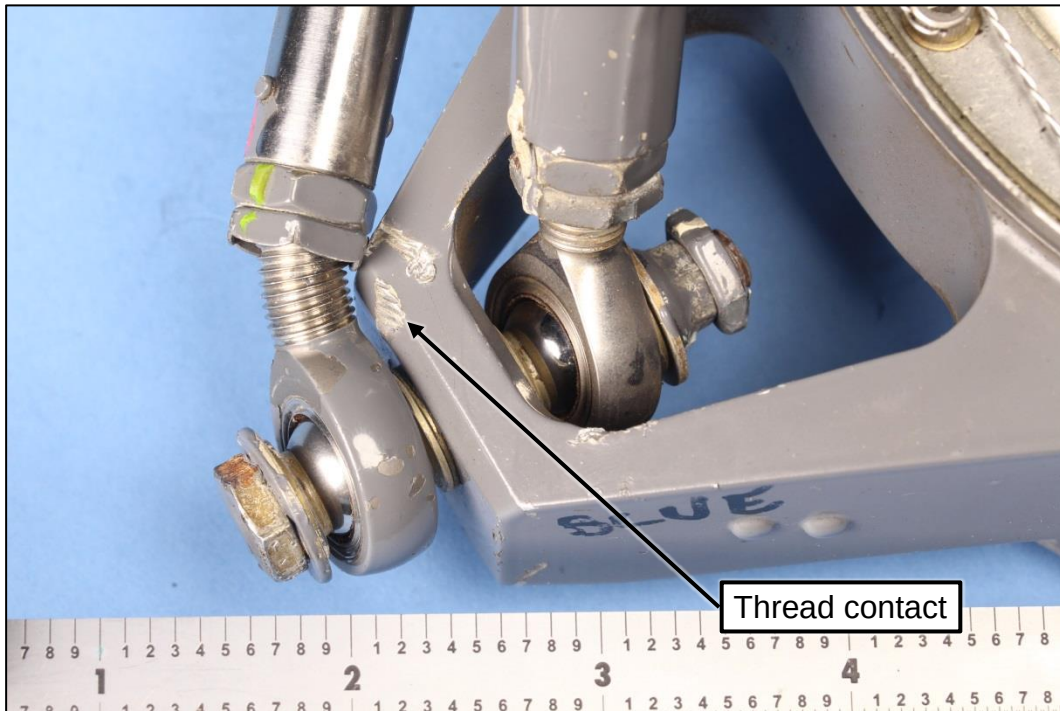
A close view of the swashplate at the blue blade pitch change attachment location is shown in figure 7. The pitch link remained attached to the swashplate, and an intact line of green torque paint was present on the lower side of the bolt, palnut, locknut, and washer as shown in figure 8. Thread impressions on the swashplate corresponding to contact with the pitch link end fitting on the upper side of the swashplate are indicated in figure 7.

Figure 7. Swashplate at the blue blade pitch change link attachment location.

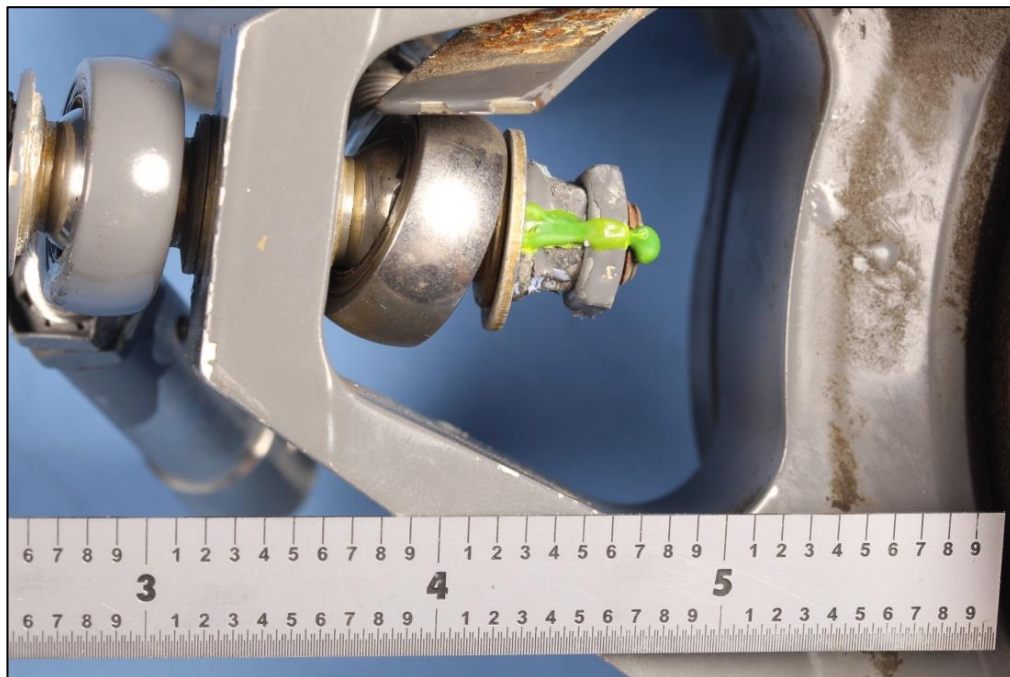
Figure 8. Underside of the swashplate showing a green line of torque seal on the bolt, nuts, and washer for the blue blade pitch change link attachment.

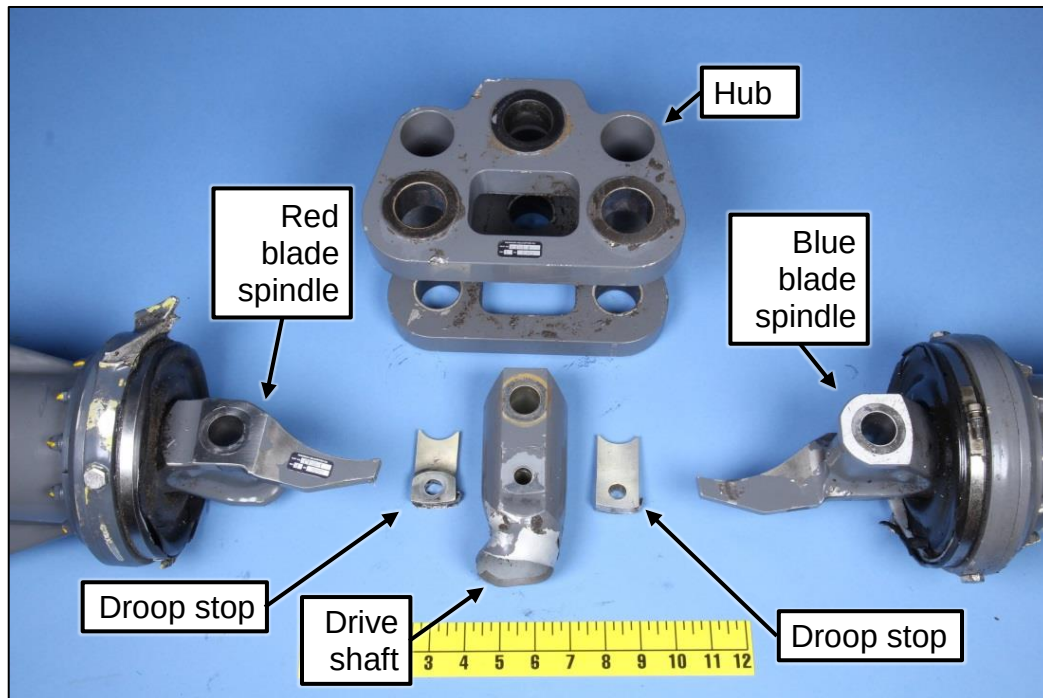
Views of the hub, drive shaft, blade spindles, and droop stops are shown in figures 9 and 10. Heavy impact marks were observed on the lower side of each droop stop corresponding to contact with stop arms on the blade spindles. The stop arms on the blade spindles were also deformed downward consistent with heavy contact with the droop stops. Deformation corresponding to contact with the upper sides of the spindles was observed on the interior of the hub (see figure 10).

The main rotor drive shaft was fractured as shown in figures 9 and 10. The shaft at the fracture location was deformed into a “D” shape, and the fracture planes were on slant angles relative to the circumferential plane; features consistent with overstress fracture under bending loads.

Figure 9. Overall view of the drive shaft, droop stops, hub, and blade spindles.

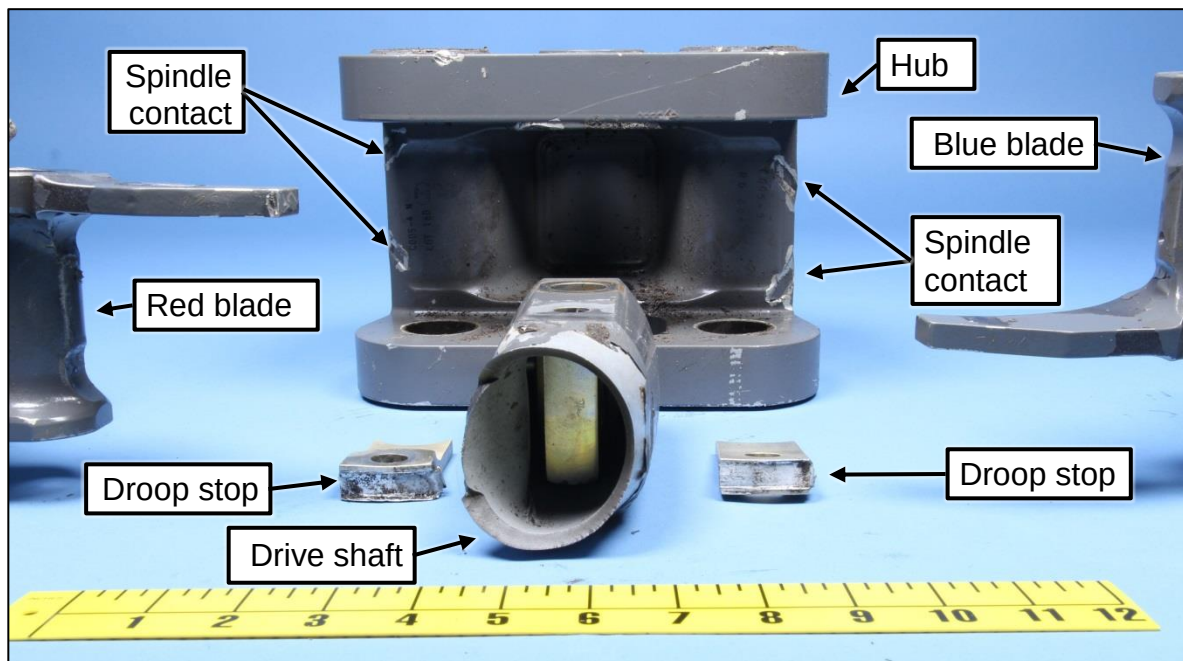
Figure 10. Components shown in figure 9 as viewed looking upward.
