## **NATIONAL TRANSPORTATION SAFETY BOARD**

# **ACCIDENT SITE EXAMINATION SUMMARY**

**WPR15FA051**

Location: North Salt Lake, Utah  
Date: December 2, 2014  
Aircraft: Robinson R44, N3234U  
NTSB Investigator-in-Charge: Andrew Swick

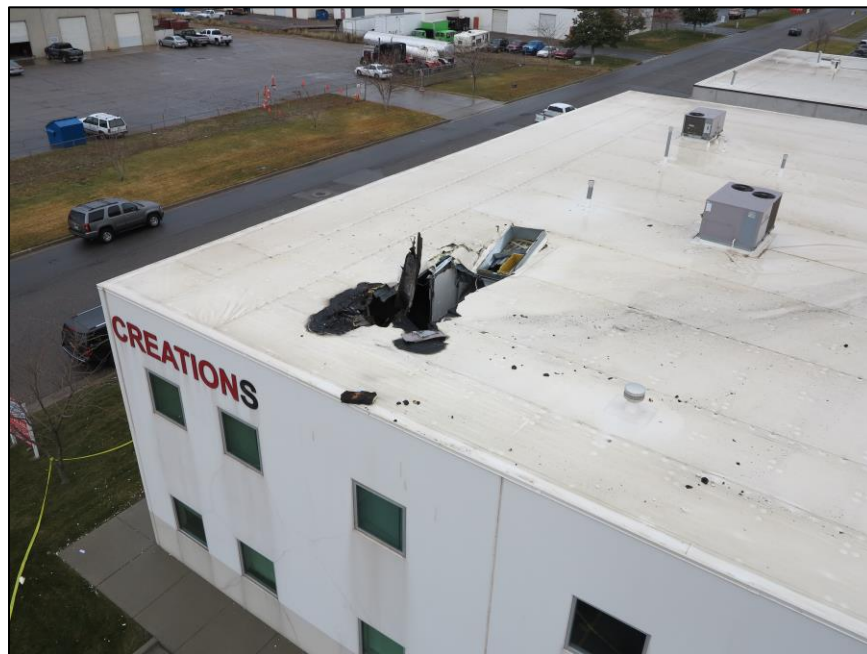
**Figure 1-Onsite Photo**

Examination of the accident site revealed that the helicopter impacted the top of a two-story building about 2,000 feet southwest of the approach end of runway 34 at Skypark Airport (BTF), Bountiful, Utah. A post-impact fire occurred that was concentrated at the main wreckage. The main wreckage had impact damage and was partially damaged by postimpact fire. The main rotor and empennage were found within the wreckage debris field. The wreckage debris field was about 880 feet in length and about 400 feet in width and on a 277-degree magnetic heading. The wreckage was recovered to a secure location for further examination.

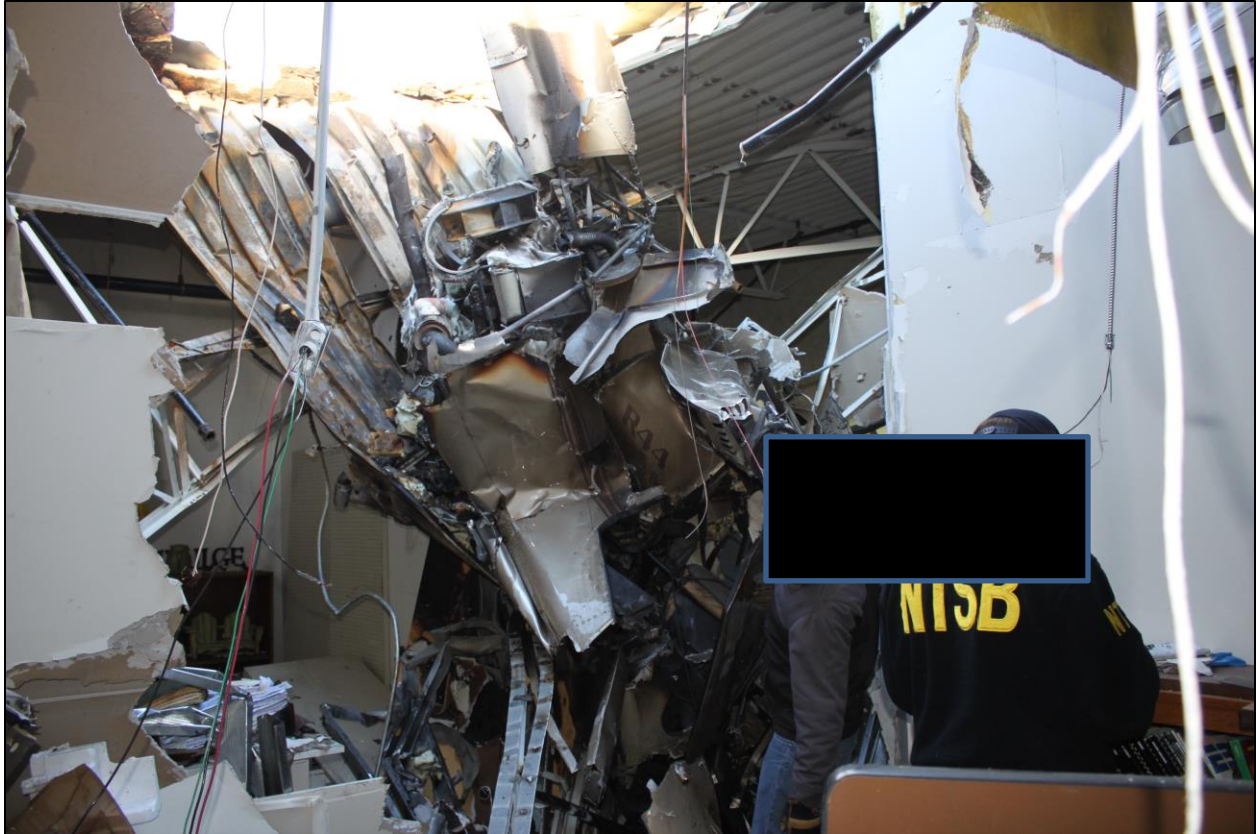
**Figure 2-Onsite Photo of Main Wreckage**

A postimpact fire was found concentrated behind the cabin area. Track and balance tools were found in the cabin area. The engine remained attached to the fuselage and thermal damage was noted on the induction box and fan shroud. The engine mounting assembly had impact damage. The landing gear and bear paws separated from the fuselage and were found near the main wreckage. The mast fairing was crushed and remained loosely attached to the main wreckage. The main rotor drive shaft was loose from the transmission housing and internal components were visible in the housing. The swash plate pitch change linkage mounting hole was visible and appeared to be undamaged.

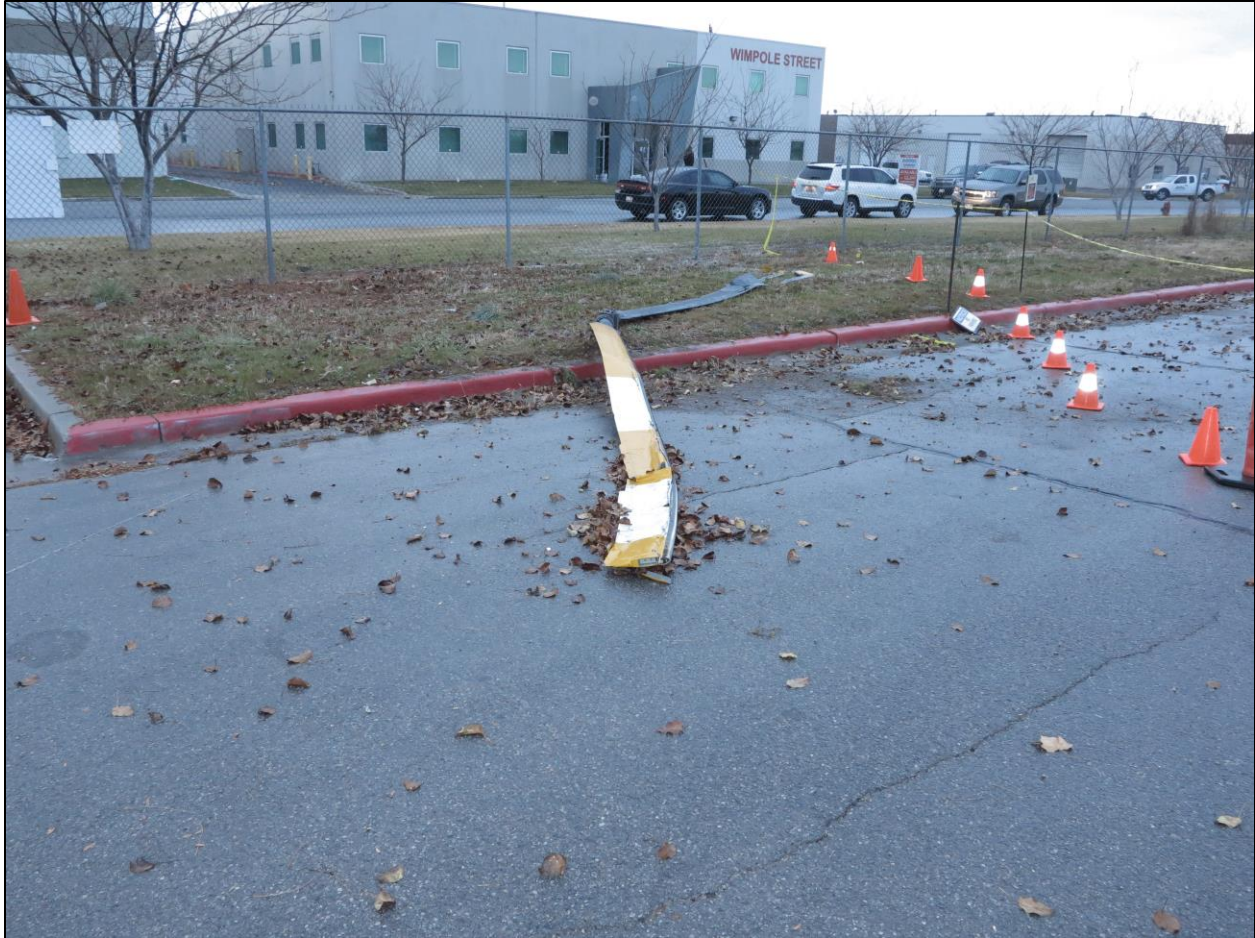
**Figure 3-Onsite Photo of Main Rotor**

The main rotor assembly was found near a parking lot about 188 feet from the main wreckage. The main rotor blades remained attached to the teetering hub and separated at the drive shaft near the teeter stops. The vertical drive shaft revealed evidence of mast bump. The empennage separated from the main wreckage and was found near a parking lot about 430 feet from the main wreckage. About 2 feet of the tail boom remained attached to the tail rotor assembly, vertical and horizontal stabilizers and the stinger. Several sections of the tail rotor drive shaft were found throughout the debris field. A large section of the tail rotor drive shaft pierced the roof about 90 feet from the fuselage roof entry on the same roof. Both pitch change linkages and transmission housing material were found throughout the debris field. Plexiglas sections were found throughout the debris field. A four-foot section of the main rotor blade tip was found in a retention pond and was furthest from the main wreckage. The wreckage debris path was oriented on an approximate heading of 277 degrees magnetic and was about 900 feet in length.

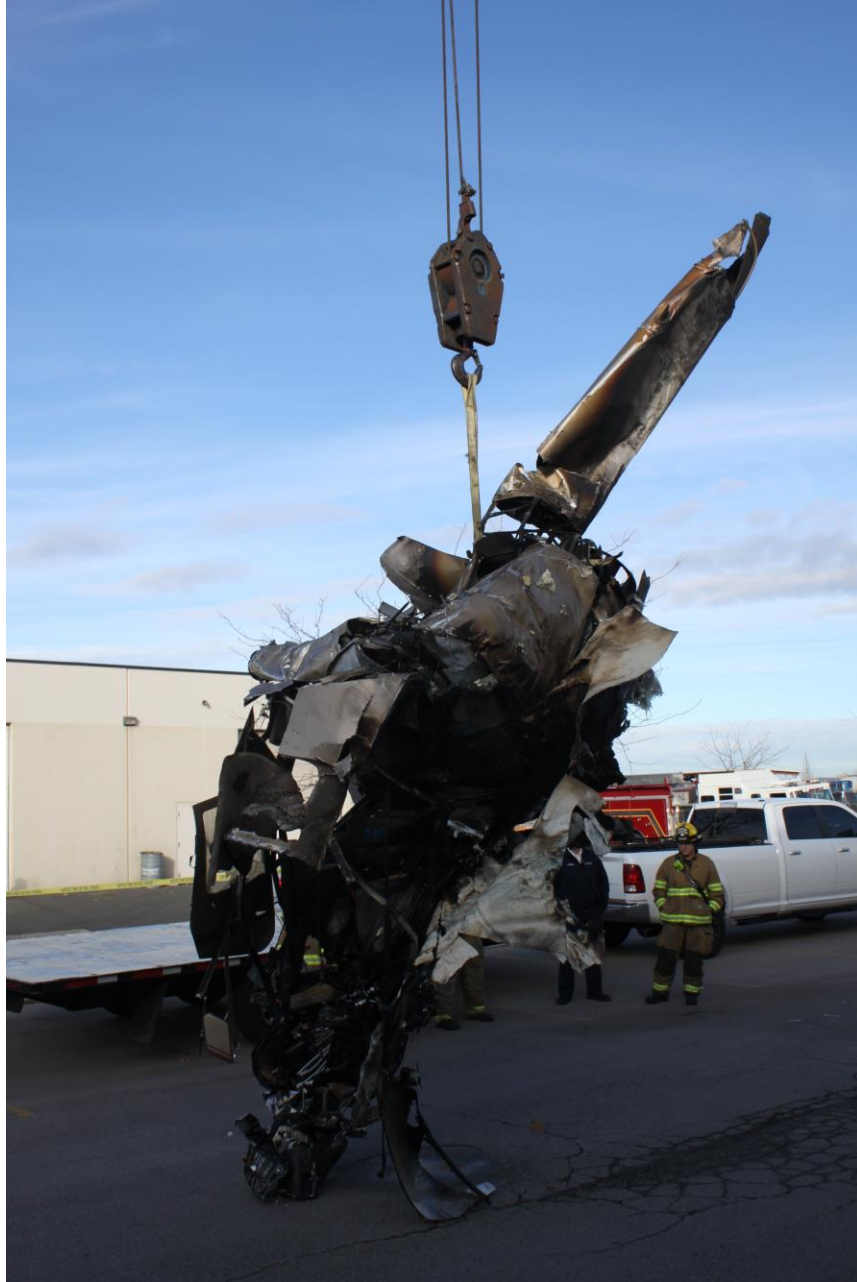
**Figure 4-Onsite Photo of Main Wreckage**

The main wreckage was removed from the building during retrieval efforts. Drive belts were unseated from both engine and drive sheaves. Rotational signatures were visible on the engine cooling fan. The instrument panel had impact damage and remained partially attached to the fuselage.
