## **NATIONAL TRANSPORTATION SAFETY BOARD**

# **AIRFRAME AND ENGINE EXAMINATION SUMMARY**

**WPR15FA051**

| Aircraft: | Robinson R44 II, N3234U |

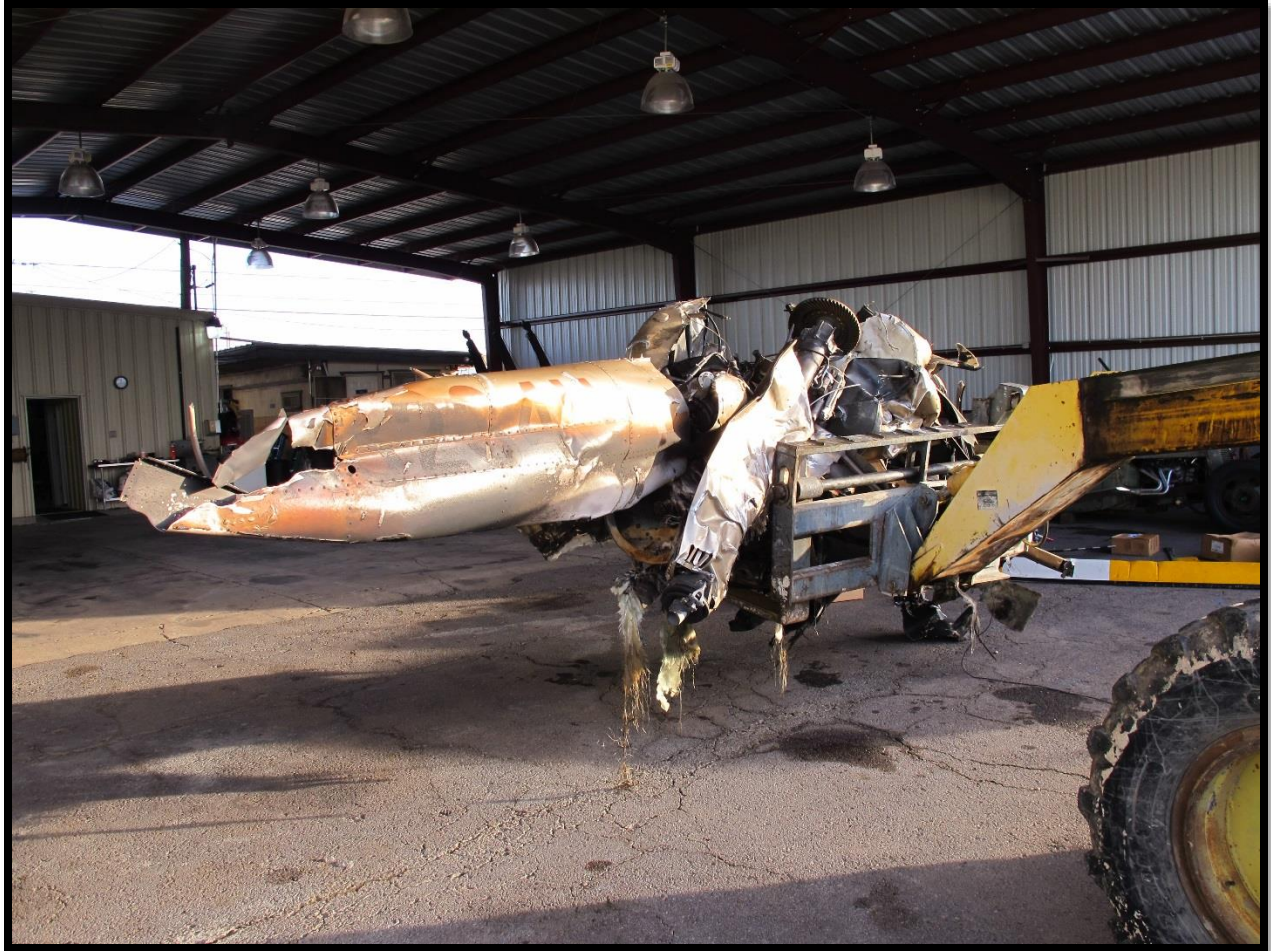
**Figure 1-Main Wreckage**

The main wreckage, consisting of the cabin area and a five-foot section of the tailboom, had impact and thermal damage. The left side of the cabin was crushed inward towards the center, and the right side near the firewall was crushed inward. The rear seat area had minor thermal damage.

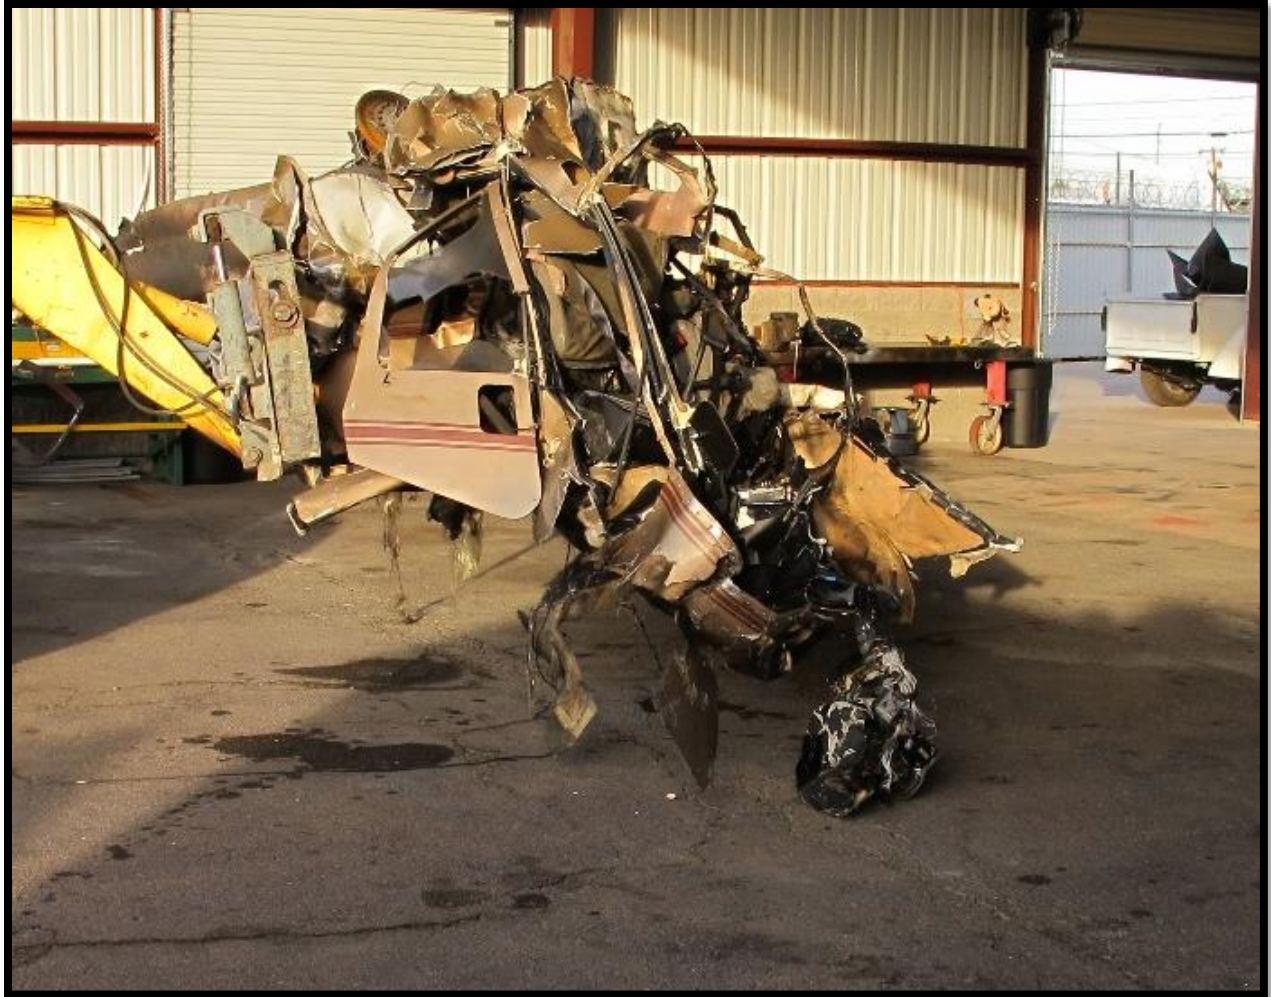
**Figure 2-Main Wreckage**

The top side of the airframe had several disconnects and separations and was bent to the right side. The tail cone separated aft of the number seven bay, and number 4, 5 and 6 separated into several sections consistent with a main rotor strike. The left side of the number 1, 2 and 3 tail cone bays were flattened inward. The empennage separated from the main wreckage and had minor damage.

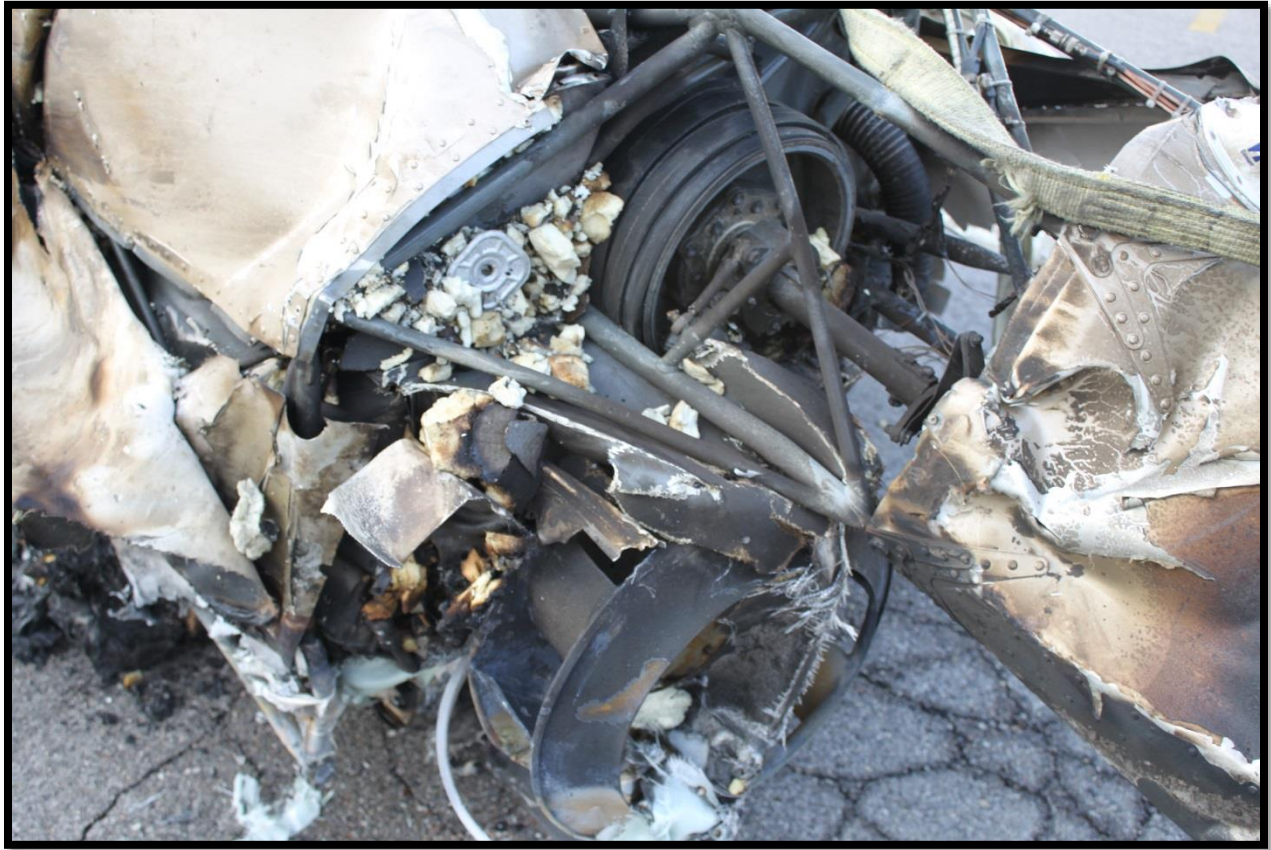
**Figure 3-Drive Train**

The v-belts remained attached to the upper sheave and was split between the vees. The belts had thermal damage. The sprag clutch was examined and operated normally. The intermediate flex plate was distorted.

The upper sheave forward and aft faces had rotational scoring around the entire circumference. The engine mounting tubes adjacent to the forward face had scoring running in the direction of rotation of the upper sheave. The clutch centering strut had rotational scoring on its forward face adjacent to the aft of the upper sheave running in the direction of rotation. The oil cooler had rotational scoring adjacent to the starter ring gear. The alternator cooling fan was distorted around its entire circumference.

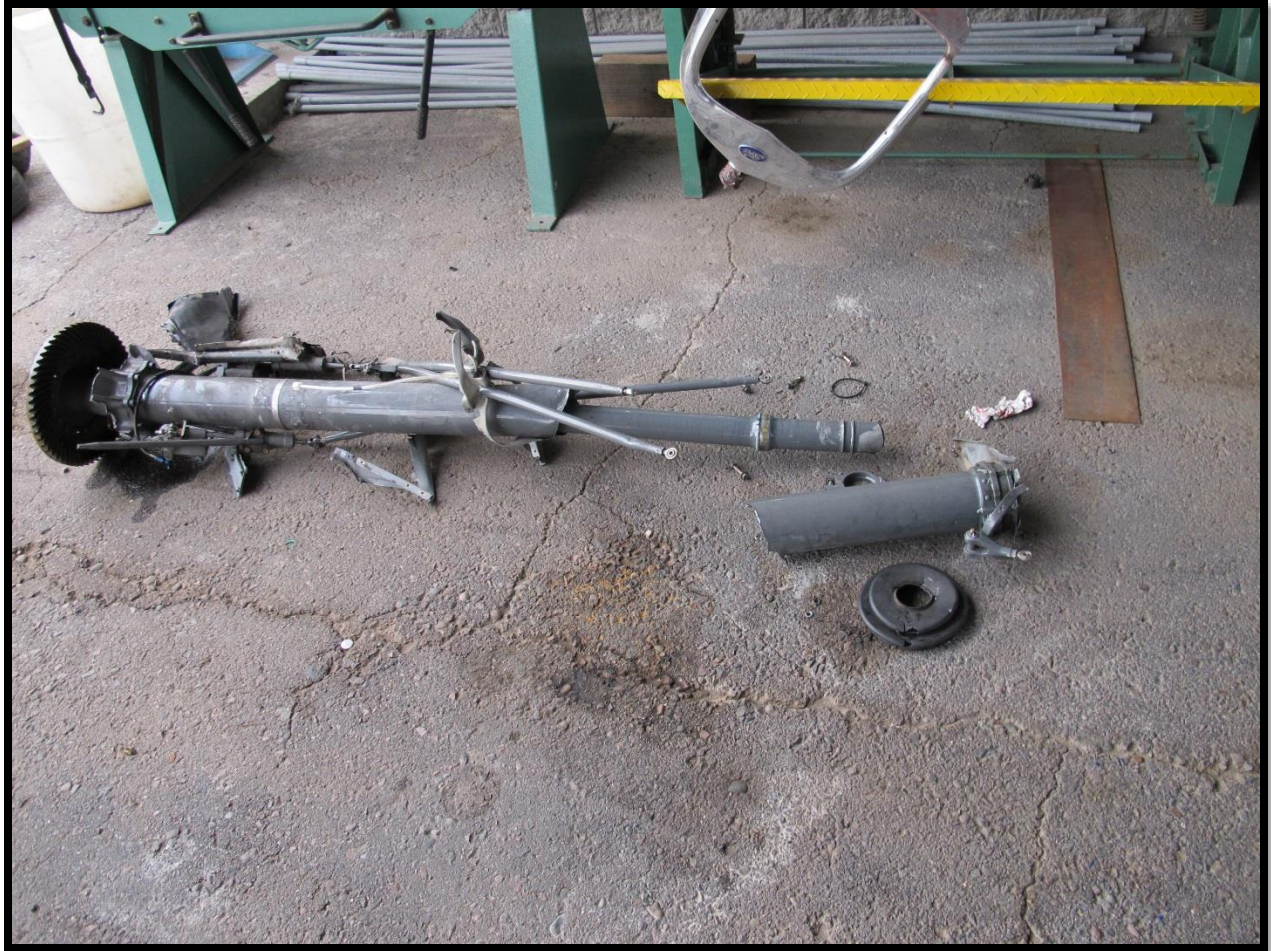
**Figure 4-Main Rotor Drive Shaft**

The main rotor gear (MRG) box separated at the gearbox housing. The MRG mast tube fractured near its midsection. The MRG drive shaft was bent below the swashplate and bent and separated at the teeter stop.

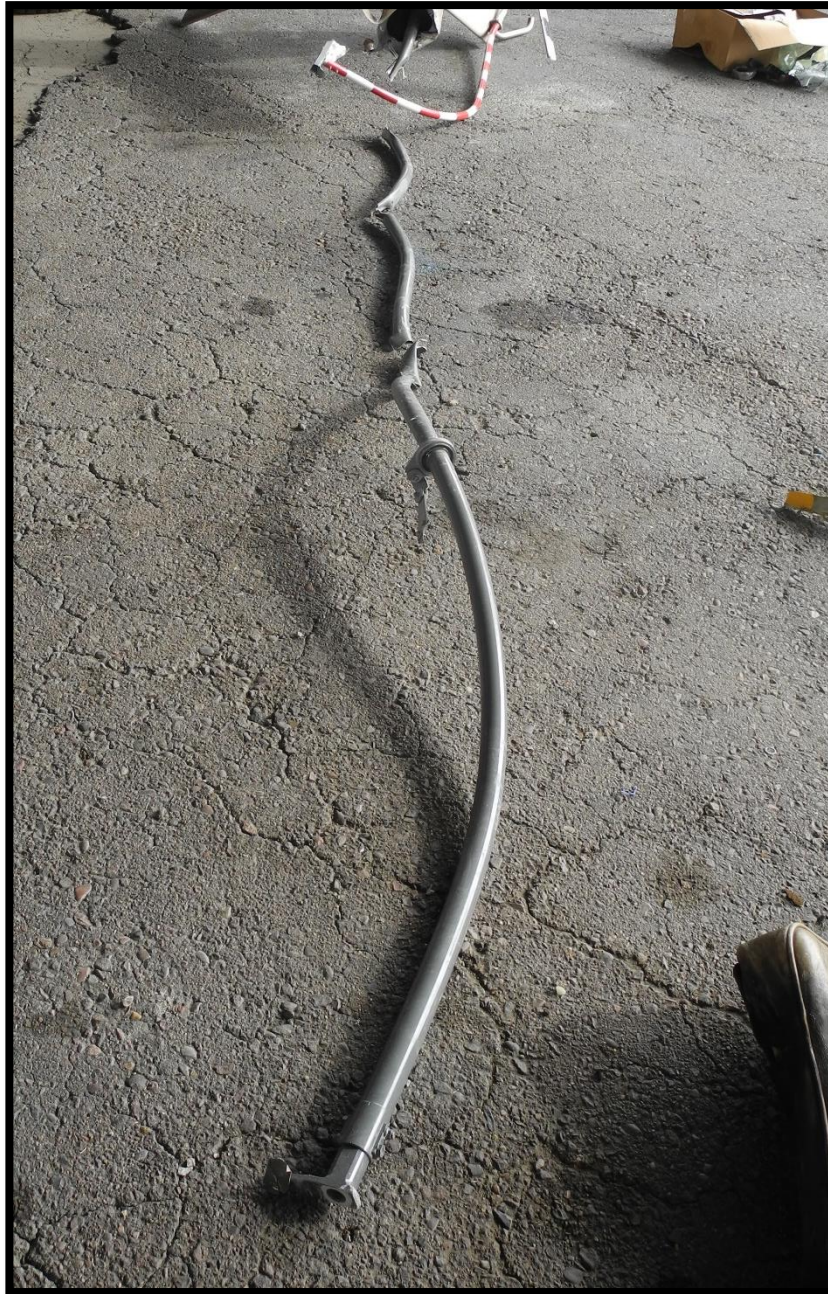
**Figure 5-Tailrotor Drive Shaft**

The tail rotor driveshaft exhibited an impact about 4 inches from the empennage separation. The curvature of the impact mark was consistent with the curvature of the main rotor blade leading edge. The tail rotor drive shaft separated in four places. The tail rotor blades exhibited signatures consistent with low rotor RPM at ground impact.

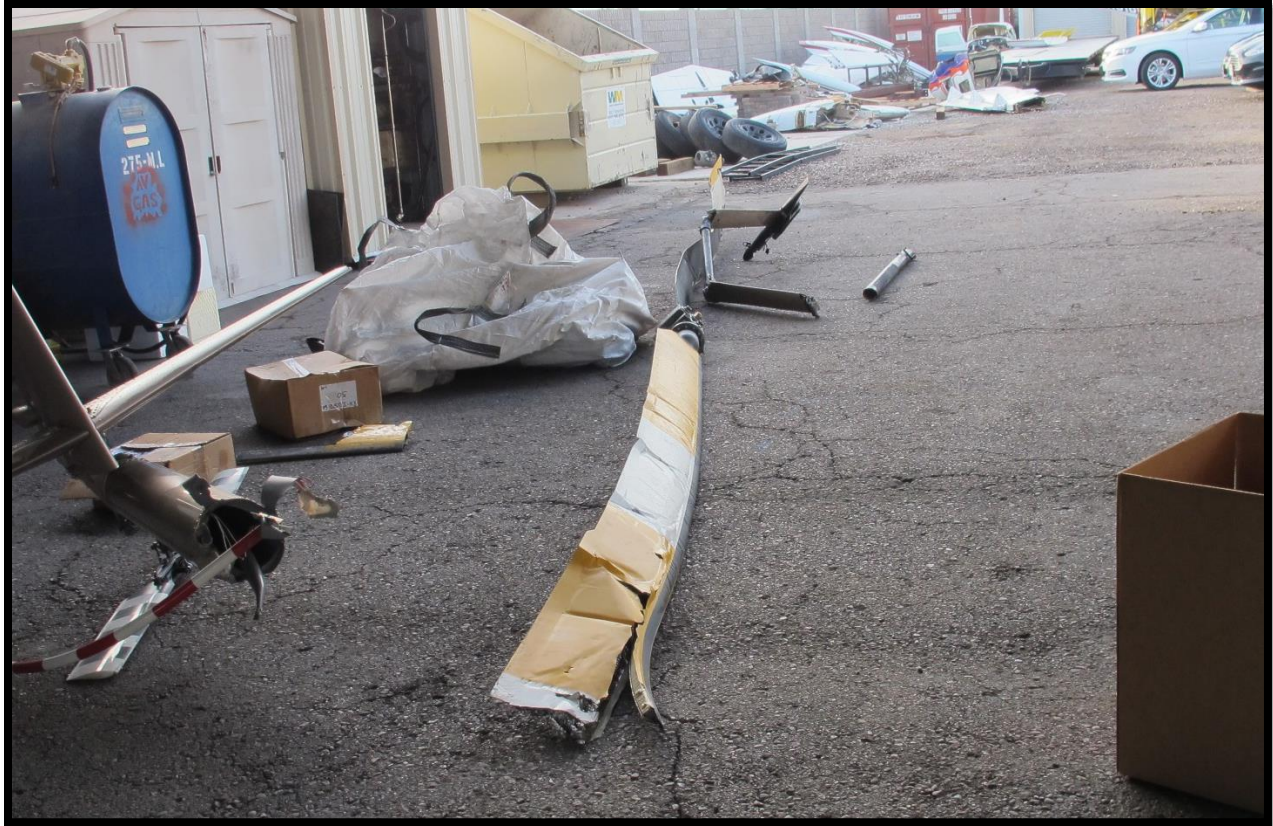
**Figure 6-Main Rotor Blade (Red Blade Serial Number 4406)**

The red blade remained attached to the main rotor hub. The separated sections of the outboard end were found in the debris field. The tip cap was broken with the attachment bolts still integral to the main rotor blade. The blade tip and about 43 inches of the leading edge spar, was found near the beginning of the debris field. Two afterbody sections measuring about 45 inches in length, separated the tip. Gray paint transfer marks, about 2 inches wide and 4 inches long, were observed on the upper surface at about 25 inches from the tip. The blade spar was bent forward about 15 degrees beginning at about 54 inches from the tip. The leading edge was damaged about 4 feet from the hub. Red transfer marks on the leading edge were found about 42 inches from the center of rotation of the blade. The pitch horn separated from the blade grip and the fractured surface was consistent with overload. Thread imprints were observed above the pitch change link upper rod end. The pitch change link remained attached to the pitch change horn and had multiple bends. The blade droop stop was bent downward and remained attached to the grip.

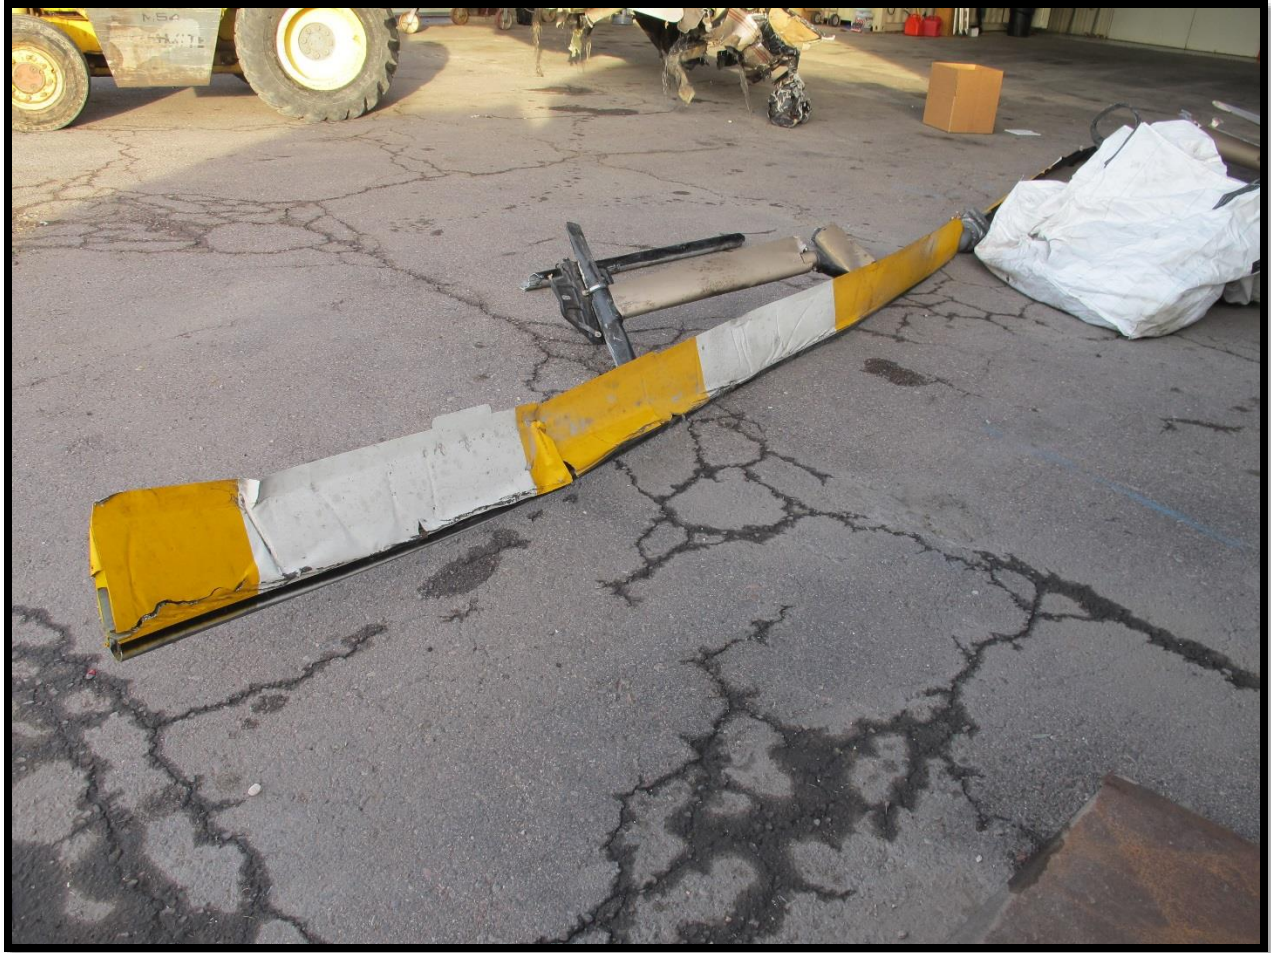
**Figure 7-Main Rotor Blade (Blue Blade, Serial Number 4402)**

The blue blade remained attached to the main rotor hub. The tip cap separated from the blade and was found in the main wreckage. The blade spar was continuous from the inboard to the outboard end. The blade afterbody was fractured from the spar to the tip end to about 72 inches inboard. The spar was bent opposite the direction of rotation about 72 inches from the tip end, bent about 15 degrees aft. The blade afterbody wrinkled aft of the spar attachment area from the tip end to 96 inches inboard of the tip end.

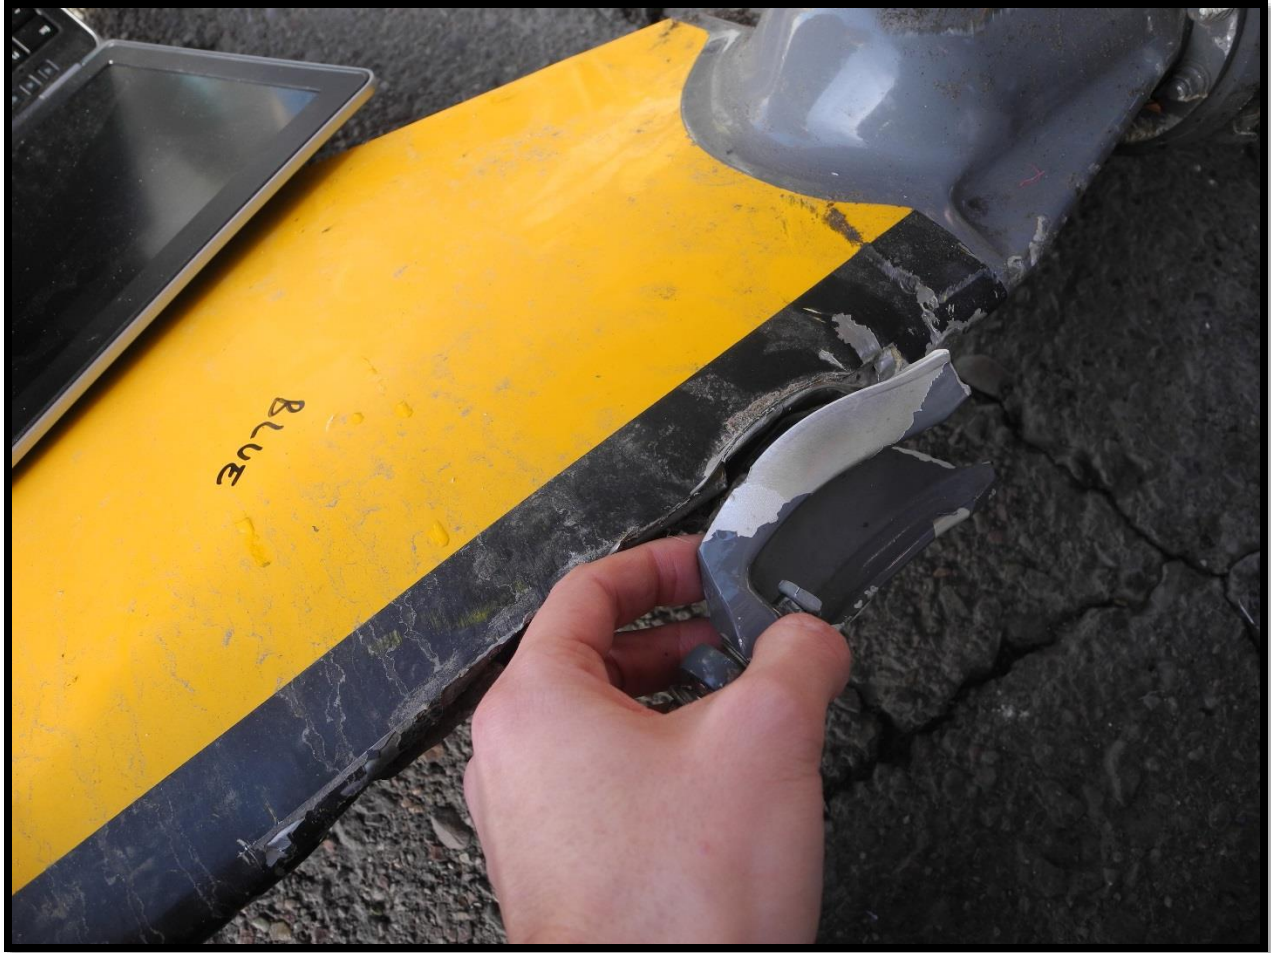
**Figure 8-Blue Blade and Impact Damage**

The blue blade had impact marks on the leading edge, observed about 20 inches from the center of rotation. The curvature of the impact marks was consistent with the curvature of damage on the blue blade's pitch horn. The pitch horn was fractured at the blade grip, and the fracture surface was consistent with overload. Thread imprints were observed on the pitch horn above the pitch change link upper rod end. The droop stop was bent downward but remained integral to the grip. The pitch change horn was recovered in the debris field. The upper rod end remained attached to the pitch change horn but was fractured at the threads beneath the upper rod end bearing. The midsection of the pitch change link was recovered loose, but was fractured at the pitch change link barrel. The lower section of the pitch change link remained attached to the swashplate. The threads adjacent to the lower rod end were bent.

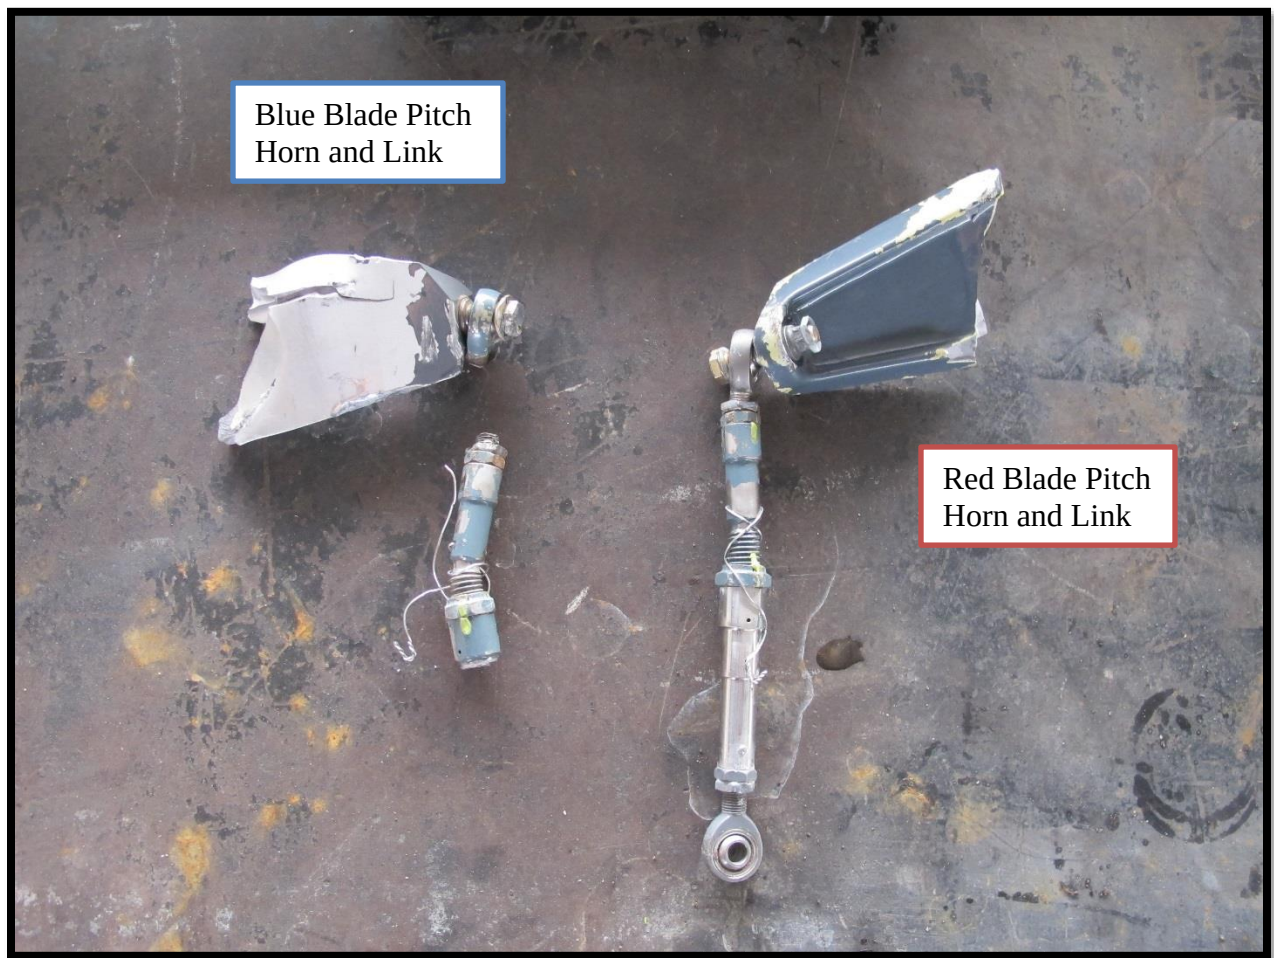
**Figure 9-Pitch Horns and Pitch Change Links**

The swashplate red blade pitch change link bolt hole exhibited dark surface markings on the outboard edge and about midway down the bore. Thread impact marks were found on the swashplate adjacent to the lower rod end bearing of the blue blade pitch change link attachment location.

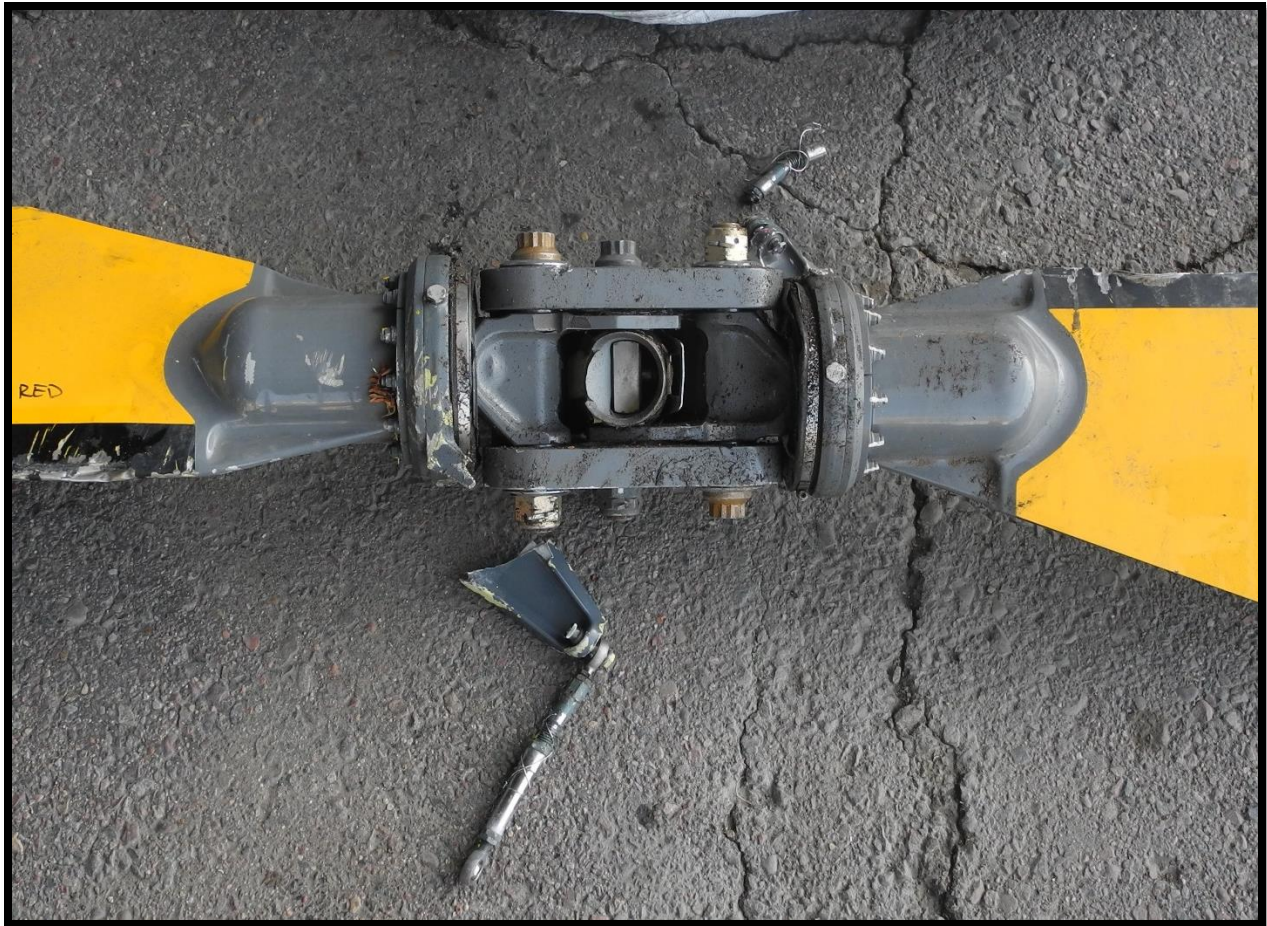
**Figure 10-Main Rotor Hub and Blades**

The main rotor hub hardware including the bolts, shims, nuts and safeties remained intact. The hub exhibited impact marks of the blue blade grip contacting the hub consistent with flapping exceedance. Similar impact marks of less severity were observed on the red blade grip side. A small upper section of the main rotor mast remained attached to the hub via the teetering bolt. The small upper section separated a few inches below the hub and was severely bent inward on the side of the red blade spindle. Coarse thread imprints were found on the lower edge of the hub immediately beneath the red blade coning bolt, consistent with a pitch change link. On the upper surface of the hub, adjacent to the teetering bolt on the red blade side, an impact mark was consistent with the impact from a pitch change rod link end bearing.

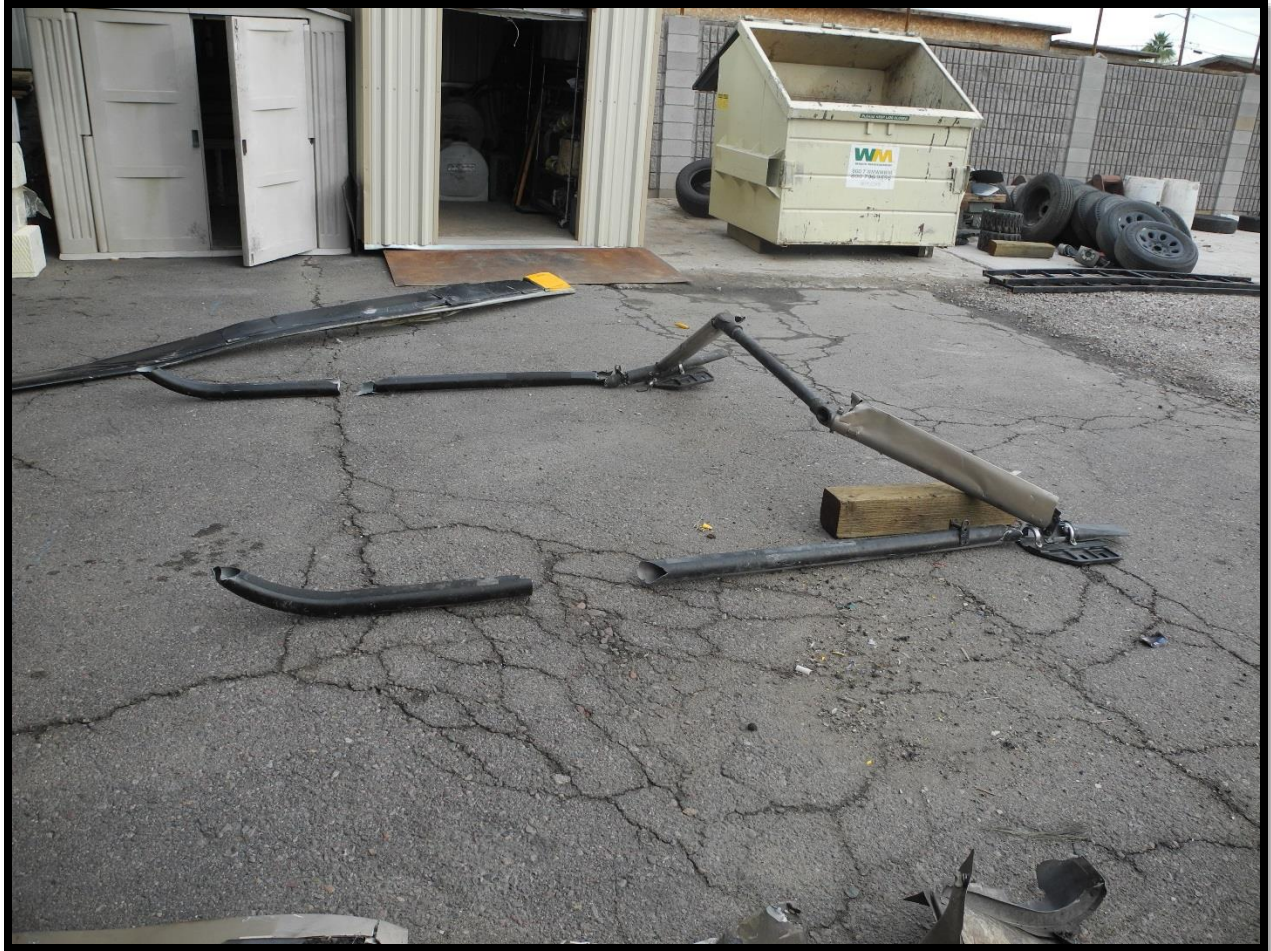
**Figure 11-Landing Gear Skids**

The landing skids were fractured in multiple locations. The aft crosstube separated from the main wreckage. The forward crosstube remained attached to the main cabin. Both the forward left and aft left struts were bent aftward.

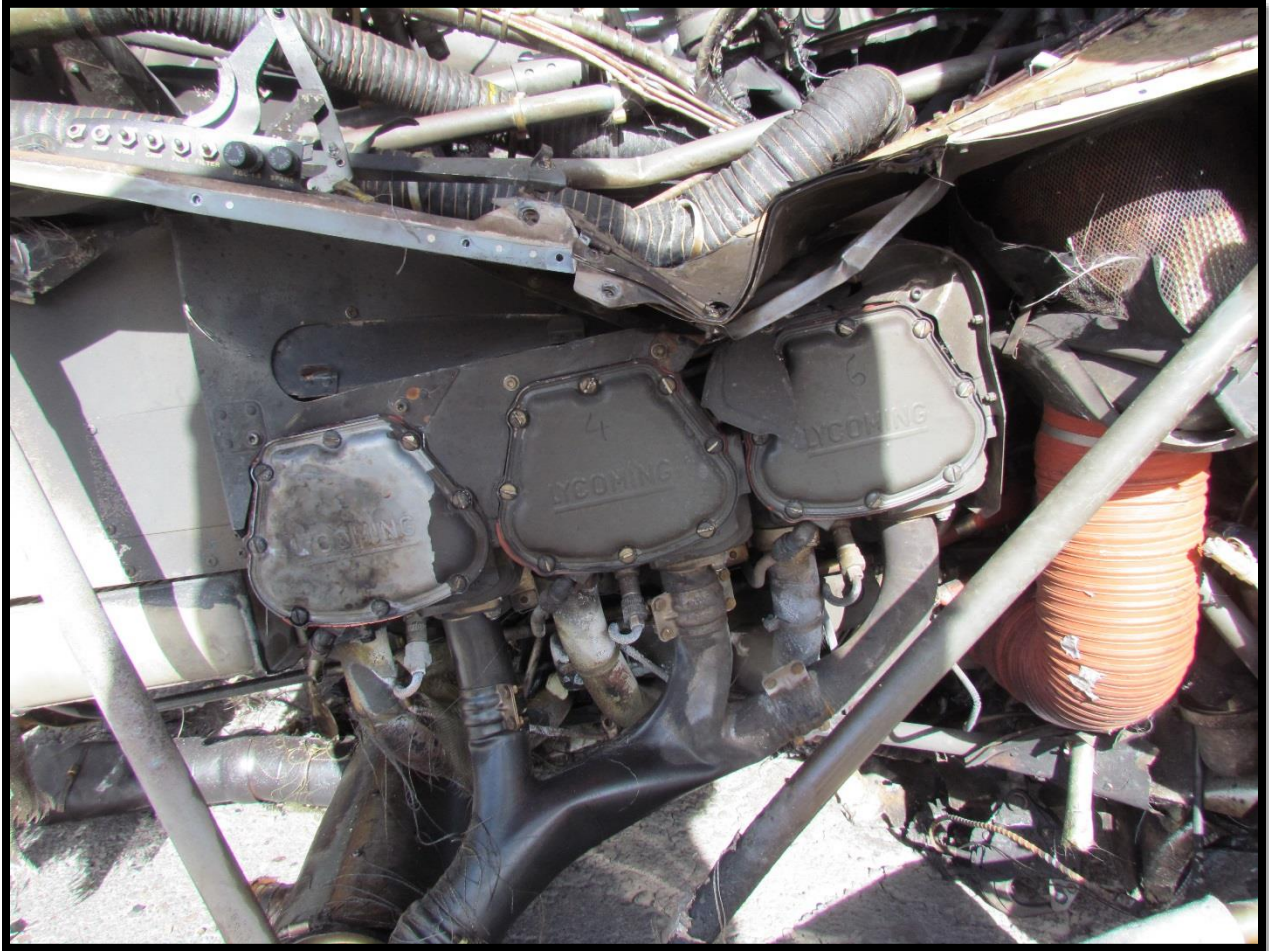
**Figure 12-Engine**

The engine remained attached to the fuselage and thermal damage was noted to the wiring harness and ignition leads. The engine was covered in a sooty residue. The firewall had impact damage and the fuel pump had impact damage to its housing. The magneto ignition leads had impact damage near the distributor cap and thermal damage near the cylinders. The lower sparkplugs were removed and revealed normal wear conditions and light gray deposits. Two of the spark plugs were saturated in oil. The crankshaft was rotated by hand and cylinder compression was obtained. The ignition leads were cut near the thermal damage and spark was obtained from all leads during crankshaft rotation. The magnetos were not removed during the examination. Rotational scoring was evident on the fan wheel assembly. The starter ring gear separated from the flywheel. The oil pickup screen was removed and was clear of debris. The exhaust assembly was crushed upwards.
