## Air Safety Investigations Aircraft Incident/Accident Technical Report

| <b>Aircraft Incident/<br/>Accident Information</b> | Year: 1968 | Make: Beechcraft | Model: 36 |
| | Serial number: E-80 | | Registration: N999CJ |
| Senior Air Safety Investigator: Paul E. Yoos | | Report #: ASI-15-AF-T | Report date: 12-21-15 |

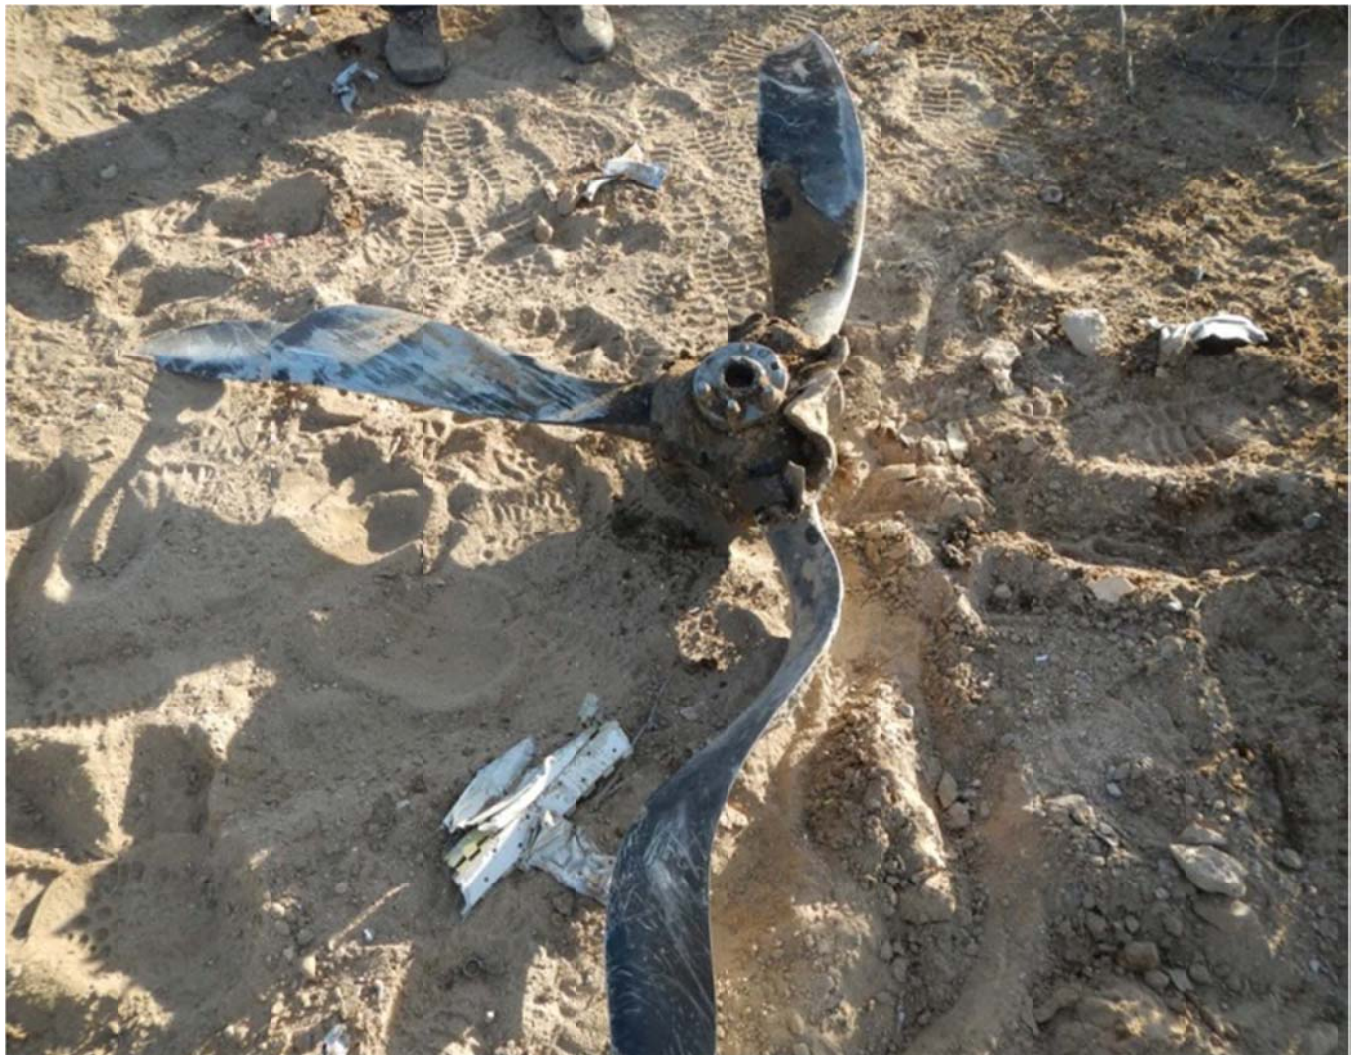
The constant speed 3-bladed propeller was found near the initial impact crater. All three blades remained attached to the damaged propeller hub, and each blade was marked with either an A, B or C to identify each blade for photographs. Blade A was the least damaged but with chord wise scratching across the face of the blade. Paint transfer was noted and several gouges were noted on the leading edge approximately 20 in. outboard of the propeller hub. Blade B displayed reverse bending along its length beginning approximately 6 in. from the propeller shank. Paint transfer was noted. The end of Blade C was separated approximately 22 in. from the blade shank. The separated outboard portion was not located. Deep scratching was evident across the blade face and a deep gouge was noted on the trailing edge approximately 12 in. from the blade shank. Rearward bending began approximately 12 in. from the blade shank. The propeller spinner was separated and not observed.

The propeller governor was separated from the engine, and the governor case was open, exposing the fly weight assembly.
