# Continental Motors

## ENGINE FIELD INSPECTION REPORT

Addendum to Original Report dated 02/09/2015

| ENGINE MODEL | IO-520-BA12B Converted to IO-520-XXBB <sup>2</sup> |

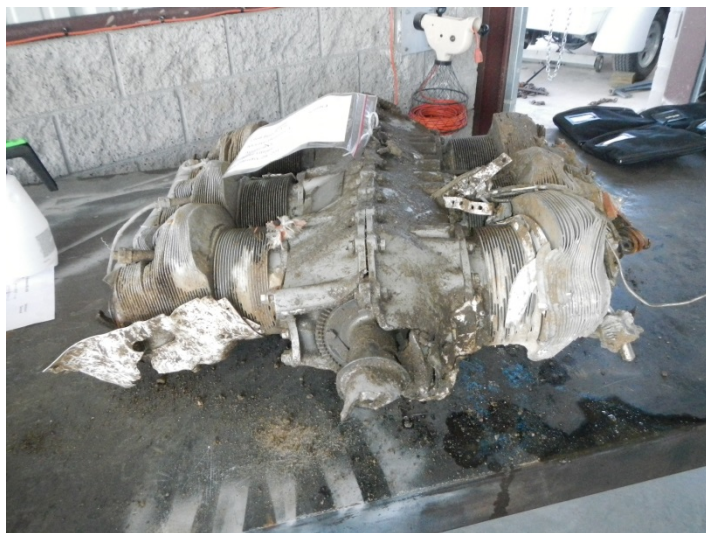
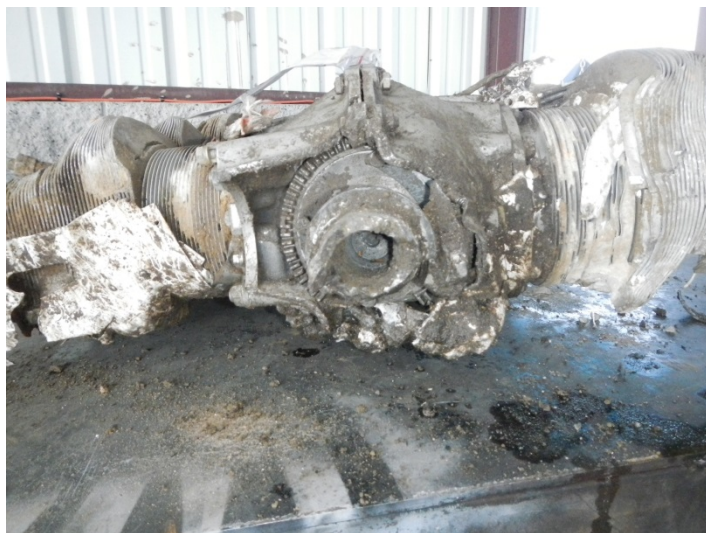
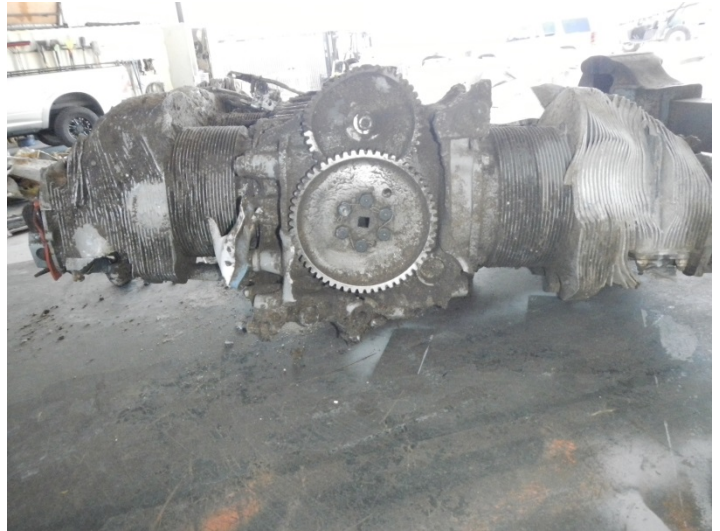
Please see the February 9, 2015 report for more details as to the engine's post-accident condition. The engine was placed on an examination table for the inspection. The rocker covers and/or rocker cover remnants were removed from the cylinders as were the top sparkplugs. A borescope inspection of the cylinders was conducted with no anomalies noted. The recovered wreckage was examined by the investigative parties and the observed components are described in their pertinent sections below.

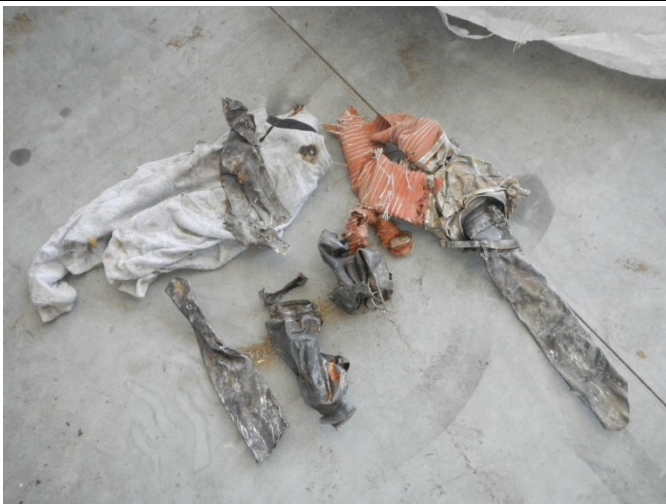
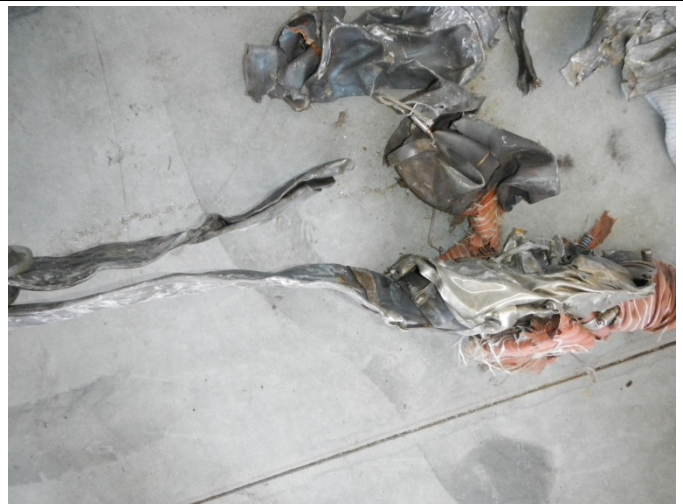
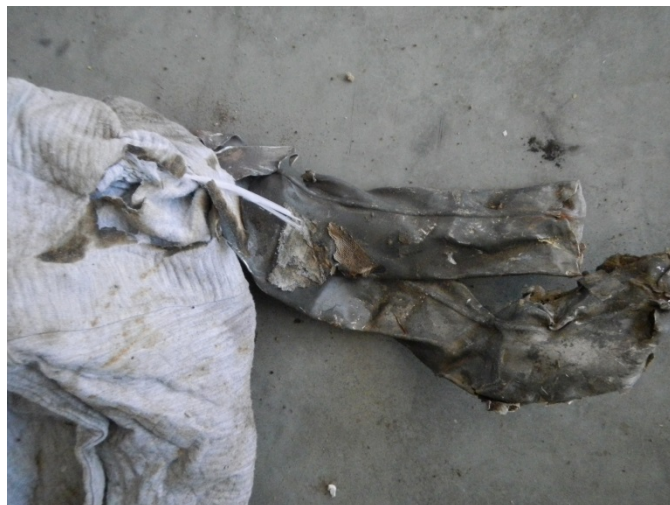
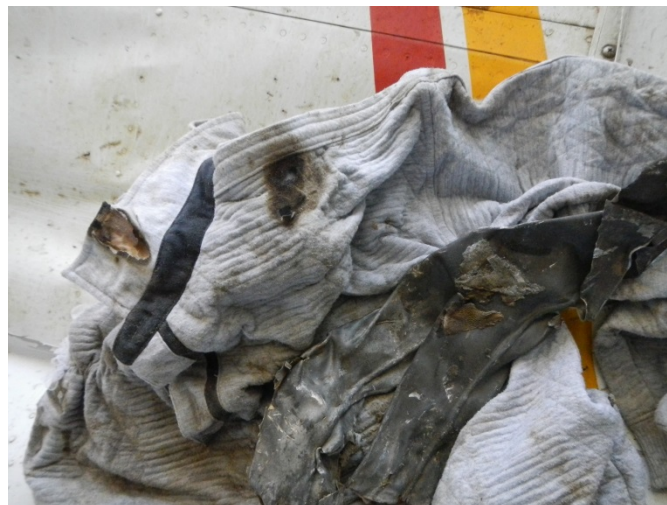
#### EXHAUST SYSTEM

The exhaust system was separated from the engine. Segments of exhaust risers along with the exhaust manifolds and mufflers were located within the recovered wreckage. All of the exhaust system components displayed ductile deformation and flattening. A segment of exhaust manifold was found adhering to a piece of synthetic clothing. Examination of the exhaust manifold revealed that the material that came into contact with the exhaust manifold was burnt and some areas of the synthetic material had been melted to the manifold.

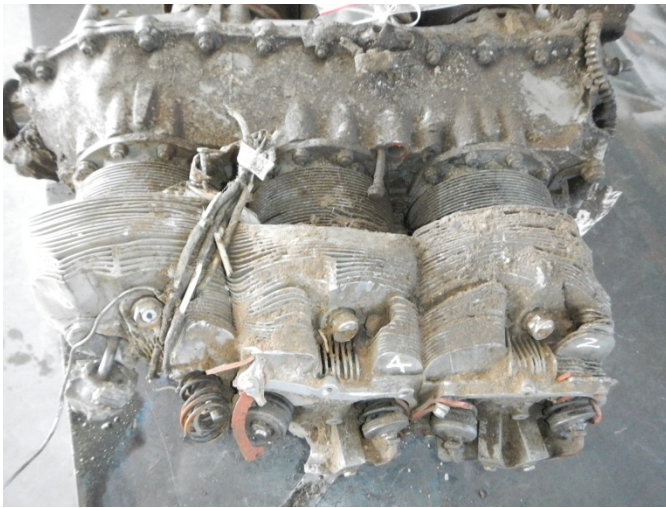
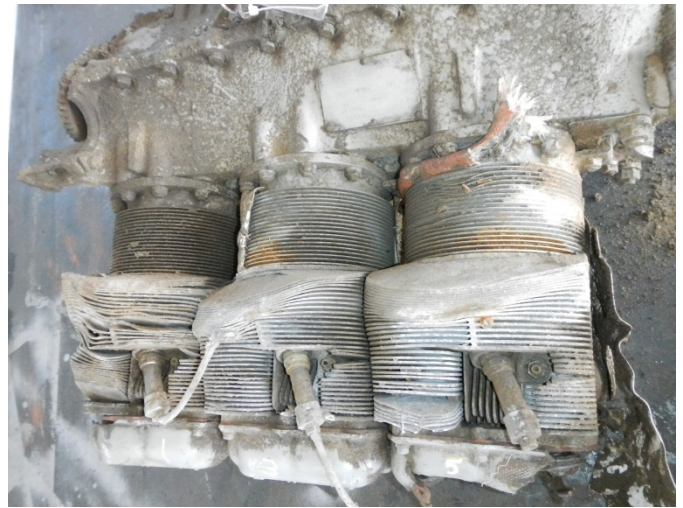
| Condition: | The ignition harness was destroyed and only portions of the leads or terminal ends remained with the engine. | | |

| Condition: | The #2, #4, and #6 top sparkplugs were fractured, but the electrode end remained inserted in their respective cylinders. The top sparkplugs were removed from the cylinders and examined. All of the sparkplugs displayed a new electrode condition along with combustion deposits that were consistent with lean engine operation. The #2, #4, and #6 top sparkplug center electrodes were displaced from the center position. | |

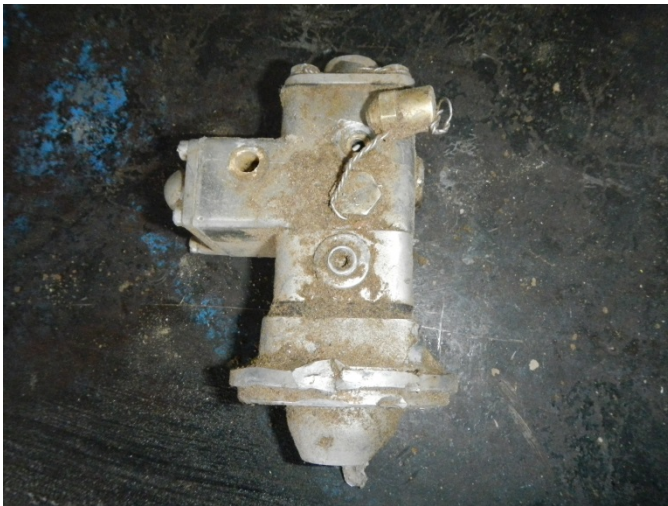
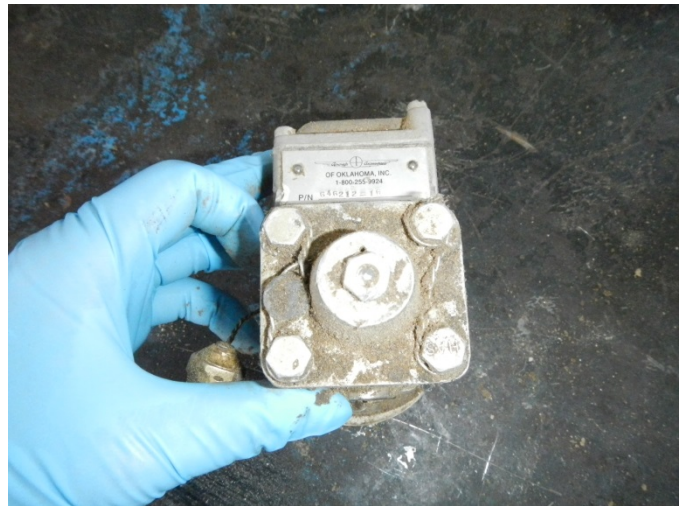
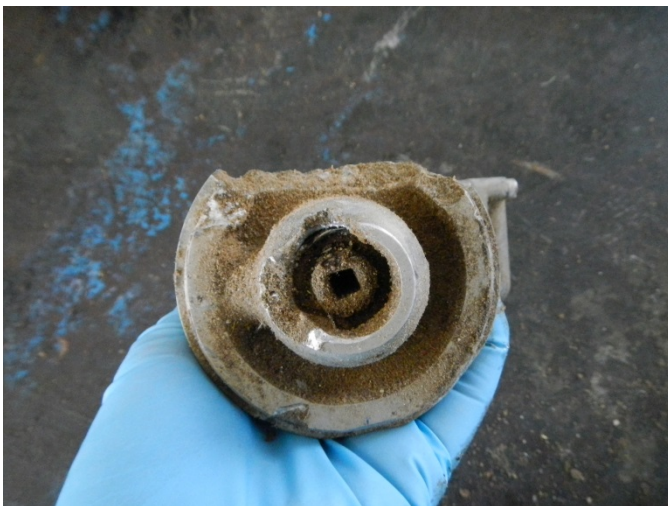
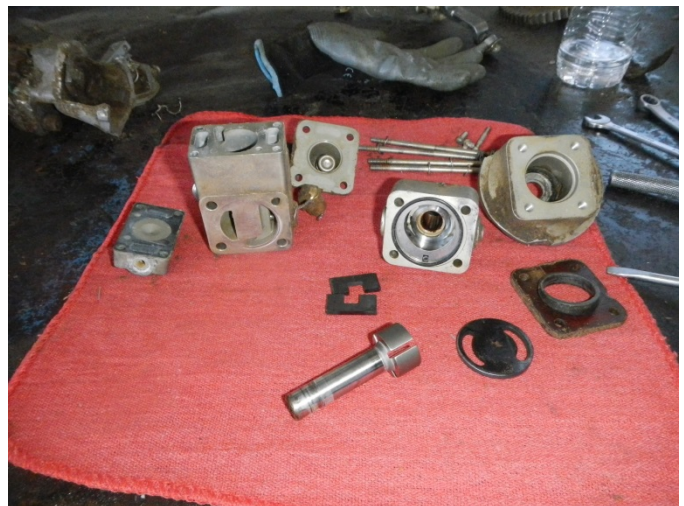
**FUEL PUMP**

**Condition:** The fuel pump was separated from the engine and all of the fuel fittings were fractured as was the adjustable orifice fitting (though it remained safety-wired to the fuel pump housing). The mounting flange was fractured and mechanically deformed. The low pressure relief valve adjustable screw was fractured and its stop nut was displaced into the cap. The drive coupling was not identified. Inserting a screw driver into the base of the fuel pump drive shaft and manually rotating the screw driver resulted in a coinciding rotation of the drive shaft and revealed no binding. Disassembly of the fuel pump revealed no pre-accident anomalies with the internal components. Dirt consistent with that photographed at the accident site and noted on the engine's external surfaces was found within the fuel pump.

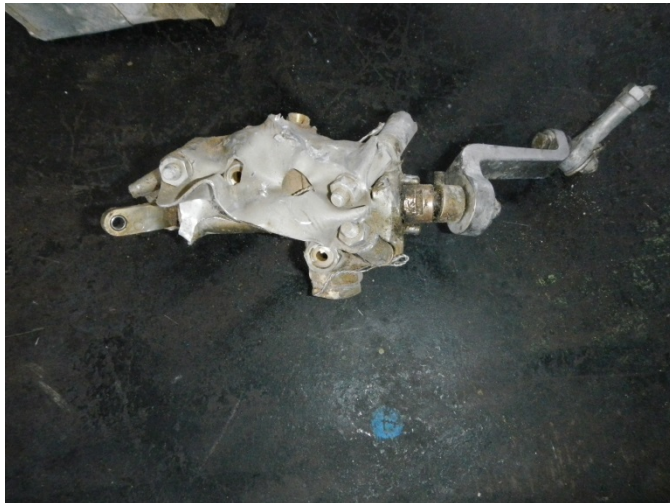
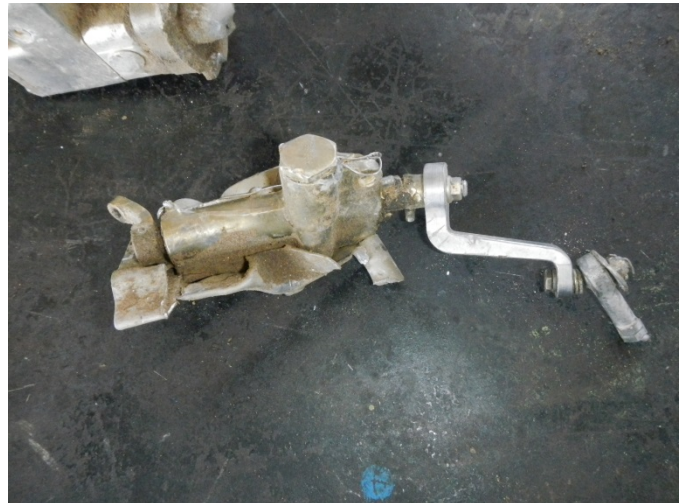
## THROTTLE BODY METERING UNIT

The throttle body was destroyed and the throttle valve was not identified among the recovered wreckage. The metering unit housing was deformed and the throttle synchronization lever was intact but deformed and the mixture lever remained intact and secured to the mixture shaft and cam; however the cam was pulled out of the metering unit housing and was bent. The fittings were all separated from the metering unit. The fuel inlet screen was in place with remnant of safety-wire. Removal of the fuel inlet screen did not reveal any signs of obstruction.

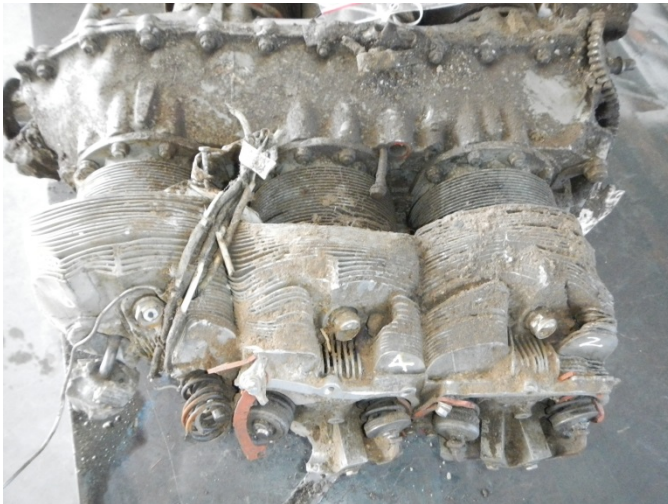
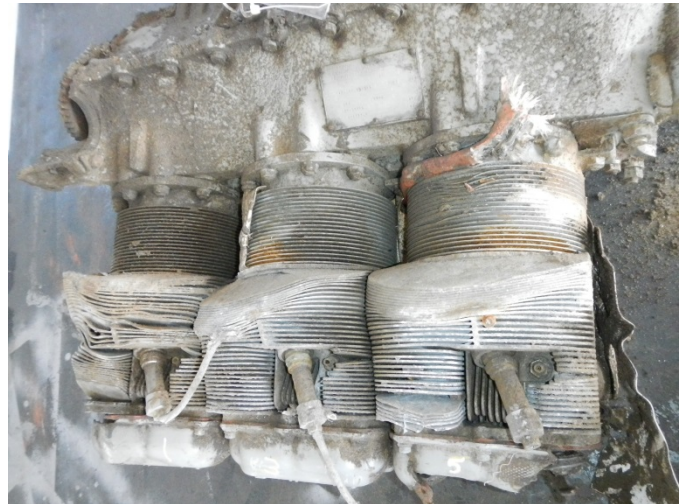
## FUEL NOZZLES AND LINES

Condition: The GAMI injectors were fractured (with the exception of the #6, which was bent) and the bases remained secured to the cylinders. The #6 fuel injector line remained connected to the nozzle.

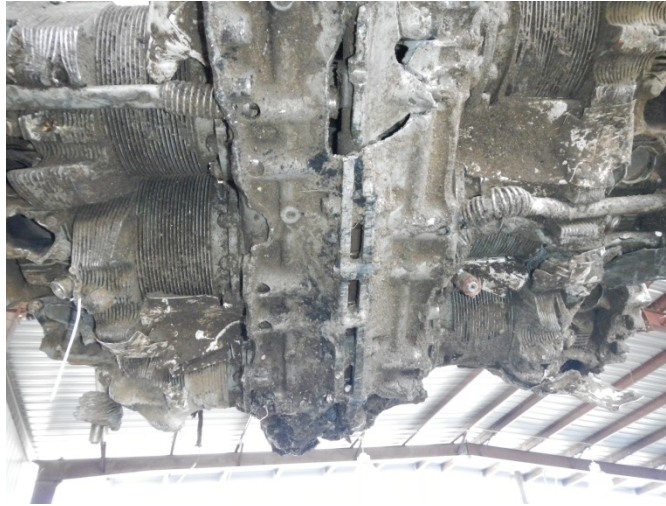
#### OIL SUMP

Condition: The oil sump was separated from the engine and was not observed. However, there was no evidence of an oil starvation or exhaustion event.

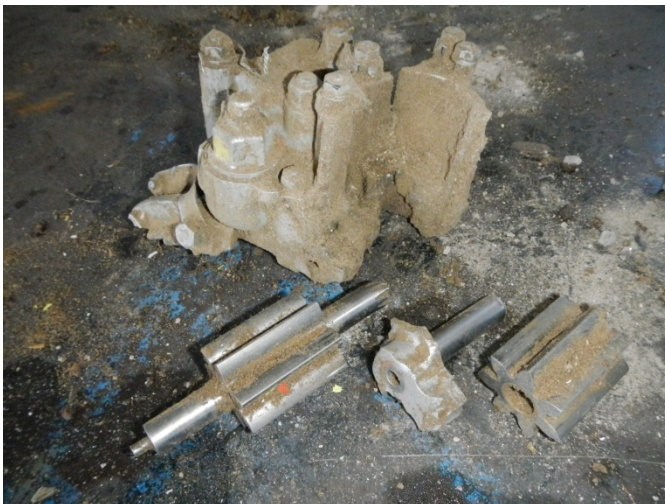
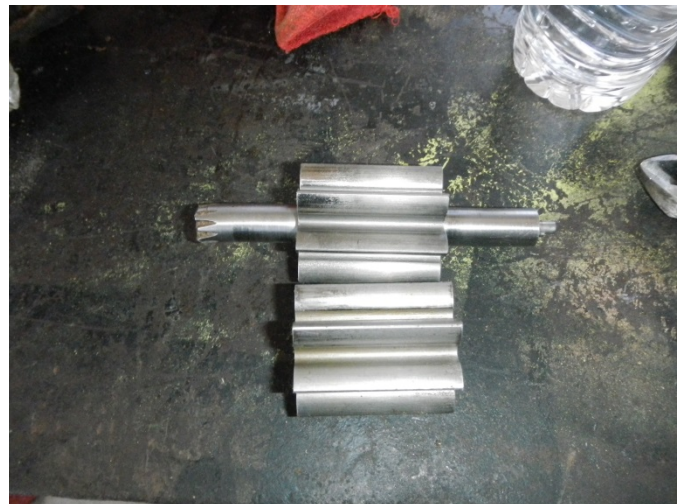
#### OIL PUMP

Condition: The oil pump was separated from the backside of the engine and the housing was fractured. The pump gears were located within the recovered wreckage. The drive shaft was fractured and bent, but there were no anomalies noted with the gears. A portion of the housing containing the oil pressure relief valve was recovered and no pre-accident anomalies were noted.

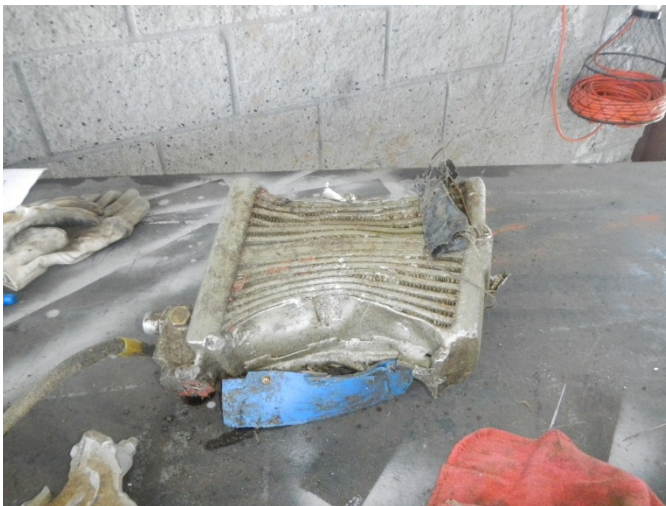
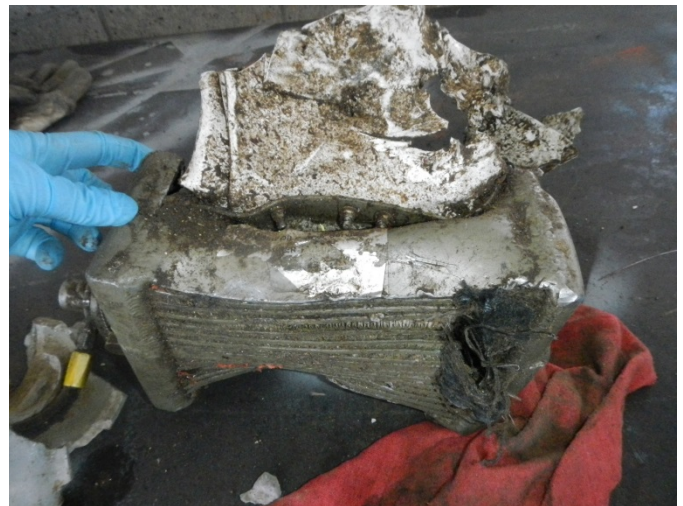
## OIL COOLER

The oil cooler was located among the recovered wreckage. It was separated from the engine and sustained deformation damage that crushed the cooling fins and bent the cooler.

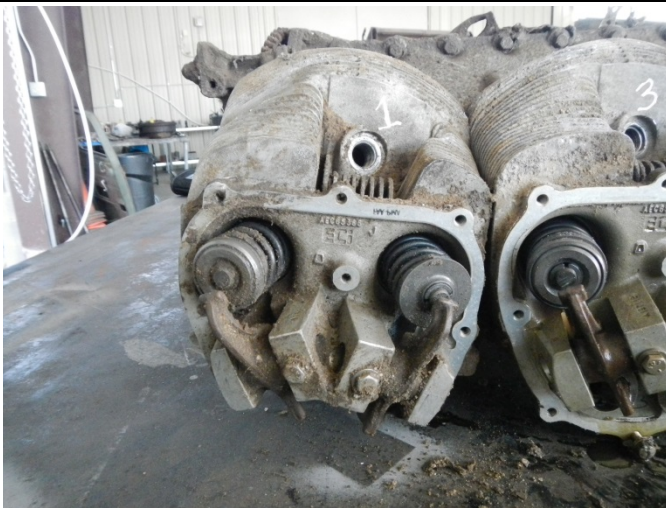
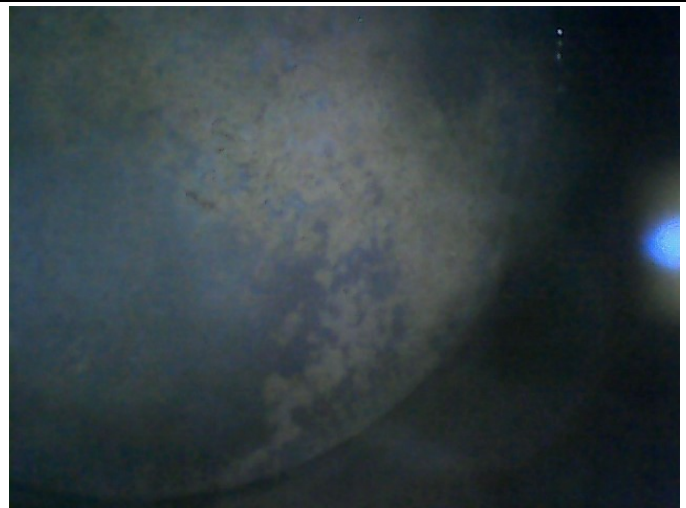
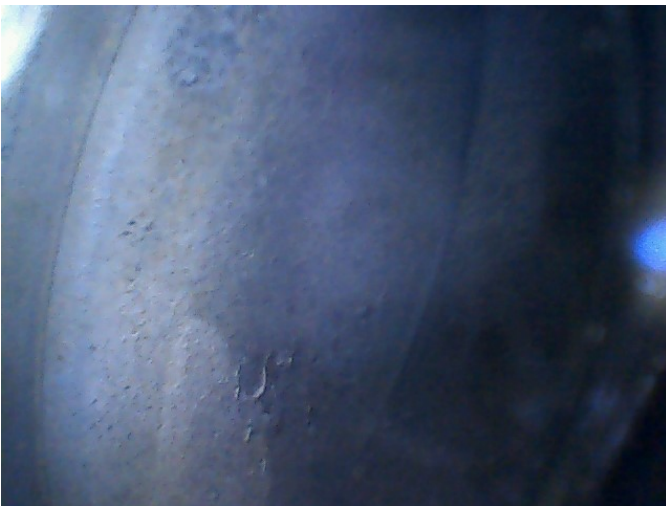
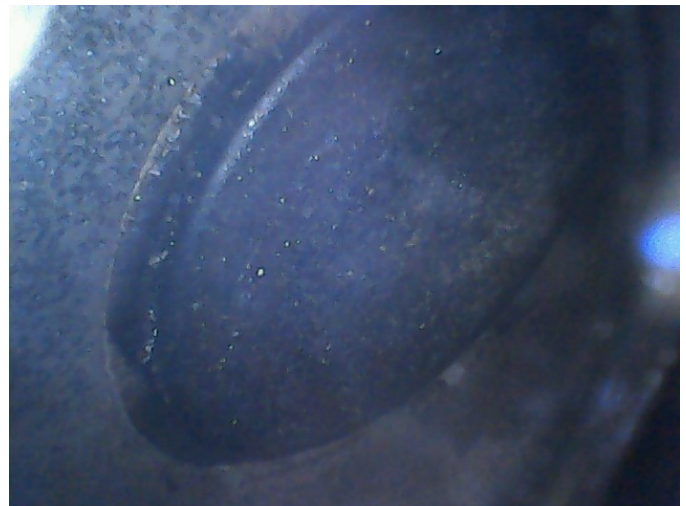
| CYLINDER #1 | ECI AEC65385 |

| Condition: | The bottom section of the cylinder head was fractured. None of the cylinder components revealed any evidence of thermal distress or lack of lubrication. The cylinder piston, head, valves and valve seats displayed deposits consistent with a lean combustion process. |

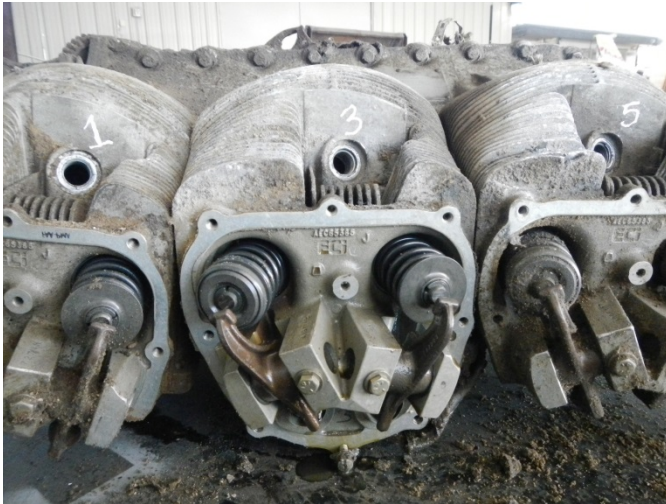
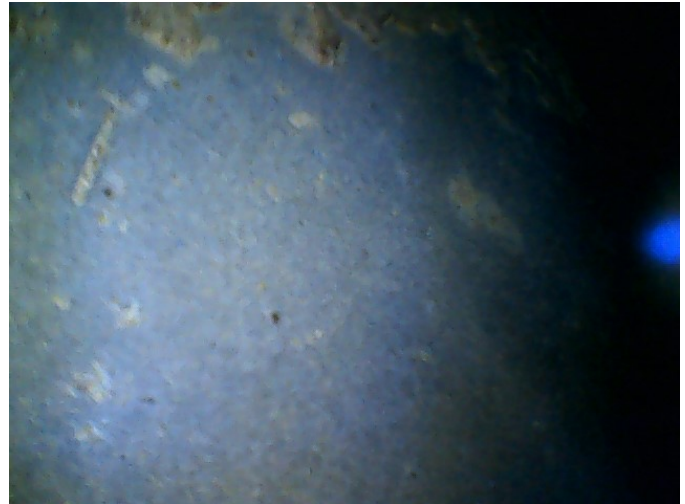
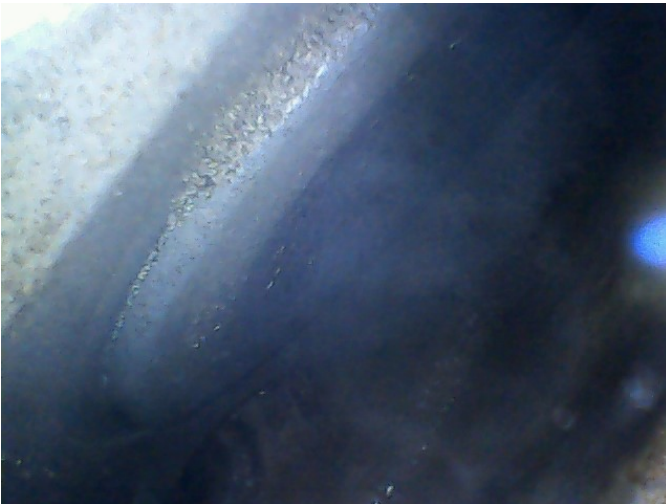
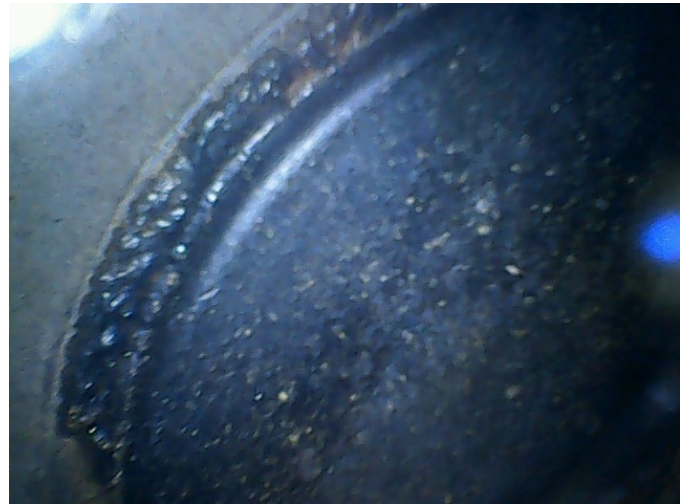
CYLINDER #3

None of the cylinder components revealed any evidence of thermal distress or lack of lubrication. The cylinder piston, head, valves and valve seats displayed deposits consistent with a lean combustion process.

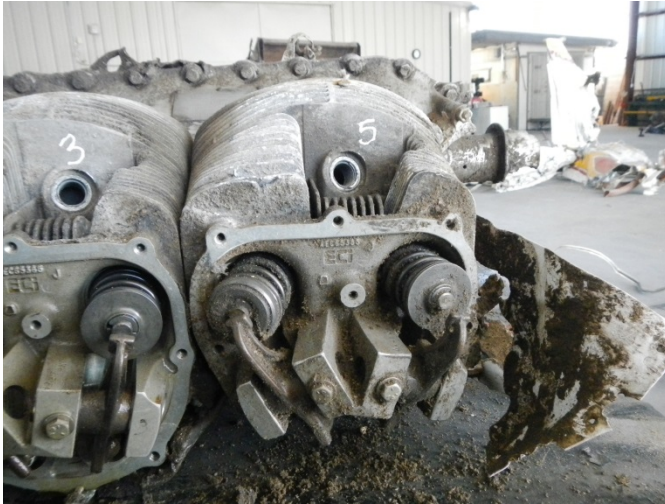
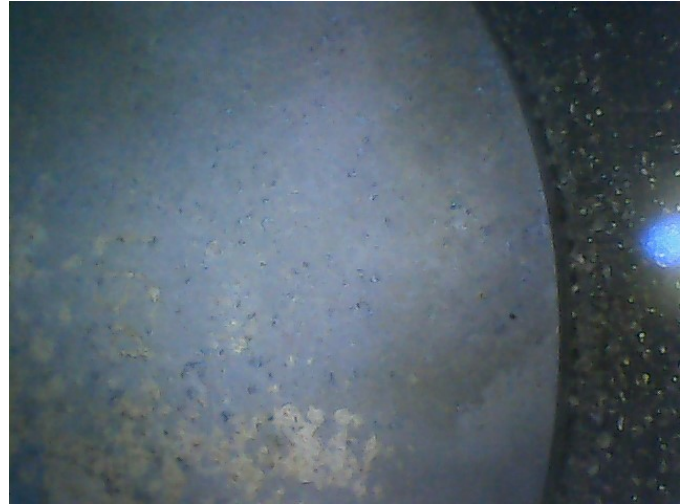
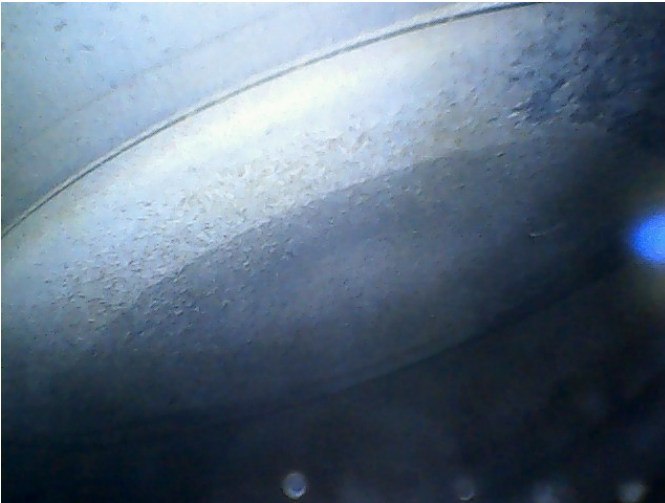
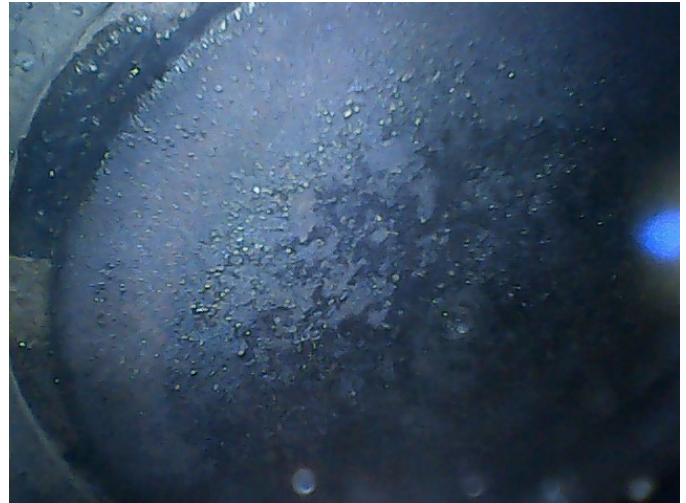
CYLINDER #5

The bottom section of the cylinder head was fractured. None of the cylinder components revealed any evidence of thermal distress or lack of lubrication. The cylinder piston, head, valves and valve seats displayed deposits consistent with a lean combustion process.

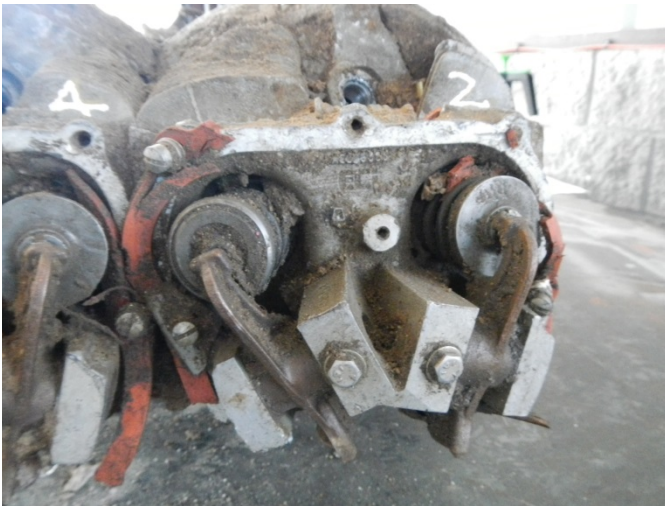
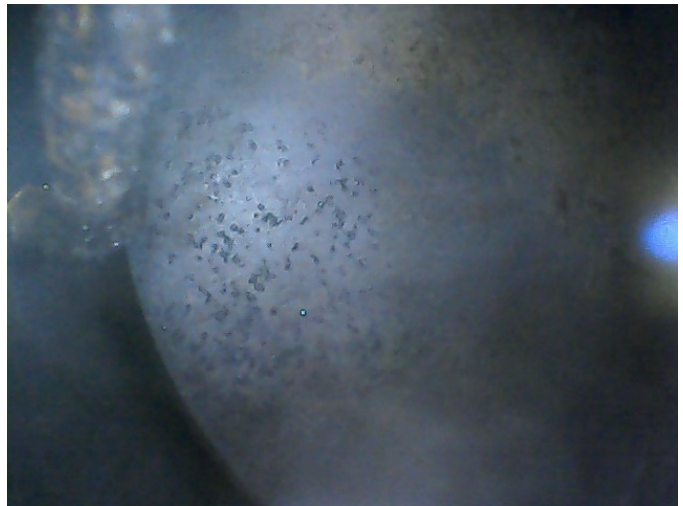
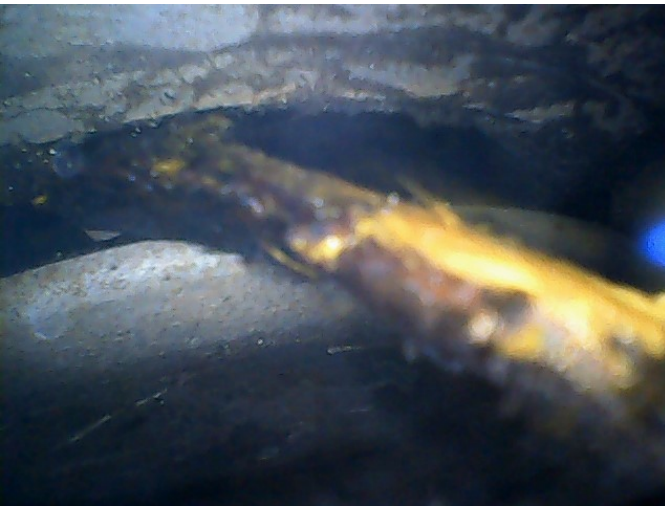
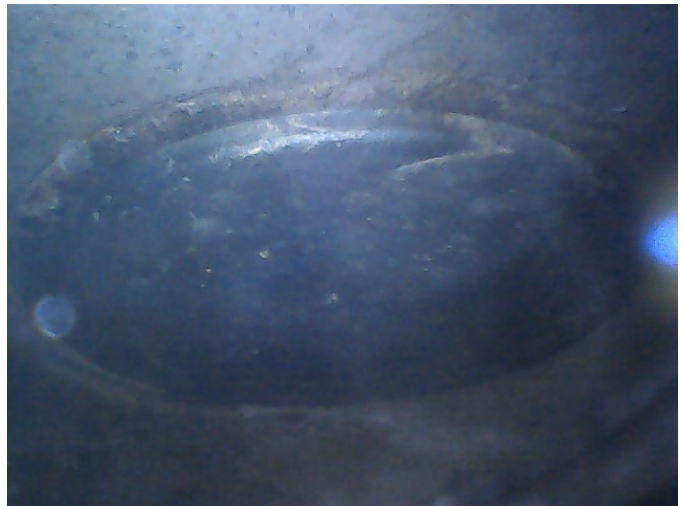
CYLINDER #2

The bottom section of the cylinder head was fractured. None of the cylinder components revealed any evidence of thermal distress or lack of lubrication. The cylinder piston, head, valves and valve seats displayed deposits consistent with a lean combustion process. A stick was observed protruding into the cylinder via the intake port/valve.

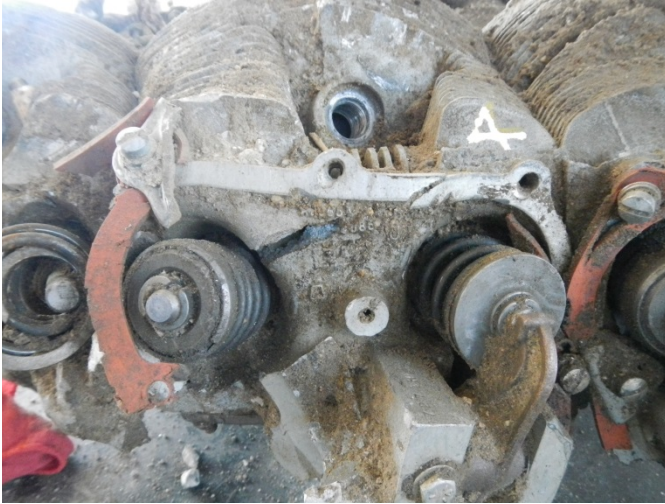
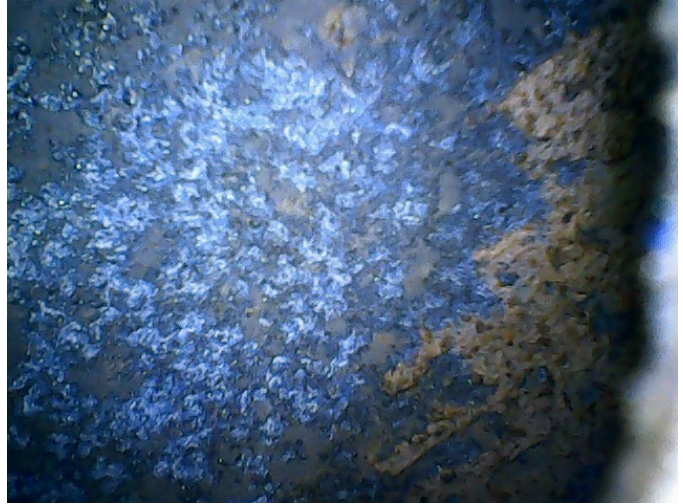
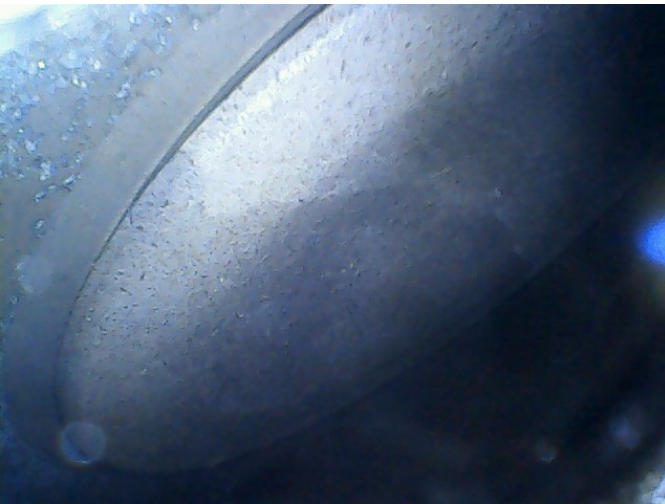
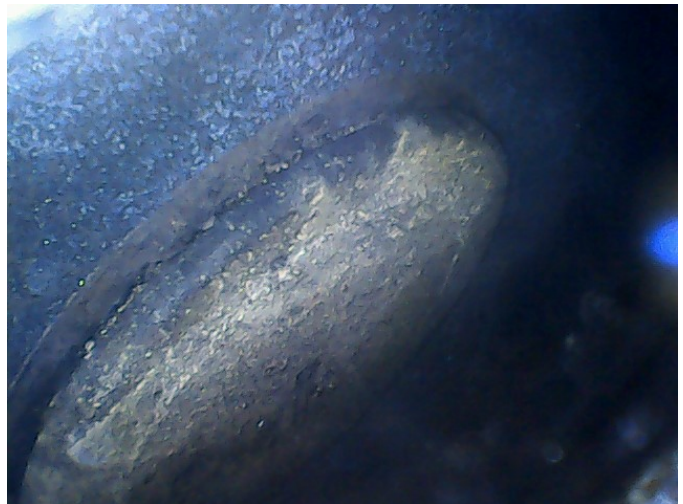
| CYLINDER #4 | ECI AEC65385 |

| Condition: | The cylinder head was fractured and the exhaust rocker and shaft was missing. None of the identified cylinder components revealed any evidence of thermal distress or lack of lubrication. The cylinder piston, head, valves and valve seats displayed deposits consistent with a lean combustion process. |

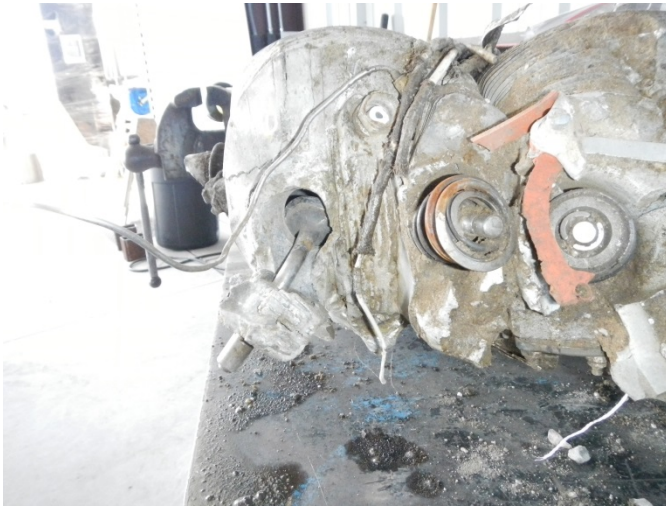
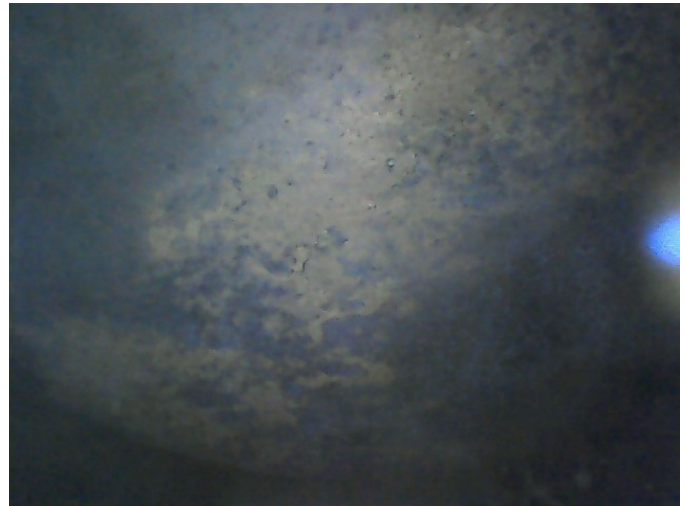
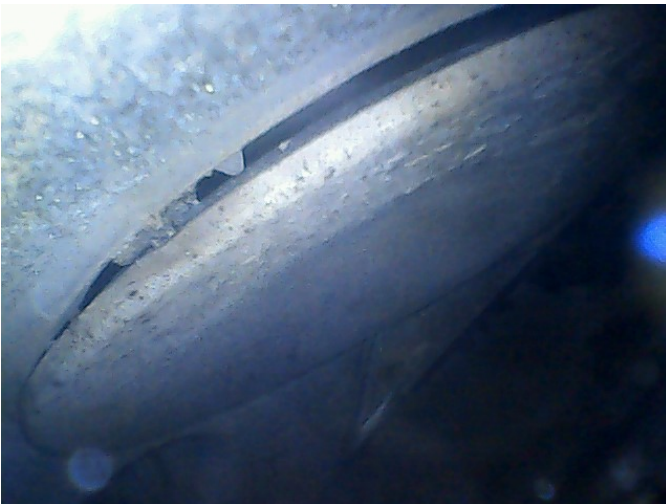
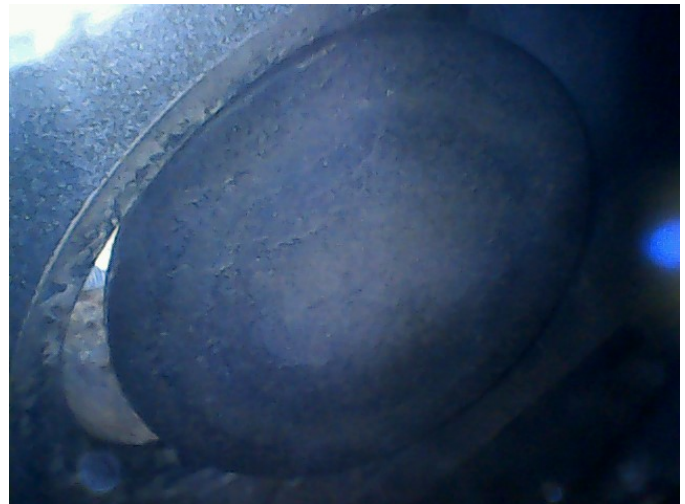
CYLINDER #6

The cylinder head was fractured and both rockers and rocker shafts were separated from the head. The rocker shafts remained with the separated boss. None of the identified cylinder components revealed any evidence of thermal distress or lack of lubrication. The exhaust valve was hanging out of the exhaust port with the valve guide in place. The exhaust valve was displaced from its valve seat. The cylinder piston, head, valves and valve seats displayed deposits consistent with a lean combustion process. Debris was noted between the intake valve and its seat.

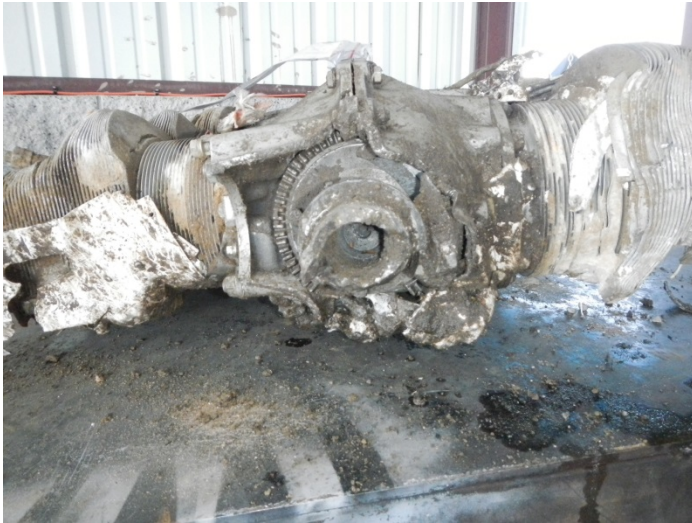
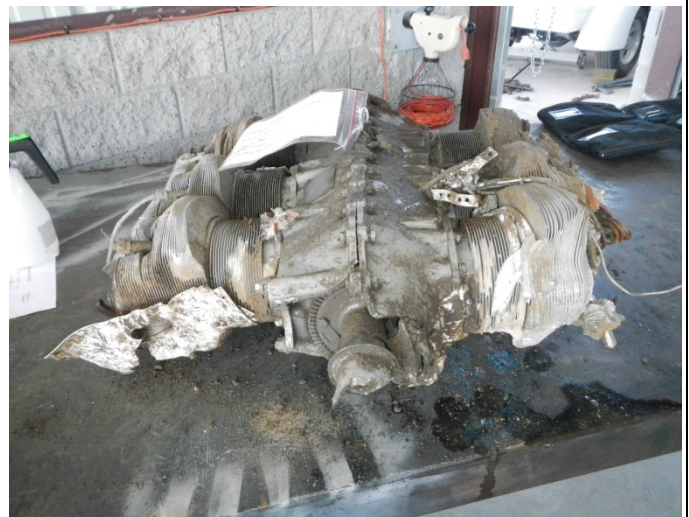
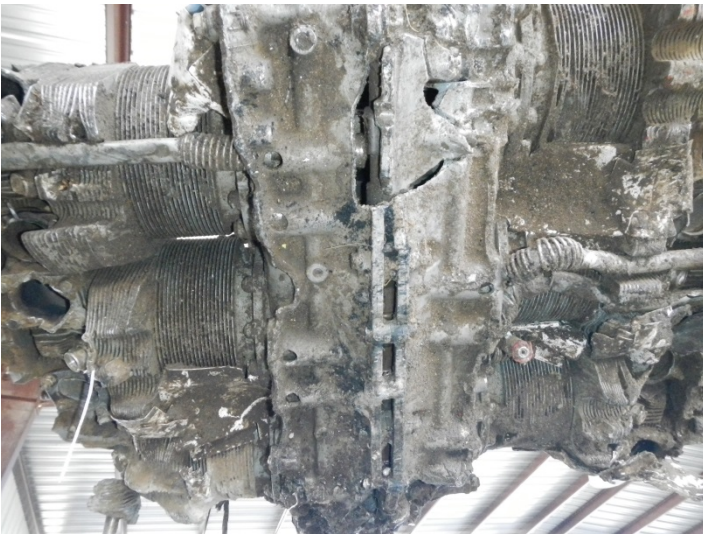
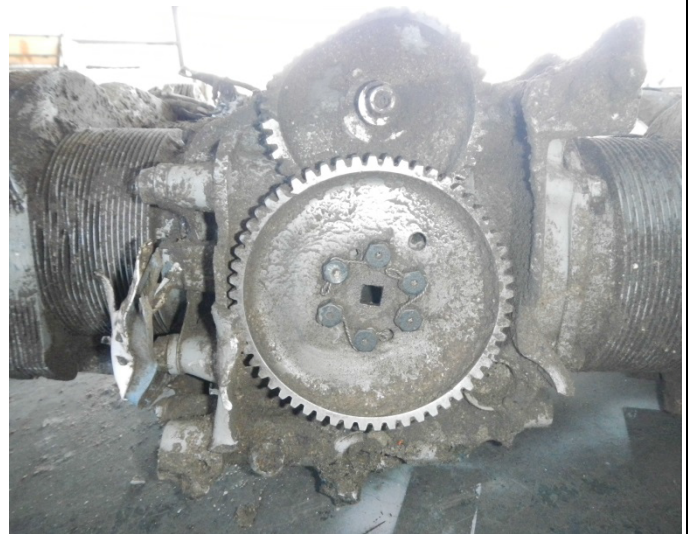
| Condition: | The crankcase was fractured in numerous areas; however, there was no sign of pre-accident anomalies with the crankcase halves. | | | |

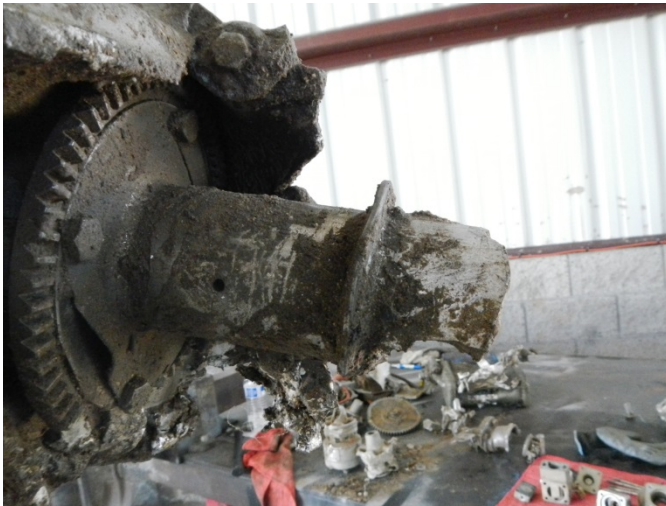
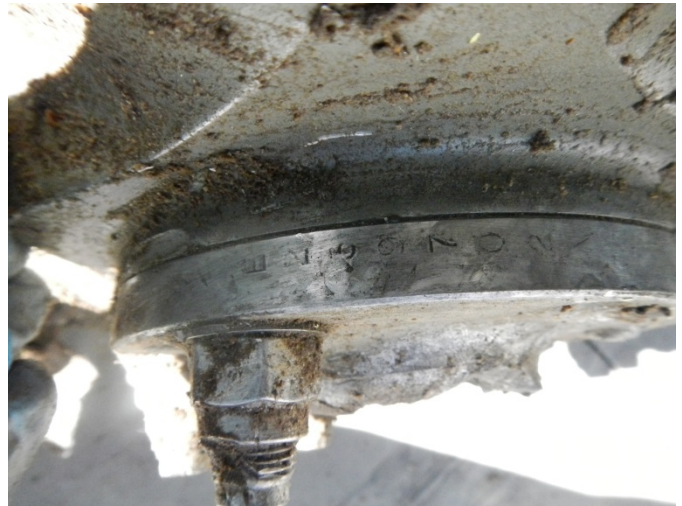
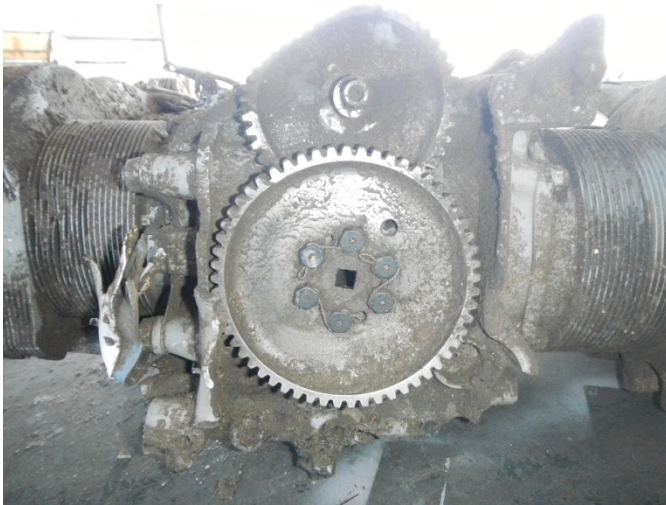
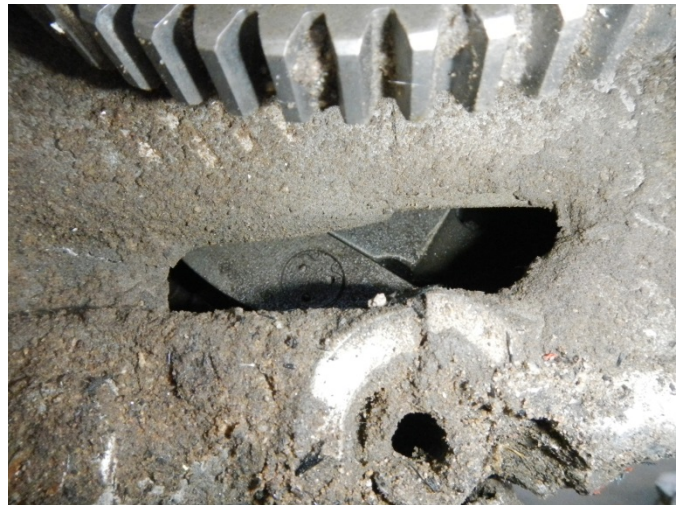
| CRANKSHAFT | Forging Number: Not Observed | S/N: E239702N | Heat code: Not Observed |
|---|---|---|---|
| Condition: | The crankshaft was deformed and fractured aft of the propeller flange. The crankshaft gear remained secured and safety-wired to the crankshaft. There were no pre-accident anomalies or signs of operational distress noted with the visible portions of crankshaft or crankshaft gear. Also, a borescope inspection of the connecting rods and counterweights revealed that the internal components were lubricated and showed no signs of thermal distress or operational anomalies. | | |

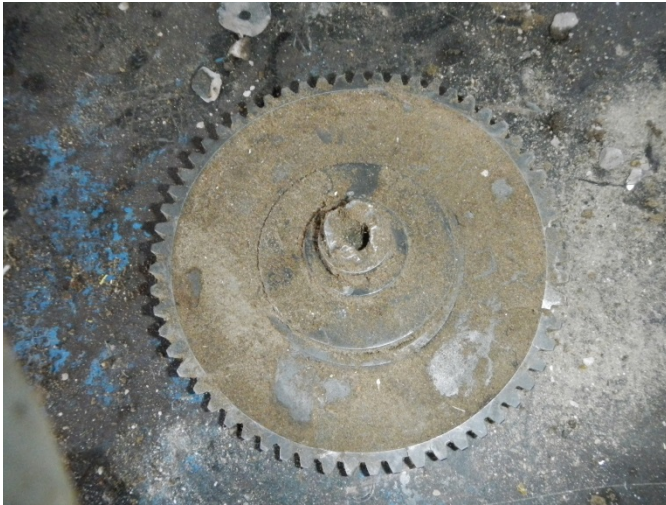
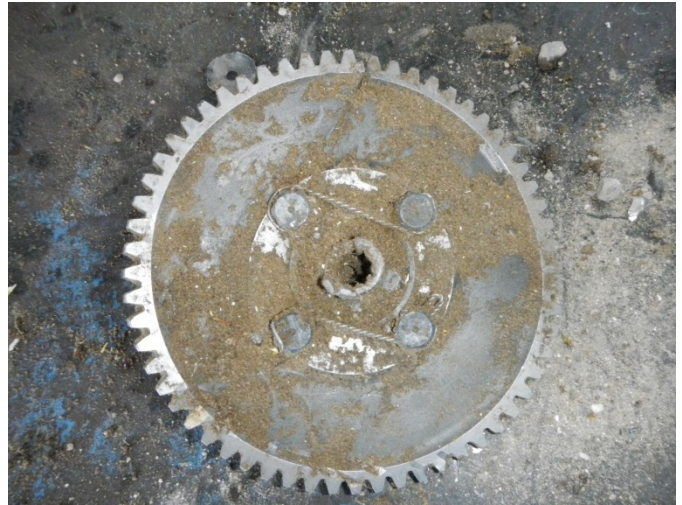
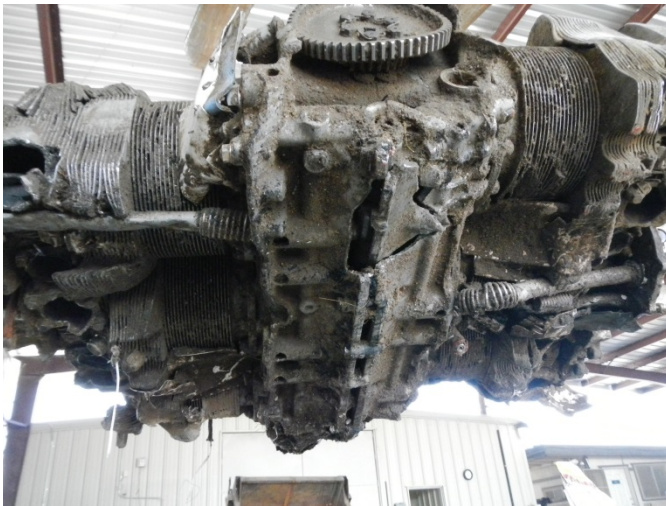
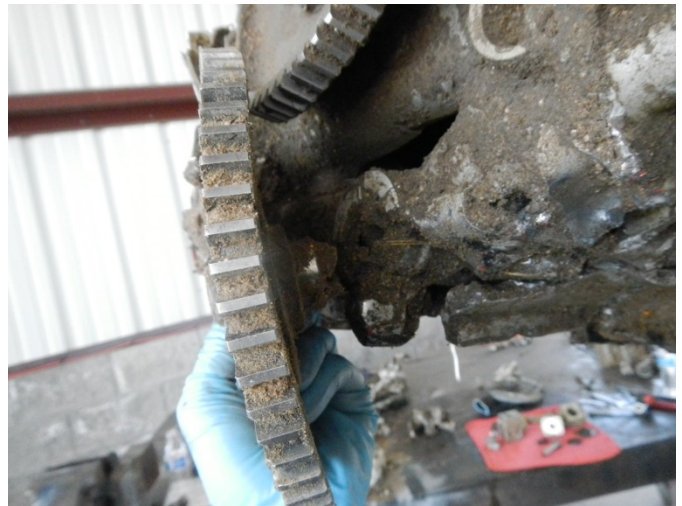
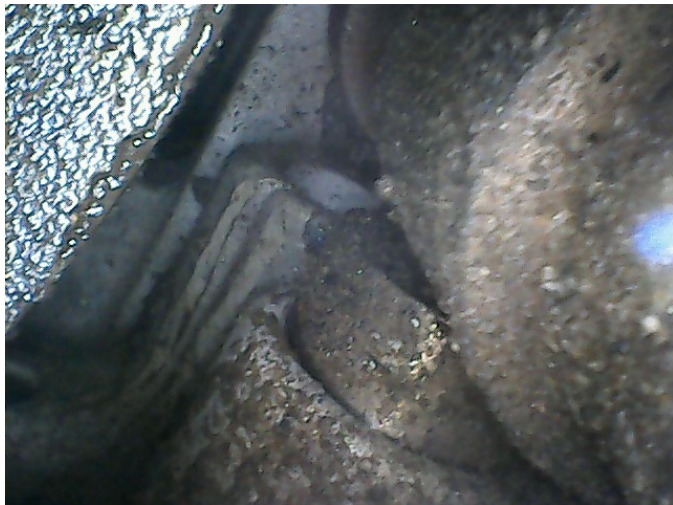
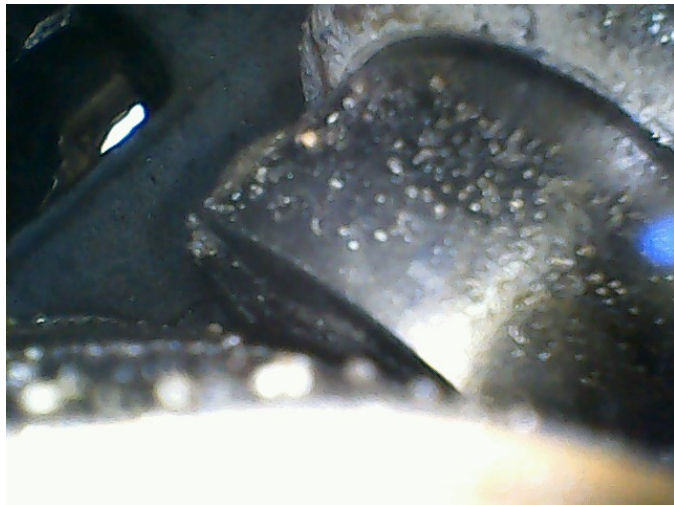
The camshaft was fractured in the front and aft sections. The camshaft gear remained secured and safety-wired to the aft-end of the separated camshaft segment. No pre-accident anomalies were noted with the observed components. Borescope of the internal engine components revealed that the lifters were lubricated and did not display any signs of thermal distress.
