# Continental Motors

## ENGINE FIELD INSPECTION REPORT

Addendum to Original Report dated 02/09/2015

| ENGINE MODEL | IO-520-BA12B Converted to IO-520-XXBB <sup>2</sup> |

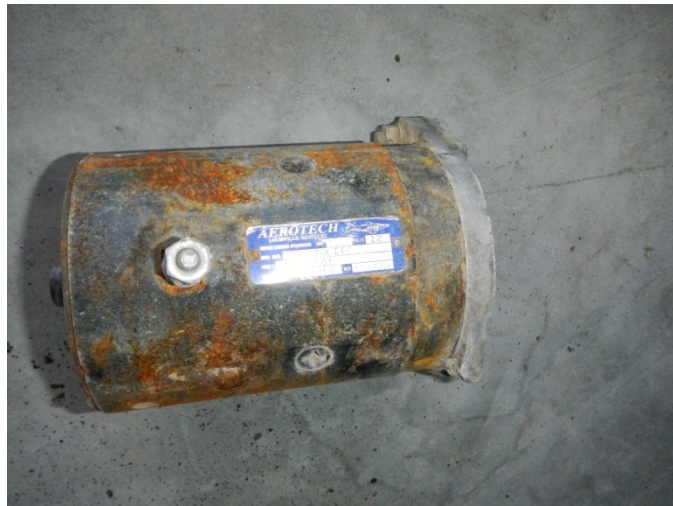
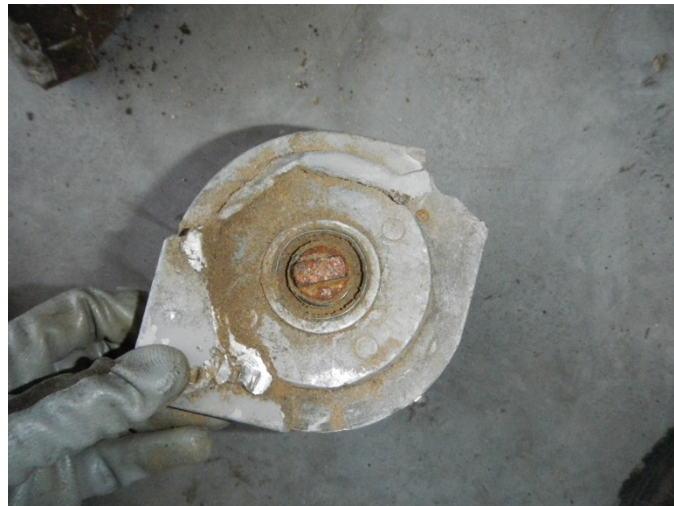
| Condition: | The starter motor was separated from the adapter and its mounting flange was fractured. | | |

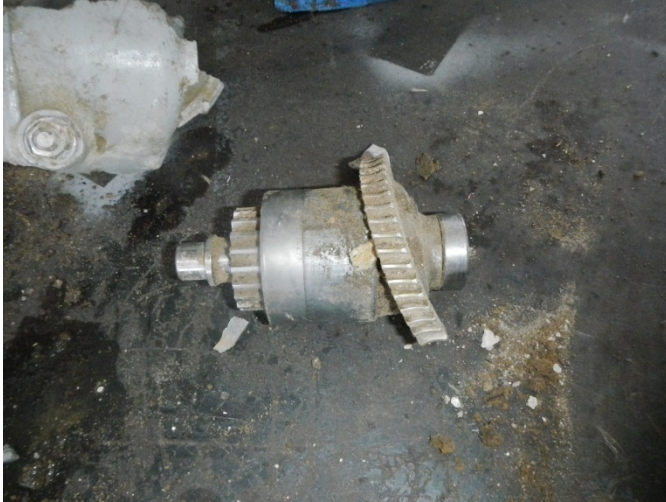
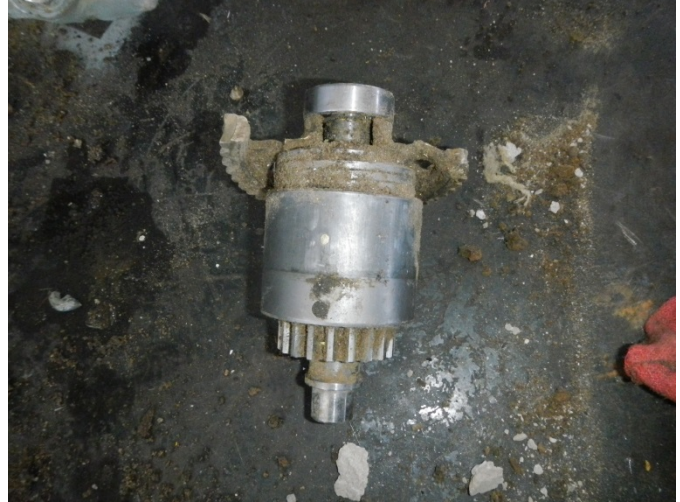
## STARTER ADAPTER

Condition: The starter adapter was separated from the engine and the housing was not observed. Only a portion of the adapter was identified.

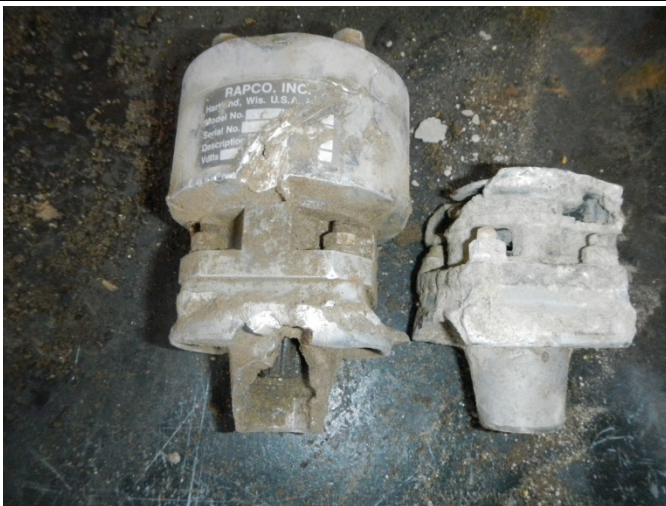
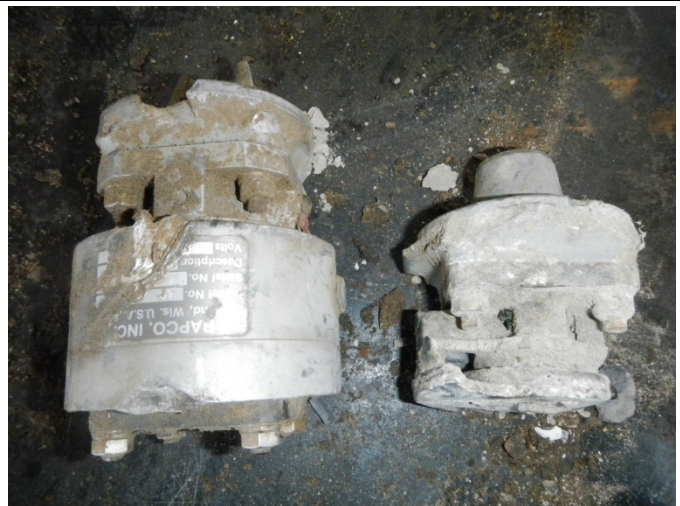
## VACUUM PUMP

Condition: The separated portions of the engine driven vacuum pump were identified and its drive coupling remained intact. The pump housing rotor and vanes were not observed.

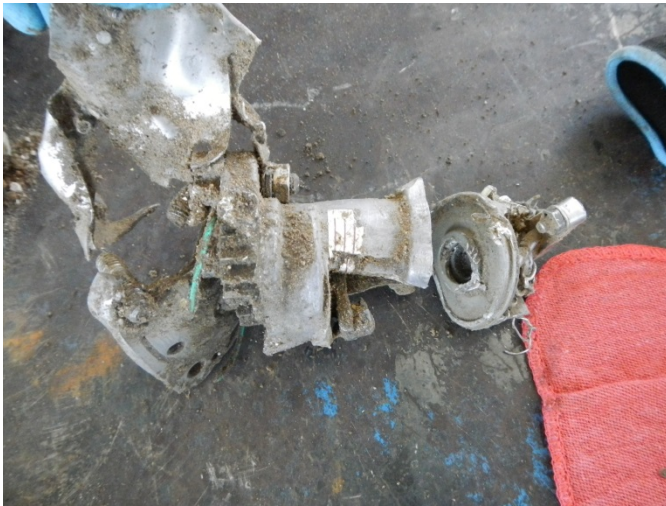
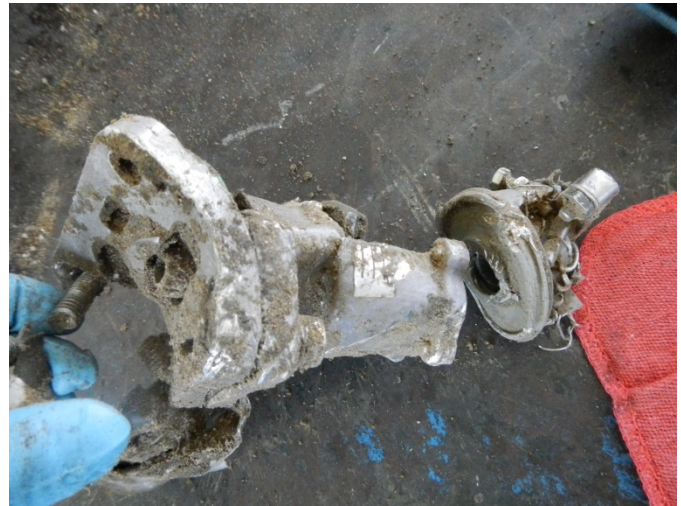
The propeller governor was separated from the engine and the housing was fractured. The governor gears were visible and there were no signs of pre-accident operational distress. Only one of the flyweights remained with the governor housing. The lever remained secured to the top cap of the flyweight housing.

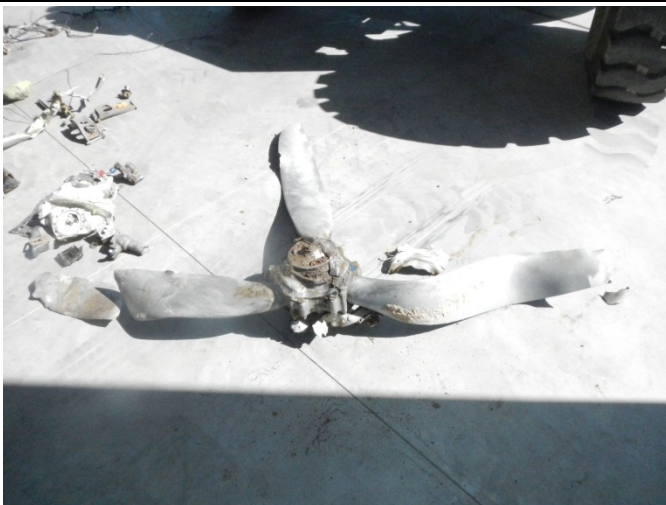
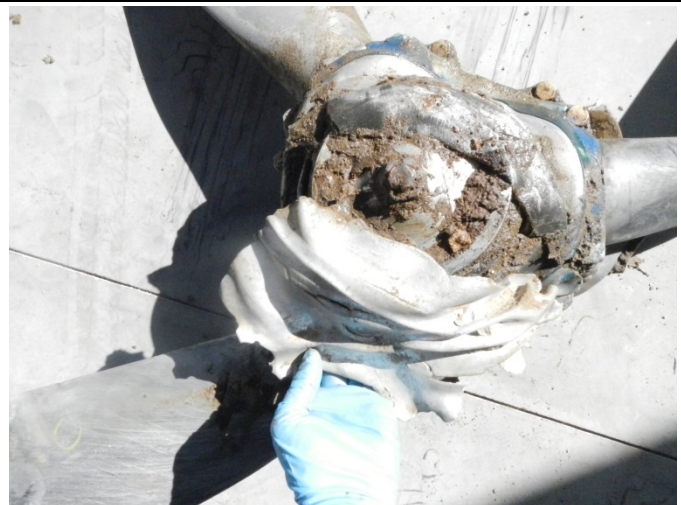
**PROPELLER**

The three-bladed, constant-speed propeller was separated from the engine. The propeller hub remained secured to the crankshaft's propeller flange by three of the six propeller bolts. The propeller flange fracture was irregular in shape and displayed shear lips. The propeller hub was fractured. All three blades were loose in the propeller hub. All three blades displayed significant s-bending, leading edge gouging and paint erosion on the camber side, and scraping. The blade labeled C for investigative purposes was torn about mid span. The blade labeled B had its tip torn away and curled toward low pitch. No pre-accident anomalies were noted.
