**NATIONAL TRANSPORTATION SAFETY BOARD**  
Vehicle Recorder Division  
Washington, DC 20594

## **Onboard Image Recorder**

**Specialist's Factual Report**  
**By Sean Payne**

| Aircraft: | Great Lakes 2T-1A, N7LM |

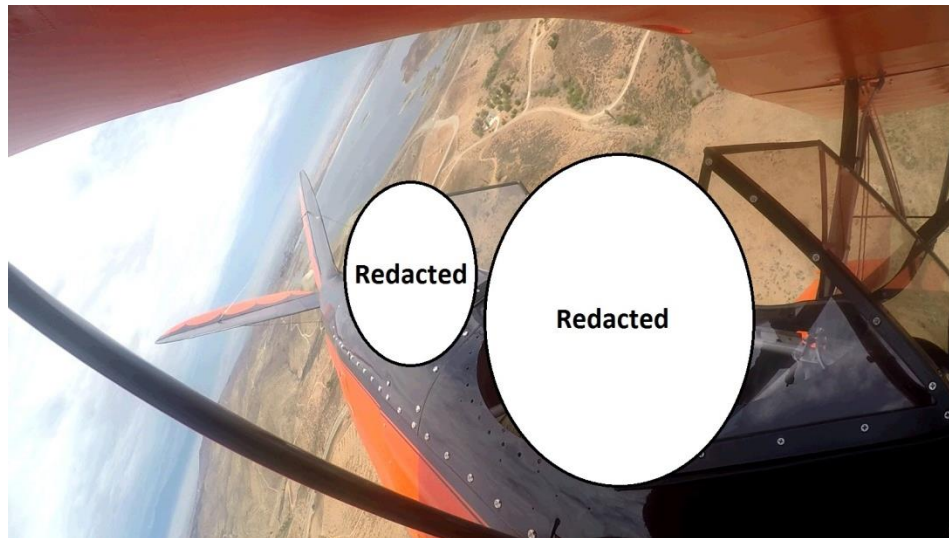
Around 12:03:53, the aircraft entered a steeply banked right turn. The front seat passenger looked toward the ground and smiled. At 12:04:01, the aircraft swept back into a steeply banked left turn. At 12:04:09 a notable decrease in engine power was audible. Figure 1 shows the angle of the aircraft's bank at this time. One second later, the nose sharply fell through the turn, the aircraft appeared to depart controlled flight and entered an aerodynamic stall. The pilot immediately reacted to the upset. The control positions were seen as follows: up elevator, right rudder, left roll aileron. The pilot continued to manipulate positions of all control surfaces and by 12:04:14, the aircraft had become level and began pulling out of a descent. At no time during the recovery was the elevator surface seen in a position other than a nose up command. By the time of recovery, the elevator had become neutral, along with the rudder and ailerons.

**Figure 1. The aircraft's attitude at 12:04:09 just prior to the first departure from controlled flight.**

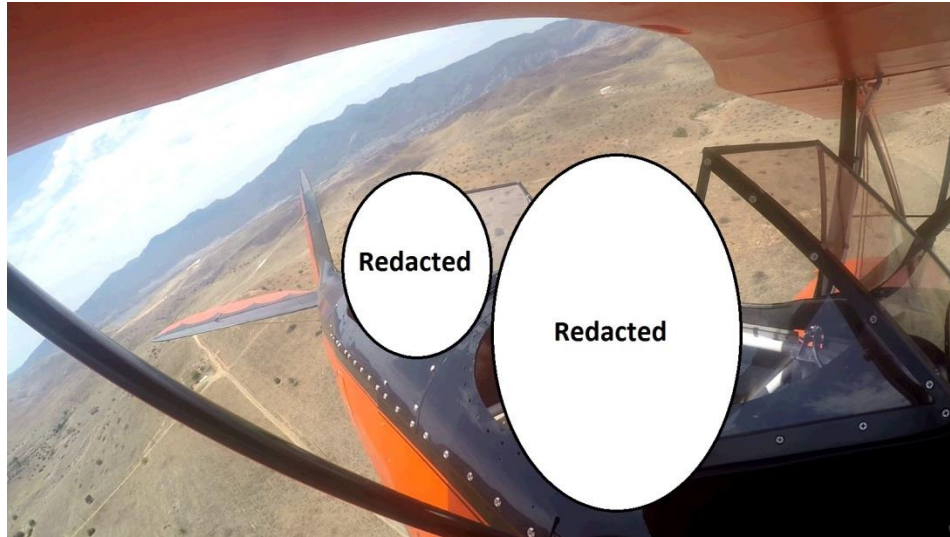
Throughout the left turn, the elevator position became increasingly more positive. Around 12:04:29, a further decrease in engine noise was audible. Two seconds later, at 12:04:31, the aircraft continued into the moderate left bank turn and the camera began shaking in a manner consistent with airframe buffeting. Figure 2 shows the condition of the aircraft's attitude at 12:04:31. One second later, at 12:04:32, the aircraft began to depart controlled flight. The aircraft's elevator control surface commanded a nose up pitch attitude. By this moment, the aircraft had begun to roll sharply to the left. By 12:04:33, the aircraft's roll attitude had become almost 90 degrees left in reference to the horizon. By 12:04:34, the engine's sound was non-nominal. The aircraft began a quick descent while rolling sharply left and back to the right. This roll condition repeated until ground impact. The aircraft was seen moving quickly toward the ground and by 12:04:39, the first indication of impact appeared and the aircraft struck pine-like vegetation with the left wing. In the same second, the camera had broken free of it's mounting position and began rolling in debris. One second later, at 12:04:40, the camera had come to rest and continued recording. The front seat female passenger's voice was audible for the remainder of the recording which ended at 12:15:52.

**Figure 2. The aircraft's attitude at 12:04:31 just prior to the second and last departure from controlled flight.**

The elevator was mostly in a full nose up command position. At brief moments during the descent, the elevator command had slightly relaxed; however, the position mostly displayed a full nose up pitch command.

The rudder swung full left and full right in the direction opposite of the aircraft's rolling motion as the descent continued until ground impact.

The lower wing's left aileron was seen moving to roll command positions opposite of the aircraft's rolling direction as the descent continued toward impact. The magnitude of the aileron command position could not be characterized.
