## **NATIONAL TRANSPORTATION SAFETY BOARD**

### **ON SITE EXAM REPORT**

WPR15FA200

Location: Corona, CA  
Date: June 28, 2015  
Aircraft: Great Lakes 2T1A-E, Registration Number: N7LM, Serial #: 1  
NTSB IIC: Howard Plagens

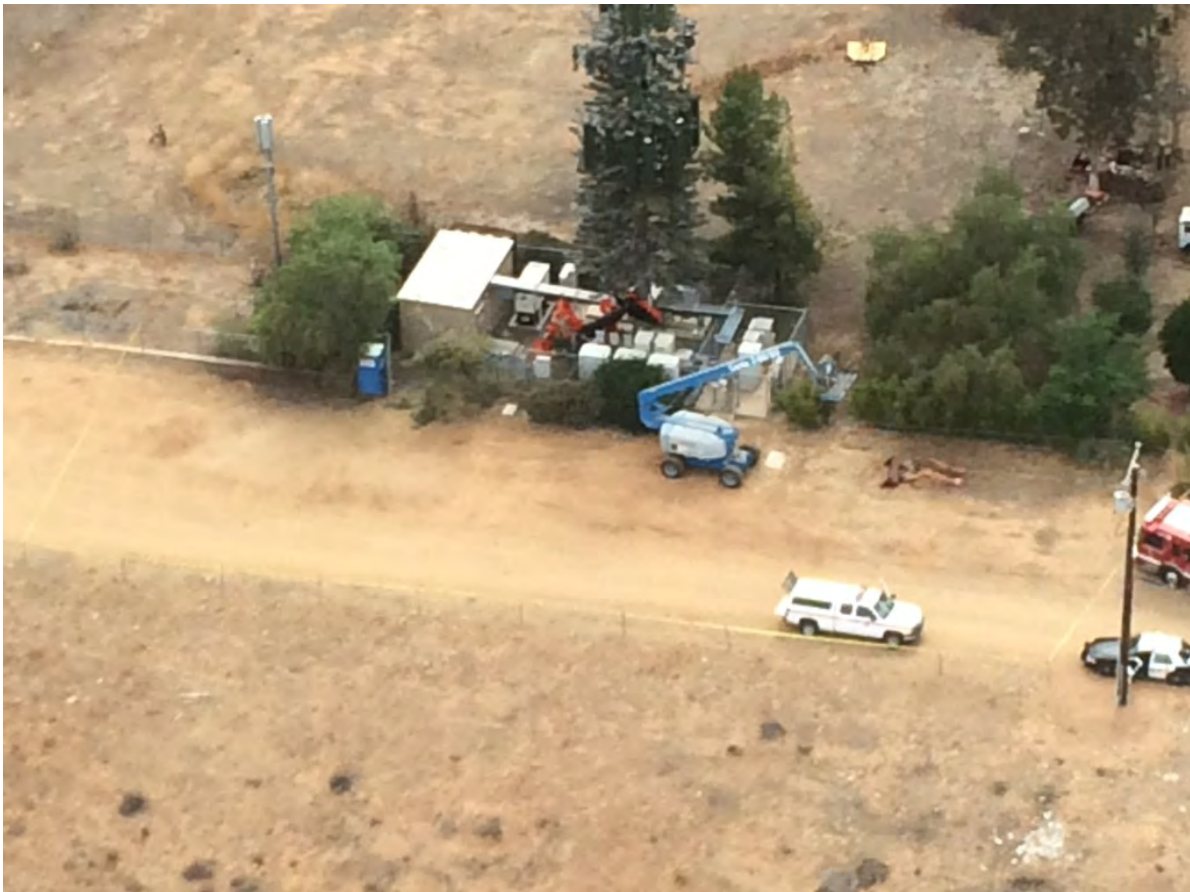
Photo 1 Sheriff's Aerial of Site

The wreckage came to rest in a fenced in area containing a cell phone tower and associated buildings. The GPS coordinates were 33 degrees 49 minutes 20 seconds north 117 degrees 27 minutes 48 seconds west at an estimated elevation of 1,430 feet. Power lines running north-south 50 feet east of the site and power lines running east-west of the site were not damaged.

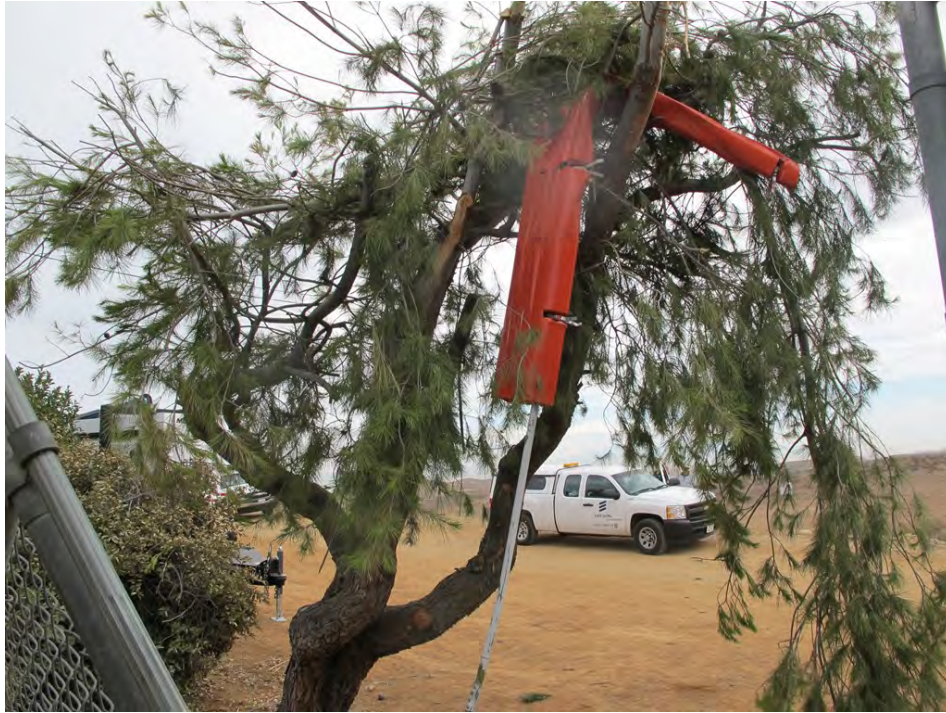
**Photo 2 Left Aileron**

The first identified point of contact was a damaged tree, which contained the separated left aileron. The aileron was bent 90 degrees over a branch. The tree was next to a fence that was bent into the fenced area in the direction of the wreckage.

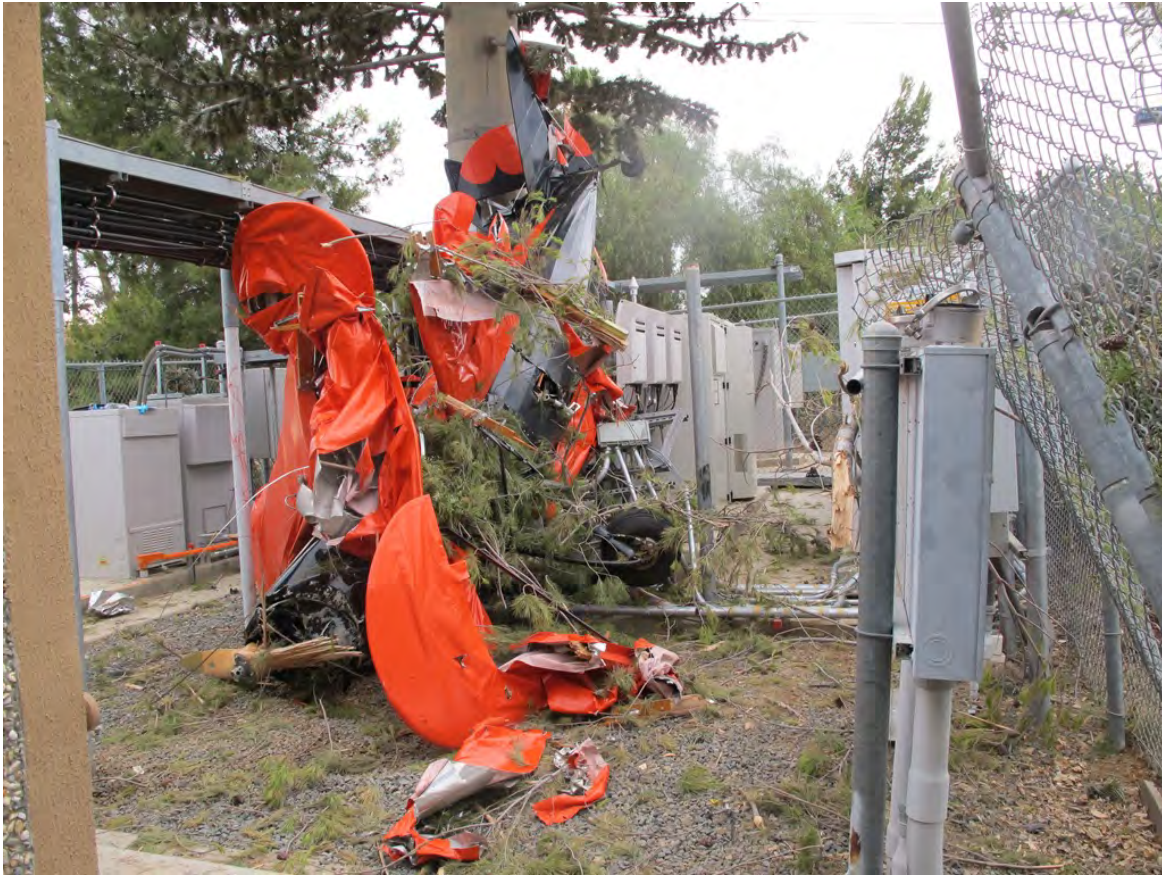
Photo 4 Front Left View Main Wreckage

The airframe came to rest with the propeller and engine on the ground. The tail angled up about 50 degrees, and was leaning against the cell phone tower.

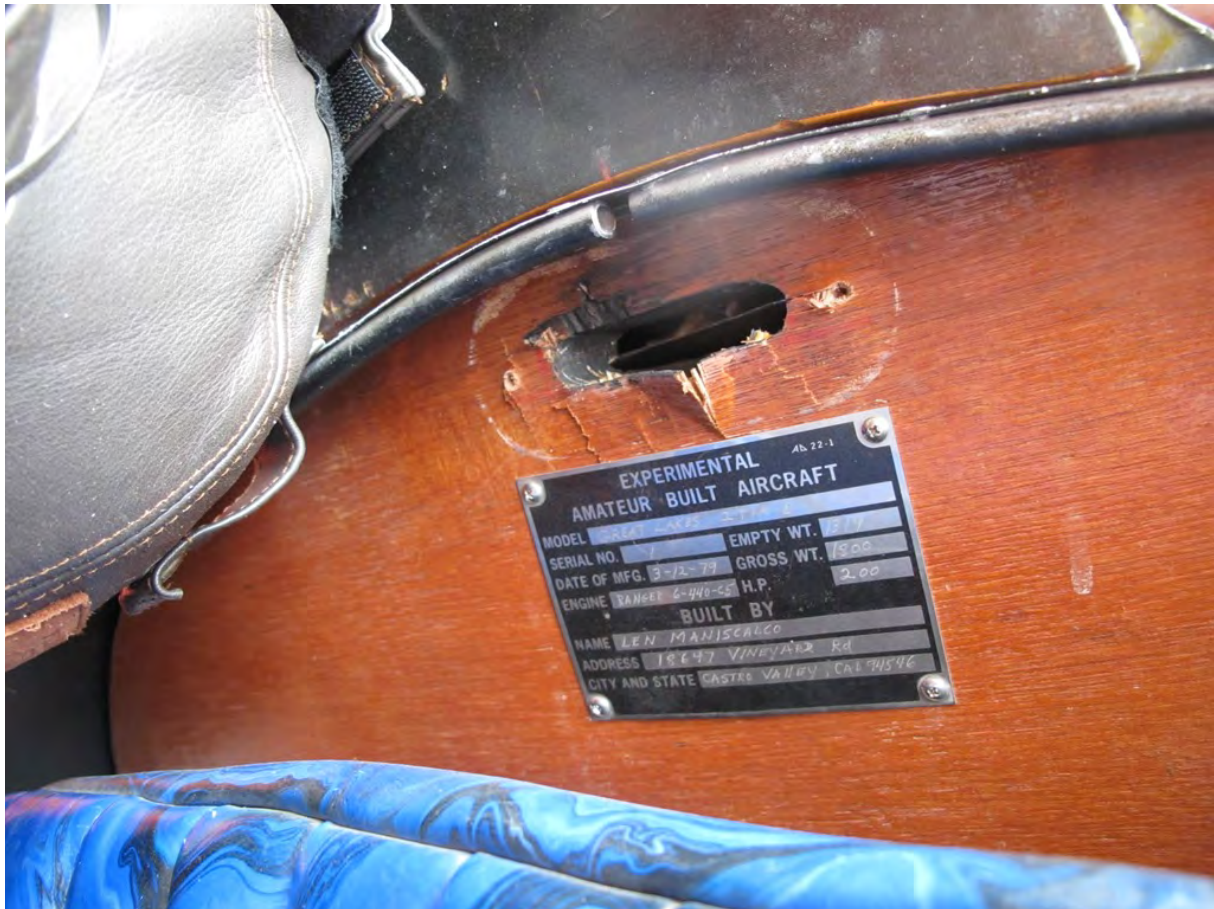
Photo 8 Airplane Data Plate

The data plate indicated that the airplane was an experimental Maniscalco Great Lakes 2T/A-E, serial number 1. The empty weight was 1,319 pounds, and the gross weight was 1,800 pounds. The date of manufacture was March 12, 1979.

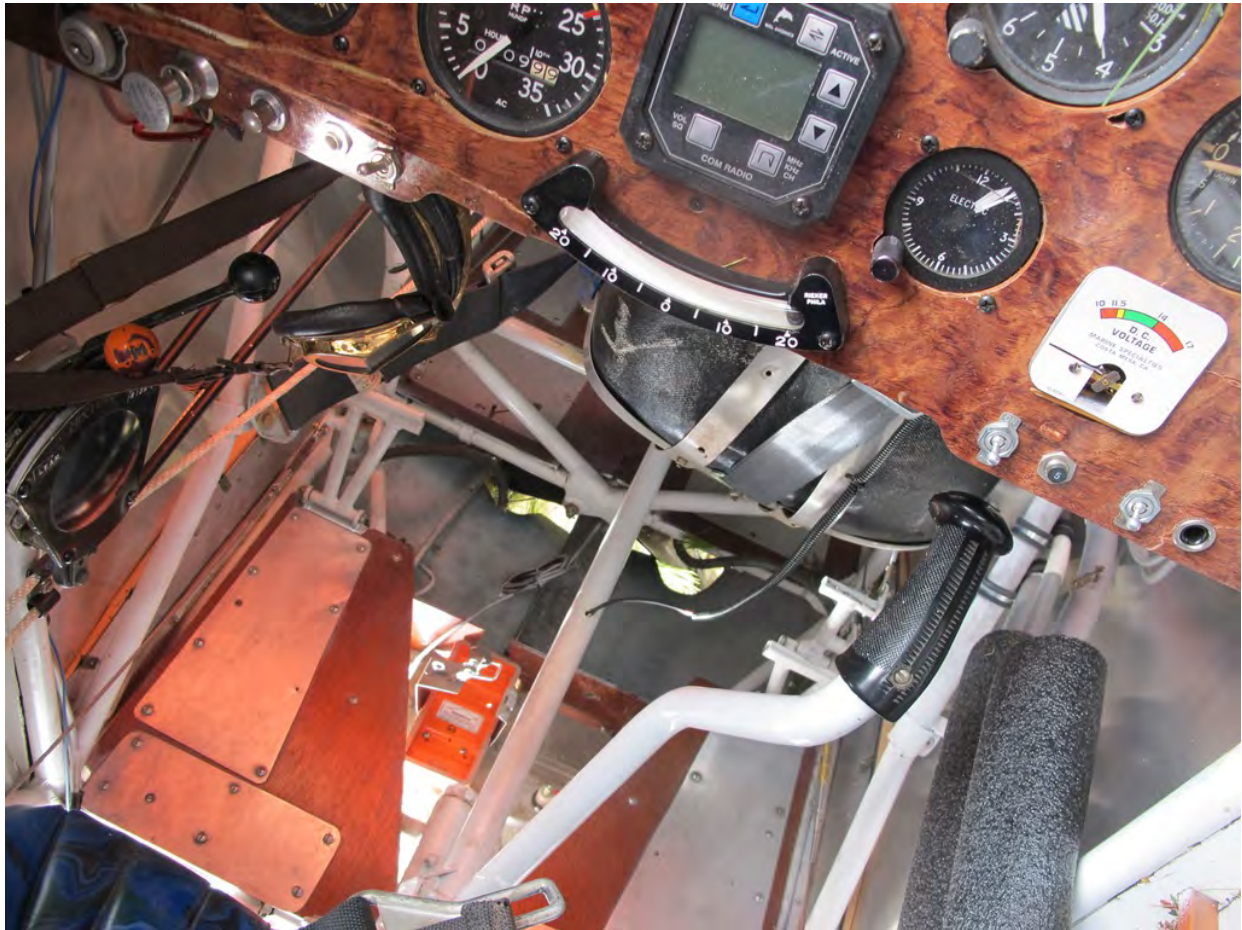
Photo 9 Rear Cockpit

The tachometer read 0109.99.

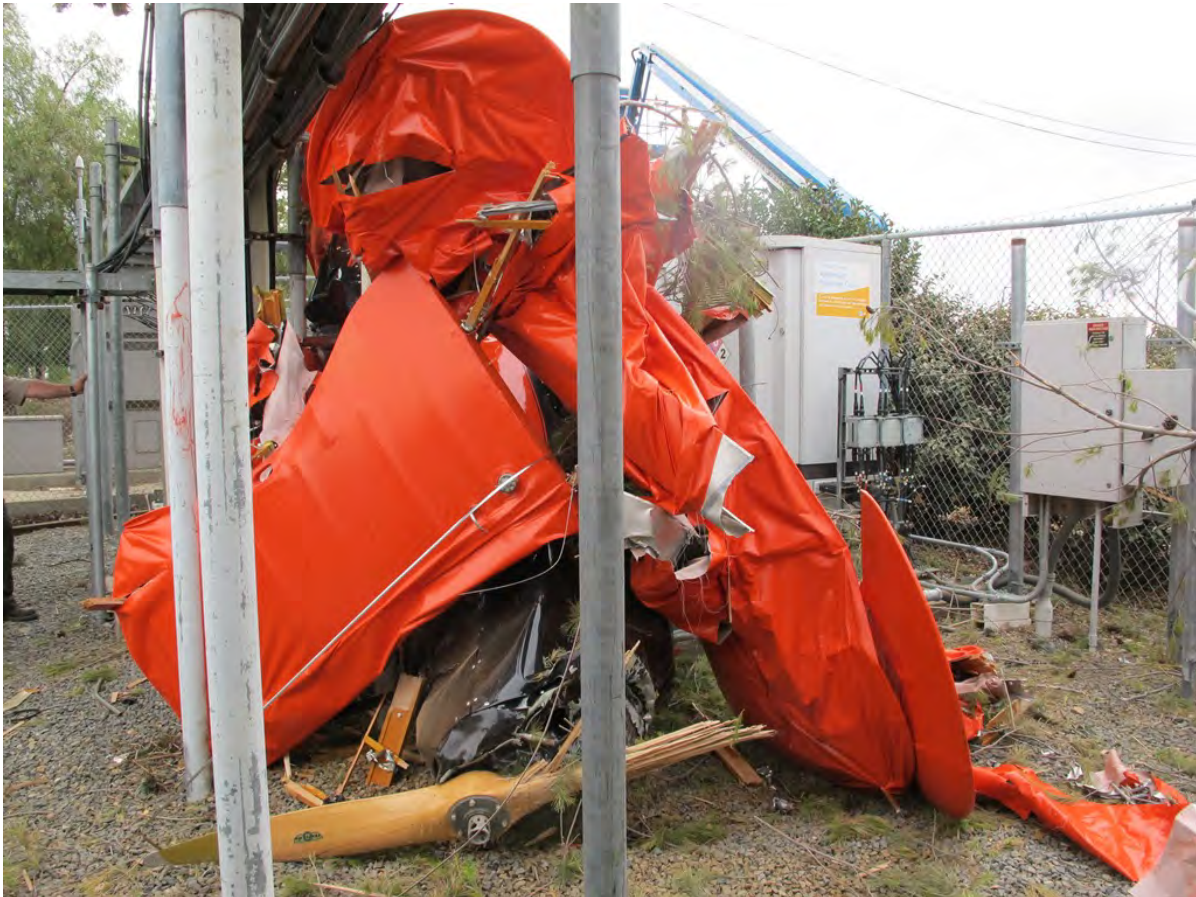
Photo 10 Top View of Wreckage

Both left wings fragmented, and folded onto the fuselage. Both right wings fragmented.

The center of the top wing over the fuselage was oriented with the leading edge about 80 degrees down; the right edge angled about 30 degrees down, and touched the ground. This piece contained the fuel tank, and the filler hole was in the front left. The fuel tank did not appear to be breached. The outboard fuel vent was bent. There was no fuel odor, and no signs of leakage such as stains on the wing or ground. A stick dipped into the tank through the filler port came out dry.

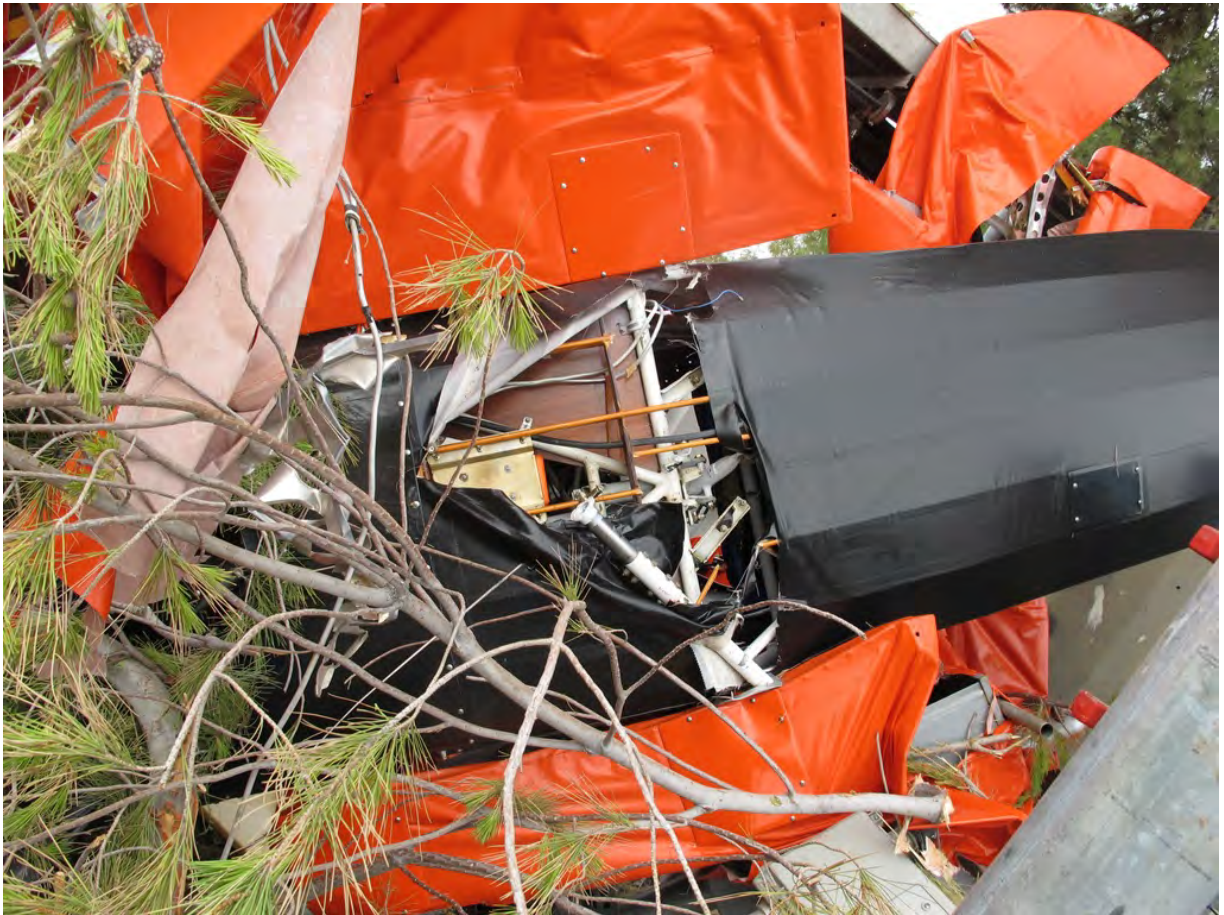
Photo 11 Bottom of Fuselage

The aileron controls ran along the belly of the airplane, and had multiple disconnects. All identified disconnects were along uneven, jagged, and angular planes.

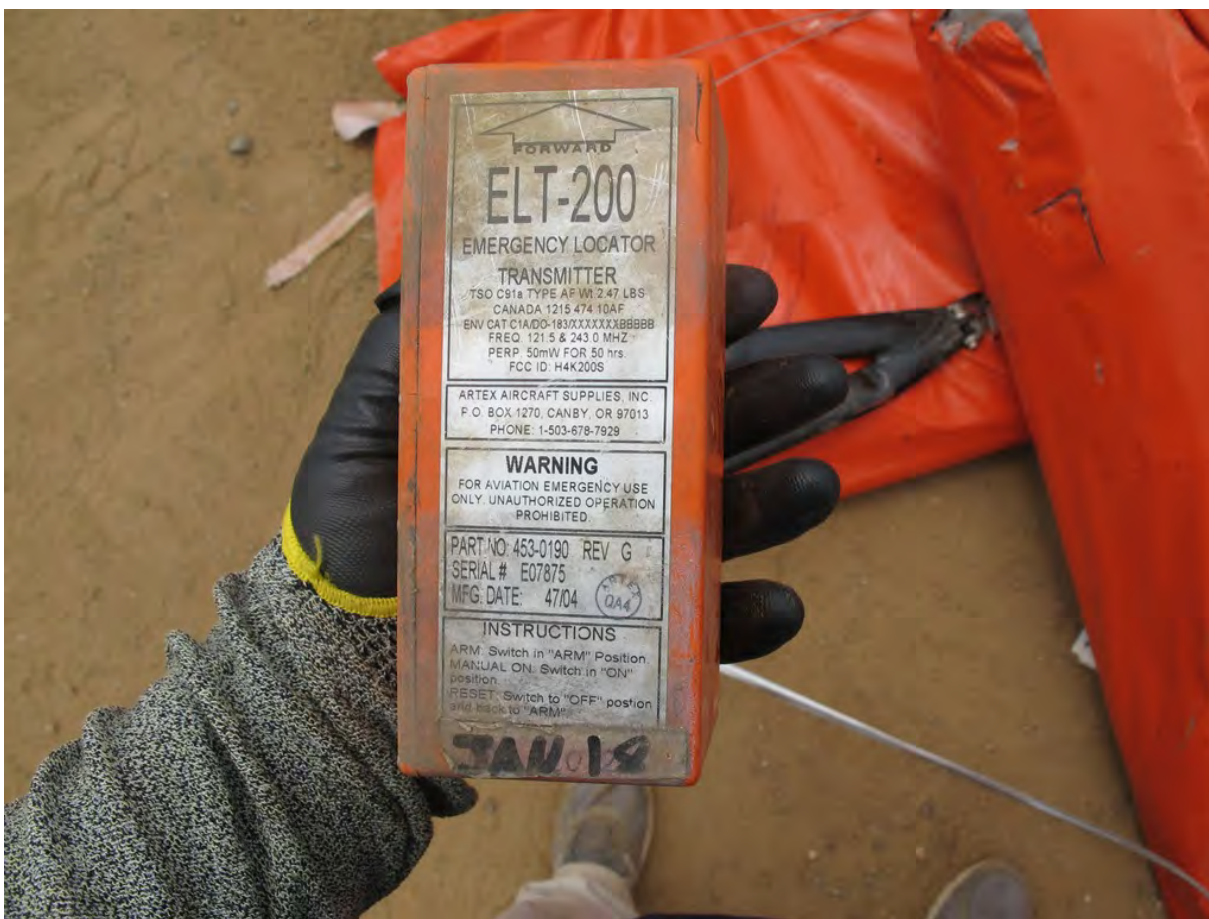
Photo 12 Emergency Locator Transmitter

The Emergency Locator Transmitter (ELT) was an ARTEX Aircraft Supplies Inc. ELT-200, part number 452-0190, serial number E07875, TSO C91a.

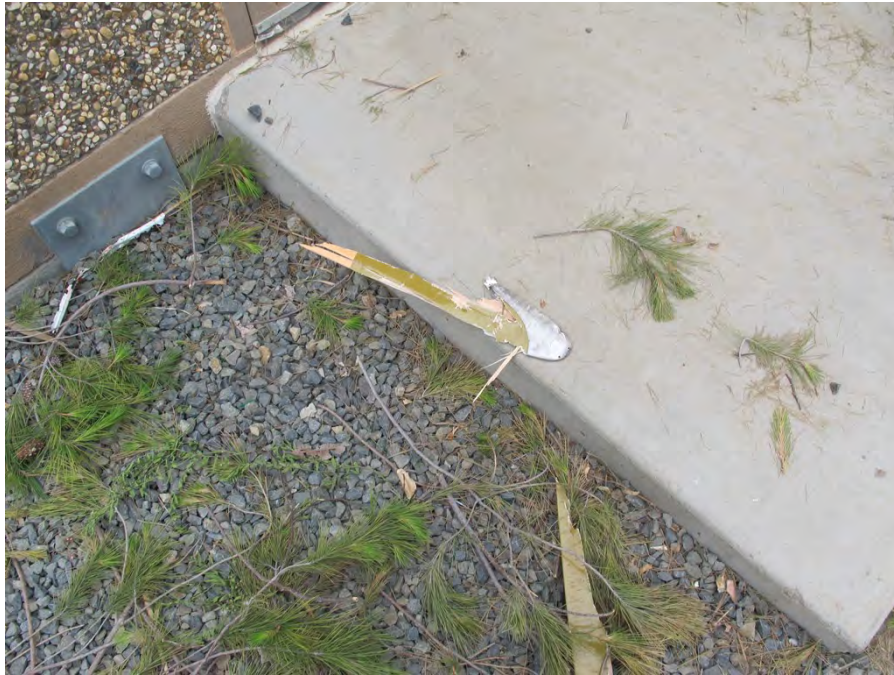
**Photo 13 Separated Blade Tip**

The two-blade wooden propeller remained attached to the engine. One blade splintered near the hub. The separated tip had leading edge dents in the metal sleeve on the leading edge. The other blade had scratches on the cambered side.
