## **NATIONAL TRANSPORTATION SAFETY BOARD**

### **AIRFRAME AND ENGINE EXAM REPORT**

WPR15FA200

Location: Corona, CA  
Date: June 28, 2015  
Aircraft: Great Lakes 2T1A-E, Registration Number: N7LM, Serial #: 1  
NTSB IIC: Howard Plagens

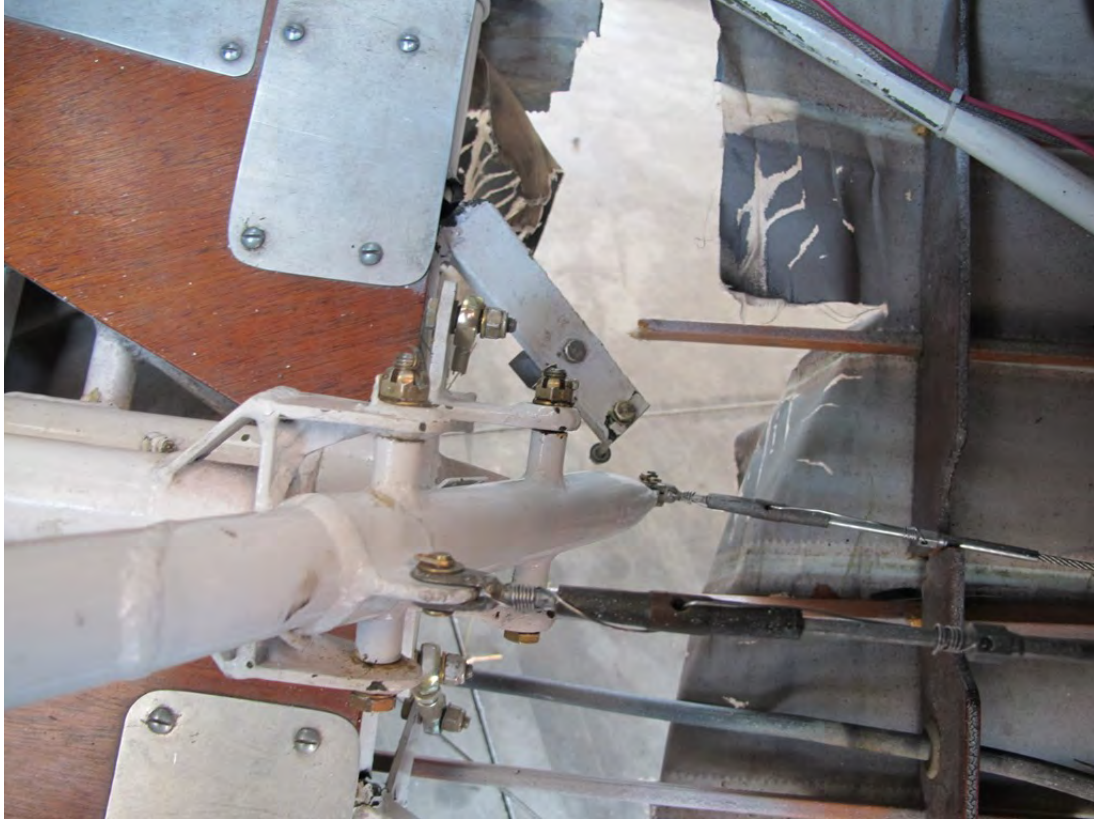
Photo 2 Rear Yoke Flight Control Connections

The aileron and elevator flight control cables and push-pull tubes remained connected to the rear control yoke, which also had an interconnect to the front control yoke. There were multiple disconnects within the aileron control system. All identified fractures on push pull tubes were angular and jagged.

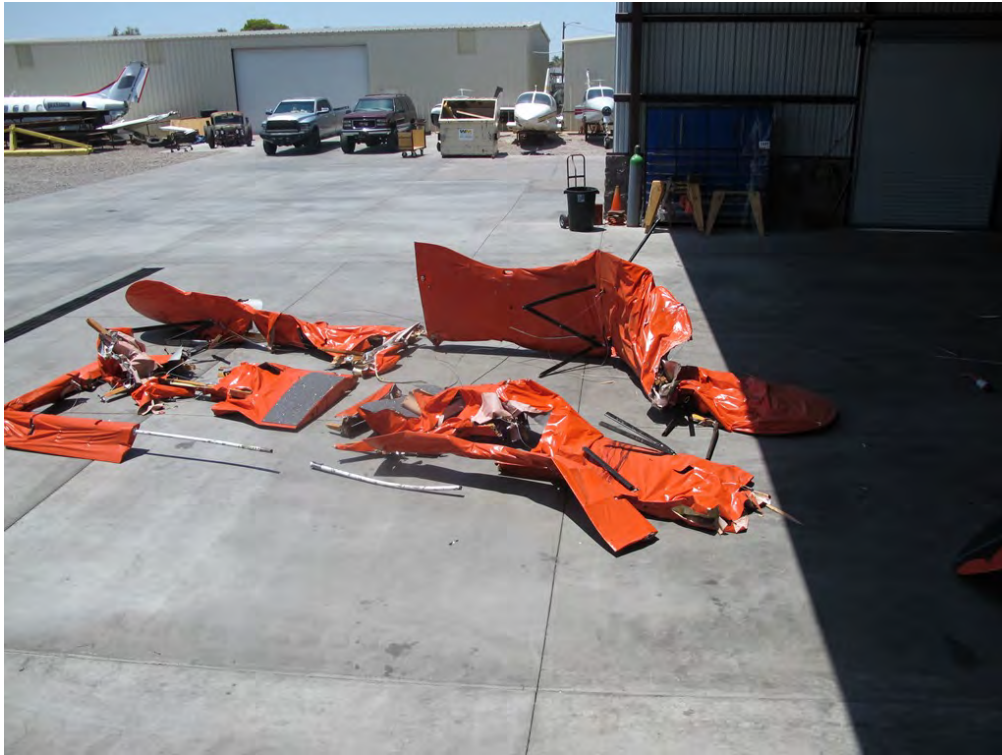
Photo 5 Right Rear View of Wings

The wings were highly fragmented. The tips of all wings were identified, as were both ailerons.

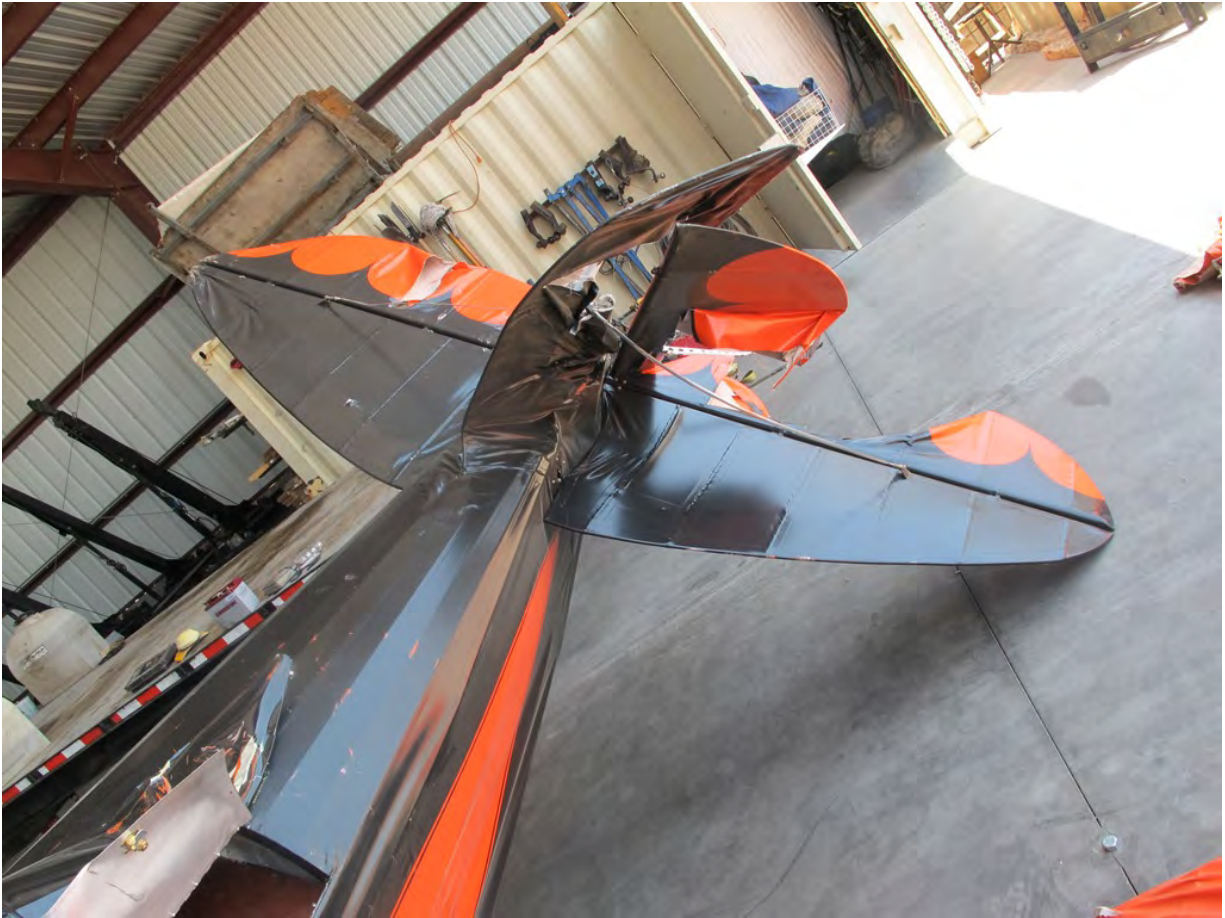
Photo 9 Empennage

The IIC established control continuity for the left and right elevators. The cables for both were connected at the control surface and were continuous to the control yoke. The left elevator is more damaged than the right, and the center section is crushed in a semicircular pattern.

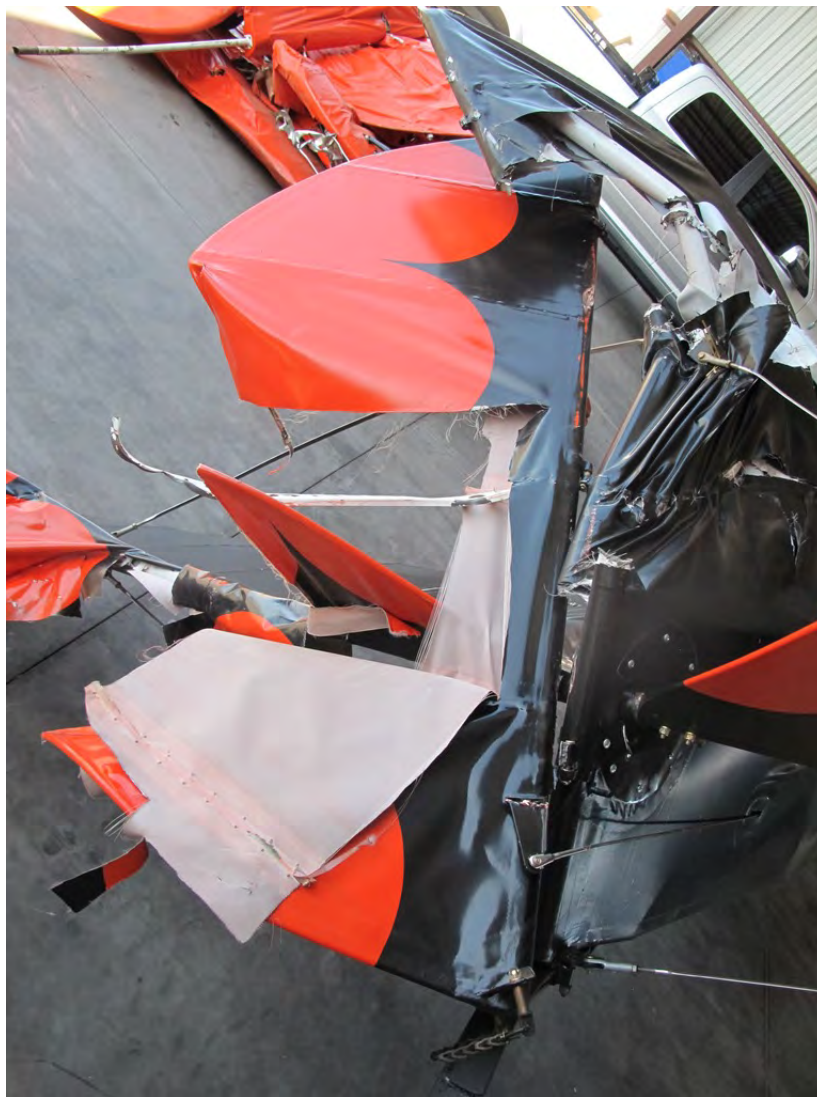
Photo 10 Rudder

The IIC established control continuity for the rudder. The cables for both left and right sides were connected at the control surface, and were continuous to the front and rear pedals.

The top hinge was in an area of heavy crush damage, and was disconnected. The fracture surfaces were angular and jagged. The middle hinge was bent, but connected; the bottom hinge remained in place.

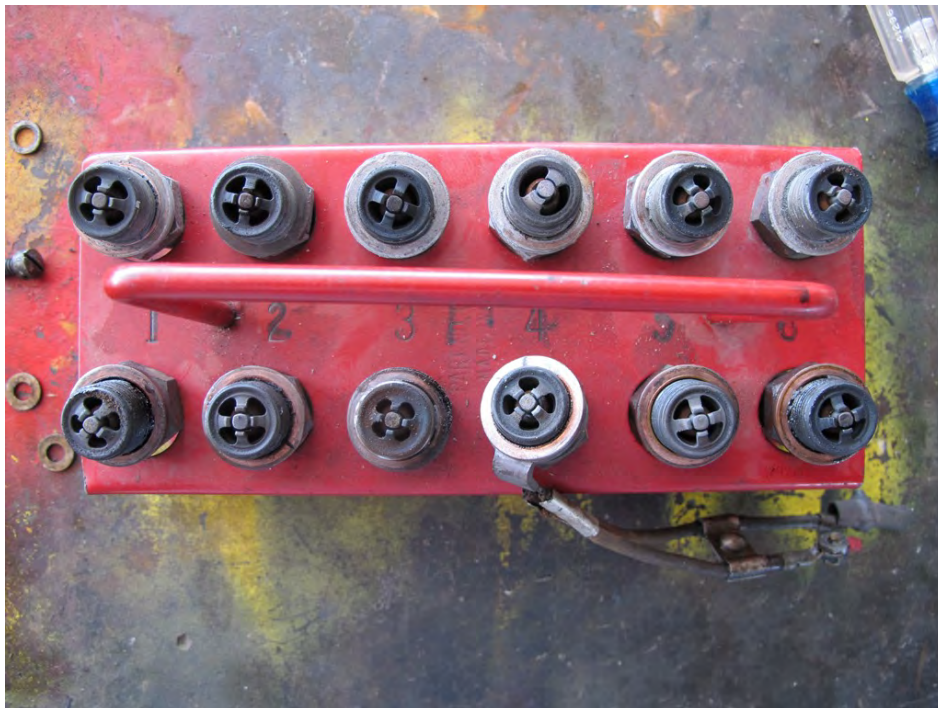
Photo 17 Spark Plugs

The IIC removed the spark plugs. All spark plug center electrodes were circular with no mechanical deformation. All spark plugs had four ground electrodes except cylinder number four on the right side, which had two. The electrodes were gray, which corresponded to normal operation in accordance with the Champion Aviation Check-A-Plug AV-27 chart.

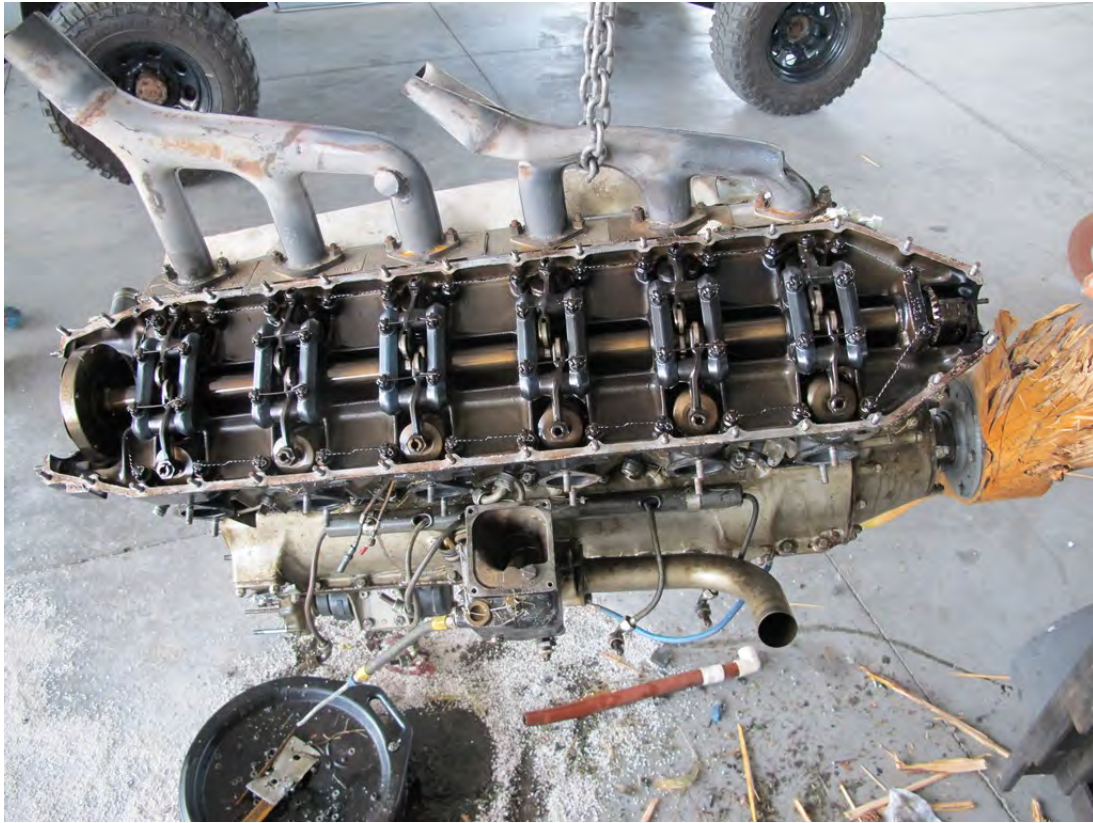
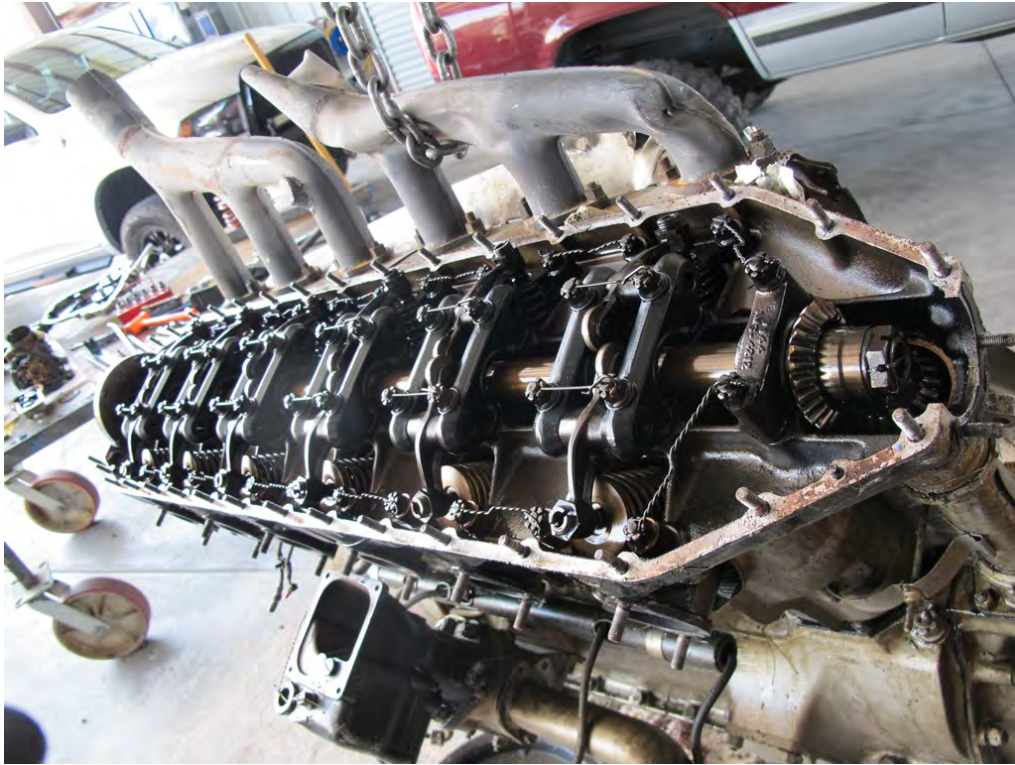
The IIC manually rotated the crankshaft with the propeller. The crankshaft only rotated about 200 degrees. Removal of the alternator, starter, and accessory case did not create any additional travel. The valve cover was removed. Recovery personnel rotated the crankshaft, and the IIC observed movement of the exhaust valves on cylinders one, four, and five. The intake valves on cylinders two and six moved; neither valve moved on cylinder number three.

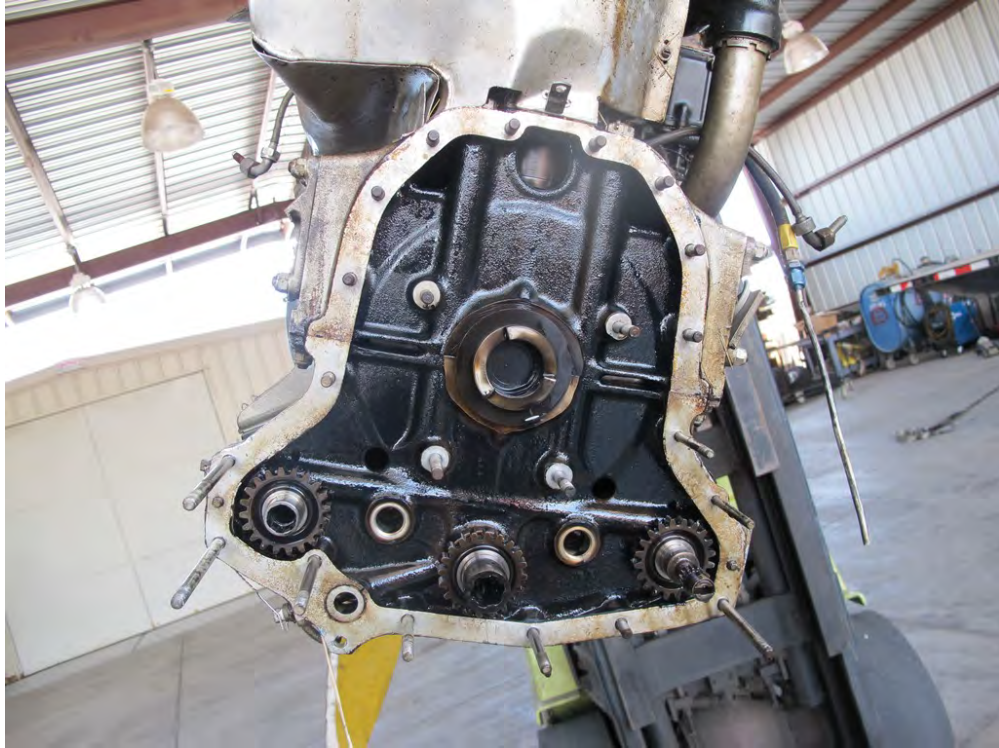
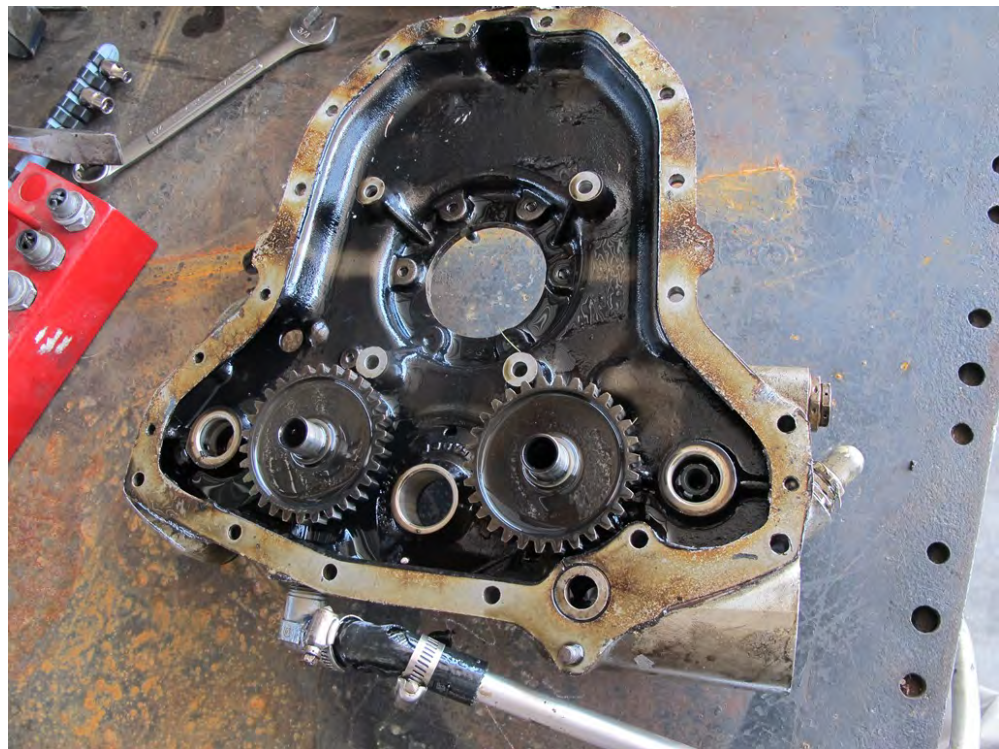
The crankshaft and camshaft gears in the accessory case turned freely.

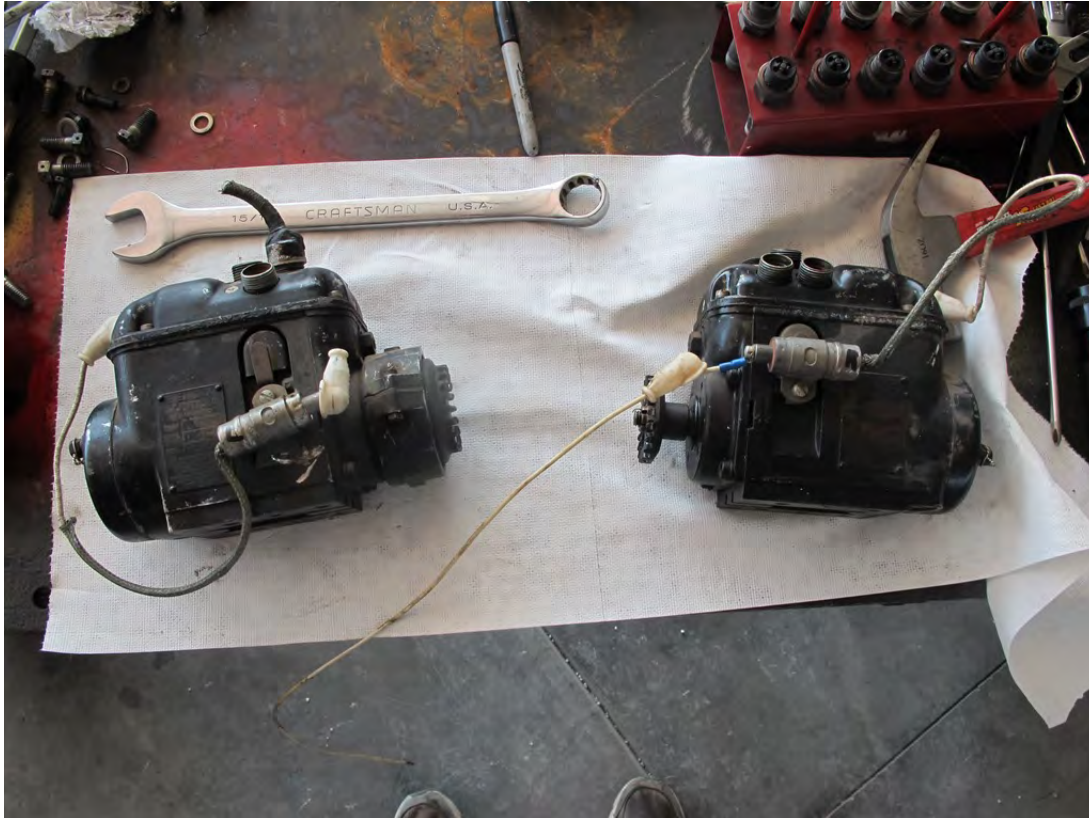
Photo 23 Magnetos

The magnetos were Bendix Scintella models. The IIC manually rotated the magnetos, and obtained spark at all terminals.

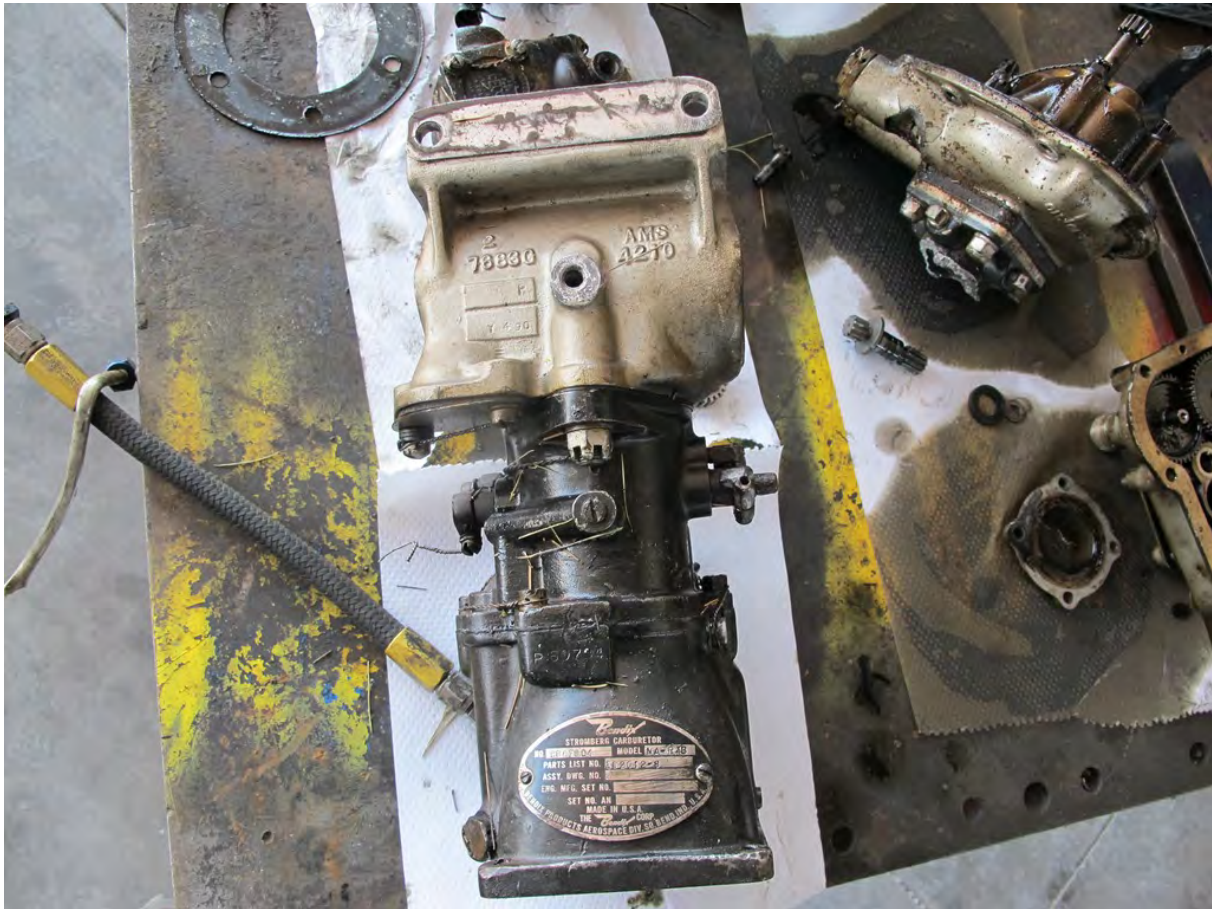
Photo 24 Carburetor

The carburetor was a Bendix Stromberg number 5807804, model NA-R4B, part number 382012-8. The throttle and mixture valves moved freely from stop to stop. The carburetor heat valve was in the open position, and moved freely from stop to stop.

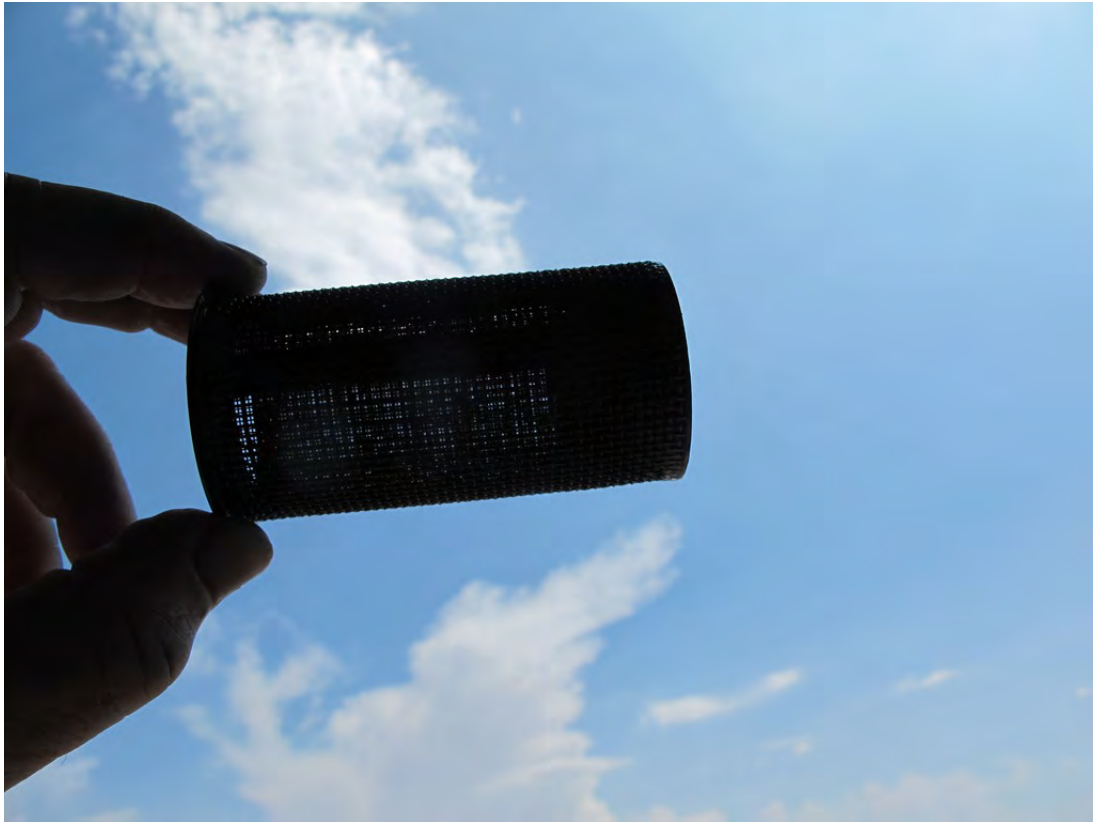
Photo 27 Oil Screen

The oil screen was full of a black clean fluid.

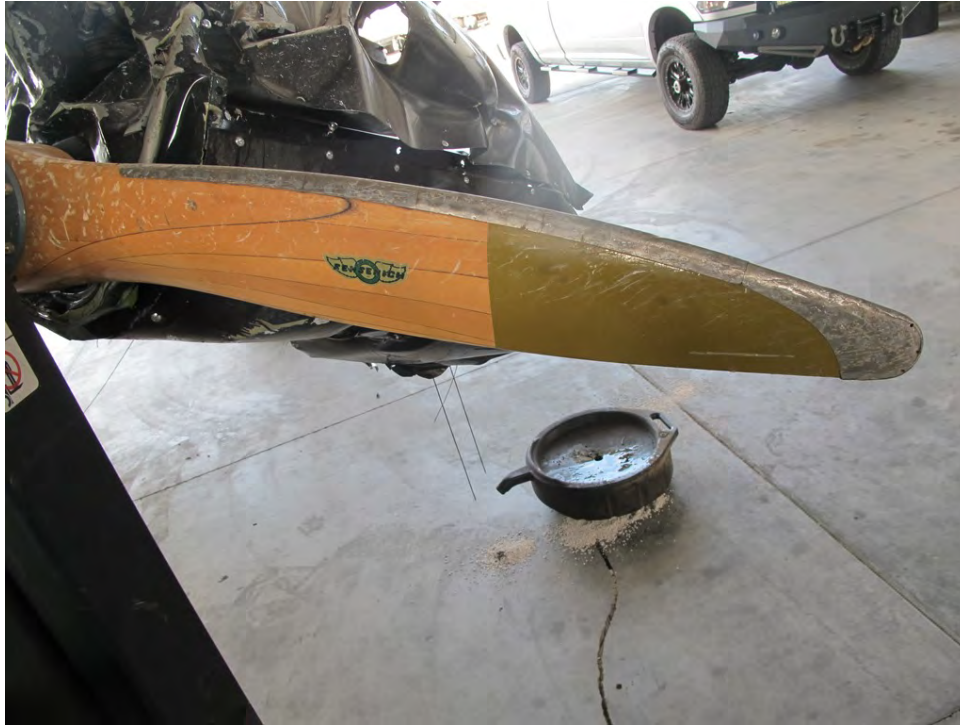
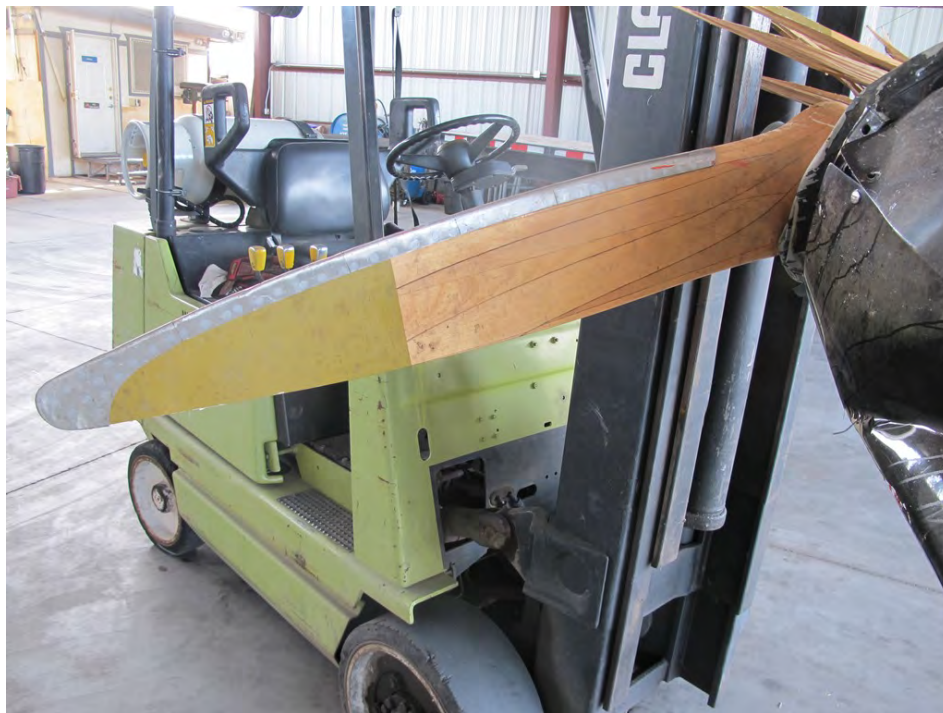
The cambered side of the whole propeller blade had scratches.
