# NATIONAL TRANSPORTATION SAFETY BOARD

MATERIALS LABORATORY FACTUAL REPORT

Report No. 16-060

Place : Newburg, Oregon  
Date : July 1, 2015  
Vehicle : Schweizer 269C  
NTSB No. : WPR15FA205  
Investigator : Thomas M. Little, AS-WPR

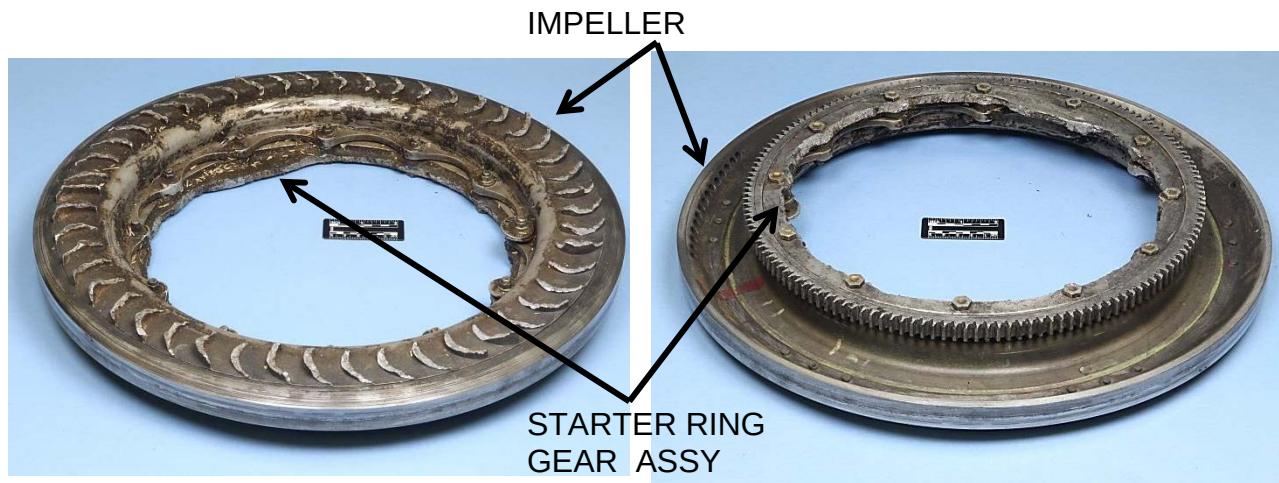
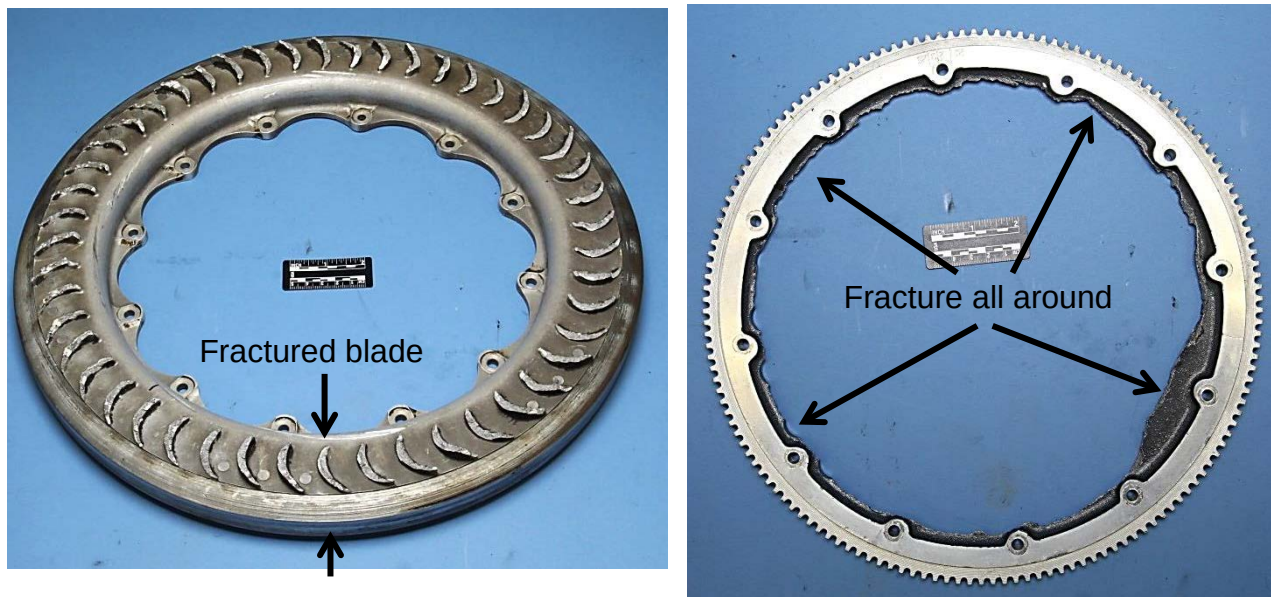
Figure 1. Impeller Schweizer P/N 269A8527 and starter ring gear assembly Lycoming P/N 77579.

The impeller was attached by twelve bolts and nuts to the starter ring gear assembly (see Figure 1). The blades were specified to be made from an aluminum alloy and the starter ring gear specified to be made from steel. A magnet was brought near the two pieces. The magnet was not attracted to the impeller indicating it was non-magnetic, but was attracted to the starter ring gear indicating the starter ring gear was made from a ferrous alloy, such as steel. All the blades on the aluminum fan assembly were fractured at the root portion. The impeller fractured all around the circumference in the areas near the twelve attachment bolts. The two assemblies were cleaned with Alconox detergent and the two assemblies were disassembled from one another (by removal of the bolts). Bench binocular microscope examination of the fracture faces on both assemblies contained a rough texture on a slant fracture consistent with overstress separation, with no evidence of a pre-existing crack, such as a fatigue crack.

As-received impeller (left side of page) that was attached by bolts to the starter ring gear assembly (right side of page).

Disassembled impeller (left) and starter gear assembly (right) after cleaning.

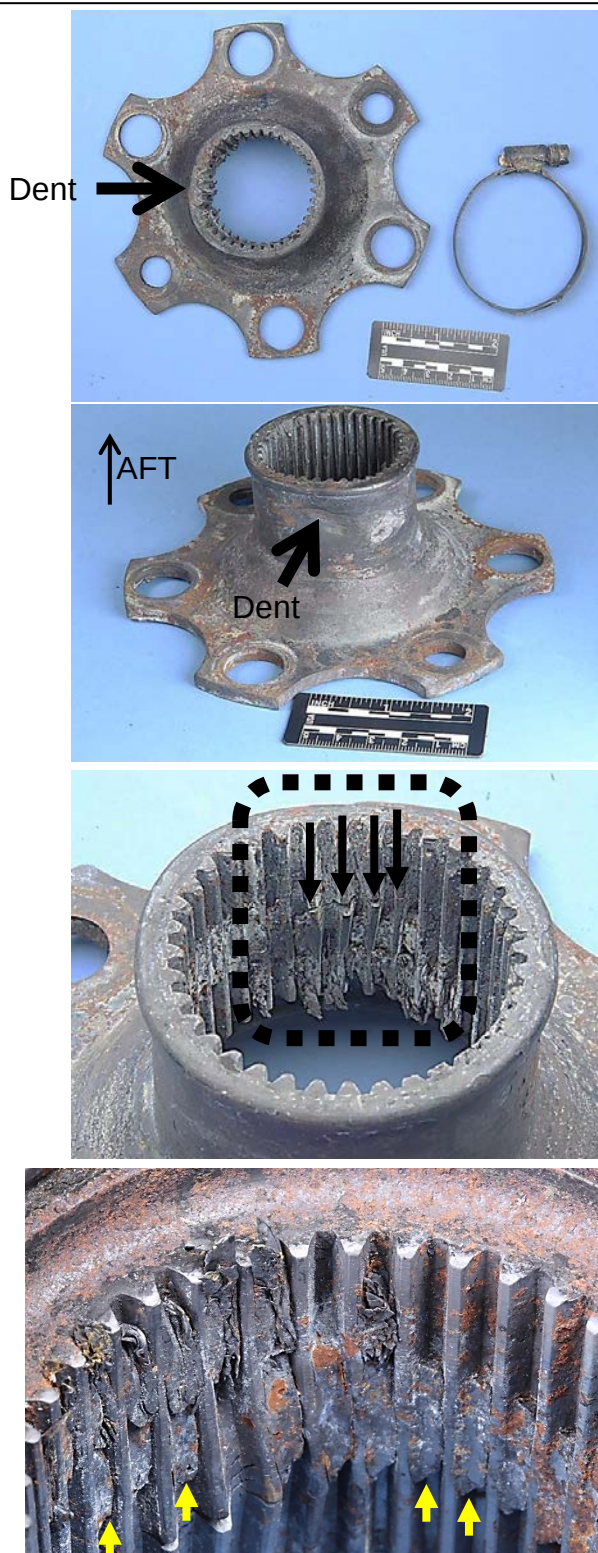
Figure 2. As-received drive adapter Schweizer P/N 269A5411.

The drive adapter is specified to be made from a steel alloy. The surface of the drive adapter contained a blue/gray tint and isolated areas of the adapter contained scale, both conditions are consistent with a steel part that had been exposed to heat, see figure 2. The outer surface contained a dent in the area indicated by an arrow in figure 2. The drive adapter contained an inner spline. Several spline teeth exhibited severe inward deformation and gaping cracks in the general area that corresponded to the dent. The exposed faces of the cracks in the spline exhibited blue/gray tint and was covered with scale. The spline teeth were intact and showed evidence of minor wear. Fragments of the mating spline teeth were found wedged in between the inner spline teeth.

Drive adapter (left side) and clamp (right side) that was secured to the forward rubber grease bolt. The drive adapter contained a dent in the area indicated by an arrow,

Oblique view of the drive adapter showing a dent on the outside surface in the area indicated by an arrow.

Oblique view of the drive adapter showing the inner spline. Several spline teeth exhibited severe inward deformation (within dashed box) and gaping cracks (indicated by arrows) in the general area that corresponded to the dent.

Close-up view of the inner spline showing fragments from the mating spline teeth (several are indicated by arrows).

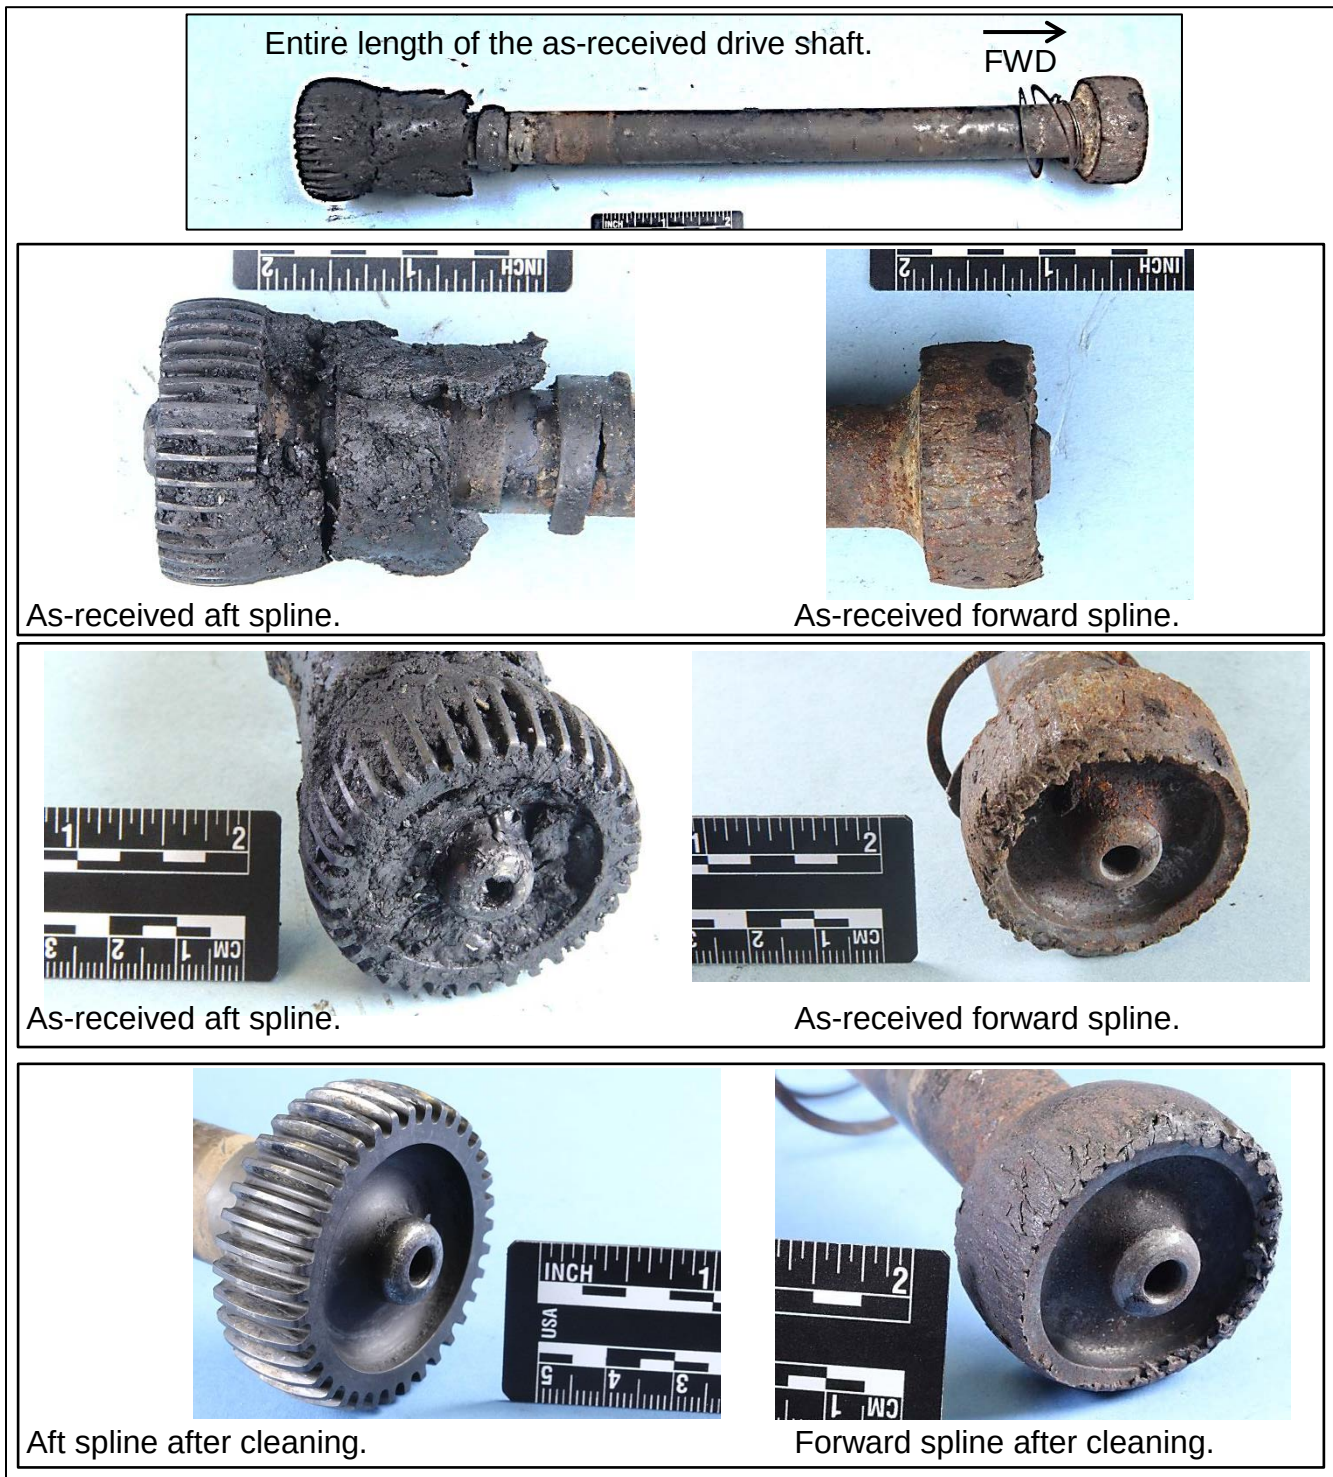
Figure 3. Drive shaft assembly Schweizer P/N 269A5559.

Figure 3 show photographs of the drive shaft assembly before and after cleaning. The drive shaft contained spline teeth on the forward and aft ends. The shaft portion between the forward and aft spline showed evidence of bending deformation. The as-received aft spline was covered with black lubricant (grease) and all the spline teeth were intact. The rubber boot for the aft spline was partially torn, attached to the drive shaft, and covered with black grease. A sample of the black grease was removed from the aft spline prior to cleaning and retained. No further work was performed on the grease sample. The lower portion of figure 3 shows the aft spline after cleaning. The aft spline teeth all around the assembly showed evidence of minor wear.

The forward spline was dry, exhibited a light brown oxide film consistent with iron oxide, with no evidence of grease. The rubber boot (a component that is used to retain grease) was not attached to the forward end. The forward spline exhibited severe wear and deformation damage that extended beyond the root of the spline teeth. The forward and aft ends of the forward spline all around the spline exhibited metal squeeze out (metal flow that extended forward and aft). The root radii between the spline teeth were not visible. The lower portion of figure 3 shows the aft spline after cleaning. A circumferential-radial section was made through the forward spline. The section was made partially through the spline and did not intersect the longitudinal axis. Examination of the section revealed the spline was worn beyond the root of the spline teeth.

Examination of the aft spline revealed all the teeth were intact. The surfaces of the aft spline teeth exhibited minor wear. A circumferential-radial section was made through the intact aft spline. The section was made partially through the spline and did not intersect the longitudinal axis. The prepared section was etched with Nital reagent. Examination of the etched section revealed the core of the shaft contained a microstructure of tempered martensite, typical for a quench and tempered steel, and the surfaces adjacent to the spline teeth contained a darker band consistent with a carburized surface treatment. According to the representative from Sikorsky, the spline teeth are specified to be carburized to a depth between 0.02 inch and 0.04 inch. The

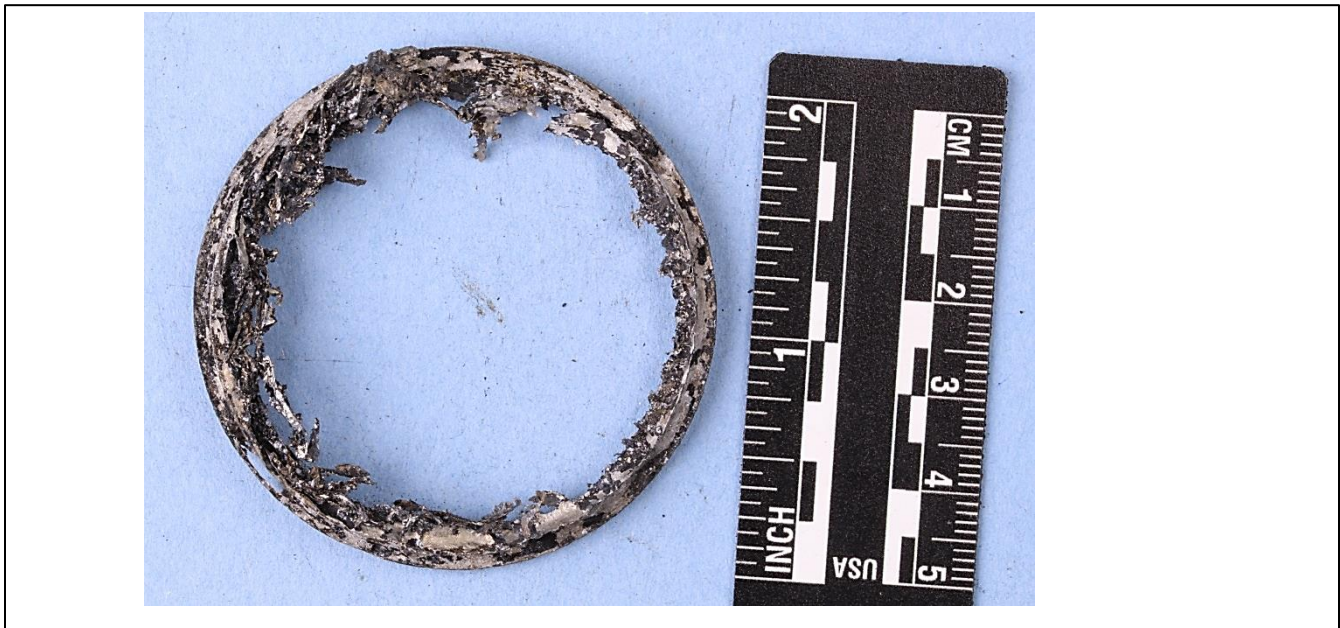
Figure 4 shows a photograph of the remains from the plug (bump stop). The plug is specified to be made from aluminum. A magnet was brought near the plug. The magnet was not attracted to the plug indicating it was non-magnetic. The core portion of the plug was missing but the outer circumferential portion remained intact all around. The circumferential portion of the plug was covered with black deposits; showed no evidence of a fracture feature; and exhibited a smooth surface consistent with an aluminum alloy that had fused and re-solidified.

Figure 4. Remains of the plug (bump stop) Lycoming P/N 77416, which fits between the drive adapter and the engine crankshaft flange.

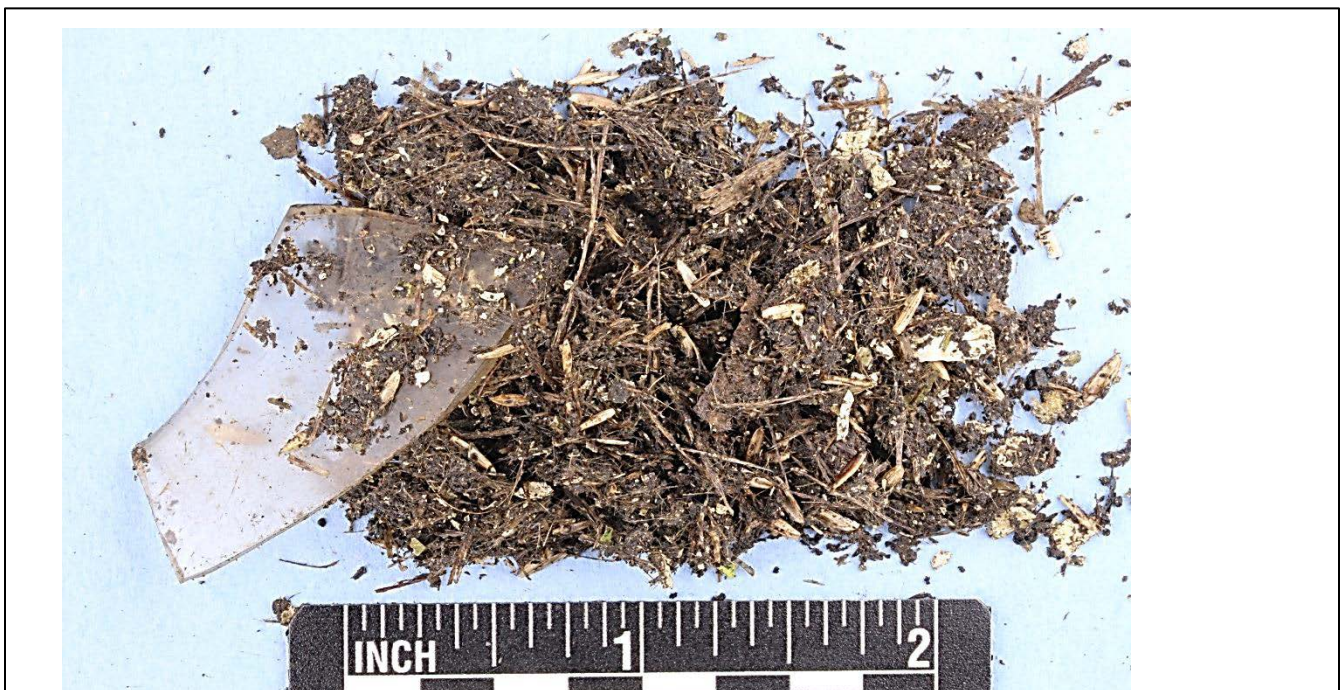
Figure 5 shows a photograph of the as-received grease sample, after it was removed from a plastic bag. Bench binocular microscope examination of the grease sample revealed the grease contained evidence of solid particles (fragments).

Figure 5. As-received grease sample from the engine cooling fan.
