## **NATIONAL TRANSPORTATION SAFETY BOARD**

### **SUMMARY OF HELICOPTER EXAMINATION**

**(WPR15FA205)**

| Aircraft: | Schweizer 269C |

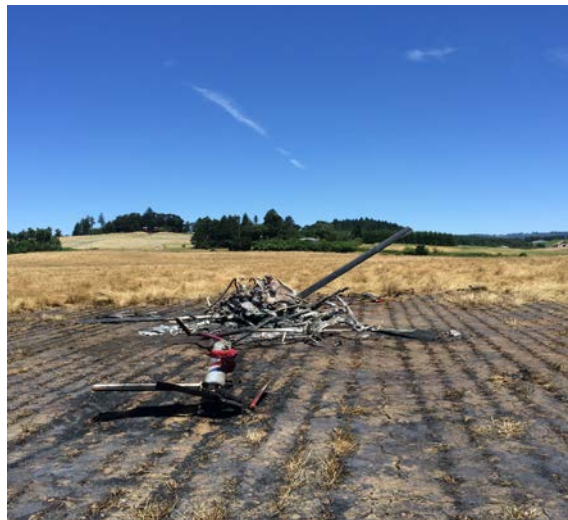
Figure 1 - photo of accident site

The helicopter impacted an open field that was recently harvested on a magnetic heading of about 173 degrees, and came to rest on a magnetic heading of about 355 degrees. The first point of impact was located about 27 feet north of the main wreckage site. A section of the tail rotor drive shaft was located about 90 feet west of the main wreckage. All three main rotor blades (MRB) and the two tail rotor blade (TRB) were observed to have been generating minimal power at the time of impact. All MRB and TRB remained to their respective hubs, with all linkages in place and not observed separated. Minimal trailing edge damage to all rotor blades was observed. The drive pulley belts were not located during the onsite examination. One forward skid was located about 25 feet south of the main wreckage. The tail boom had separated and was located about 5 feet south of the main wreckage, oriented on a north/south direction. The main rotor assembly remained attached to the main rotor mast, with all linkages observed attached. The mast-to-transmission was observed separated.

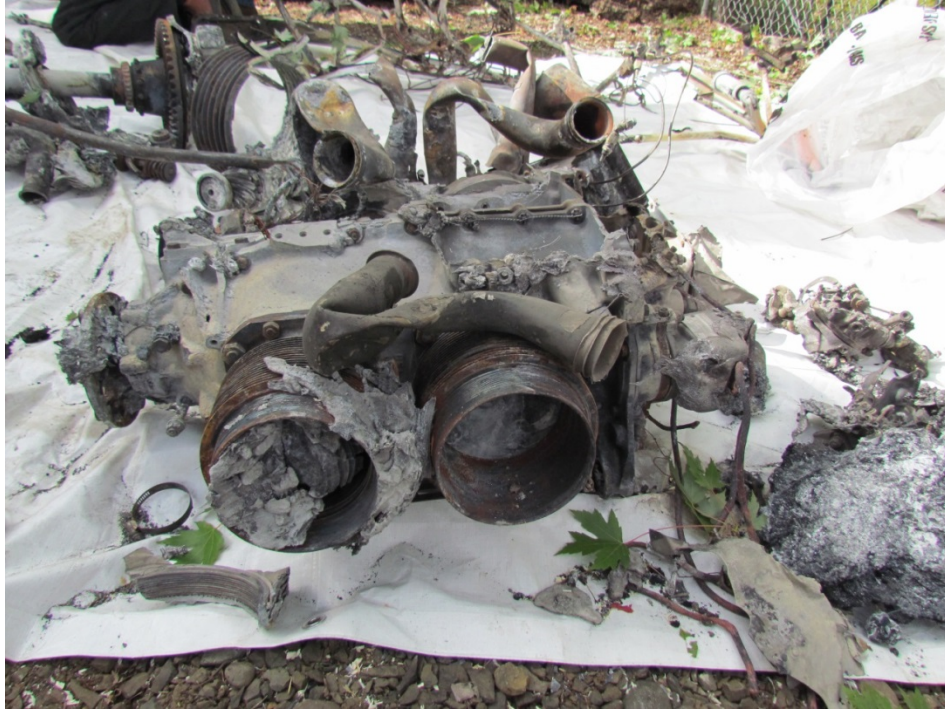
The number 1 and 3 cylinder heads and oil sump were consumed by fire. The rear accessory case was deformed and partially consumed by fire. The engine case was deformed by heat. Both magnetos were partially consumed by fire and deformed. The fuel servo was also consumed by fire. The starter ring gear support center was broken apart. The attached fan blades were broken off. And the edge of the fan blade disk showed signs of rotation at impact.

The engine to airframe drive coupler shaft splines were found sheared off and ground down on the engine side. The engine drive adapter splines contained the sheared off spline from the shaft and also had damaged splines.

No evidence was found of a catastrophic in flight engine failure.

Figure 2 - photo 1 of engine

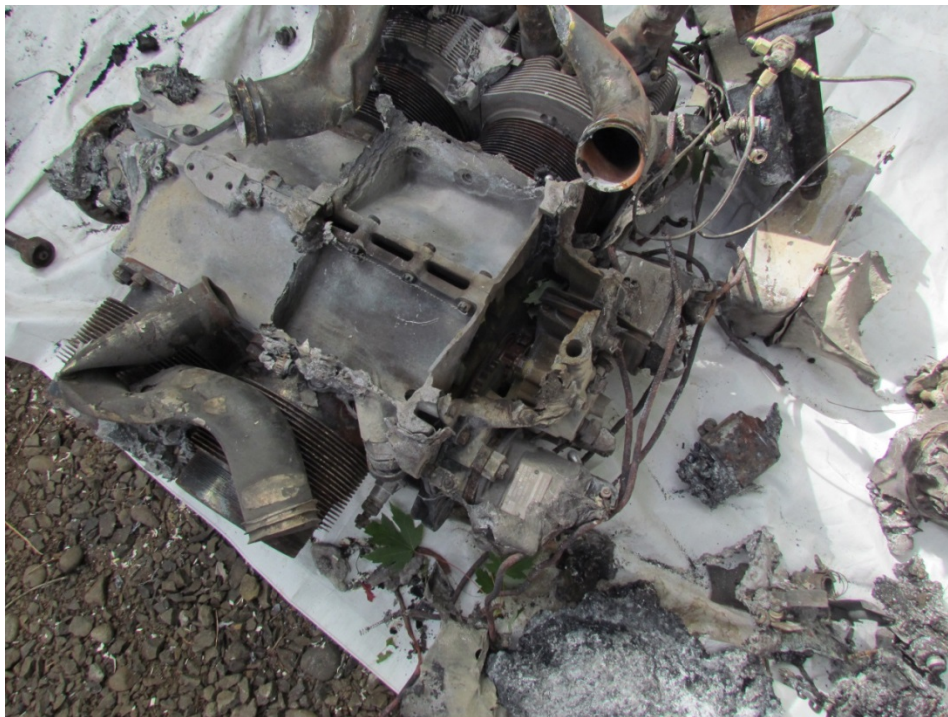
Figure 3 - photo 2 of engine
