## **NATIONAL TRANSPORTATION SAFETY BOARD**

### **AIRFRAME AND ENGINE EXAM REPORT**

WPR15FA206

Location: Carey, ID  
Date: July 2, 2015  
Aircraft: Piper PA22-135; Registration Number: N8195C, Serial #: 22-2300  
NTSB IIC: Howard Plagens

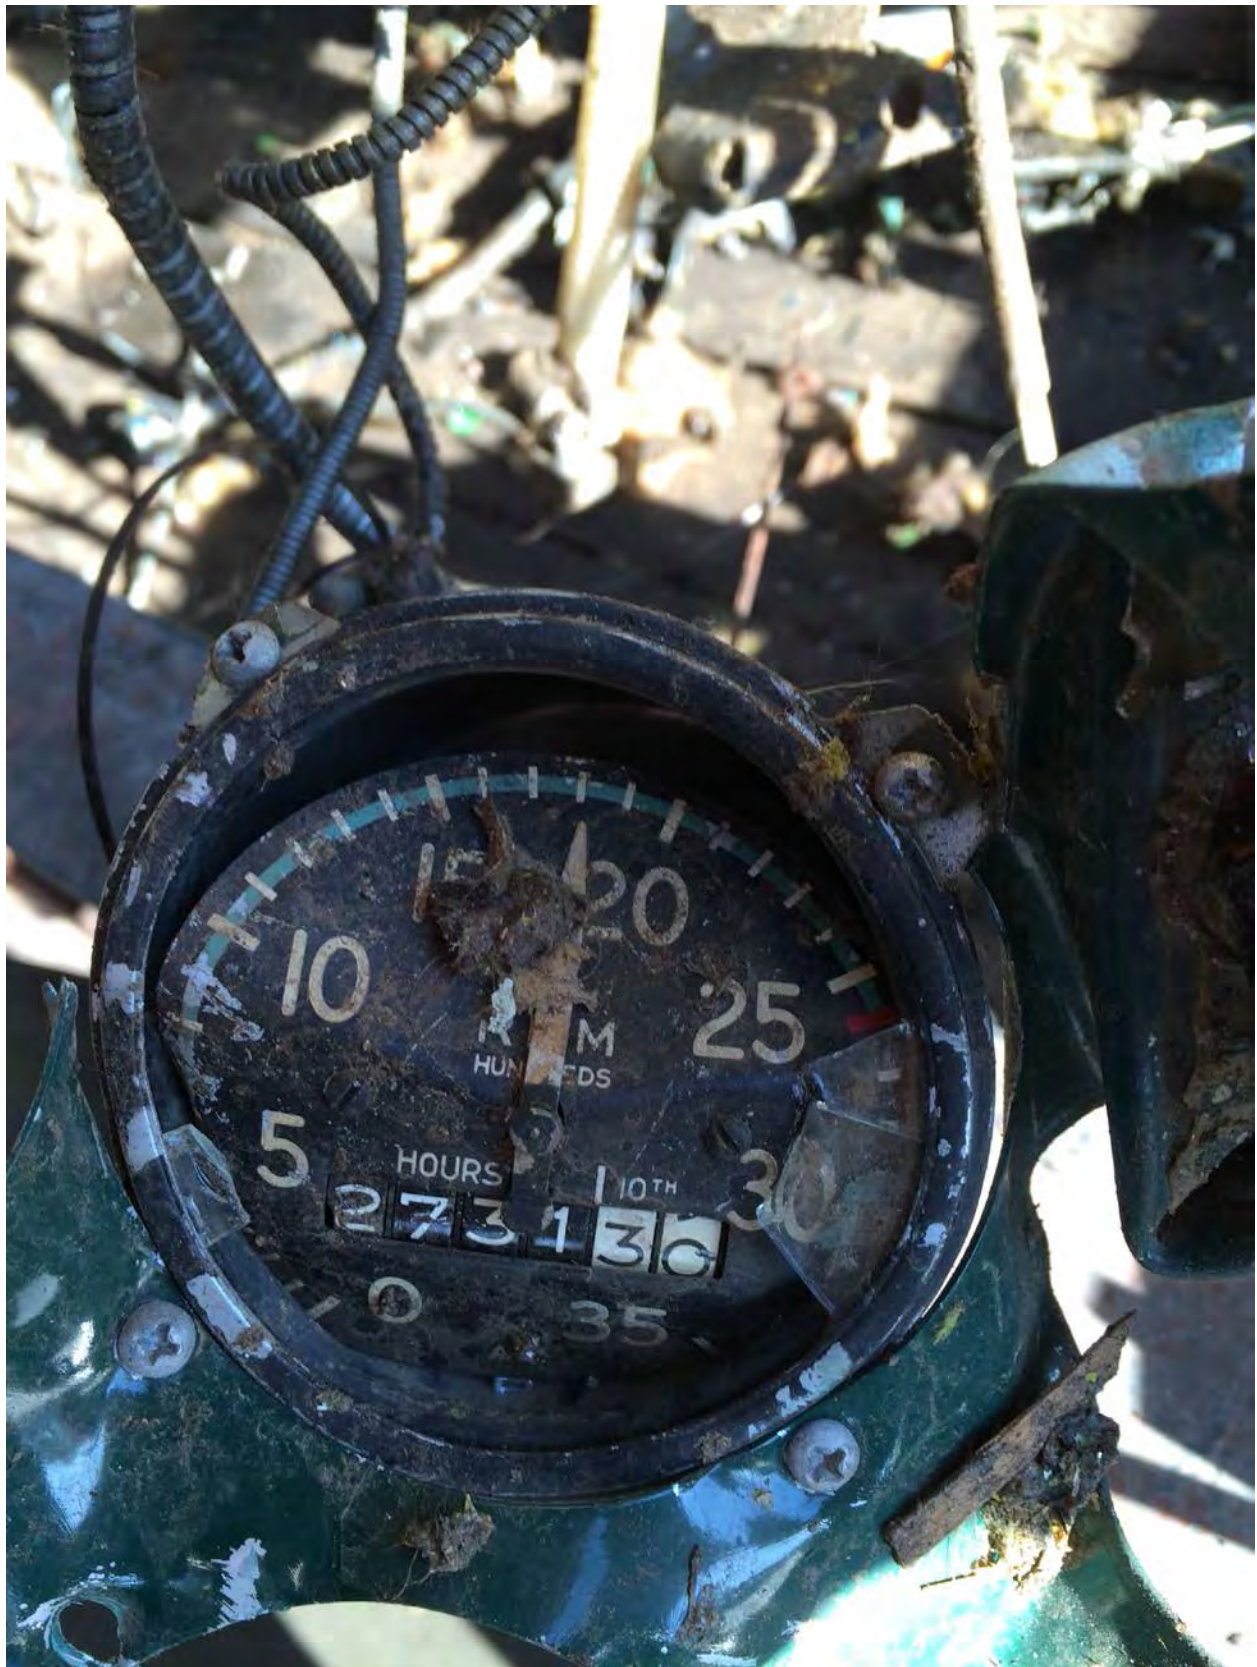
*Figure 1 Tachometer*

The fuselage sustained heavy crush damage with the forward cockpit and instrument panel mostly separated from the center fuselage section. The tachometer separated from the instrument panel, and sustained crush damage; the hour meter read 2,731.30, and the needle was trapped at 1,800 rpm.

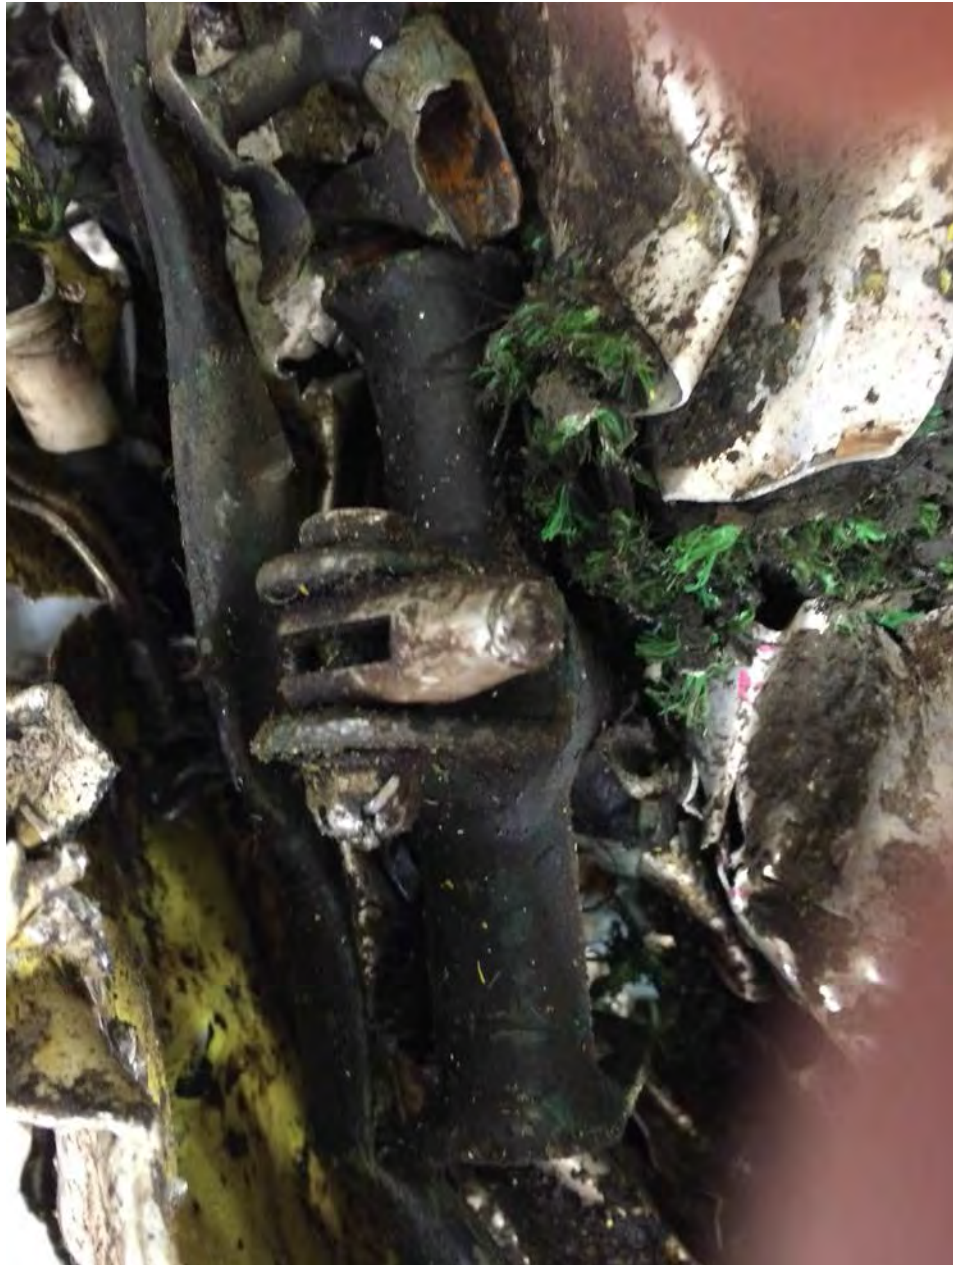
*Figure 5 Elevator Push-Pull Tube Rod End at T-bar*

The elevator push-pull tube rod end remained attached to the T-bar, but fractured and separated at the last thread. The rod assembly was bent, and the fracture surface was angular. The push pull tube remained attached to the elevator bellcrank, and the elevator control cables were also attached to the bellcrank.

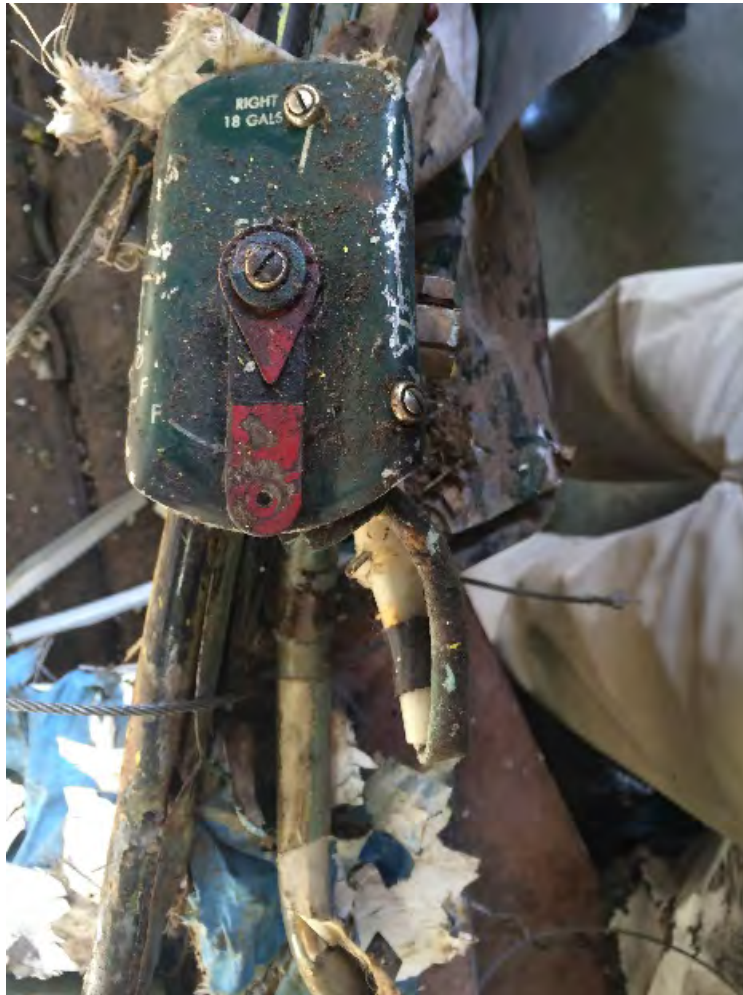
*Figure 8 Fuel Selector Valve*

The fuel selector valve (FSV) was attached to its mounting bracket, which separated from the fuselage. The FSV cover plate was loose on the FSV, and the cover was bent and trapped in a position that had the pointer in line with the lower OFF position. Air could not be blown through the FSV. Visually, the FSV was in the OFF position. Investigators moved the FSV freely through various detents, and heard a positive click at the OFF, LEFT MAIN, and RIGHT MAIN positions. Air blown into the FSV passed through the left and right port to the engine port.

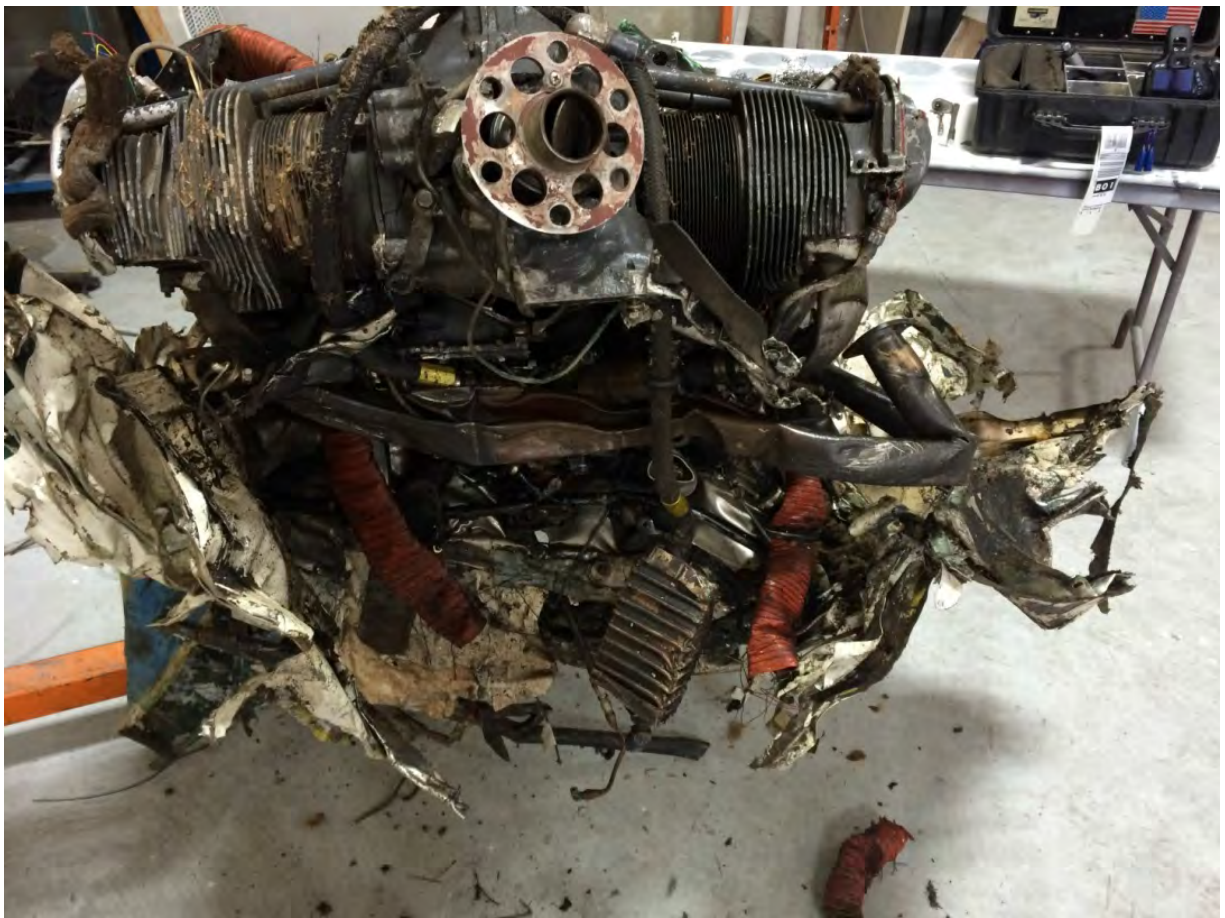
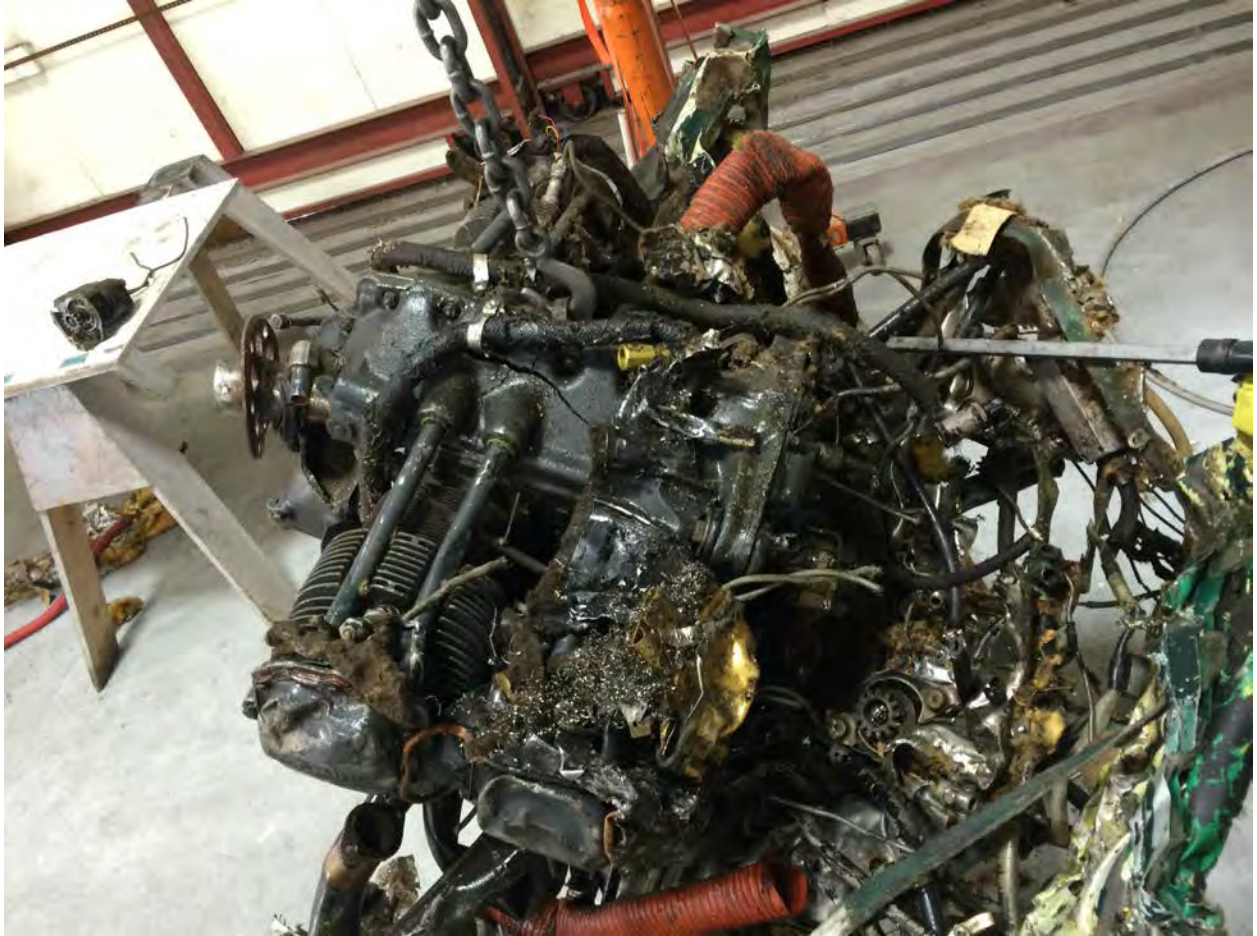
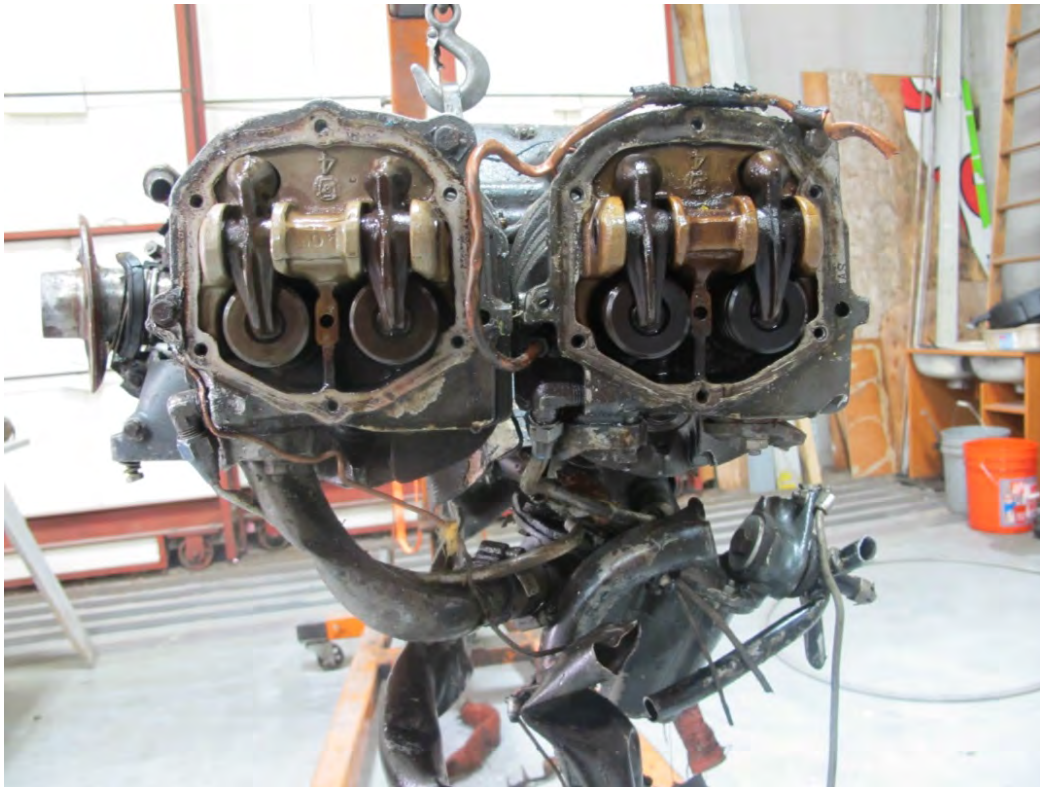
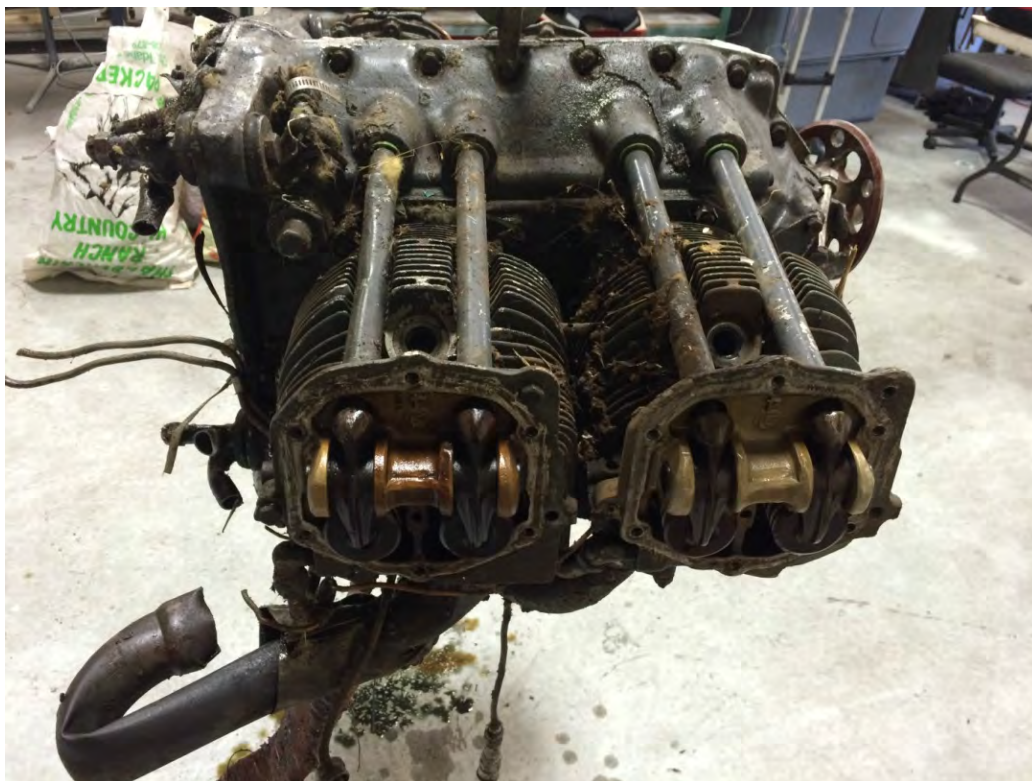
The engine remained attached to the fuselage by the engine mount assembly, and sustained extensive crush damage. The crankshaft angled left, and lower portions of the crankcase separated.

The crankshaft would not rotate; the front of the engine sustained aft crush damage, and portions of the crankcase were missing at the front of cylinder number two. The right side cylinders (one and three) had dirt debris impacted on the fins, and the front of the crankshaft with the propeller flange was bent to the left toward cylinder number two. The bottom of the crankcase had material missing, which allowed visual examination of the camshaft; the lobes were unremarkable. Mechanical continuity of the rotating components was established visually during partial disassembly of the engine.

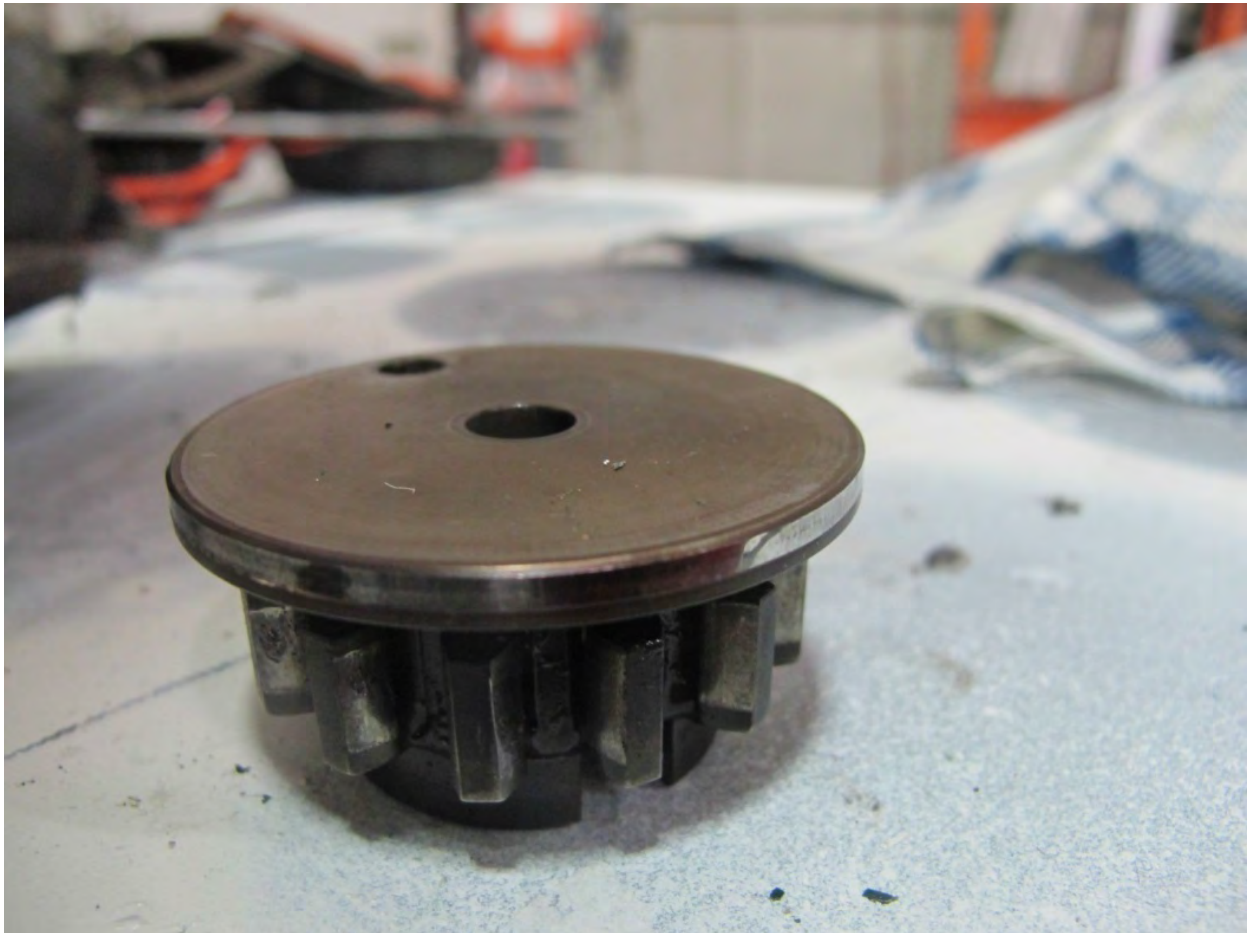
*Figure 14 Crankshaft Gear*

Examination of the crankshaft gear revealed that it was loose within the counter bore of the crankshaft. The locking ring was bent along the edge of the hex head bolt; however, a portion of the bolt locking tab that engages the crank gear was missing. Close examination of the gear counter bore circumference mating surface revealed significant fretting signatures. The edge was shiny. There was no mechanical disconnect of the interface. The engine manufacturer's investigator opined that the fretting had been occurring over a long period of time, and if uncorrected, the condition would eventually lead to a loss of engine power.

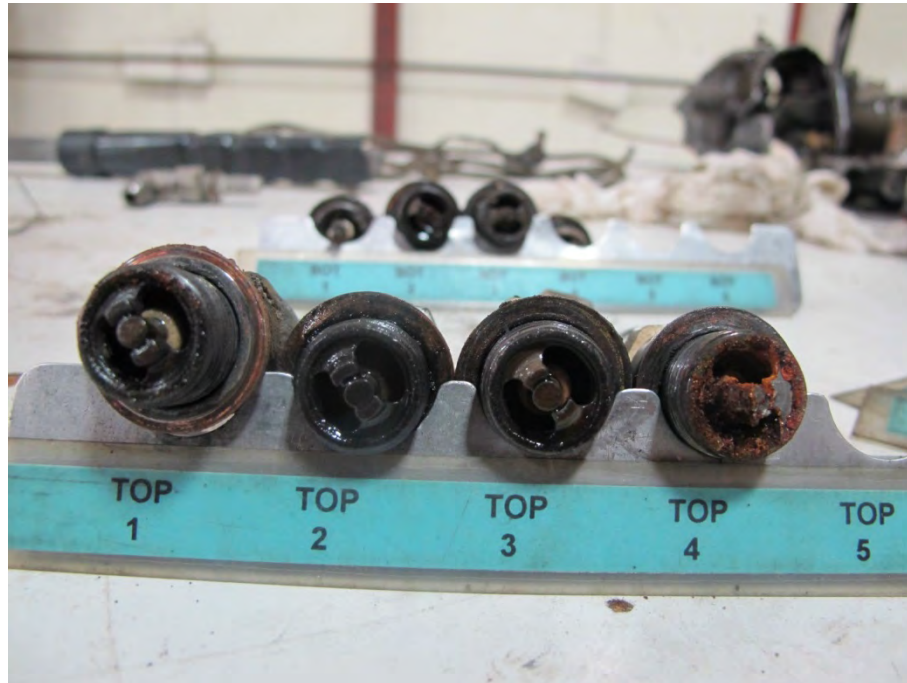
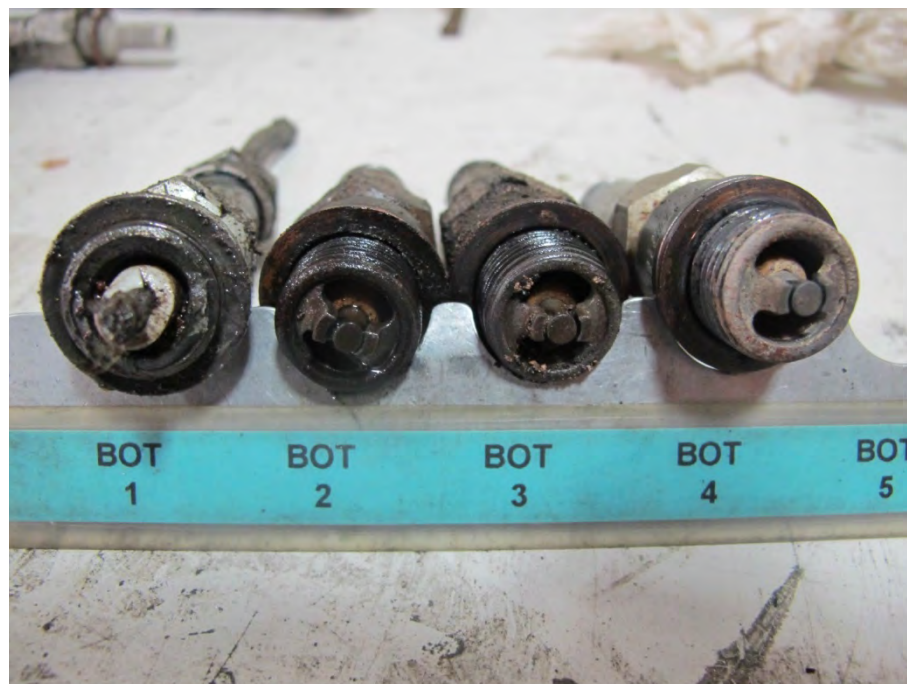
Investigators removed the spark plugs, which were Champion REM-40E. The bottom plug for cylinder number one was damaged. All center electrodes were nearly circular with no mechanical deformation. The spark plug electrodes were moist due to the position of the engine at the site and post recovery. The number four top plug, which had been exposed to the elements at the site and post recovery, was rusty.

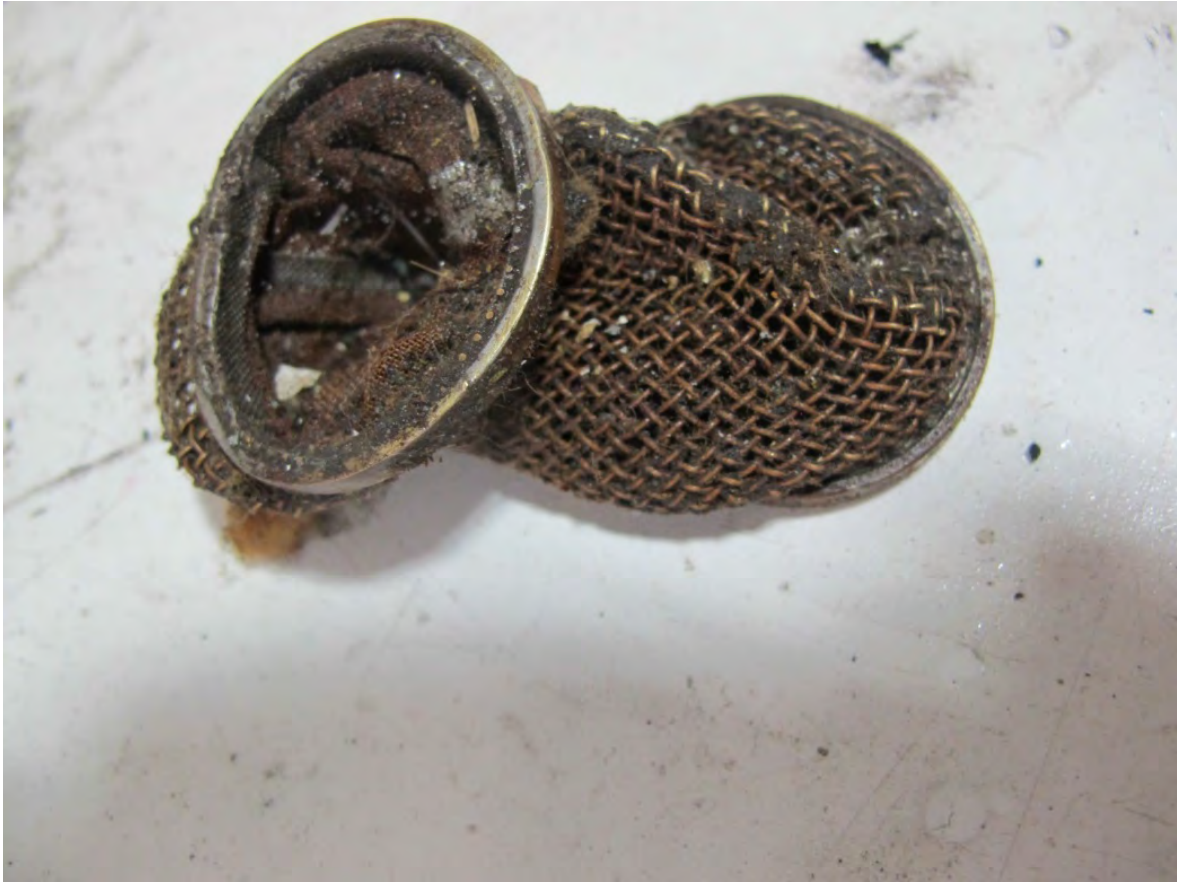
*Figure 17 Oil Screen*

The oil sump had material missing. The oil suction screen was not contaminated. The oil filter pressure screen separated, and was not identified.

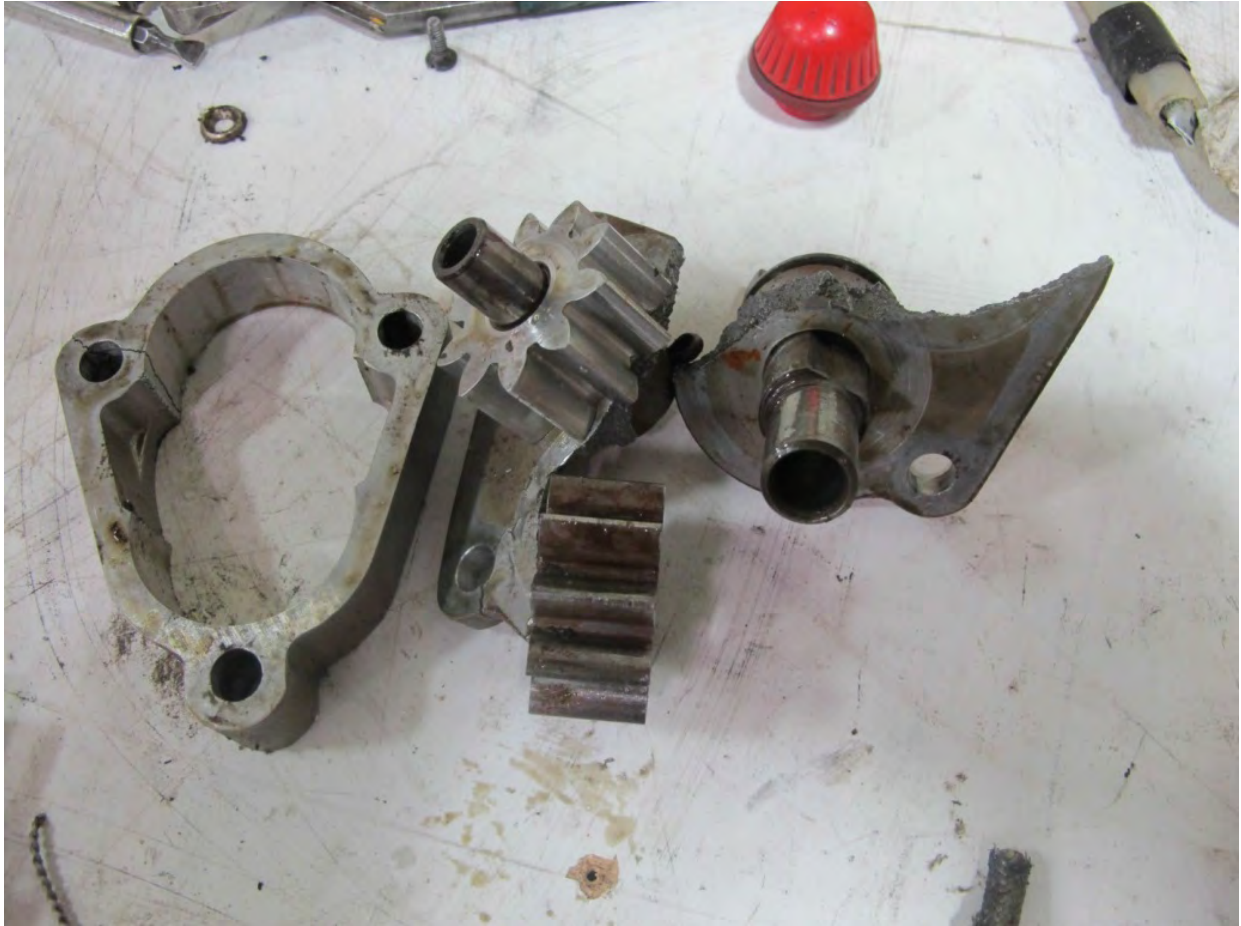
*Figure 18 Oil Pump*

Disassembly of the oil pump revealed no anomalies.

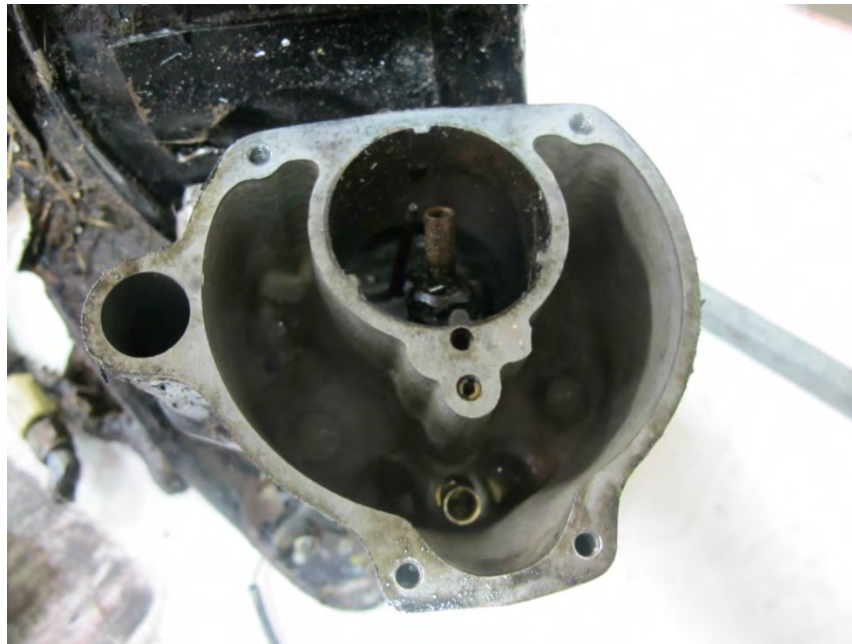
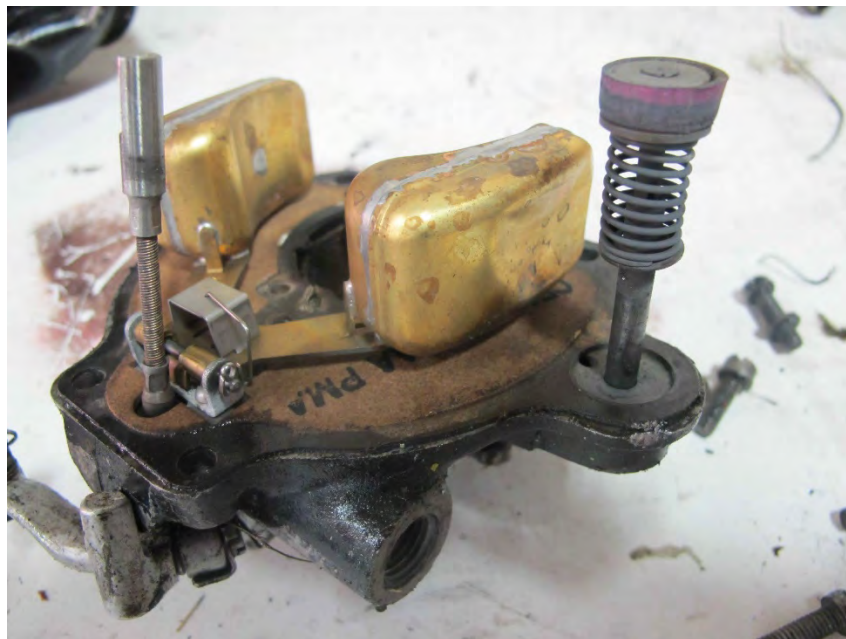
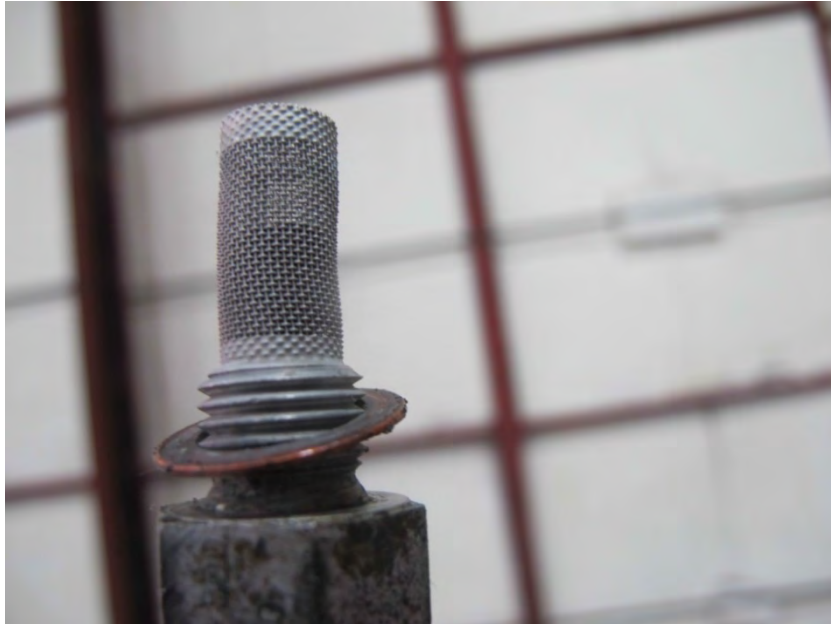
The carburetor was displaced from the engine, but the portion that remained attached to the engine was secure. Investigators disassembled the carburetor. The floats were metal, and remained secure at the mounting; they exhibited hydraulic crush damage with the right float showing more deformation than the left. A small amount of fluid that smelled like automotive fuel was in the float bowl, but no contaminants were observed. The throttle and mixture controls were securely attached to their respective operating arms on the carburetor. The fuel inlet filter screen contained visible contaminants, but there was no flow blockage.

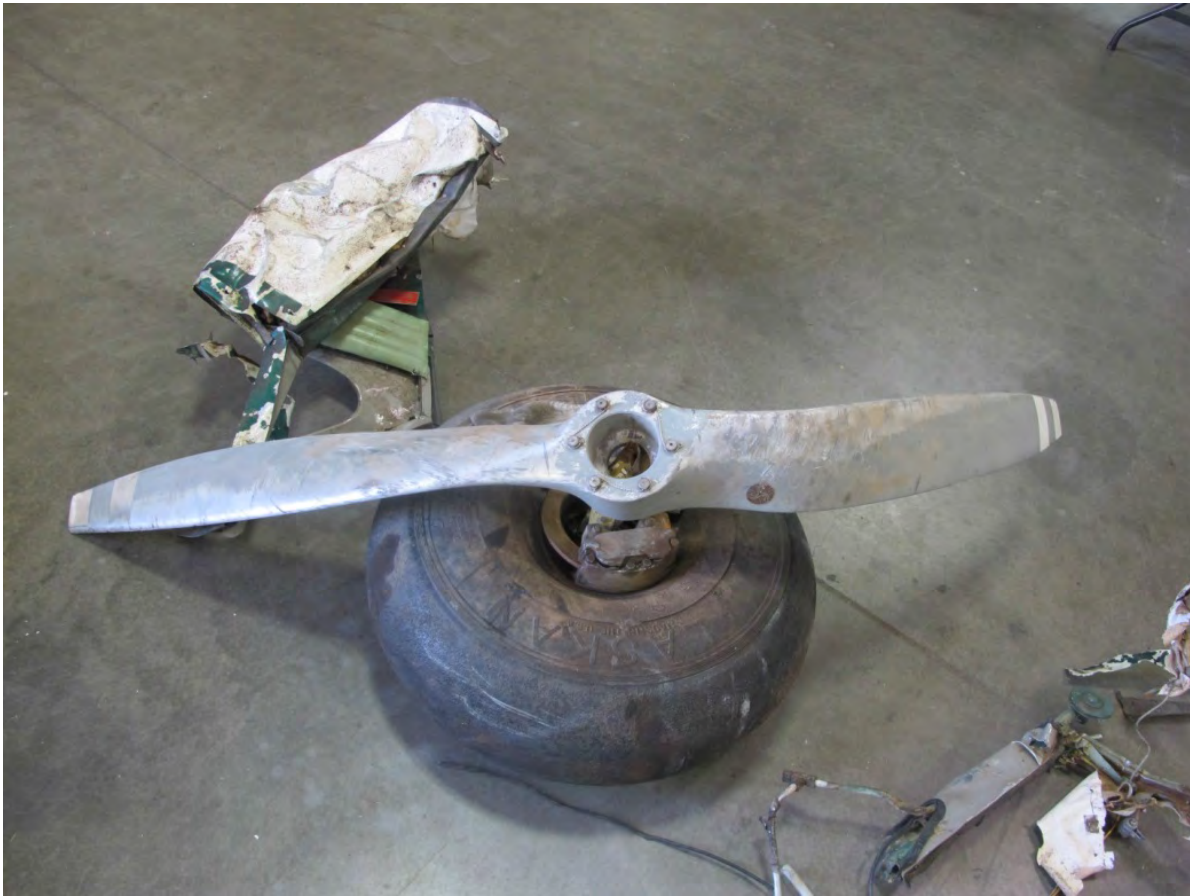
*Figure 22 Propeller*

One blade was bent aft about 30 degrees about 10 inches from the hub, and the outboard 10 inches bent aft another 20 degrees.

The second blade gradually bent aft about 10 degrees.

Both blades exhibited chordwise striations across the cambered surface.

The propeller separated from the engine crankshaft flange.
