## **NATIONAL TRANSPORTATION SAFETY BOARD**

### **AIRFRAME AND ENGINE EXAMINATION**

**WPR15FA208**

Location: Salem, OR (McNary Airport)  
Date: August 20, 2015  
Aircraft: Mooney M20E, Registration Number: N5608Q, Serial #: 660  
NTSB IIC: Tom Little

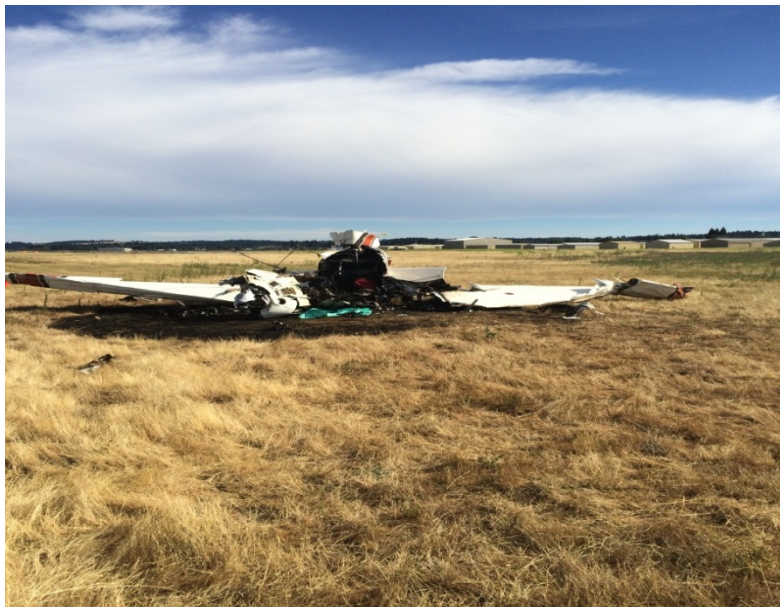
The fuselage was severely fire damaged forward of the tailcone, with most of the upper part of the tubular frame missing. The tailcone was salvage cut just aft of the baggage door. The right wing was attached, while the left wing was detached with extensive fire damage at the wing root. The engine and propeller were also both detached.

The right wing showed compression crushing along the leading edge, most severe out toward the wingtip. The right flap and aileron were still attached. About 4 ½ feet of the left wingtip was separated. The left flap and aileron were both detached. The landing gear were presumed to be retracted at the time of impact.

The empennage was mostly intact with all control surfaces attached and movable. The tail skid was intact and undamaged. The bottom of the empennage at the “stinger” showed minimal scraping, but not dents. The “clamshell” at the bottom of the rudder was crushed. By removing the empennage fairing and measuring the distance between the hinge points to be 3 1/8 inch and counting visible threads to be 5, it was determined that the longitudinal trim setting was approximately that for a takeoff trim setting.

The cabin was extensively fire damaged. The throttle cable was pulled out toward the idle position and the propeller control was pushed in toward the “full increase” position. The mixture position could not be verified. The “Johnson Bar” was broken free and loose in the wreckage.

As a result of the examination, no anomalies with the airframe were noted.

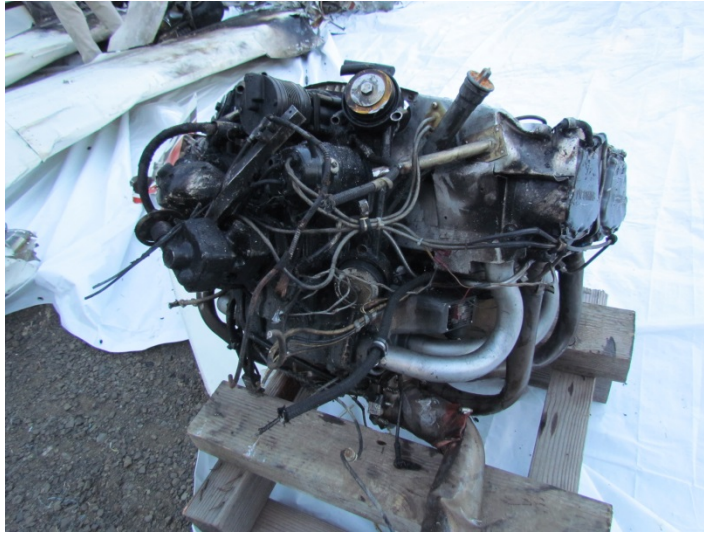
Photo Courtesy of Lycoming

The engine was examined on 8/20/2015 at the facilities of Nu Venture Air Services, LLC. The engine was previously separated from the firewall and sitting on a pallet for the examination. The propeller was broken free from the crankshaft. One propeller blade broken free from hub, it exhibited twisting, leading edge gouges, and cord wise scaring. The other two blades remained in the hub and also exhibited twisting, leading edge gouges, and cord wise scaring. The propeller governor was found broken free from the engine case.
