**NATIONAL TRANSPORTATION SAFETY BOARD**

**AIRFRAME AND ENGINE EXAMINATION**

**WPR15FA227**

# Examination Report N4CU - Cessna P337G

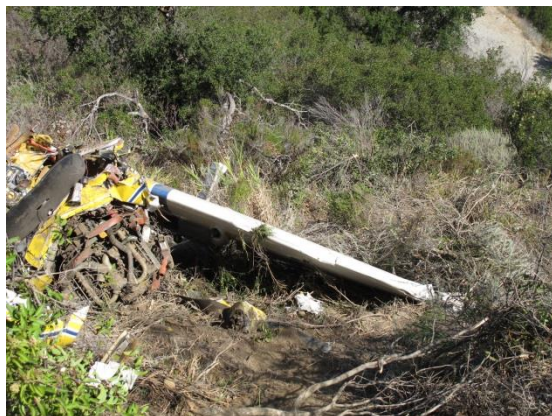
On-scene wreckage (front view)

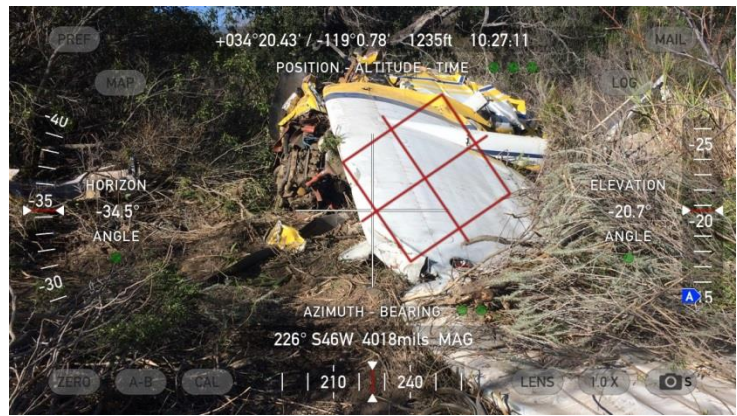
On-scene wreckage (left side view)

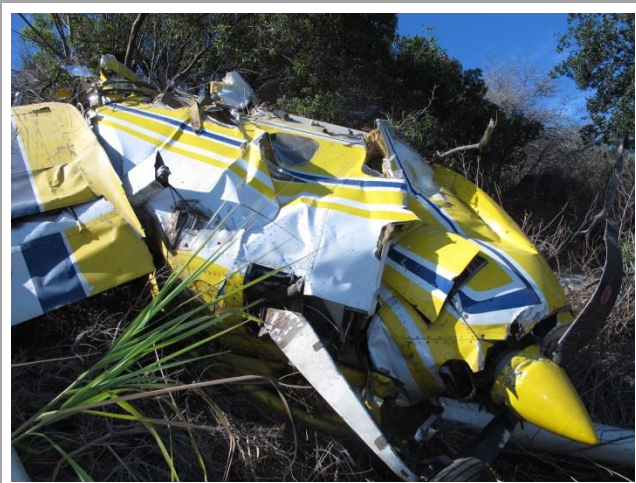
Fuselage from the left side.

Airplane was located on a 40° slope upright with wings and tail sections intact. Wings had separated at the wing roots but remained next to their approximate location along the fuselage. The forward firewall was displaced aft into the cockpit instrument panel and the cockpit floor was displaced upward into the cabin. The left tail boom remained attached to left wing and extended aft. The stabilizer and elevator remained attached to the tail booms. Both vertical fins and rudders remained attached to the tailbooms. The

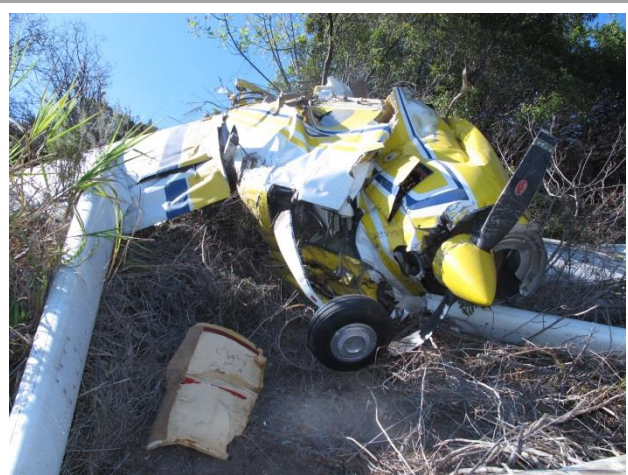
Fuselage and rear engine.

forward engine was displaced down and to the left, the propeller had separated from the crank shaft behind the propeller flange. The aft engine remained attached to the aft engine mount and displaced to the right. The propeller remained attached to the engine.

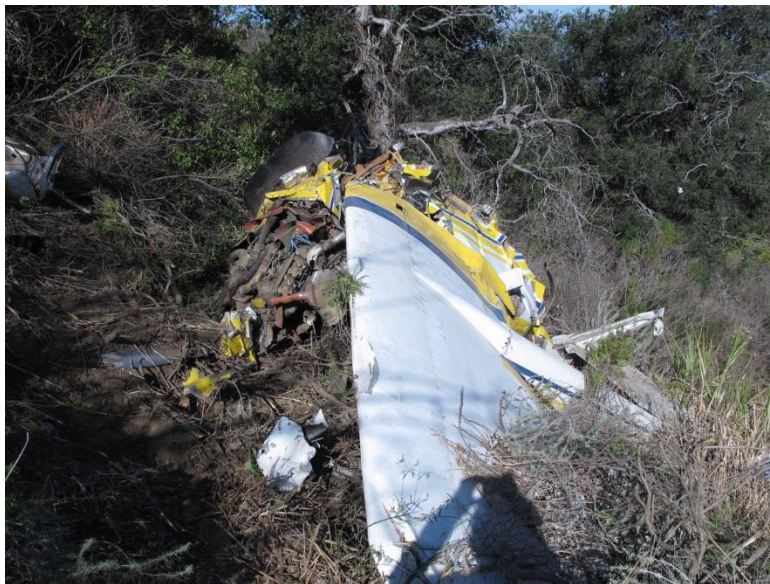
- Left Wing
  - Leading edge damage along outboard 5 feet with aft ward diagonal buckling to the tip. Wing tip fairing not on the wing.
  - Outboard 5 feet of wing bent upward approximately 30°. Large leading edge dent just forward of left wing filler port.

- Aileron remained attached to the wing. Control cable continuity was established to the fuselage. Balance cable was continuous from the left wing to the right wing. Control & balance cable ends were attached to the aileron bell crank.

- Both flaps remained attached to the wing, in the 30° down position. Flap cable exhibited separation in tensile overload.
  - Tailboom remained attached to wing structure.

- Fuel cap remained secure. Fuel cap o-ring exhibited no cracking or stiffness. An undetermined amount of fuel was observed when viewed through filler port.

Left wing.

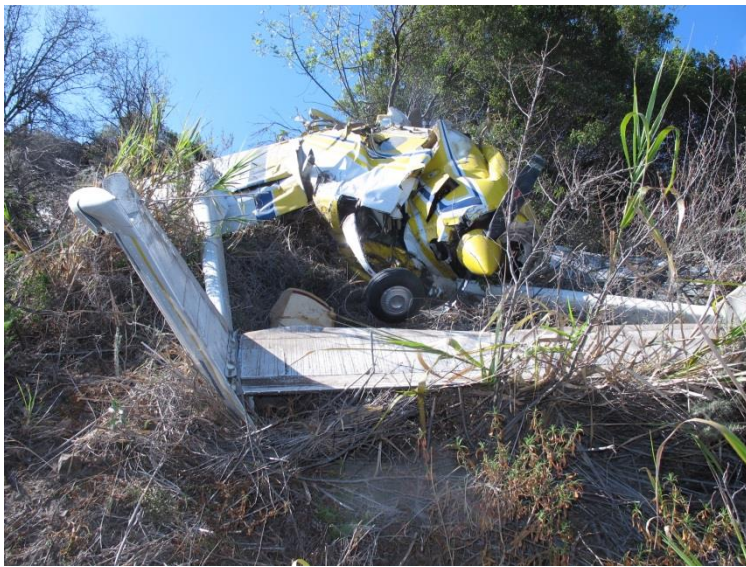
- Tail Section
  - Both vertical fins with attached rudders and the stabilizer with the elevator all remained attached to both tail booms.
  - Tearing, dents, and gouges from impact observed on the bottom side of the vertical fins and stabilizer.
  - Elevator trim cable continuity established to the right wing root. Elevator trim actuator measured 1.5 in extension measured from the stabilizer rear spar to the center of the eye end bolt.
  - Rudder and elevator cables were continuous from the cabin fuselage through the tailboom to their respective bell cranks in the tail.

Tail section with left and right tail booms.

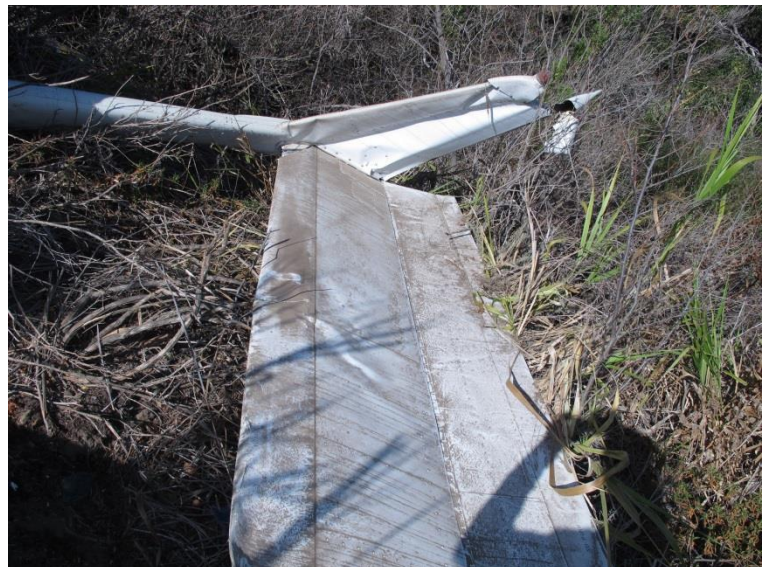
Stabilizer and elevator.

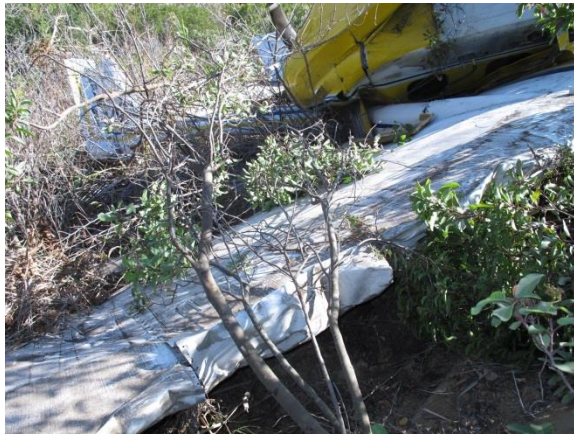
- Right Wing
  - Tailboom separated from the wing structure at the wing trailing edge.
  - Leading edge crushing long mid span.
  - Wing bent upward approximately 5° outboard of the fuel filler port.
  - Filler cap was in place and secure. Fuel cap o-ring exhibited no cracking or stiffness. No fuel was observed through the filler port.
  - Flaps were attached to the wing in the up position.
  - Aileron was attached to the wing. Control cable continuity was established to the fuselage. Balance cable was continuous from the left wing to the right wing. Control & balance cable ends were attached to the aileron bell crank.
  - Wing tip fairing had separated from the wing.

Inboard section of the right wing.

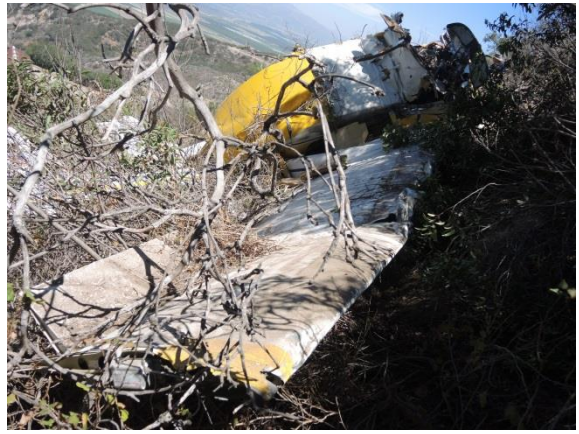
Outboard section of the right wing.

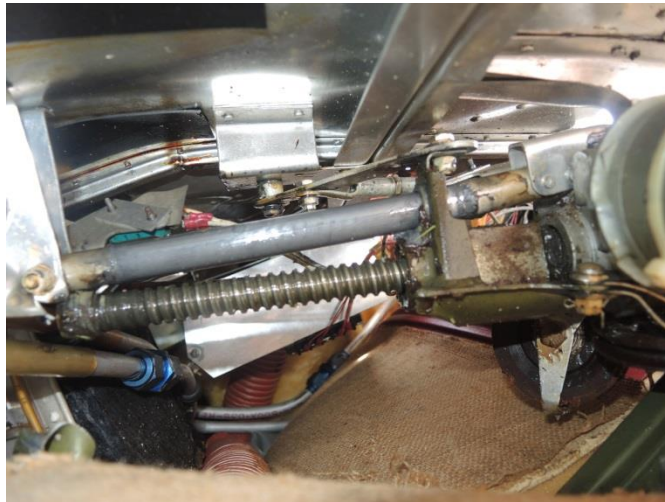
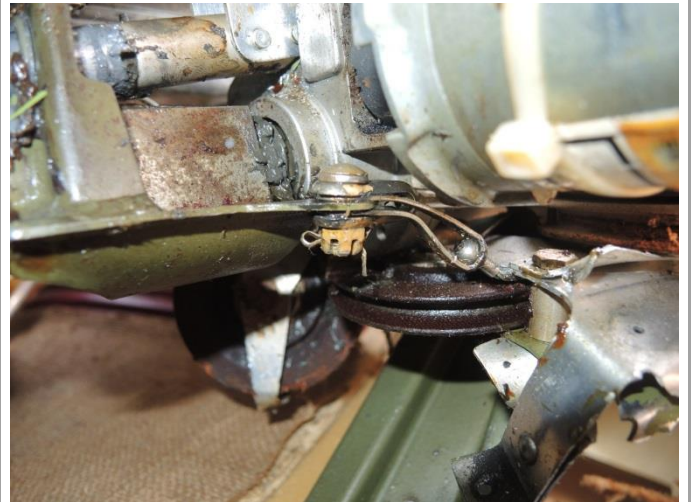
- Flap actuator was found in the full retracted position.

Flap jackscrew.

Flap jackscrew close up.

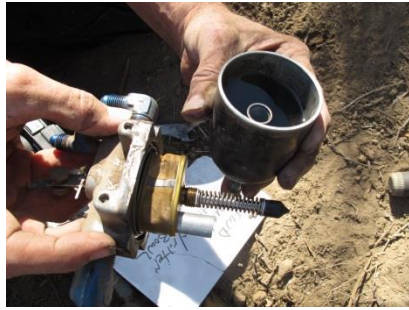
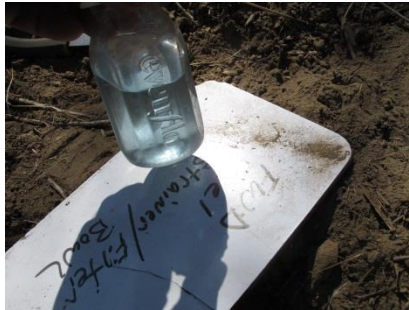
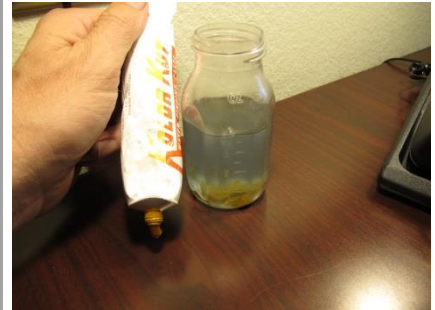
- Forward fuel strainer assembly
  - Bluish tint fluid filled the bowl (constant with 100LL)
  - Filter screen clear of debris.
  - Tested negative for water using KolorKut paste.

Front engine fuel filter & bowl.

Fuel drained from front engine bowl.

Front engine fuel water test.

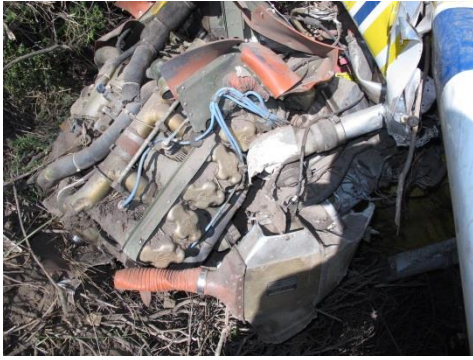
- Rolls Royce TSIO-360DG
- SN: 50R354
- HP: 225
- Propeller separated at the crank shaft behind the propeller flange
- Impact damage to the oil pan and underside of engine.

Front engine, left side.

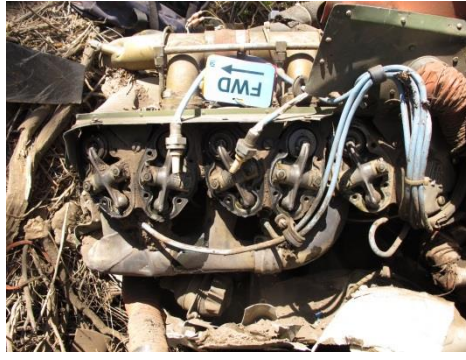
- The engine crankshaft was rotated using the vacuum pump drive. Rotation achieved thumb compression on all cylinders.
- Valve covers removed from cylinders 2, 4, 6. Valves moved in sequence.

Front engine, right side with valve covers removed.

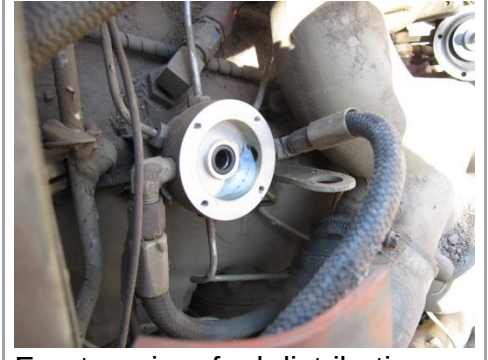
- Fuel distribution valve wire tied. Valve opened and bluish fluid observed, screen clear, and diaphragm undamaged.
- Top spark plugs (RHM38E) were removed from all 6 cylinders. Exhibited normal wear. No mechanical damage observed.

Front engine, fuel distribution valve showing fuel present.

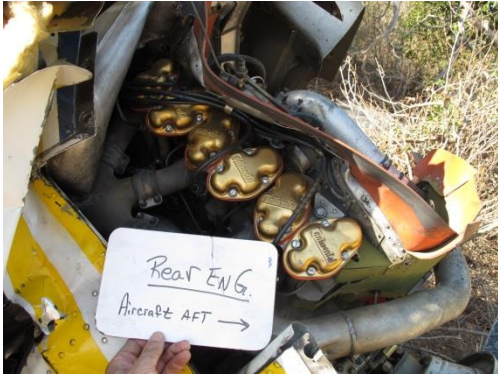
- Continental TSIO-360C(5B)
- SN: 224369R
- HP: 225
- Propeller remained attached to the engine/propeller flange.
- Rotational scoring observed along the skirt of the propeller spinner.

Rear engine, left side.

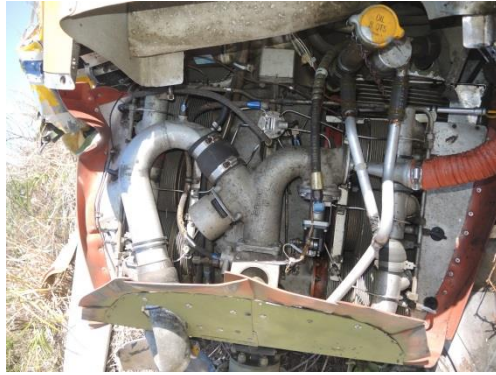
- Valve covers removed from cylinders 1,2,3,4,5, & 6. Valves moved in sequence. The magneto impulse coupling could be heard.
- Fuel pump was removed and bluish tint fluid drained from the pump. Pump rotated by hand then disassembled. The rotor and vanes were in tact and no scoring evident. The fuel pump drive spline was intact.

Rear engine, top view.

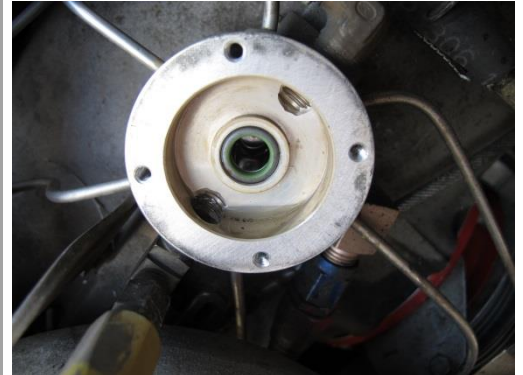
- All throttle body connections in place
- Fuel distribution valve wire tied. Valve opened and bluish fluid observed, screen clear, and diaphragm undamaged.

Rear engine, fuel distribution valve showing fuel present.

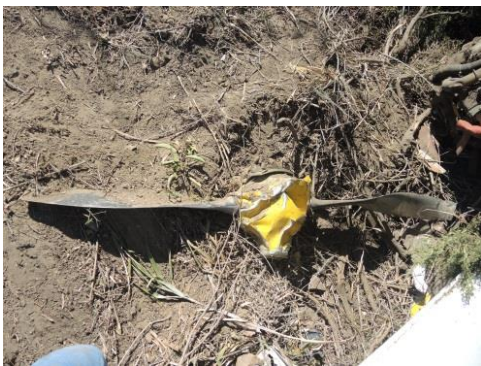
- McCaulley Hub Model No. D2AF34C303-A
- SN: 725627
- Hub separated from the engine.
- Blade 1 - twisted towards noncamber side at mid span. Leading edge gouges mid span and at the tip. Blade face polishing & chordwise scratches midspan out to blade tip.
- Blade 2 - slight leading edge damage. Longitudinal scratches.
- Spinner crushed aft over the propeller dome.

Front propeller.

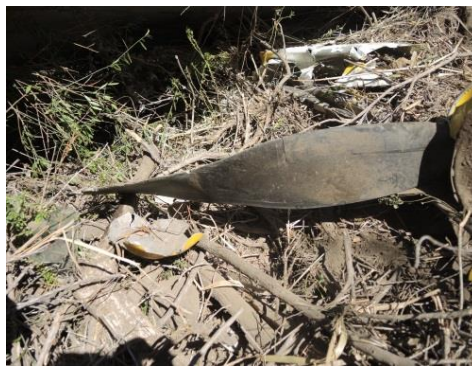
Front propeller, blade 1

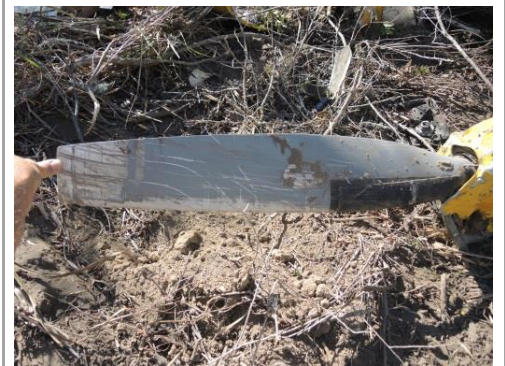
Front propeller, blade 2

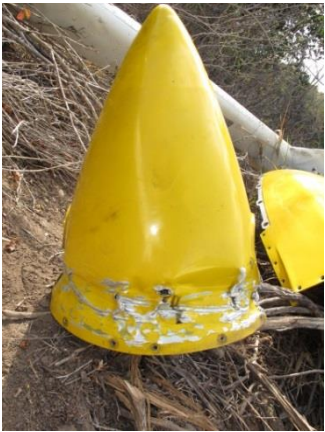
Real propeller spinner.

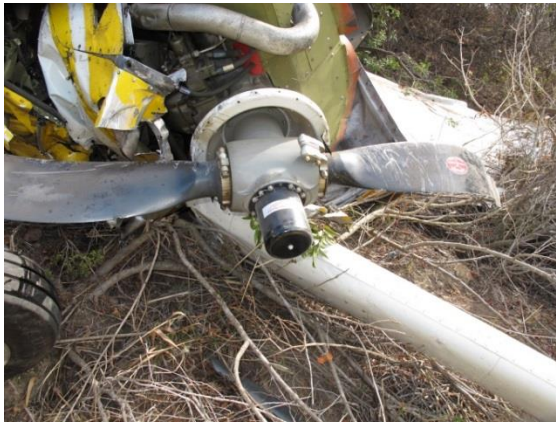
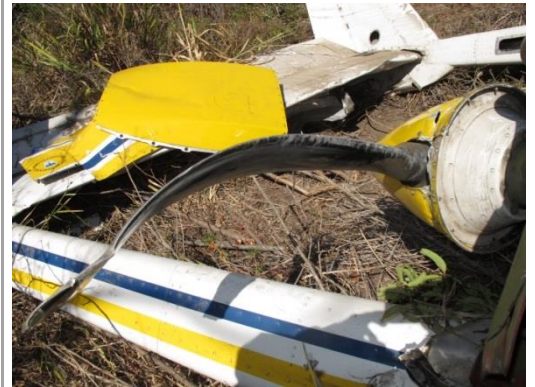
- McCaulley Hub No. D2AF34C305-A
- SN: 792704
- Hub remained attached to the engine.
- Both blades loose in the hub.
- Blade 1 - bent to the noncamber side at midspan, leading edge gouge towards tip, blade tip fractured off.

- Blade 2 - Bent to the noncamber side, blade tip fractured off

Rear propeller.
