## RECORD OF CONVERSATION

**Elliott Simpson**  
**Aviation Accident Investigator**  
**Western Pacific Region**

**NTSB Accident Number: WPR15FA250**

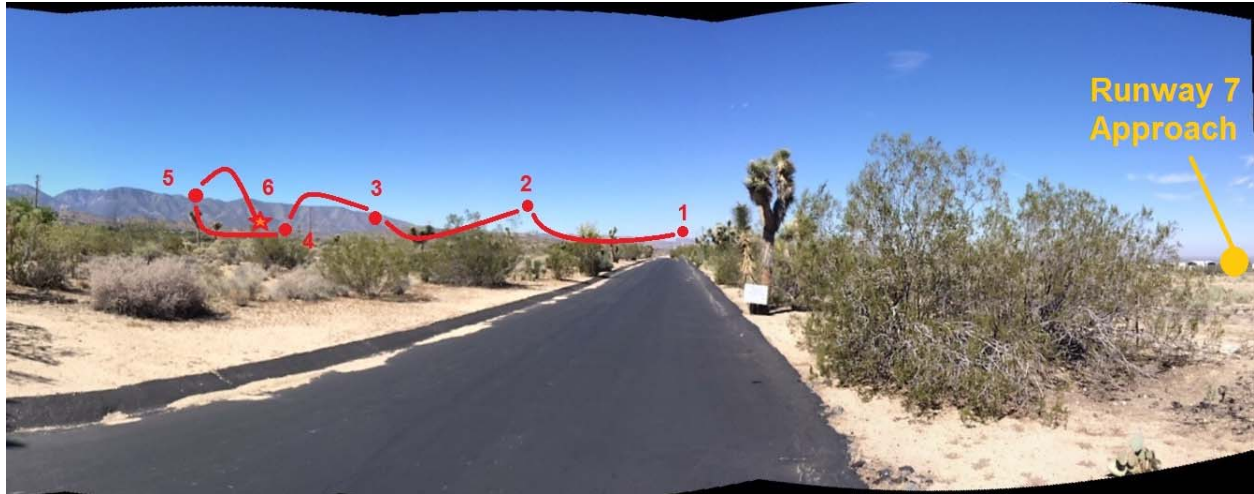
Photo 1 – View West Along Avenue X

- She turned left onto Avenue X, towards the west and directly ahead in the distance she could see a tow plane coming generally towards her in the direction of the approach end of Runway 7 (1). She was instantly concerned because it looked far lower than she is used to seeing. From her perspective, she thought it was already past the power poles on 165th street, and she could not believe it had not hit them.

- She continued driving west as her view opened to the south revealing the San Gabriel Mountain foothills. The airplane then abruptly began to climb "turned straight up" (2), turned right (her left), towards the mountains such she thought it had broken off the approach and was joining the left downwind for Runway 25 (3). The airplane then rapidly descended and appeared to turn right as it approached 165th street (4). She was not sure if it had crossed the street but it was now very low and she couldn't understand why none of the power lines had been struck and why it had not hit the ground. It then began another rapid climb (5), arching back over and striking the ground (6).

See attached photo for annotations.

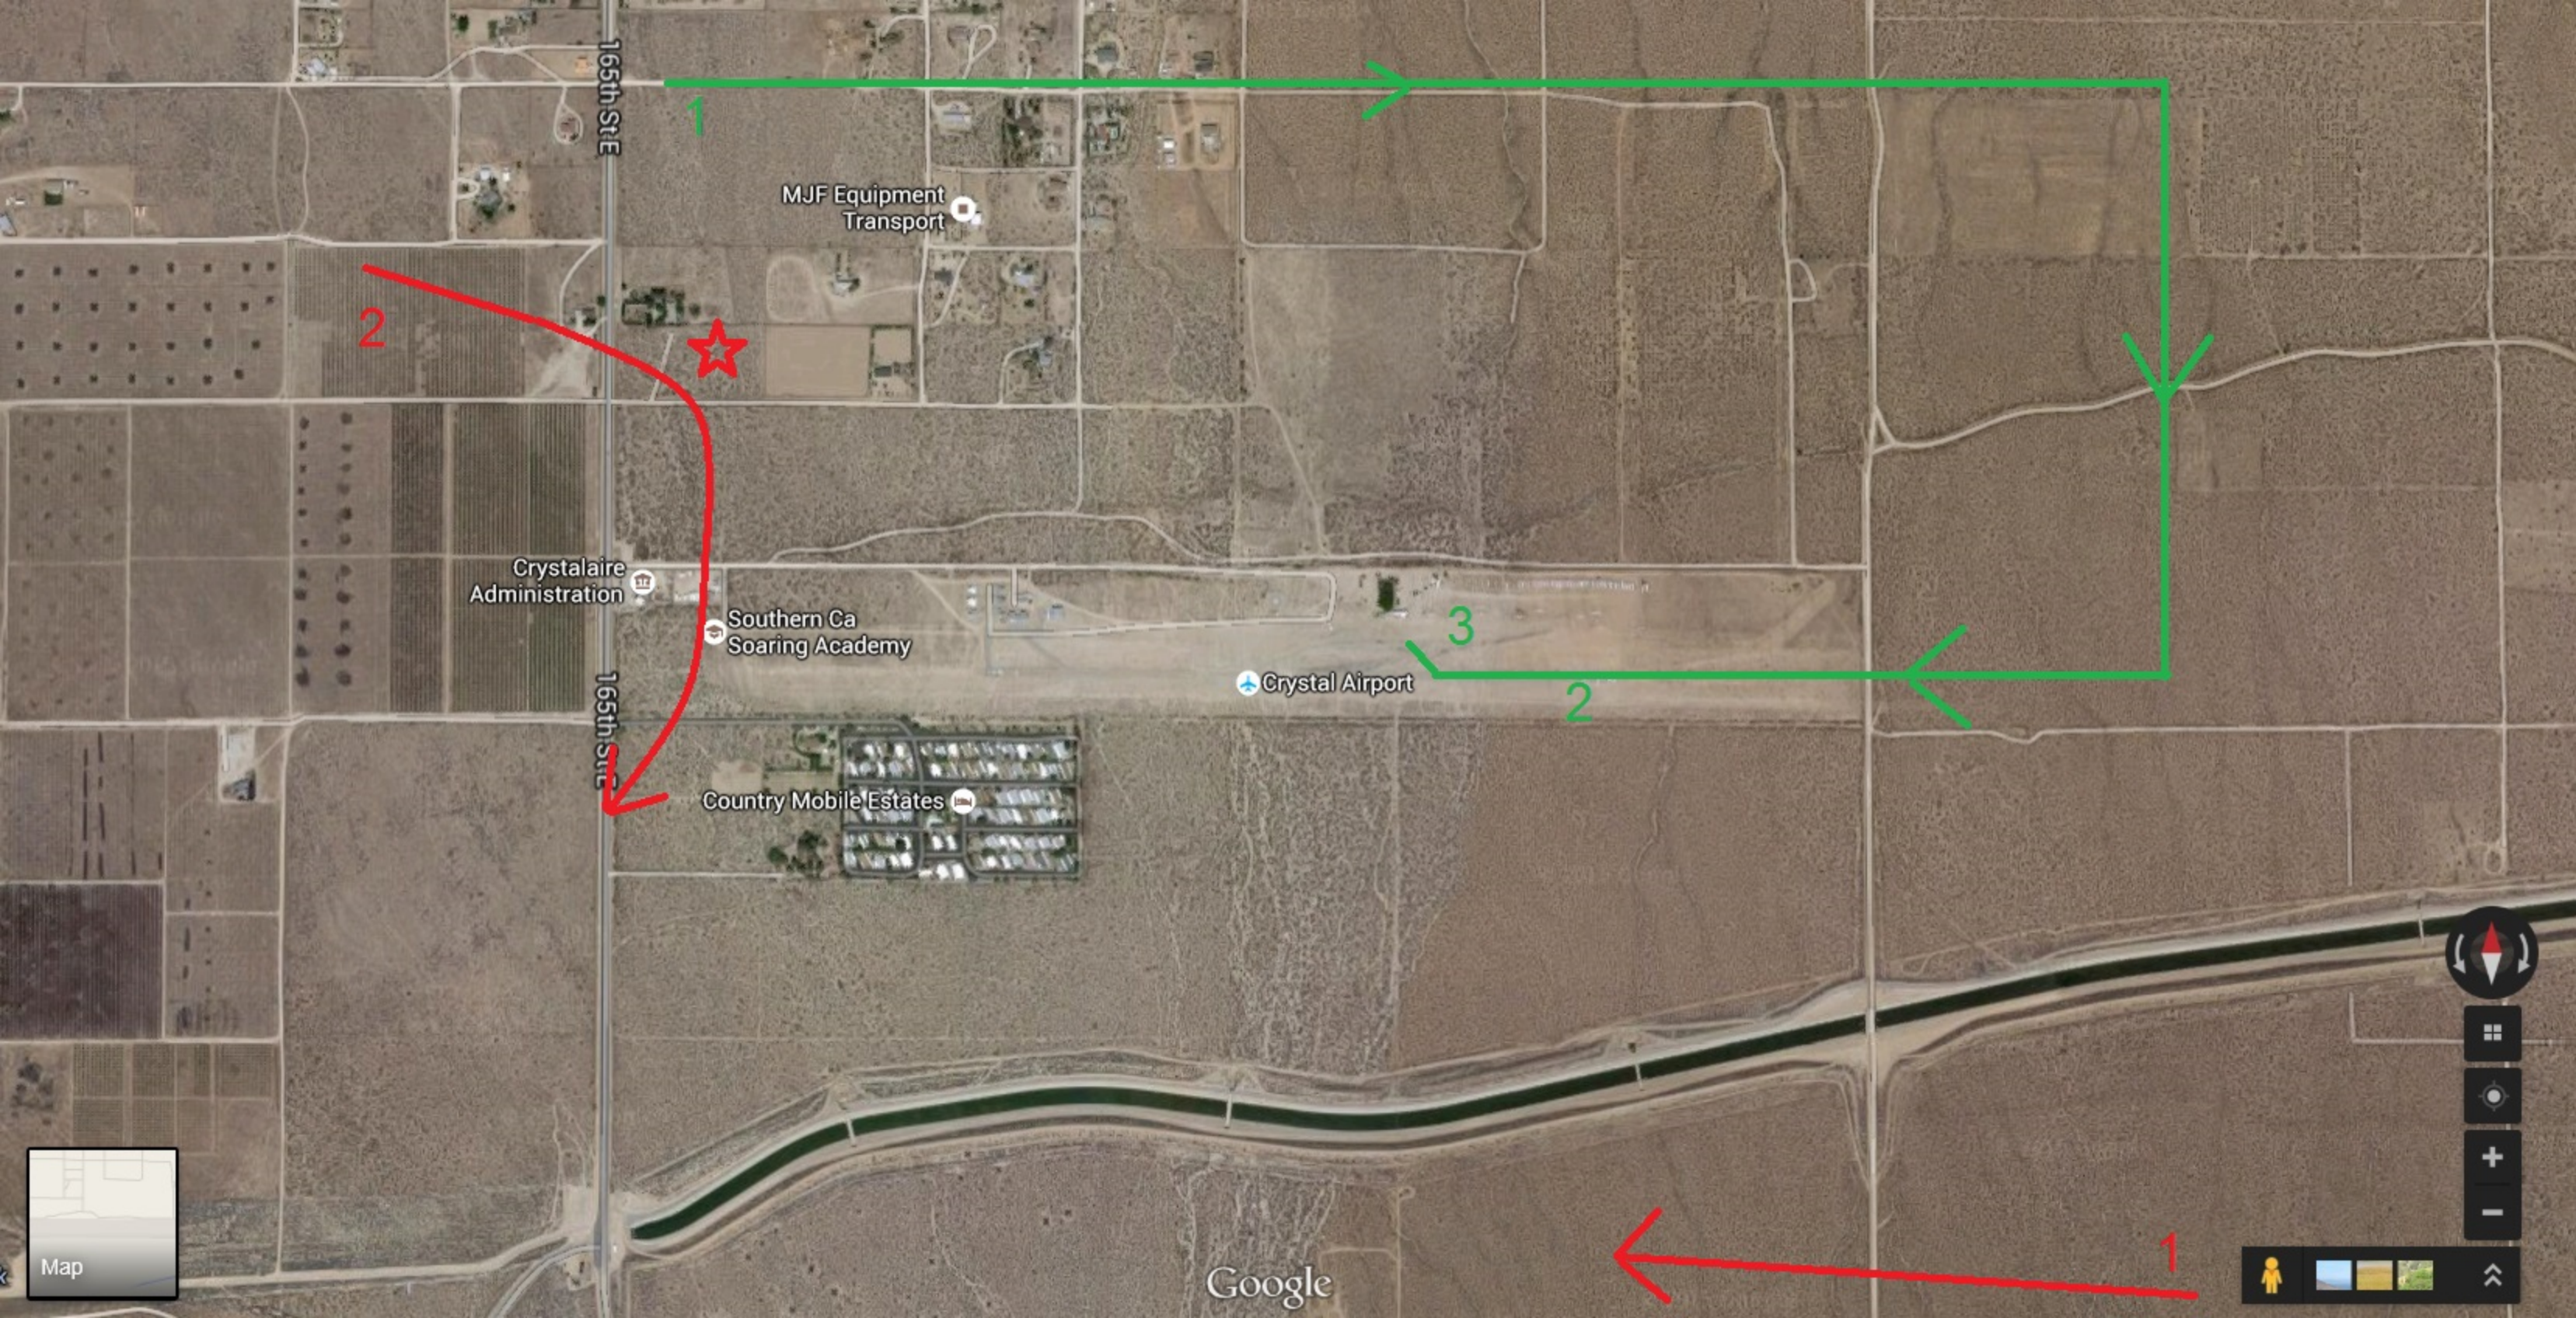
I've attached a picture for your reference.

The green flight path is mine.

The red was of the towplane.

The numbers are approximations of where we were at the same time.

The green #3 is where I pulled off the runway and attempted to make radio contact with the towplane.

I've labeled a red star as where I noticed an aggressive low altitude climbing very steep right bank maneuver. I recall this maneuver as non-standard due to the location north of the runway. The aircraft appeared to be over the hangars which is unusual for a towplane pattern.
