## **NATIONAL TRANSPORTATION SAFETY BOARD**

# **AIRFRAME AND ENGINE EXAMINATION**

**WPR15FA250**

Location: Llano, California  
Date: August 27, 2015  
Aircraft: Piper PA-25-260, N4369Y  
NTSB IIC: Elliott Simpson

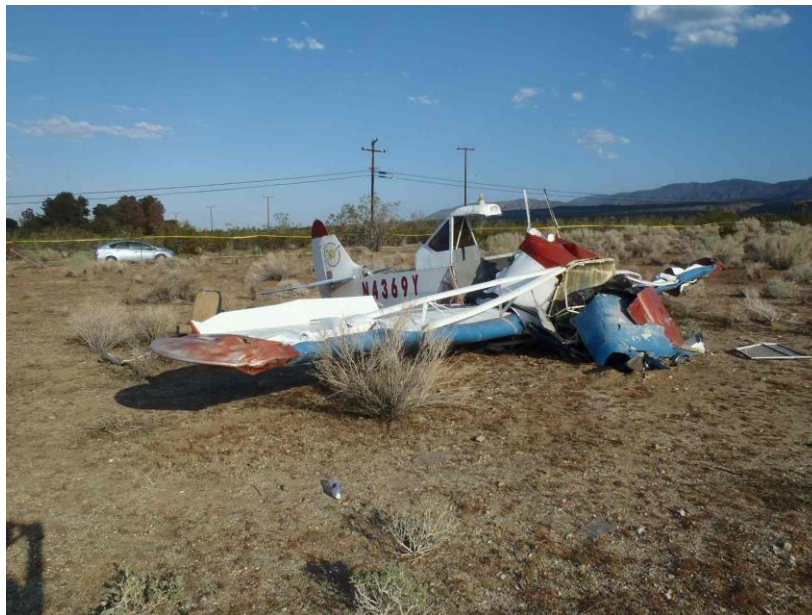
Photo 1 – Airplane at Accident Site

The cabin sustained crush damage from the firewall through to the forward legs of the pilot's seat. The remaining aft fuselage structure along with the empennage section sustained minimal damage. Both wings remained attached to the fuselage by their respective main spars and lift struts. The left wing leading edge had twisted upwards, and the wing sustained aft crush damage through to the aileron along its entire length. The right wing exhibited leading edge crush damage outboard of the lift strut attach points.

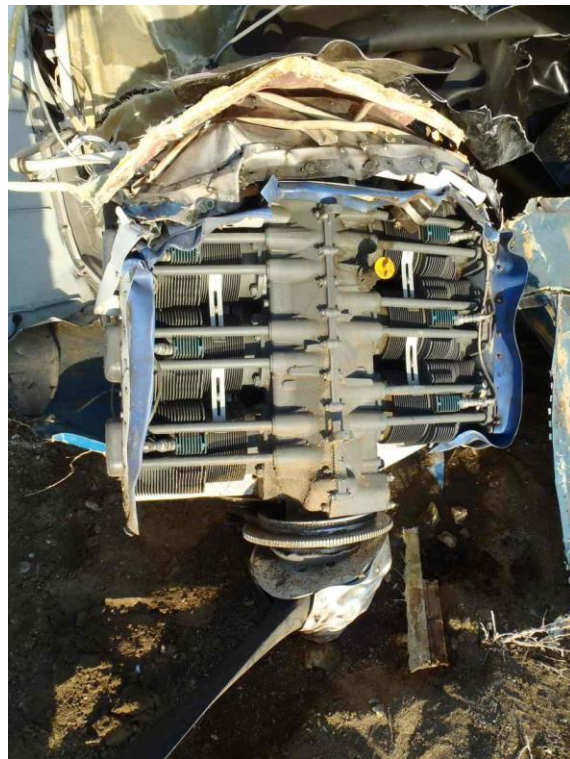
Photo 3 – Engine at Accident Site

The engine remained partially attached to its mount, and had shifted downwards and to the right of the fuselage centerline. One propeller blade exhibited a 5-degrees aft bend midspan, the other blade sustained chordwise scratches along its entire surface and nicks to its leading edge. The bladder-style fuel tank was exposed, had been breached, and came to rest covering the engine. Although no fuel was found in the tank, the soil under the engine was soaked with a liquid that had the odor of aviation gasoline.

The engine sustained damage during the accident sequence, separating the carburetor, crushing the oil filter, and impinging the ignition harness against the firewall. The inlet air filter and associated induction tubes were free of obstruction. The oil sump was empty and exhibited a puncture hole. Oil was present in the soil around the accident site. The oil filter was removed and cut open to expose the filter media. The media was coated in dark-colored oil, and free of debris.
