# NATIONAL TRANSPORTATION SAFETY BOARD

## MATERIALS LABORATORY FACTUAL REPORT

Report No. 16-024

Place : Port Townsend, WA  
Date : September 28, 2015  
Vehicle : Cessna 150F, N8529G  
NTSB No. : WPR15FA268  
Investigator : Tom Little

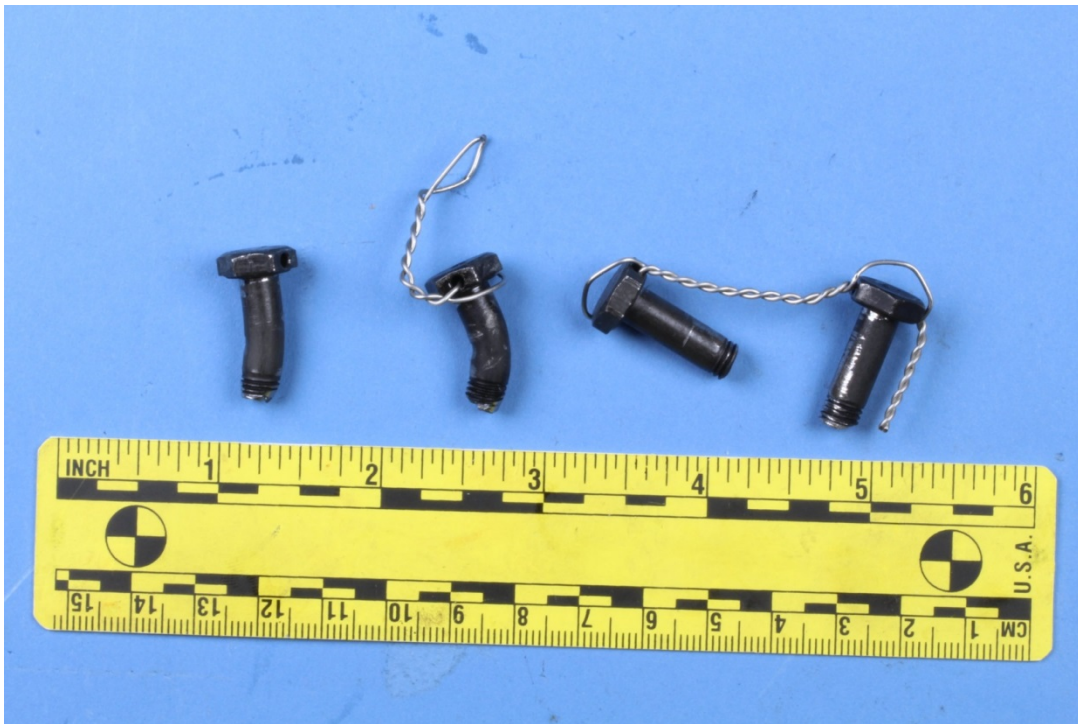
The four crankshaft gear bolts all exhibited overstress fractures in their threaded portion (figures 1). Two of the four bolts remained safety wired to each other and did not exhibit gross plastic deformation. The other two bolts exhibited gross plastic deformation in the shank portion. One of the bolts had broken free of the safety wire and the other had a portion of safety wire still attached.

Figure 1: Crankshaft gear bolts.

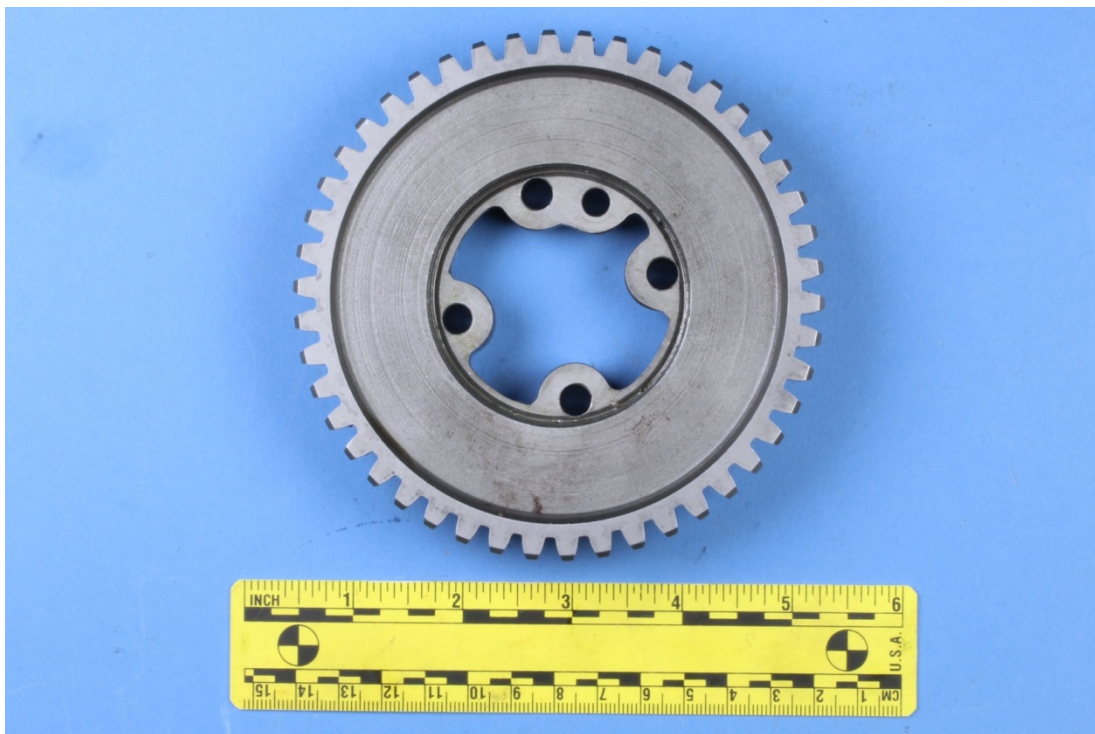
The bolt holes in the crankshaft gear had become elongated. This effect was less pronounced on the face of the gear that would have mated to the crankshaft (figure 2, crankshaft side) and more pronounced on the opposing face (figure 3 bolt head side). The crankshaft gear teeth appeared to be well formed and did not exhibit any irregularities or uneven wear.

Figure 2: Crankshaft gear (crankshaft side).

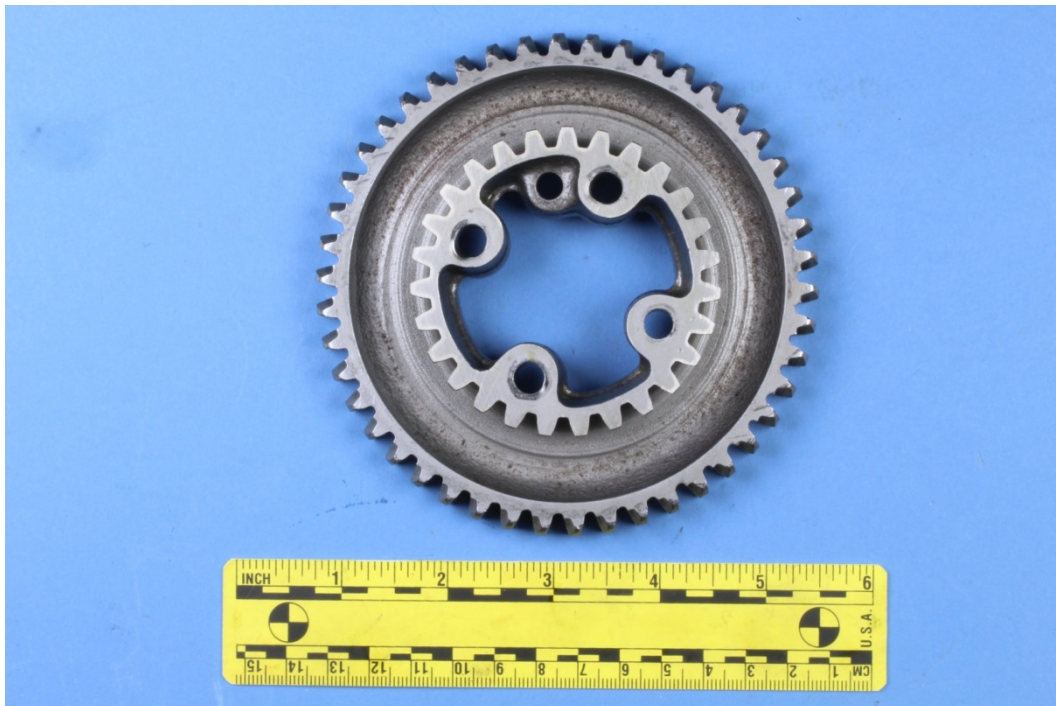
Figure 3: Crankshaft gear (bolt head side).

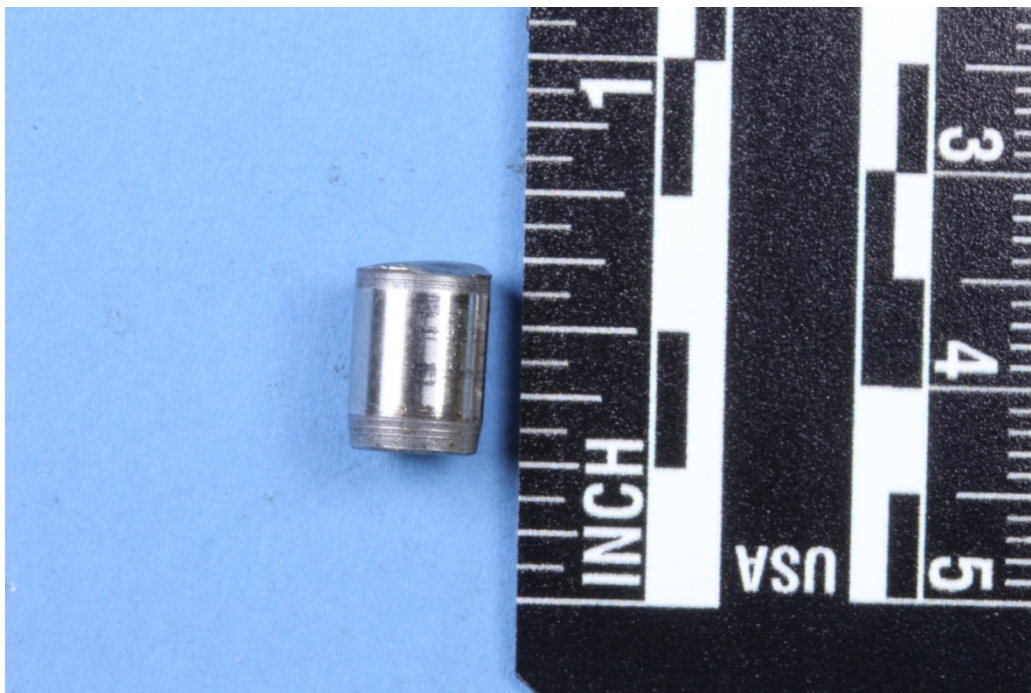
The crankshaft gear dowel pin was fractured and partially missing. The portion that was submitted to the laboratory contained a flat fracture surface (figure 4). Examination of the fracture surface using a stereo microscope revealed crack arrest marks and ratchet marks consistent with a fatigue fracture. There were 3 prominent ratchet marks indicating a fatigue fracture with multiple origins. Examination of the body of the dowel pin revealed wear marks on one side (figure 5).

Figure 4: Portion of the crankshaft gear dowel pin.

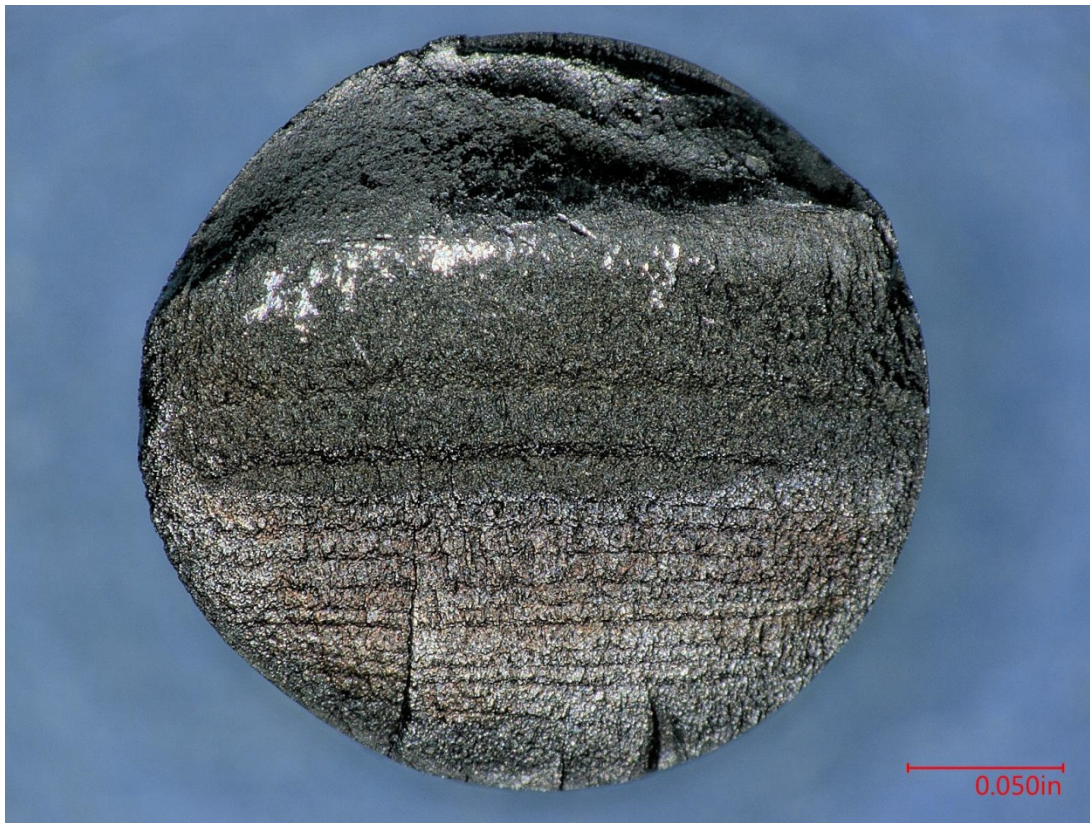
Figure 5: Crack arrest marks and ratchet marks on dowel pin fracture surface.

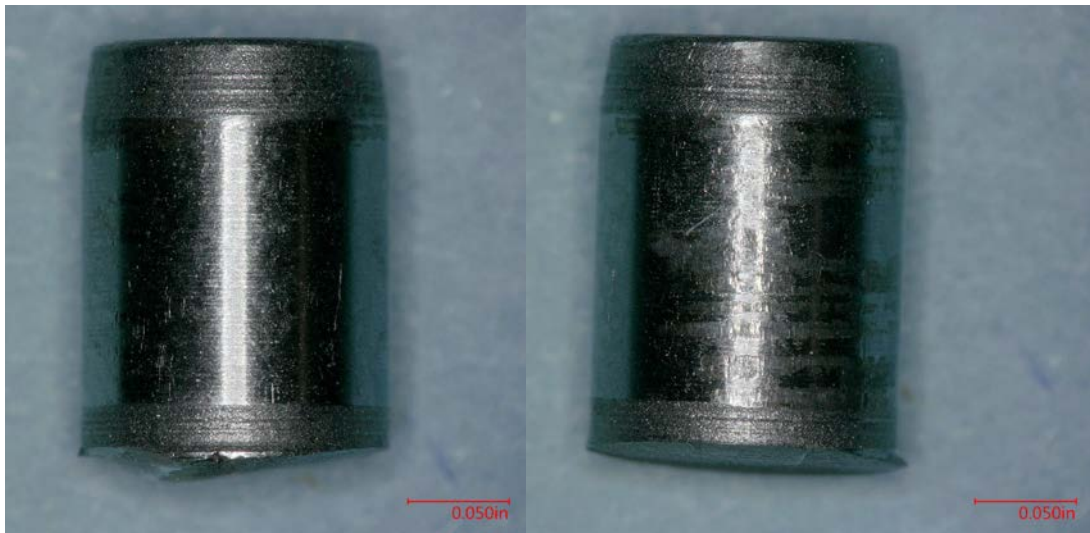
Figure 6: Opposing sides of crankshaft dowel pin body.
