## **NATIONAL TRANSPORTATION SAFETY BOARD**

### **SUMMARY OF AIRFRAME & ENGINE EXAMINATION**

**(WPR15FA268)**

| Aircraft: | Cessna 150F, N8529G |

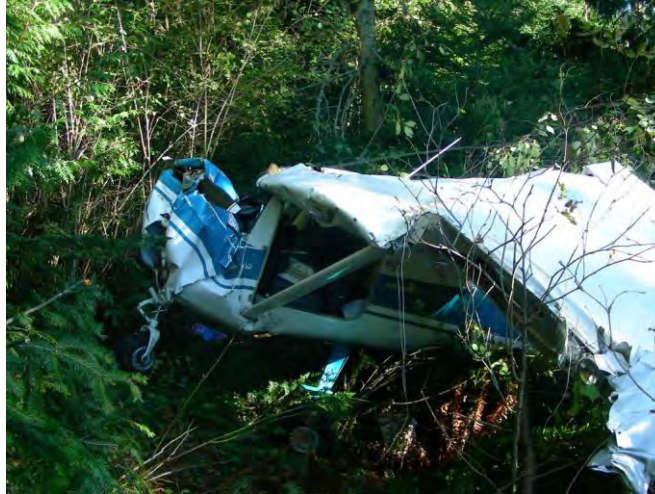
On the day following the accident, the NTSB IIC surveyed the accident site. Both of the airplane's wings had simultaneously impacted two trees on a heading of north at about the 40-foot level. This was followed by the engine colliding head on with a 28-inch diameter tree in the same direction, and at about the same height. The airplane then rotated about 90 degrees to the left prior to falling vertically to the ground, coming to rest upright in a dense forested area. The forward section of the airplane and both wings were substantially damaged, while the aft fuselage and empennage sustained only minor damage. There was no postcrash fire. All components necessary for flight were accounted for at the accident site.

Figure 1 - photo of airplane at accident site

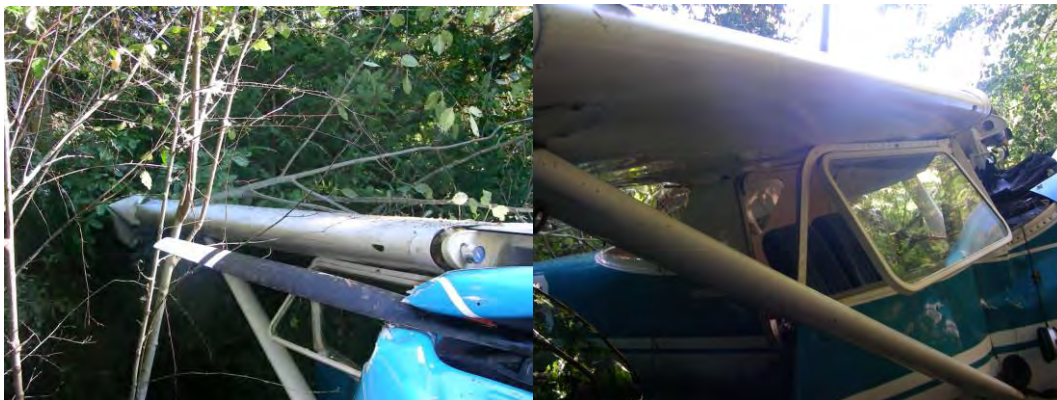
The right wing remained attached to the fuselage at all attach points, with the outboard one-third of the wing substantially damaged due to impact forces with trees. The wing strut remained in place and was not damaged. The right flap remained attached to the wing's trailing edge at all attach points with impact damage. The right aileron remained attached to the wing's trailing edge at all attach points and was not damaged. The right wing fuel tank was intact and not damaged, with the fuel cap in place and tight to touch.

Figure 2 - photos of right wing

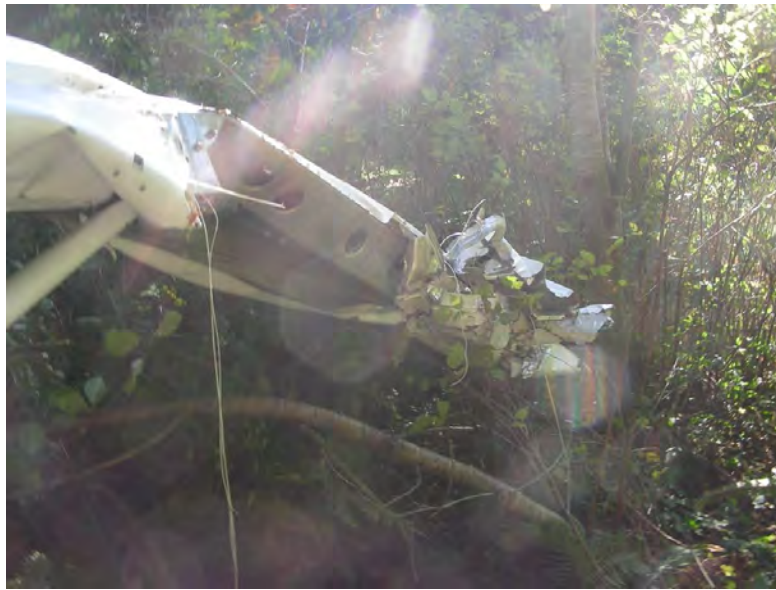
The left wing remained attached to the fuselage at all attach points. The outboard two-thirds of the wing was observed to have sustained heavy impact damage and severe deformation as a result of tree impact forces. The wing strut remained in place and was not damaged. The inboard one-third of the wing sustained moderate impact damage, with some wrinkling observed. Additionally, the wing was bent down about 45° at mid-span. The flap was observed attached to the trailing edge of the wing at the outboard two attach points, with the inboard one-third bent upward to about a 30° angle. The left aileron remained attached to the wing's trailing edge at all attach points, with minimal damage observed. The wing's fuel tank was breached due to impact damage, with the fuel cap intact, not damaged, and tight to touch.

Figure 3 - photo of front of left wing

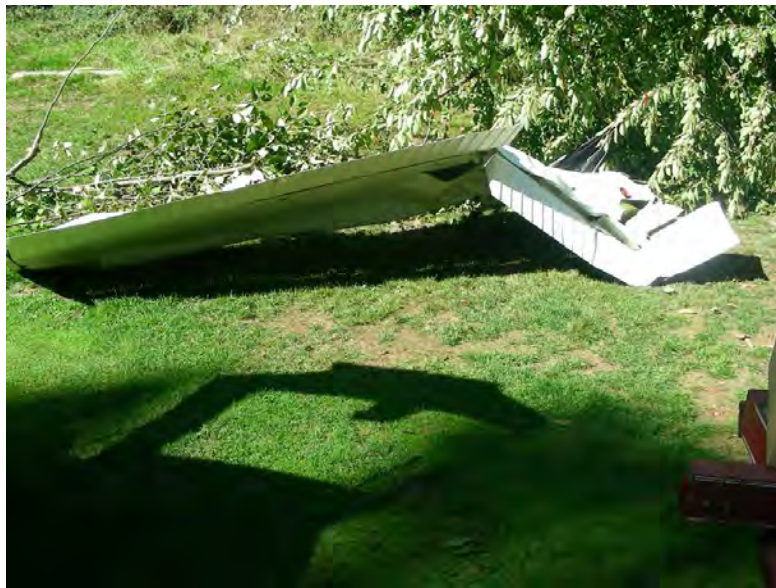
Figure 4 - photo of rear of left wing

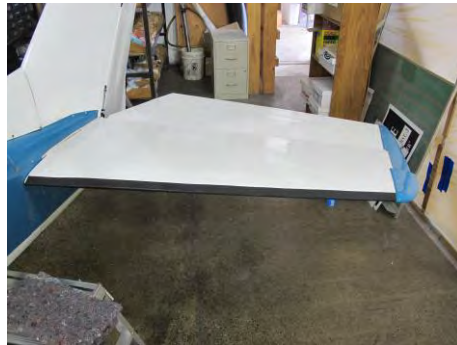
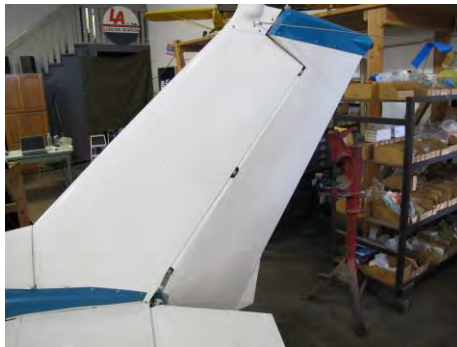
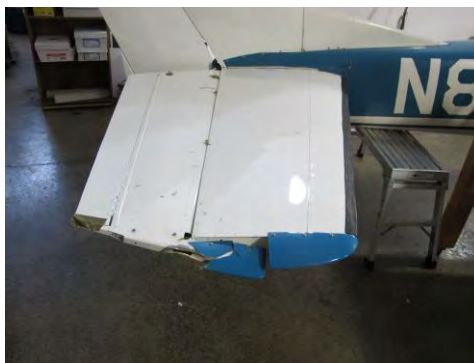
The airplane's empennage remained intact, with minor damage observed. The vertical stabilizer was not damaged, and remained attached to the aft fuselage structure at all attach points. The airplane's rudder was observed intact, not damaged, and remained attached to the vertical stabilizer at all attach points. The left horizontal stabilizer was intact, not damaged, and remained attached to the aft fuselage structure at all attach points. The left elevator was intact, not damaged, and remained attached to the left horizontal stabilizer at all attach points. The right horizontal stabilizer was observed intact, and remained attached to the aft fuselage structure at all attach points; the outboard tip of the stabilizer had sustained minor impact damage. The right elevator was intact, and remained attached to the right horizontal stabilizer at all attach points. The outboard tip of the elevator had sustained minor impact damage.

Figure 5 - photo 1 of empennage

Figure 6 - photo 2 of empennage

Figure 7 - photo 3 of empennage

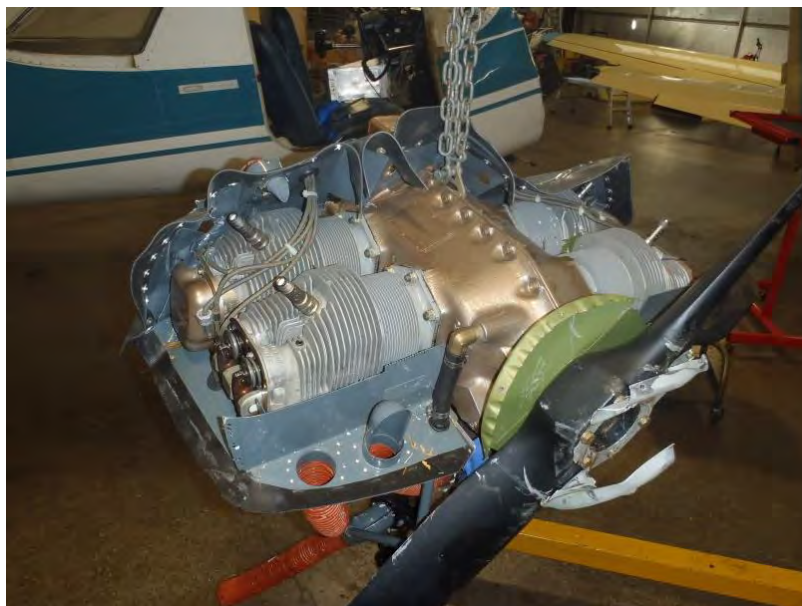
The engine remained intact and displayed impact damage. All four cylinders remained attached to the engine, and displayed varying degrees of impact damage. The crankcase remained intact and was unremarkable. The two-bladed fixed pitch propeller remained attached to the crankshaft. Both propeller blades displayed minor impact damage, with no bending or twisting deformation observed.

Figure 8 - photo of engine as received

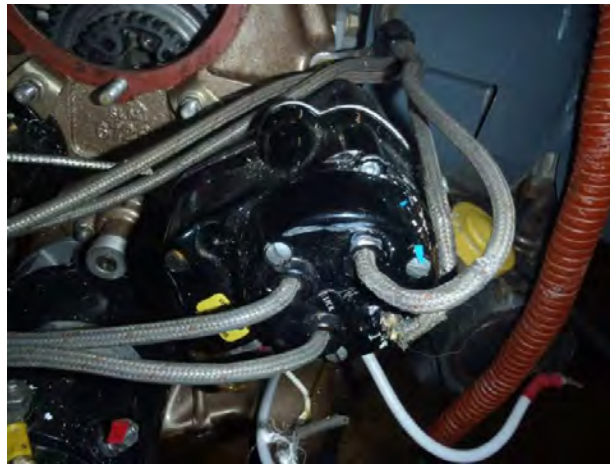
The right magneto remained attached to its mounting pad and displayed minor impact damage. The magneto was removed, and the drive shaft was rotated by hand; it was noted that the impulse coupling operated normally. During impulse coupling operation it was noted that the magneto would produce a spark for all four distributor posts in the normal order. There were no anomalies noted with the magneto.

Figure 9 - photo of right magneto

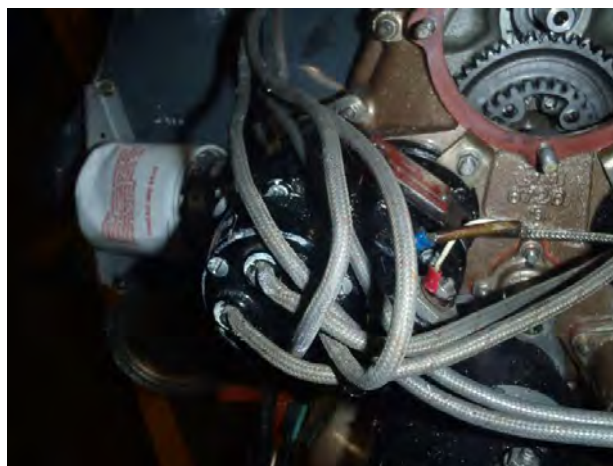
The left magneto remained attached to its mounting pad and displayed minor impact damage. The magneto was removed, and the drive shaft was rotated by hand; it was noted that the impulse couplings operated normally. During impulse coupling operation it was noted that the magneto would produce a spark on all four distributor posts at the same time. The magneto was retained by the NTSB IIC for further examination.

Figure 10 - photo of left magneto

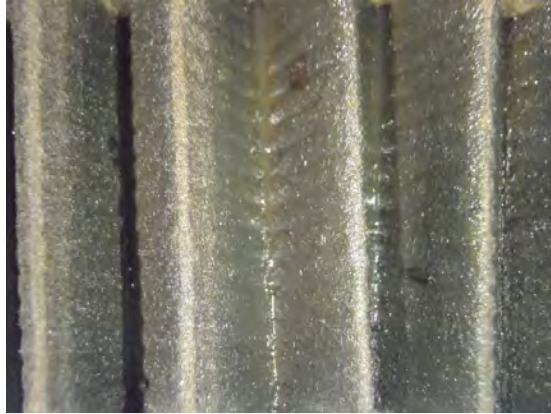
The engine had an oil filter and adapter installed. The oil filter was removed and the housing was cut open. The oil filter pleats were inspected and it was noted there was a very minute amount of metallic material noted within the filter pleats. It was reported to the investigators that the engine had been overhauled within the last 100 hours.

Figure 11 - photo of oil filter pleats

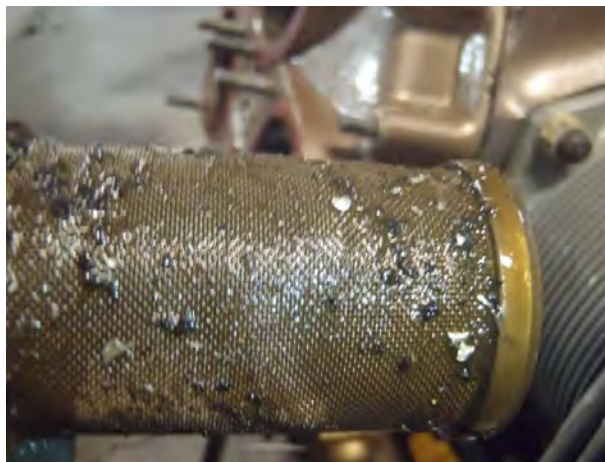
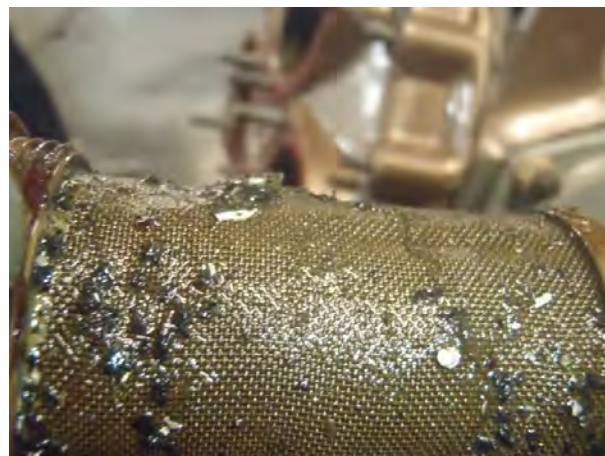
The original engine oil screen remained installed despite the fact the engine was equipped with an oil filter. The oil screen was removed and it was noted that there was a significant amount of contaminants consistent with metallic material as well as a significant amount of unidentified black colored substance.

Figure 12 - photo 1 of oil screen

Figure 13 - photo 2 of oil screen

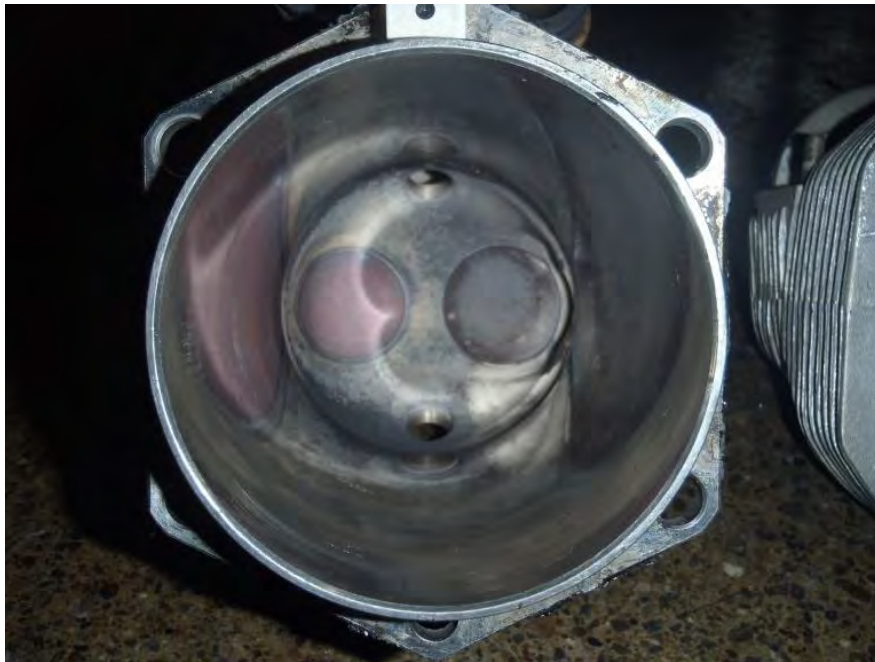
The #1 cylinder remained attached to its cylinder bay and was undamaged. It was noted that there was no torque seal on any of the cylinder attachment nuts. The cylinder was removed and visually inspected. It was noted that there was a significant amount of black sealant type material covering the majority of the cylinder flange and skirt. The internal portion of the cylinder displayed normal operating and combustion signatures. The rocker arms, valves, and springs displayed normal operating signatures.

Figure 14 - photo of #1 cylinder

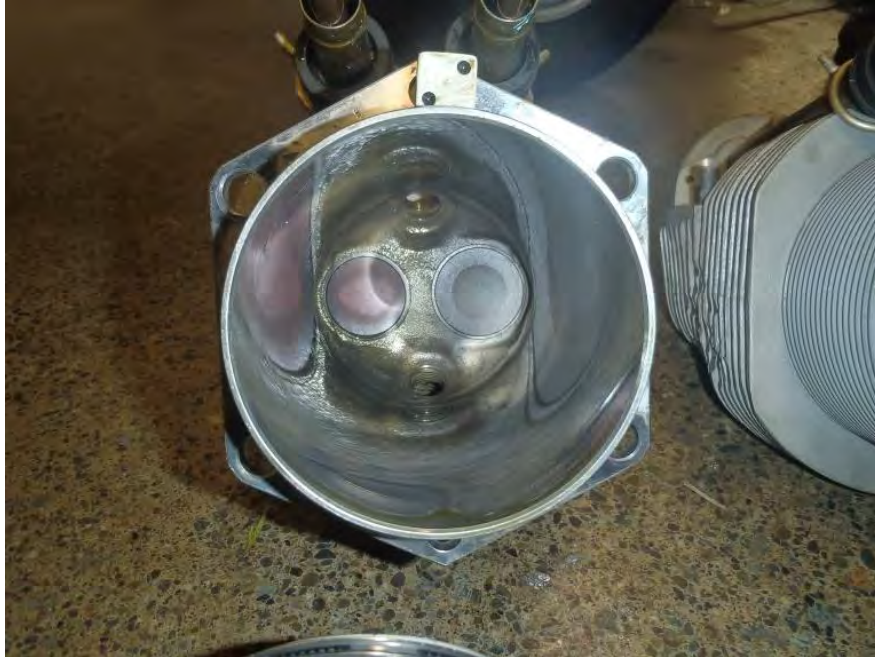
The #2 cylinder remained attached to its cylinder bay and was undamaged. It was noted that there was no torque seal on any of the cylinder attachment nuts and it was noted that one of the cylinder hold down nuts appeared to be a standard nut in contrast to typical cylinder hold down nuts. The cylinder was removed and visually inspected. The internal portion of the cylinder displayed normal operating and combustion signatures. The rocker arms, valves, and springs displayed normal operating signatures. It was noted that the #2 cylinder was the only cylinder without black sealant present around the flange and skirt.

Figure 15 - photo of #2 cylinder

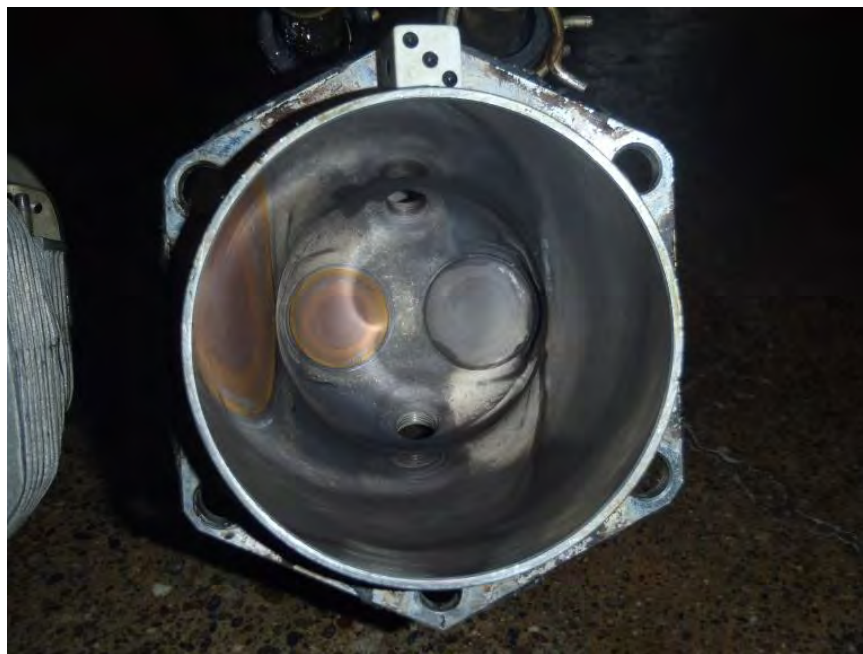
The #3 cylinder remained attached to its cylinder bay and was undamaged. It was noted that there was no torque seal on any of the cylinder attachment nuts. The cylinder was removed and visually inspected. It was noted that there was a significant amount of black sealant type material covering the majority of the cylinder flange and skirt. The internal portion of the cylinder displayed normal operating and combustion signatures. The rocker arms, valves, and springs displayed normal operating signatures.

Figure 16 - photo of #3 cylinder

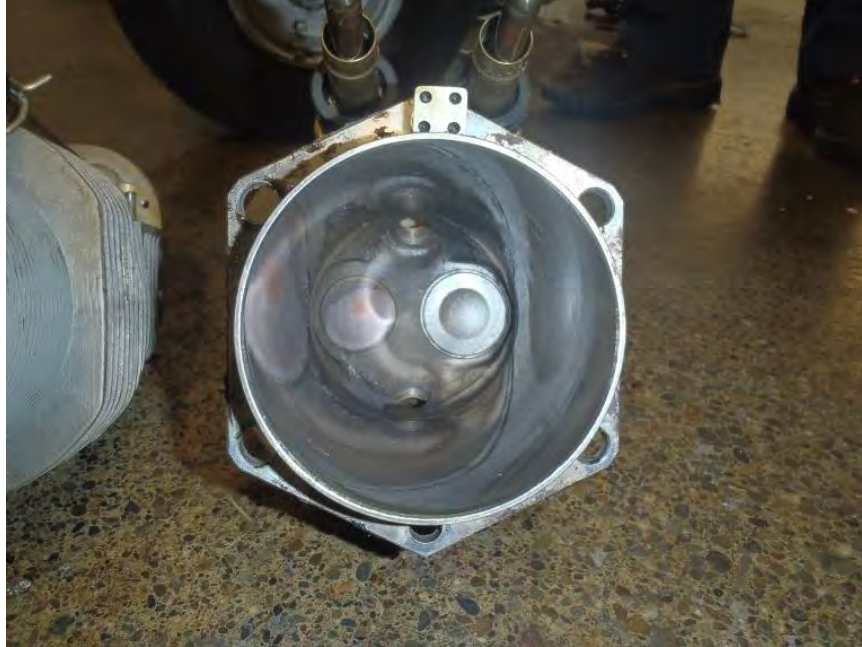
The #4 cylinder remained attached to its cylinder bay and was undamaged. It was noted that there was no torque seal on any of the cylinder attachment nuts. The cylinder was removed and visually inspected. It was noted that there was a significant amount of black sealant type material covering the majority of the cylinder flange and skirt. The internal portion of the cylinder displayed normal operating and combustion signatures. The rocker arms, valves, and springs displayed normal operating signatures.

Figure 17 - photo of #4 cylinder

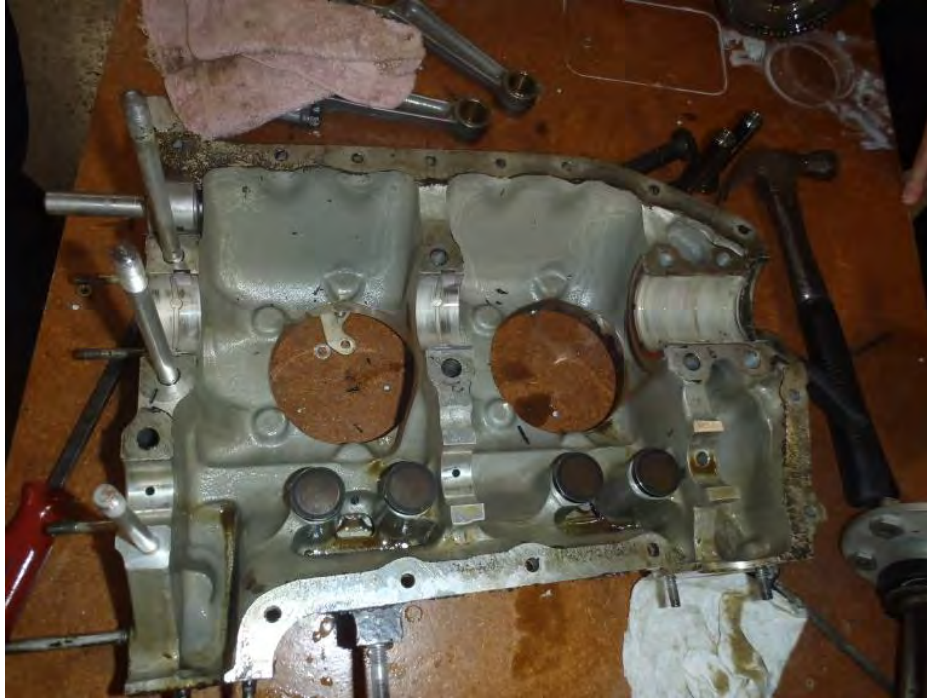
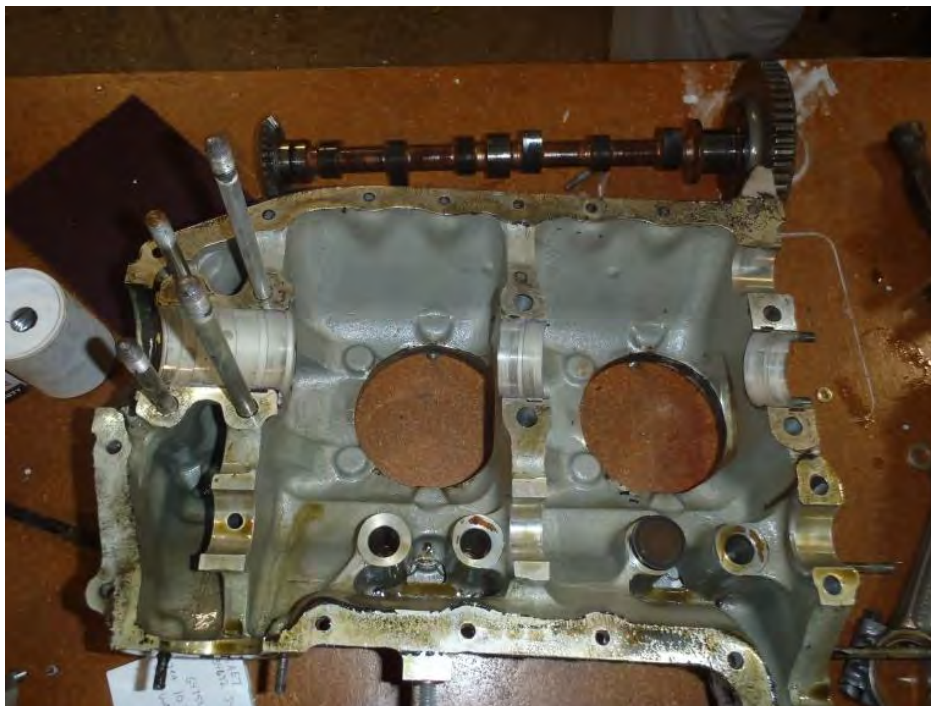
The crankcase was intact and undamaged. The crankcase halves were split and the crankcase was visually inspected. It was noted that there was black sealant applied to the crankcase halves mating surfaces and there was no silk thread noted on the crankcase half mating surfaces. It was also noted that the black sealant material was found in several of the oil galleys. There were no signs of bearing shift or lock tab elongation. The accessory case displayed damage on the inside of the case; the damage was consistent with impact with the sheered crankshaft gear bolts.

Figure 18 - photo #1 of crankcase

Figure 19 - photo #2 of crankcase

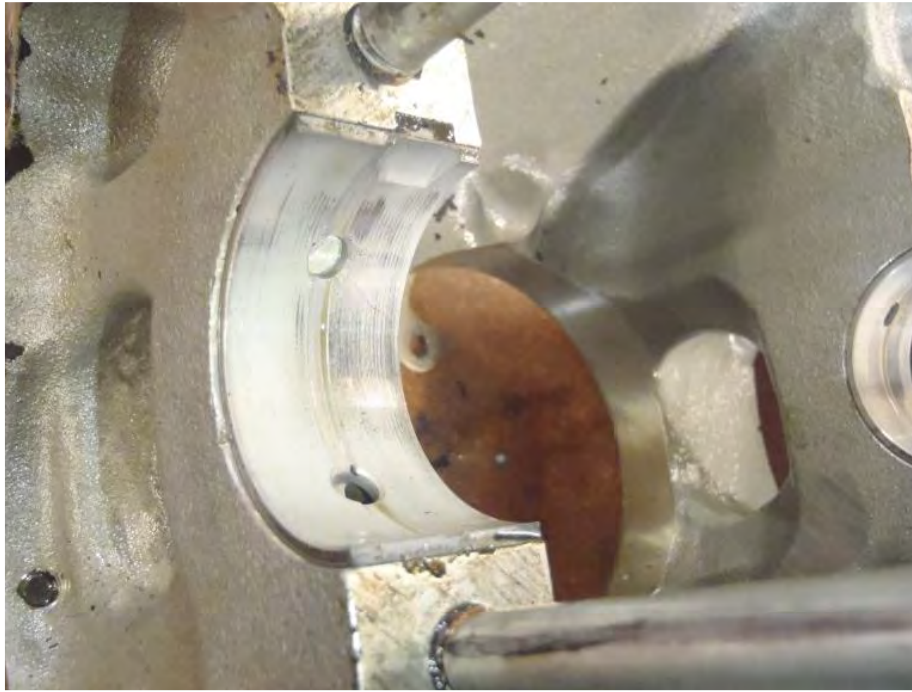
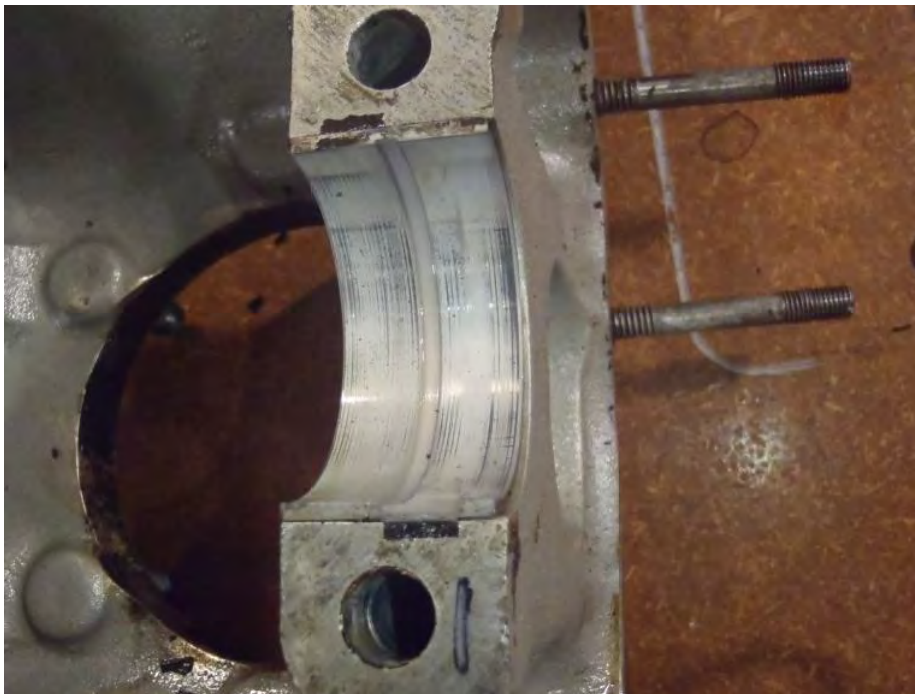
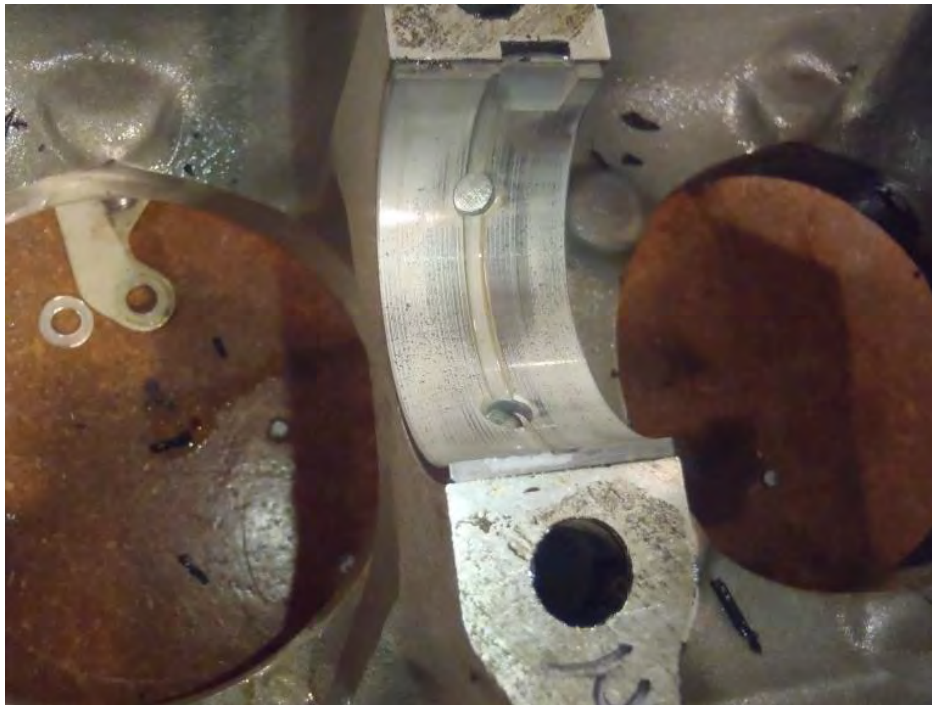
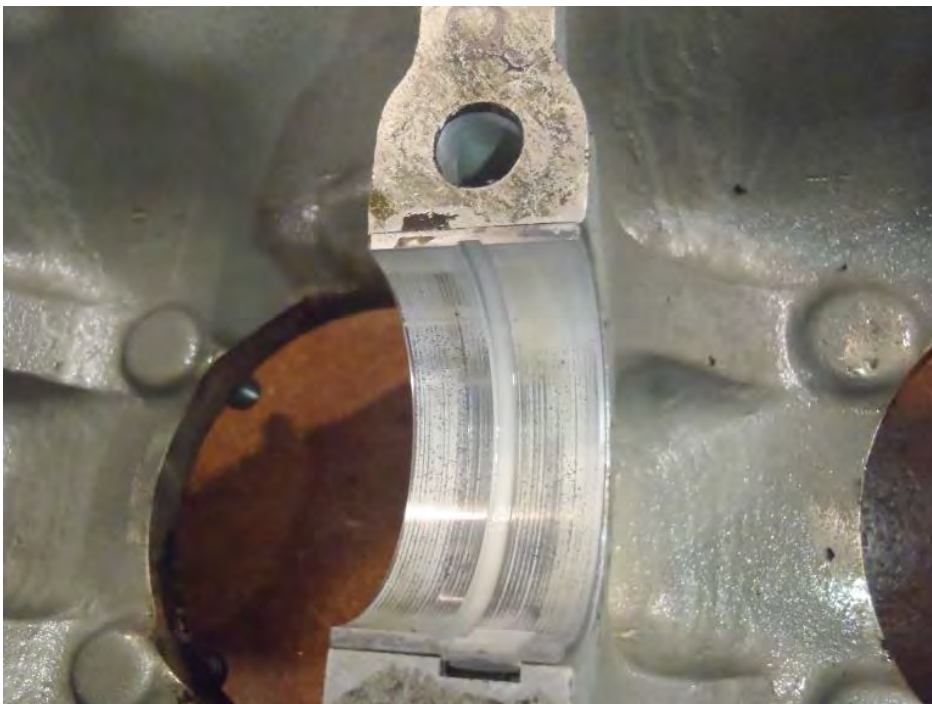
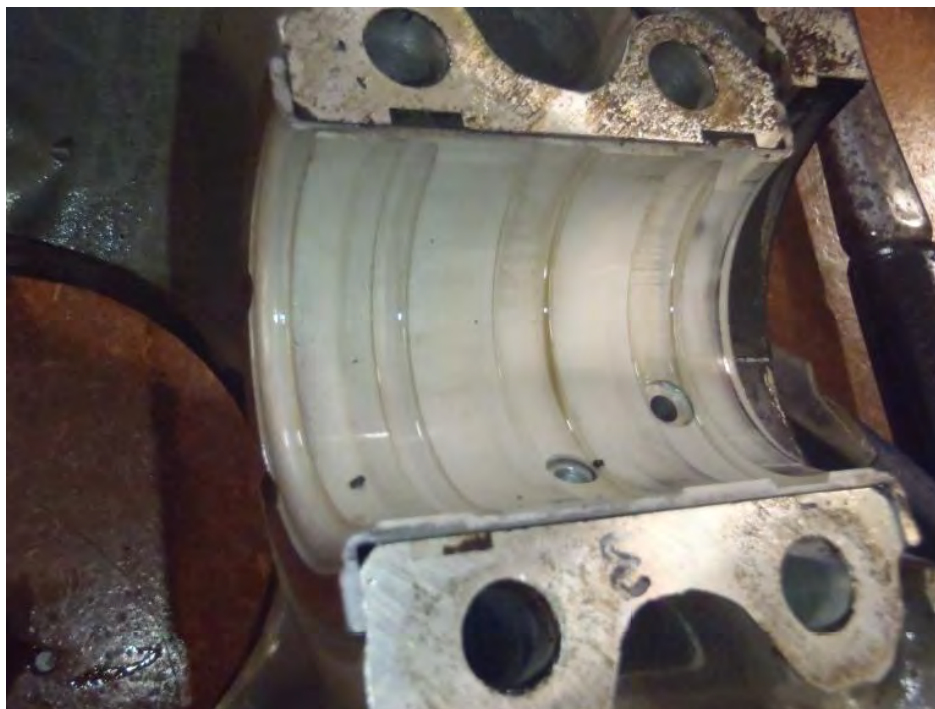
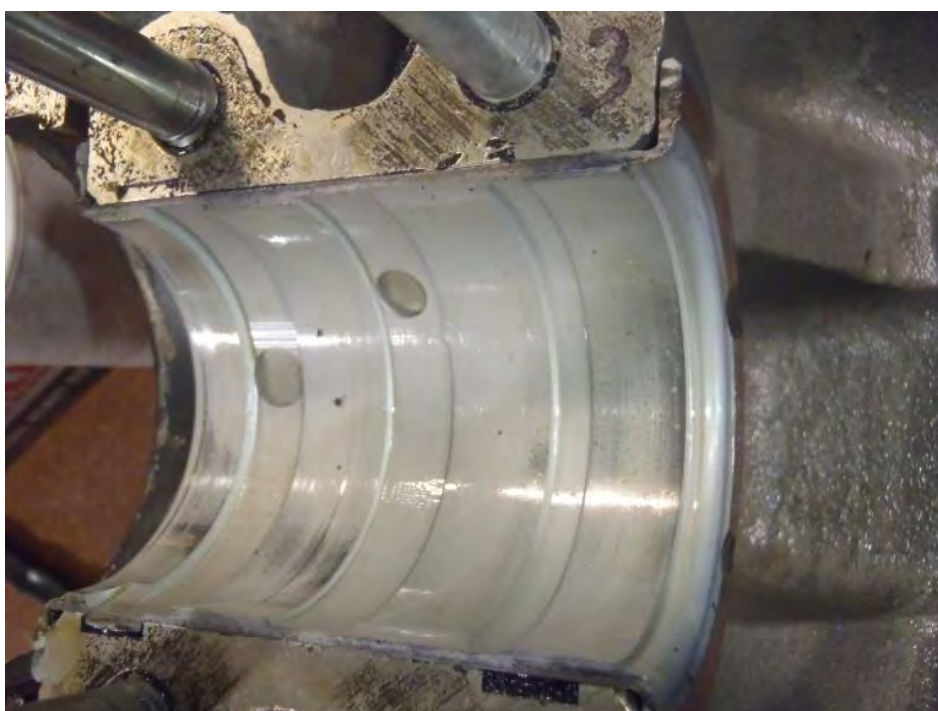
Each of the three (3) bearing remained within their bearing support and displayed normal operating and lubrication signature.

Figure 20 – photo 1 of #1 main bearing half

Figure 21 – photo 2 of #1 main bearing half

Figure 22 - photo 1 of #2 bearing half

Figure 23 - photo 2 of #2 bearing half

Figure 24 - photo 1 of #3 bearing half

Figure 25 - photo 2 of #3 bearing half

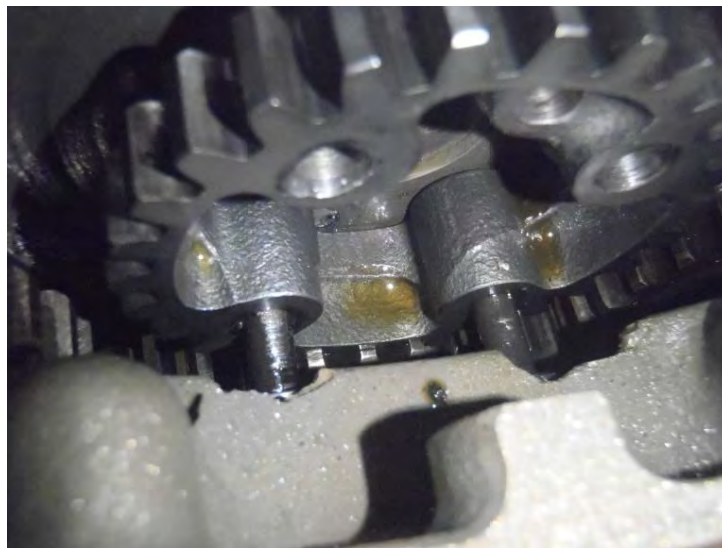
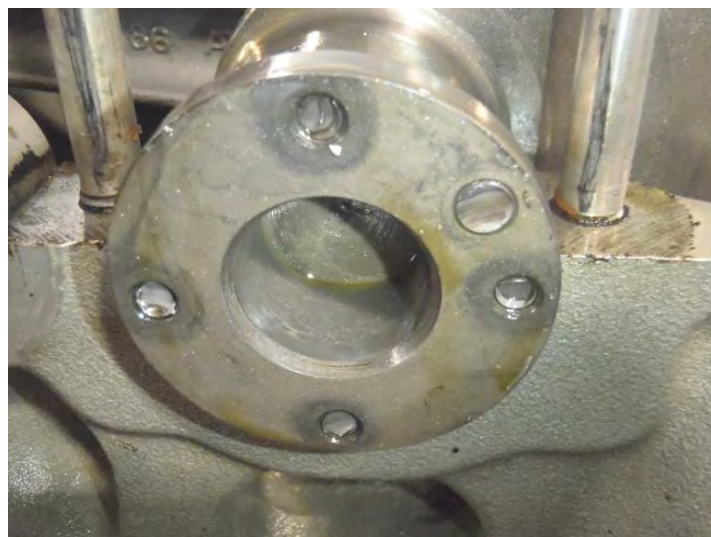
The crankshaft remained intact; however, it was noted that the crankshaft gear bolts and dowel pin had sheered, and the crankshaft gear was no longer secured to the crankshaft. Two of the crankshaft gear bolts remained partially within the gear and were impinged against the accessory case. Additionally, one bolt was located in the oil sump, while another bolt was located in the accessory case. The two bolts that were impinged against the accessory case were noted to be safety wired together, while the other two bolts were not safety wired together. It was noted that one of the bolts had safety wire, and the wire was broken at one end, the other bolt was void of any safety wire. The crankshaft was removed from the crankcase and the connecting rods were removed. The crankshaft, crankshaft gear, crankshaft gear bolts, and crankshaft gear dowel pin were retained by the NTSB IIC for further examination.

Due to the sheered crankshaft gear nuts and dowel pin, the internal timing could not be verified.

Figure 26 - photo of crankshaft gear

Figure 27 - photo of crankshaft

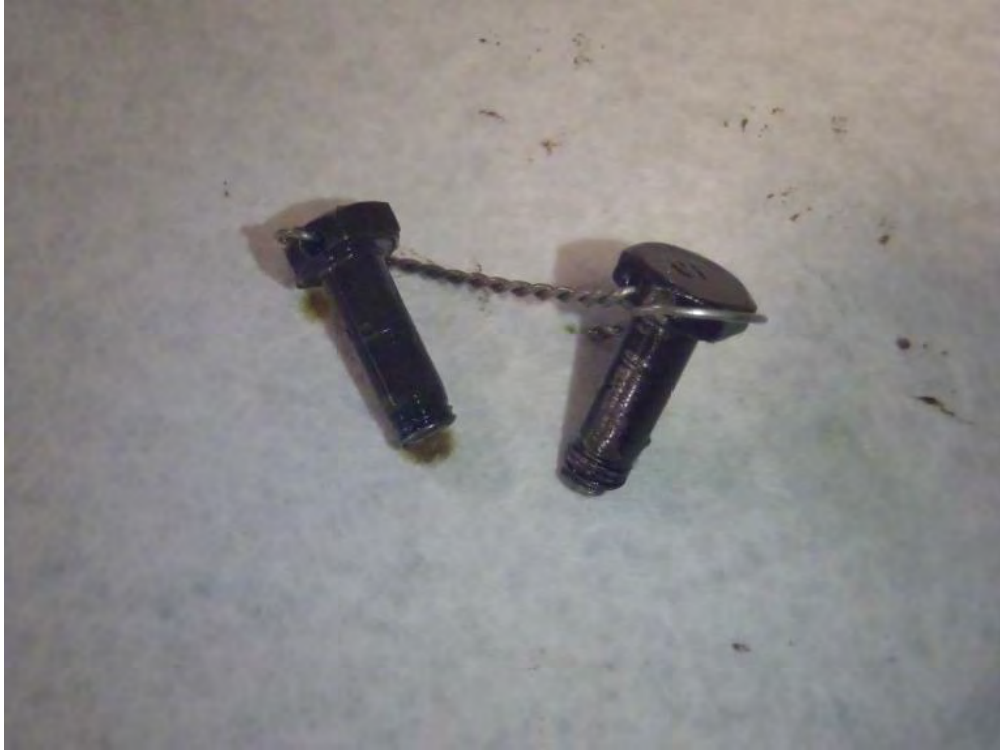
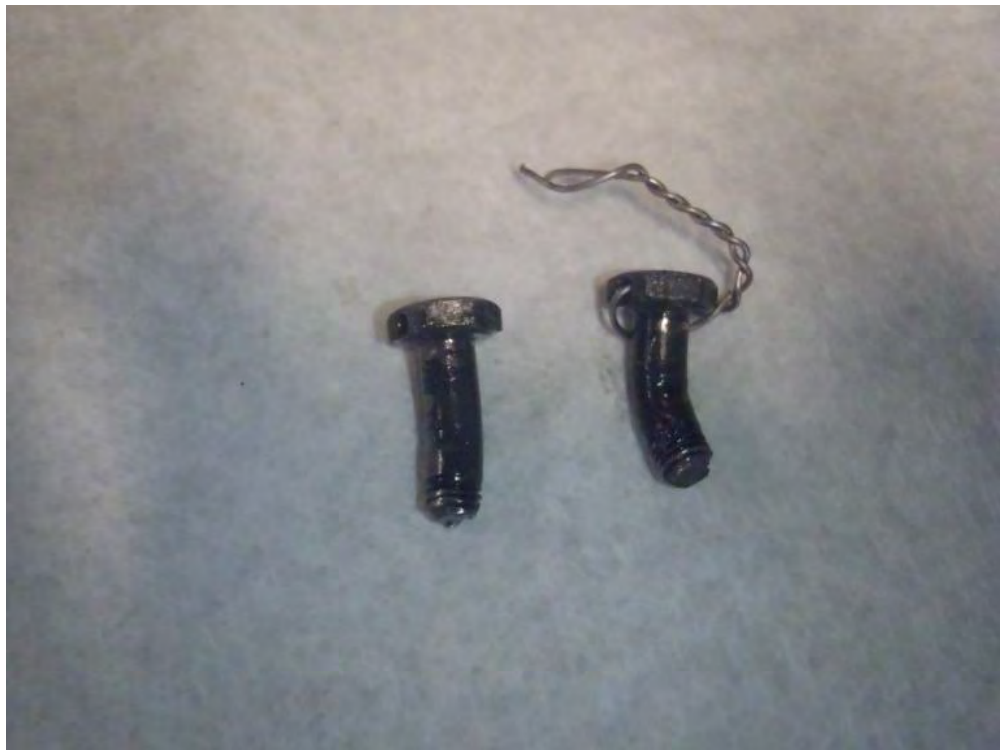
Figure 28 - photo of crankshaft gear bolts

Figure 29 - photo of crankshaft gear bolts

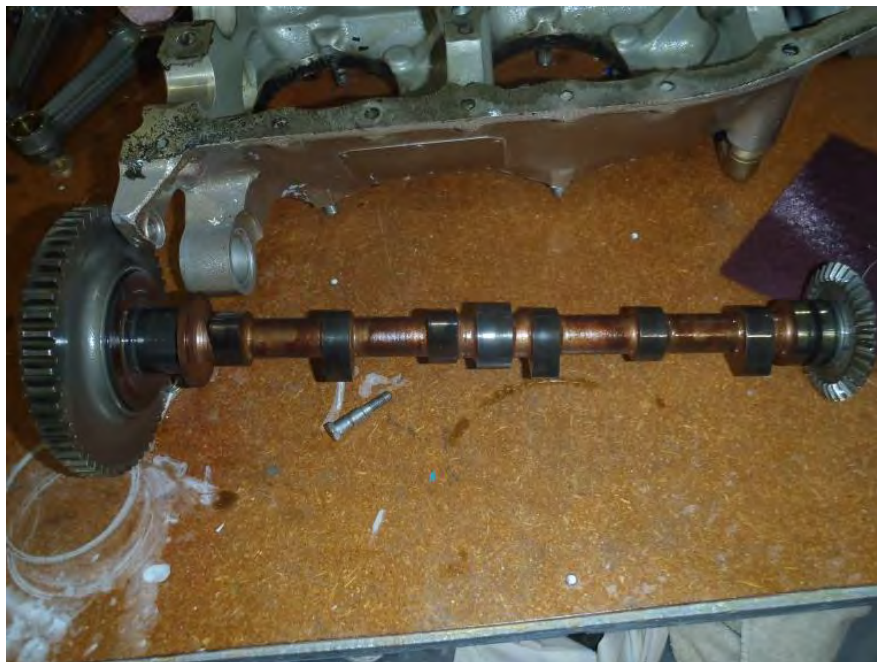
The camshaft remained intact and undamaged. Due to the sheered crankshaft gear bolts and dowel pin the camshaft would not rotate during crankshaft rotation. A tool was placed in the rear of the camshaft and the camshaft was rotated by hand; it was noted that the camshaft was capable of normal rotation and the camshaft operated valve train.

Figure 30 - photo of camshaft

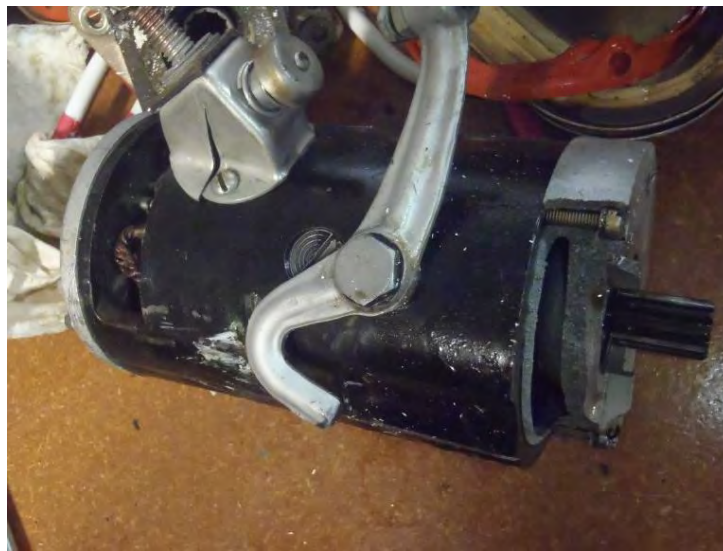
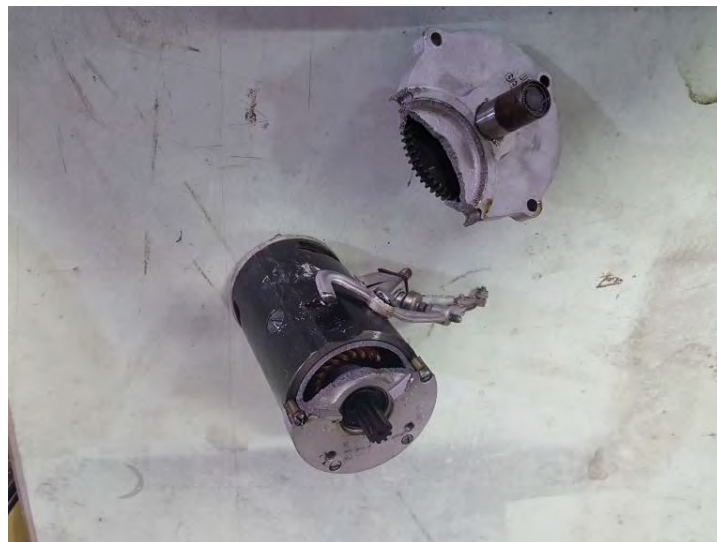
The starter had been removed prior to the investigator's arrival. According to the recovery personnel the starter motor was imbedded in the aircraft firewall and was removed for safety reasons. The starter displayed damage consistent with impact damage and was broken into two pieces. The starter gear and clutch assembly was separated from the rest of the motor; the starter gear that engages the crankshaft gear was checked to ensure it would spin freely when spun in the direction of normal crankshaft rotation, the gear operated normally. The starter was retained by the NTSB for possible further examination.

Figure 31 - photo #1 of starter

Figure 32 - photo #2 of starter

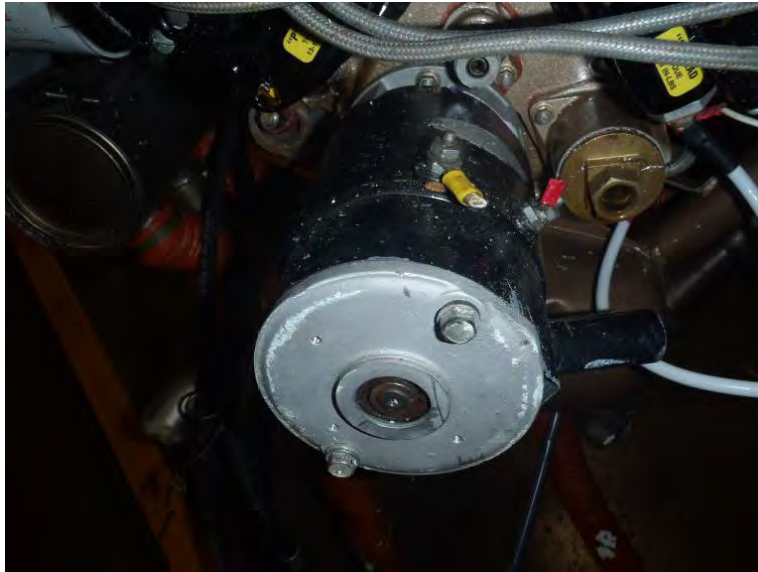
The generator remained intact and undamaged. There were no anomalies noted with the generator.

Figure 33 - photo of generator

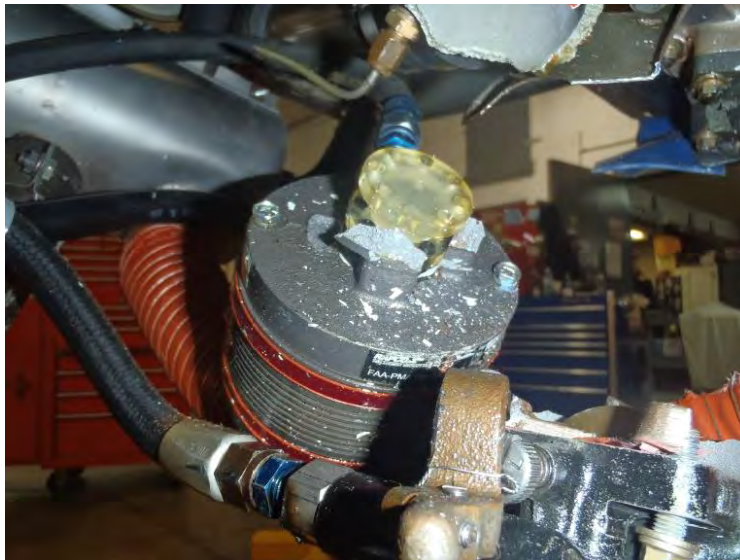
The vacuum pump had broken free from its mounting location and displayed damage consistent with impact damage. It was noted that the sheer coupling remained intact. There were no anomalies noted with the vacuum pump.

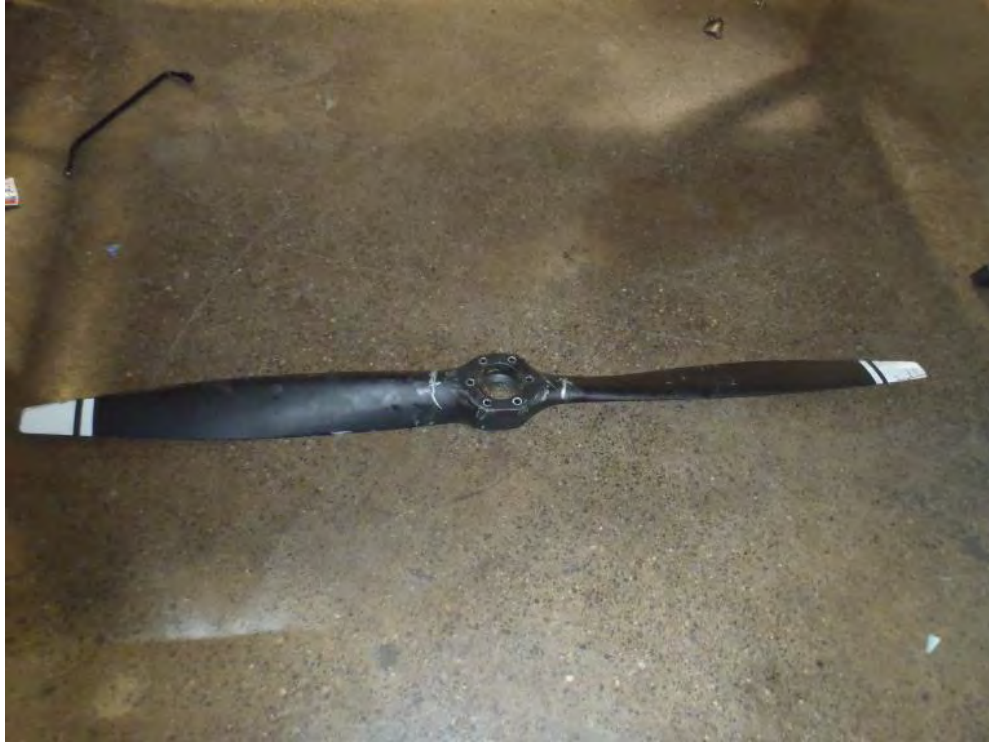
The propeller remained intact and attached to the crankshaft. Both of the propeller blades displayed very little impact damage and it was noted that there was no bending or twisting deformation. The spinner was crushed aft and had material consistent with wood imbedded in the center portion of the spinner.

Figure 34 - photo of propeller

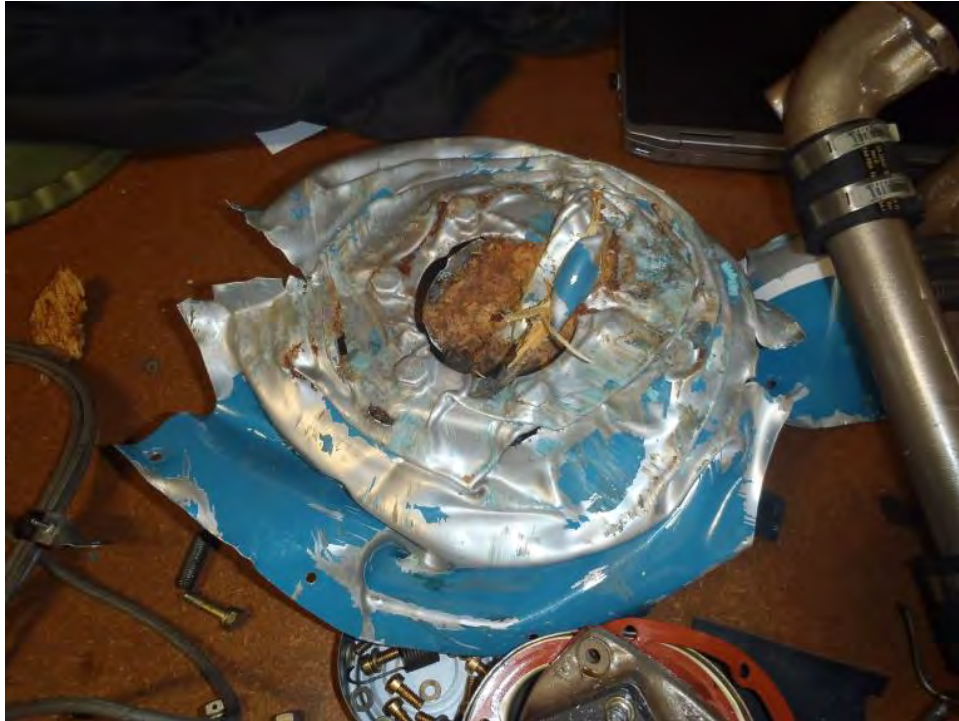
Figure 35 - photo of propeller spinner
