# NATIONAL TRANSPORTATION SAFETY BOARD

## MATERIALS LABORATORY FACTUAL REPORT

Report No. 16-024

Place : Port Townsend, WA  
Date : September 28, 2015  
Vehicle : Cessna 150F, N8529G  
NTSB No. : WPR15FA268  
Investigator : Tom Little

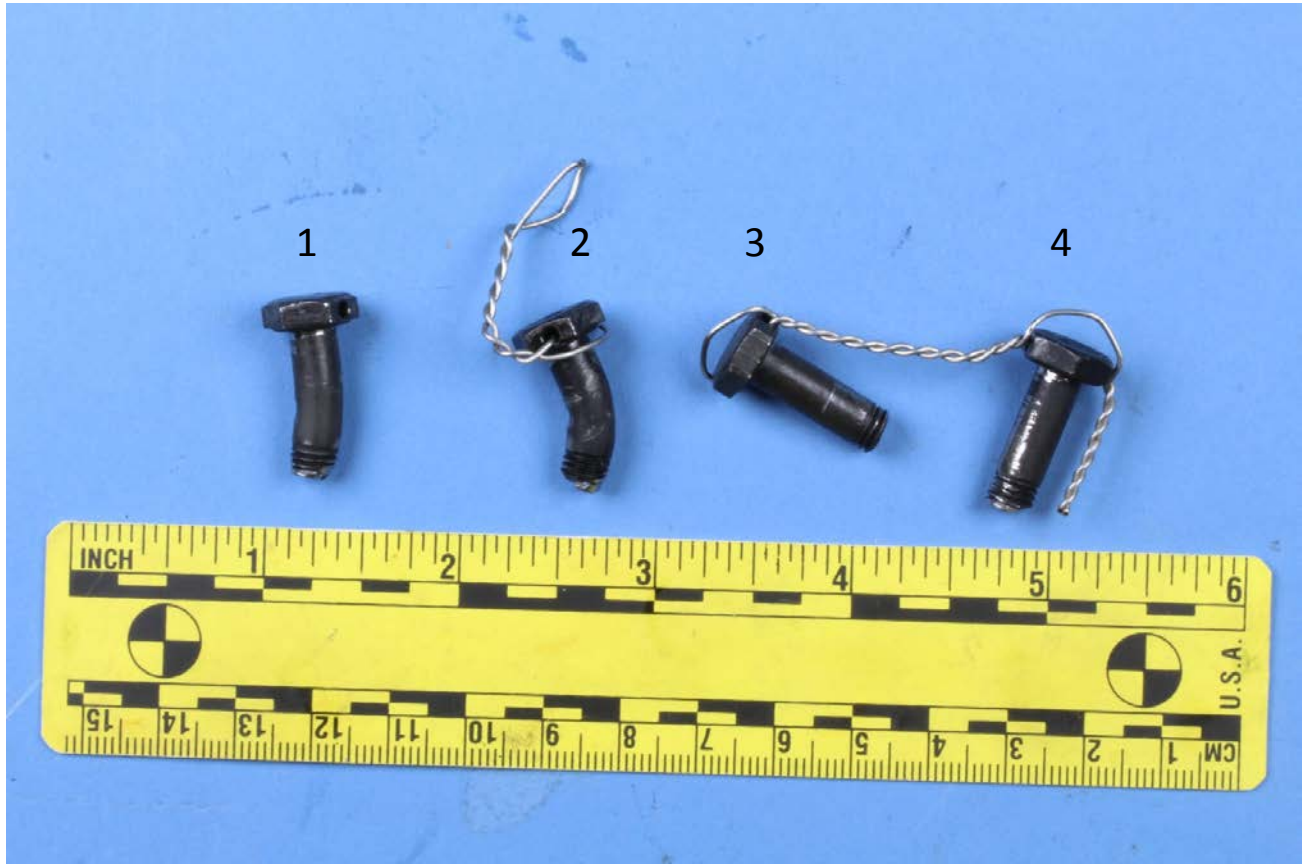
The four crankshaft gear bolts all exhibited fractures in their threaded portion (figure 1). These bolts are labeled 1 – 4 in figure 1. Bolts #3 and #4 remained safety wired to each other and did not exhibit gross plastic deformation (figure 2). These two bolts both exhibited flat fractures and crack arrest marks consistent with fatigue fractures (figures 3,4). Bolts #1 and #2 exhibited gross plastic deformation in the shank portion. Bolt #1 had broken free of the safety wire and bolt #2 had a portion of safety wire still attached. Both of these two bolts exhibited fractures consistent with overstress. Hardness measurements (average of 4 measurements) of bolts #3 and #4 resulted in a measured hardness of 28.5 HRC and 23.6 HRC respectively.

Figure 1: Crankshaft gear bolts.

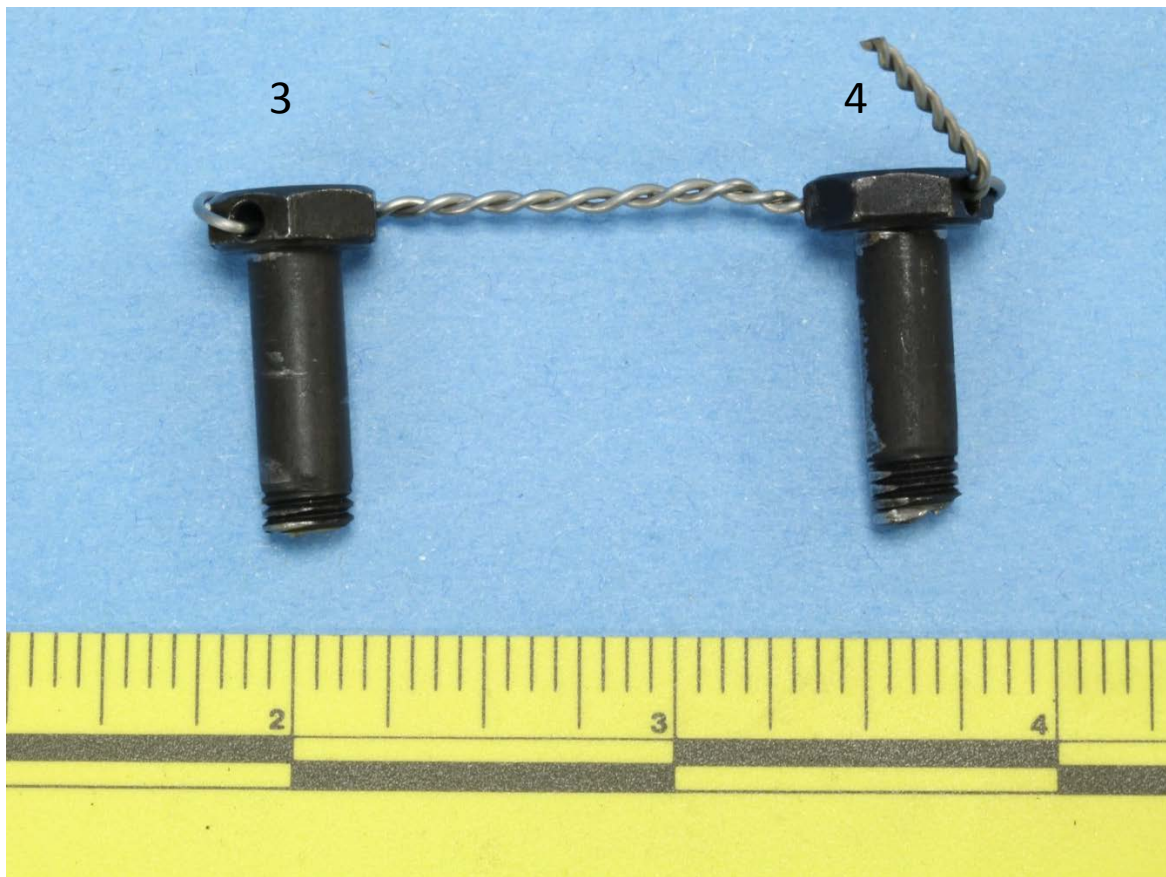
Figure 2: Two gear bolts without plastic deformation and exhibiting flat fracture surfaces.

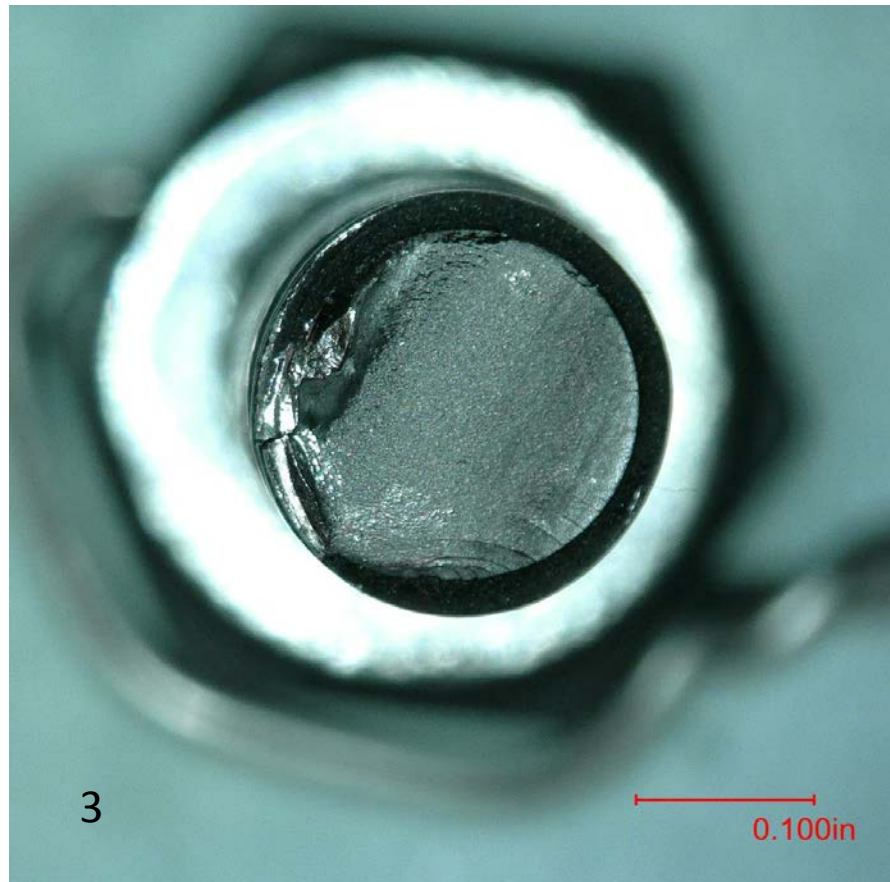
Figure 3: Crankshaft gear bolt fracture surface (bolt #3).

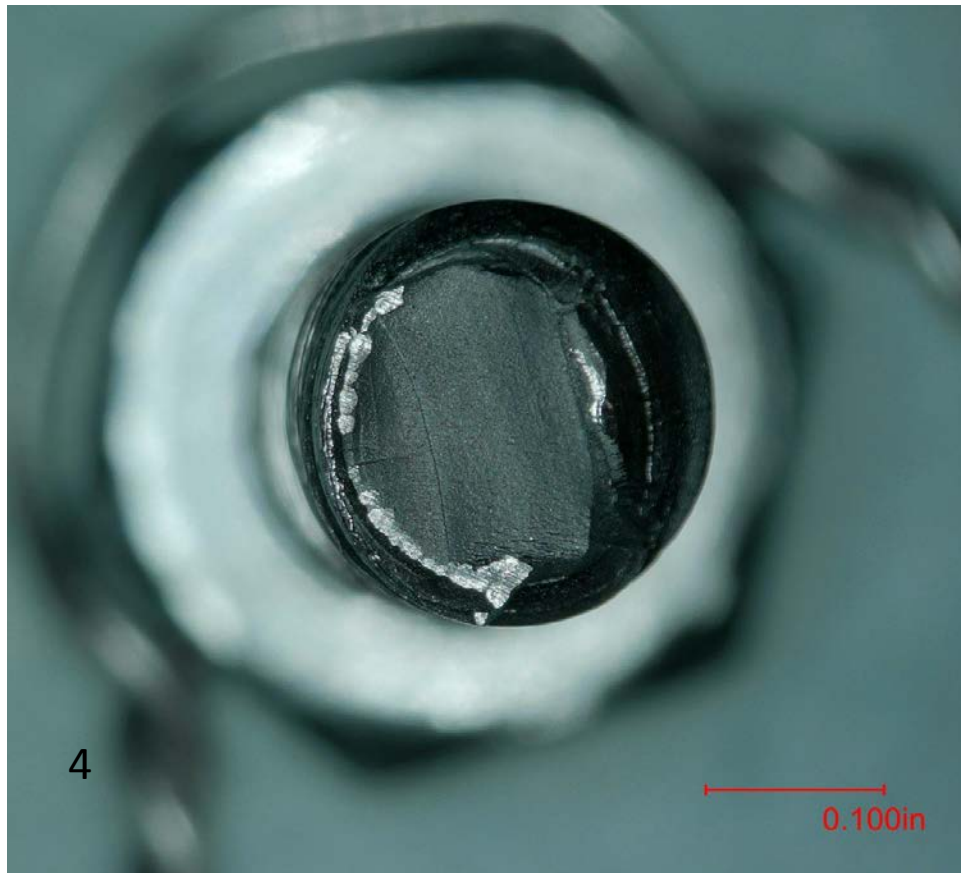
Figure 4: Crankshaft gear bolt fracture surface (bolt #4).

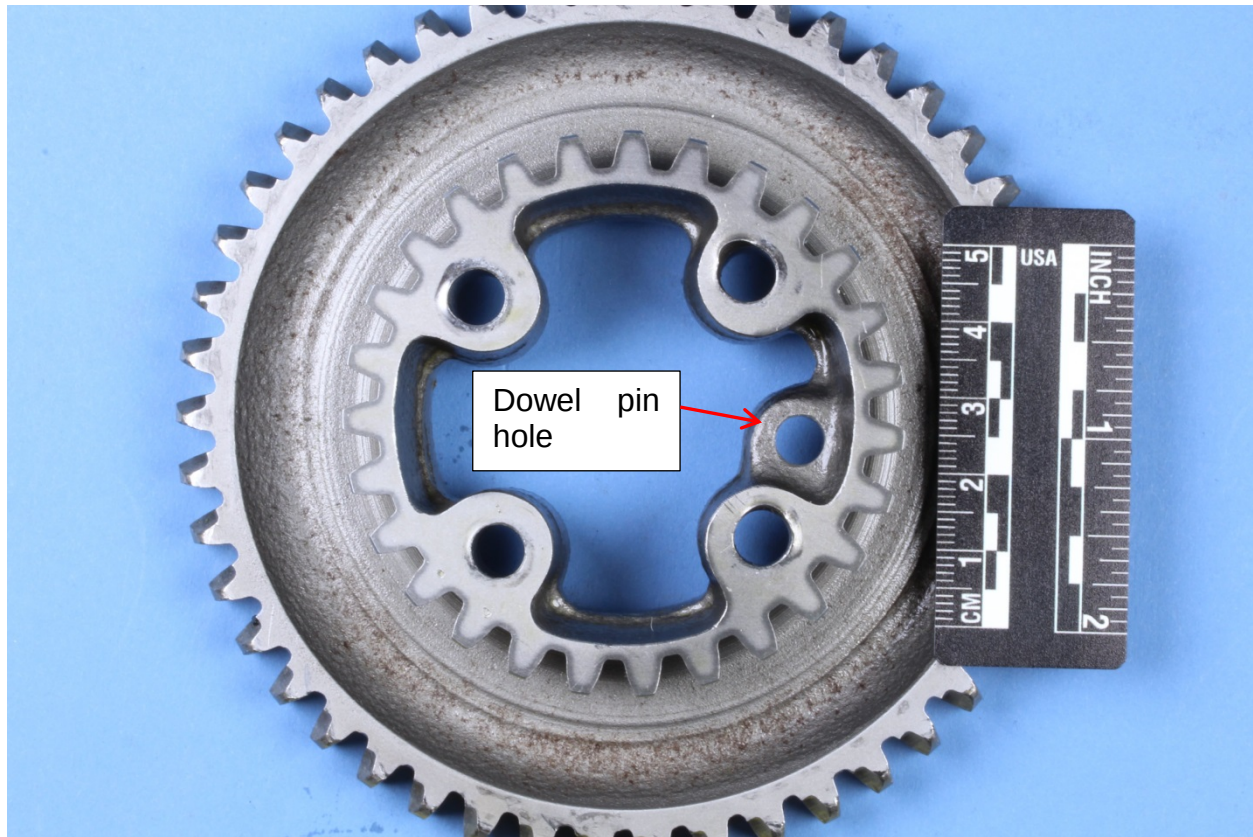
The bolt holes in the crankshaft gear had become elongated. The effect was more pronounced on the side facing the bolt heads. The two bolt holes surrounding the dowel pin hole appeared more elongated than the other two bolt holes (figure 5). The crankshaft gear exhibited polishing wear at the interface with the bolt heads. This polishing wear was evident at all of the bolt holes and resembled the pattern of the bolt heads. The crankshaft gear teeth appeared to be well formed and did not exhibit any irregularities or uneven wear.

Figure 5: Crankshaft gear (bolt head side).

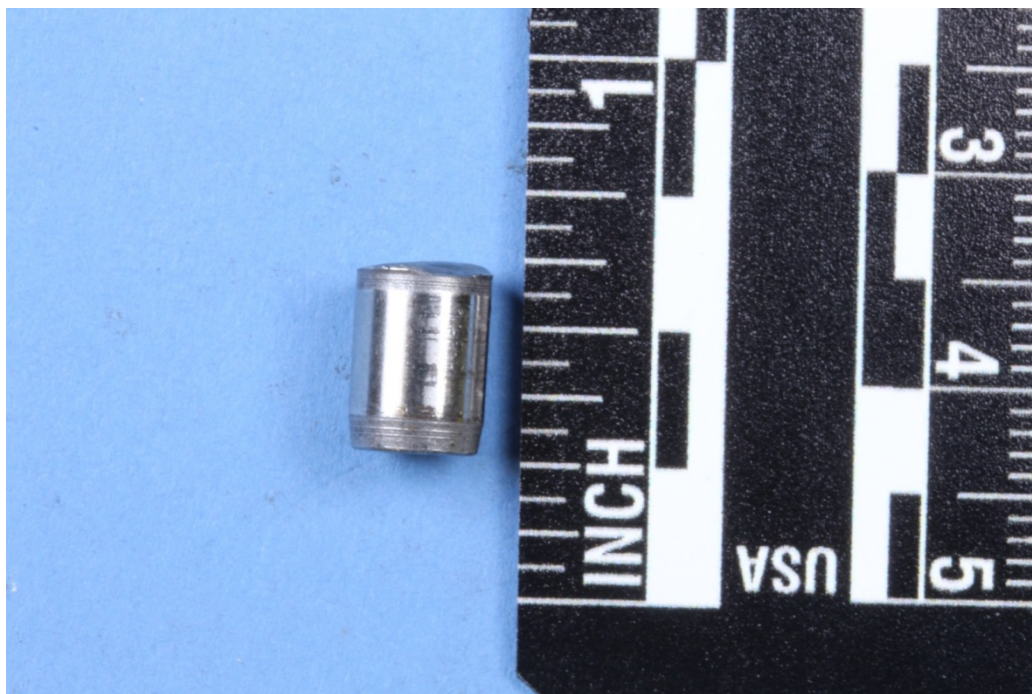
The crankshaft gear dowel pin was fractured and partially missing (figure 6). The portion that was submitted to the laboratory contained a flat fracture surface. Examination of the fracture surface using a stereo microscope revealed crack arrest marks and ratchet marks consistent with a fatigue fracture (figure 7). There were 3

Figure 6: Portion of the crankshaft gear dowel pin.

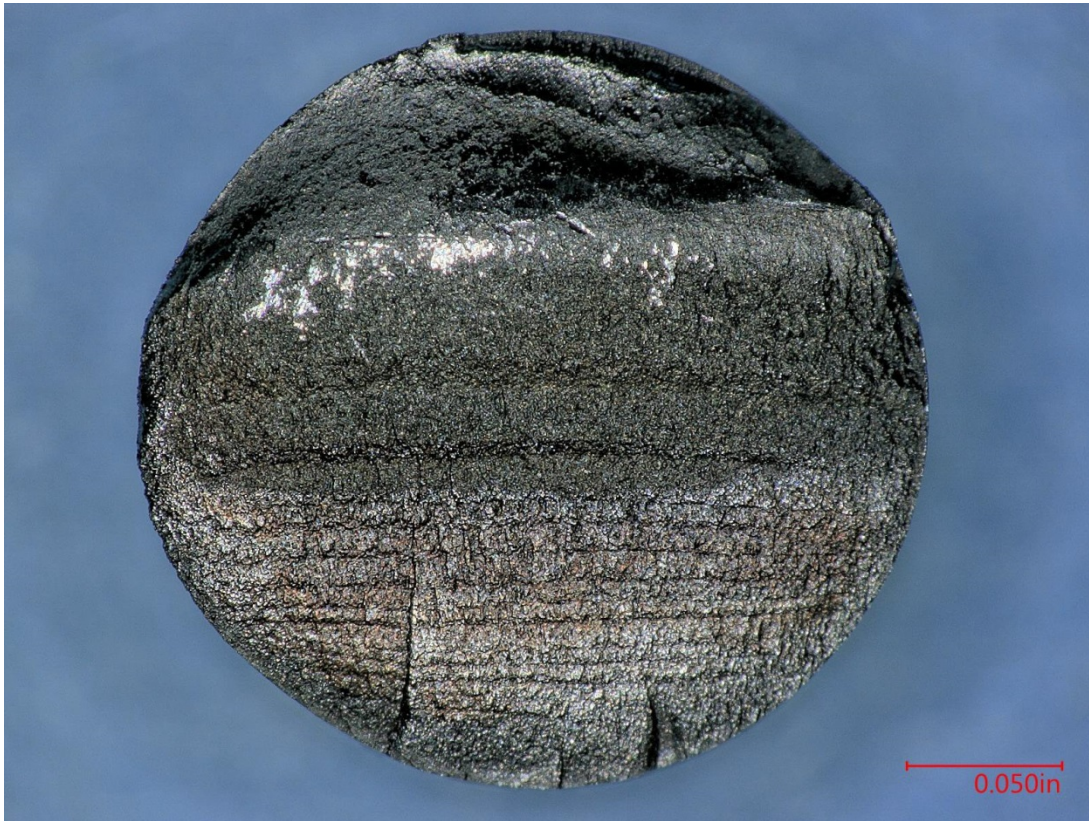
prominent ratchet marks indicating a fatigue fracture with multiple origins. Examination of the body of the dowel pin revealed wear marks on one side (figure 8)

Figure 7: Crack arrest marks and ratchet marks on dowel pin fracture surface.

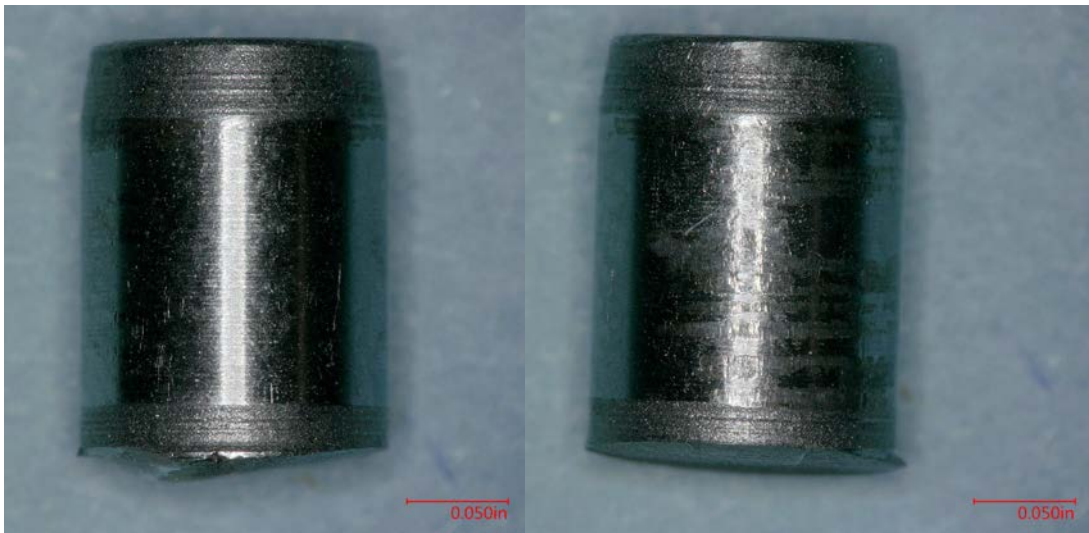
Figure 8: Opposing sides of crankshaft dowel pin body.
