## Service Bulletin

SB99-71-06

ENGINE EXHAUST TAILPIPE LANYARD INSTALLATION AND FUEL FLOW TRANSDUCER RELOCATION

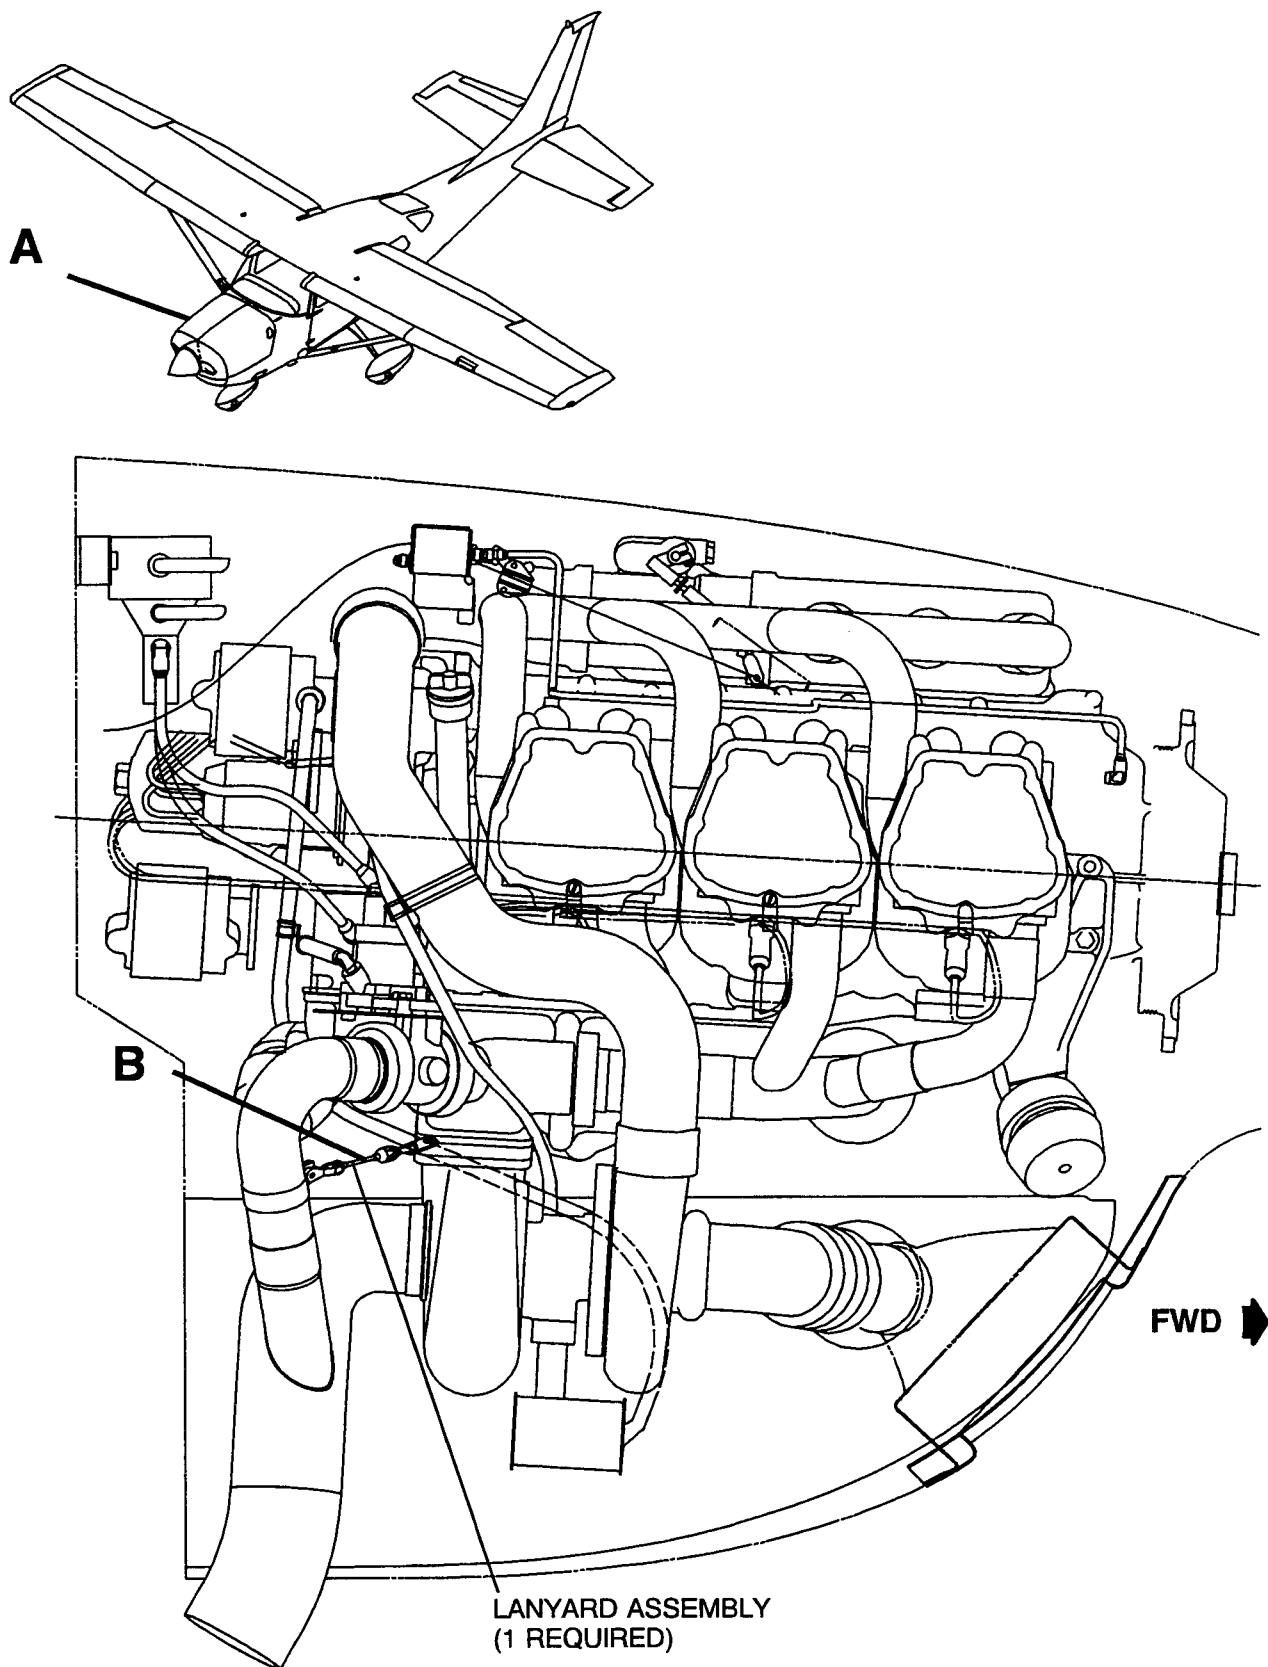
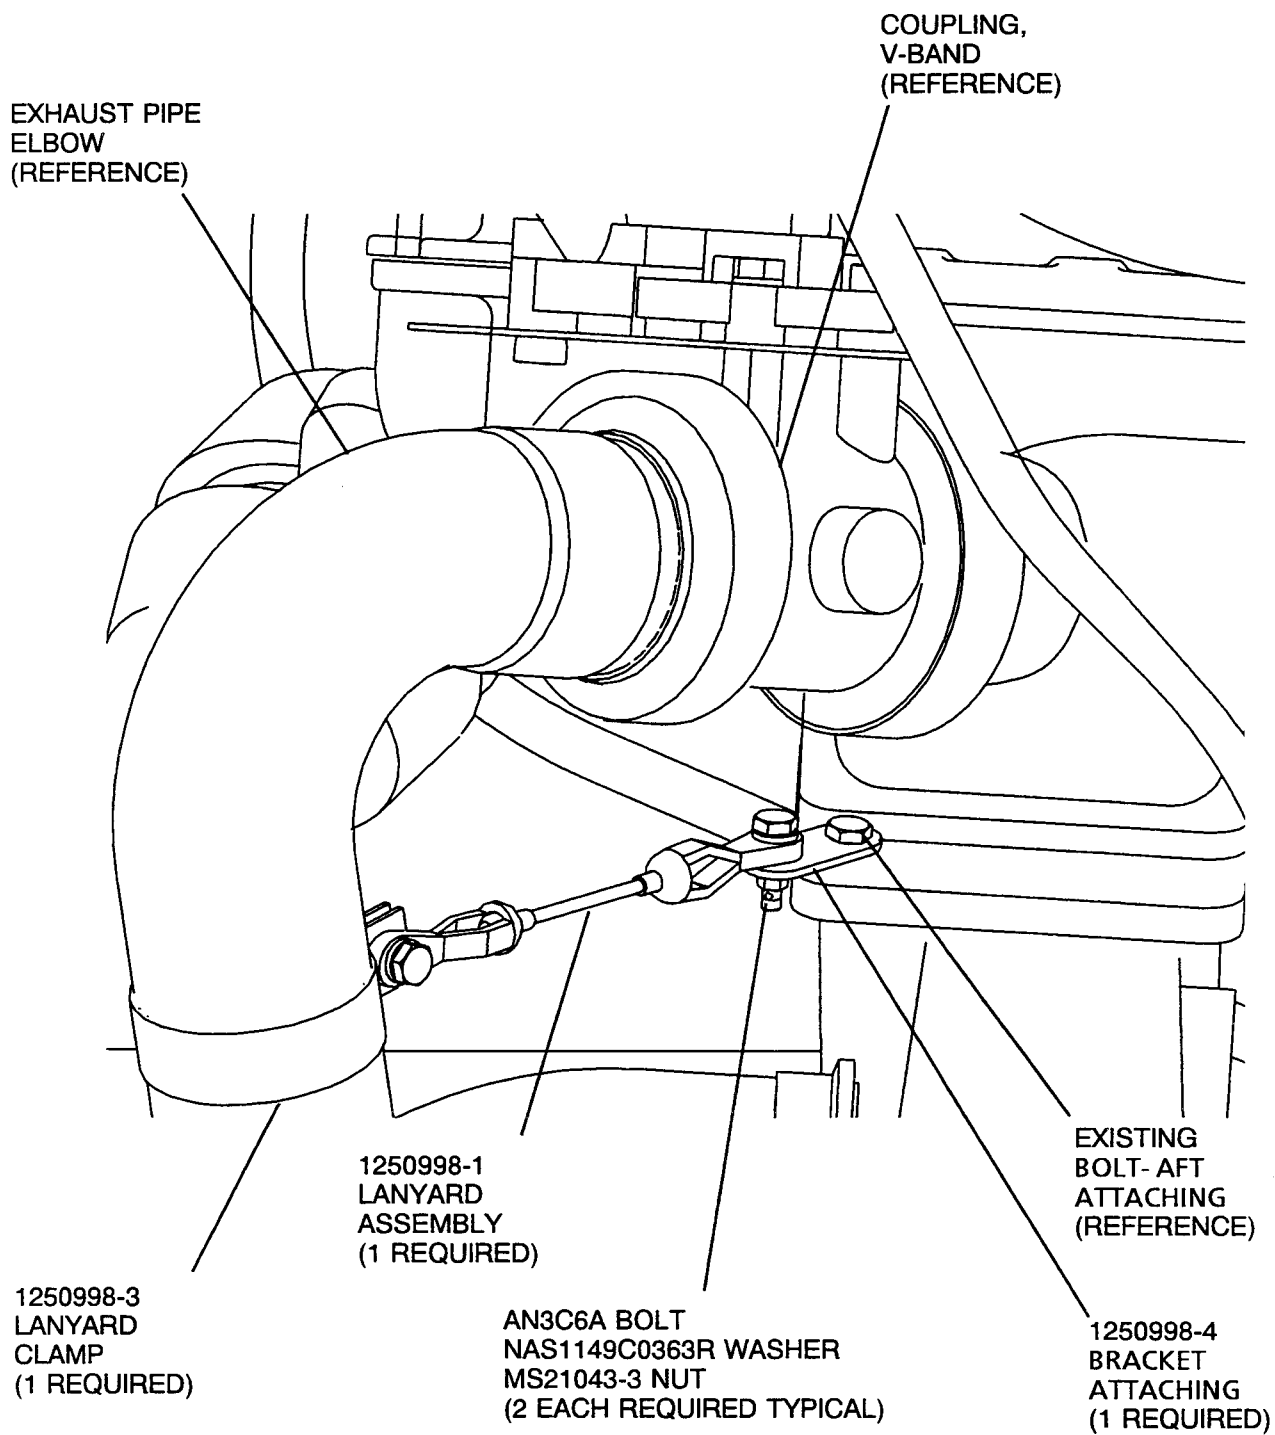
Figure 2. Exhaust Lanyard Installation. (Sheet 1 of 2)

For airplane serial numbers T20608001 thru T20608112: installation of an exhaust tailpipe lanyard is required to provide a safety link ensuring positive turbocharger exhaust tailpipe retention should the clamp become loose.

A. (Refer to Figure 3, Sheets 1 and 2) Exhaust lanyard installation:

- (1) Use existing turbocharger attaching hardware (aft outboard attaching bolt) to attach the tailpipe lanyard.

**NOTE:** Install the 1250998-4 Lanyard Attaching Bracket in place of the upper washer for turbo attachment flange bolt. Torque bolt to 360 inch-pounds after lanyard is positioned.

- (2) Install 1250998-3 Lanyard Clamp around the exhaust pipe elbow and reattach the 1250998-1 Lanyard Cable to the clamp with AN3C6A Bolts, MS21043-3 Nuts and NAS1149C0363R Washers.
- (3) Slide lanyard clamp up the waste gate pipe until lanyard assembly is tight or has reached the bend in the exhaust pipe elbow, and torque the clamp bolt.
