**From:** Ryan Sims [REDACTED]  
**Sent:** Tuesday, December 02, 2014 7:13 PM  
**To:** McKenny Van  
**Subject:** Re: NTSB Pilot Accident Report

**From:** Ryan Sims [[mailto:\[REDACTED\]](mailto:[REDACTED])]  
**Sent:** Tuesday, December 02, 2014 6:04 PM  
**To:** McKenny Van  
**Subject:** Re: NTSB Pilot Accident Report

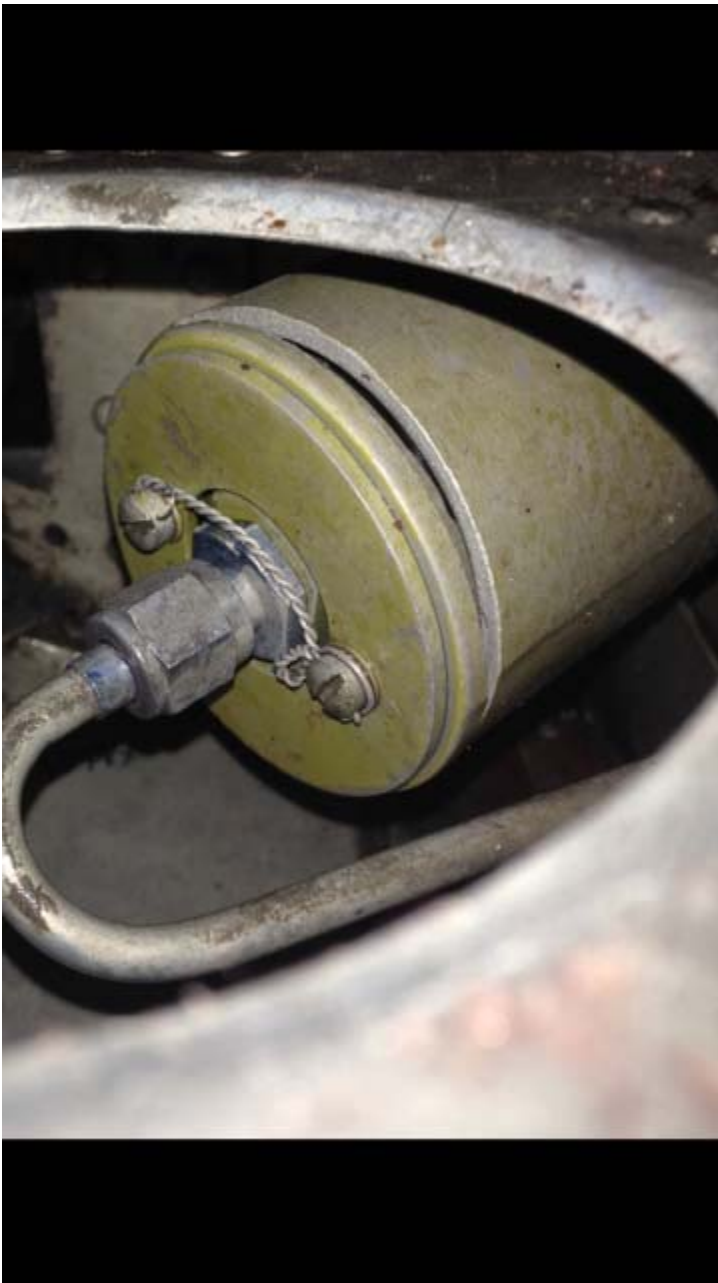
Here is a better picture if this helps.

This is the right main landing gear actuator. Split open at the end there and leaked out all of the hydraulic fluid. I'm assuming this was the loud metal pop I heard when I tried retracting the gear. The mechanics really haven't looked at anything else since they are waiting for the insurance company to take a look at it first. If there are any more findings, I will let you know! Thanks
