## **NATIONAL TRANSPORTATION SAFETY BOARD**

# **ENGINE EXAMINATION**

**WPR15LA067**

Location: Perris, California  
Date: December 21, 2014  
Aircraft: Beaver RX-550, N105JF, Serial #: 105  
NTSB IIC: Elliott Simpson

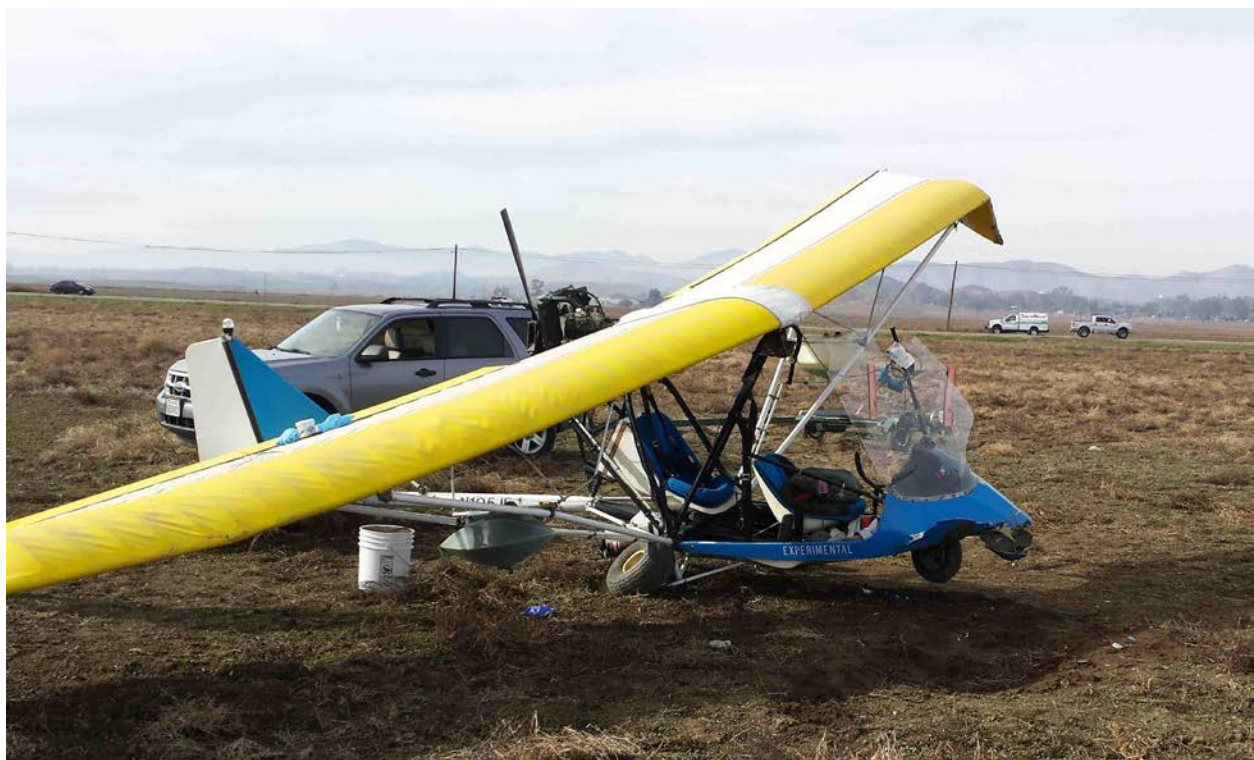
Photos taken at the accident site indicated the airplane came to rest with the right wing low. In those photographs the right wing-mounted fuel tank appeared to be full and leaking blue-colored fuel out of its vent (Photo 1). The left fuel tank, which in the accident orientation was about 3 ft above the right tank, was about 1/5th full (about 1/2 gallon) with fuel. A clay plug had been installed over the right tank vent line by the HAZMAT team in an effort halt the flow of fuel at the accident site. Both fuel tank lines had been crimped by first responders, who reported that fuel was transferring from the right to left tank through gravity as the airplane rested in the field.

Photo 1 - Airplane at Accident Site

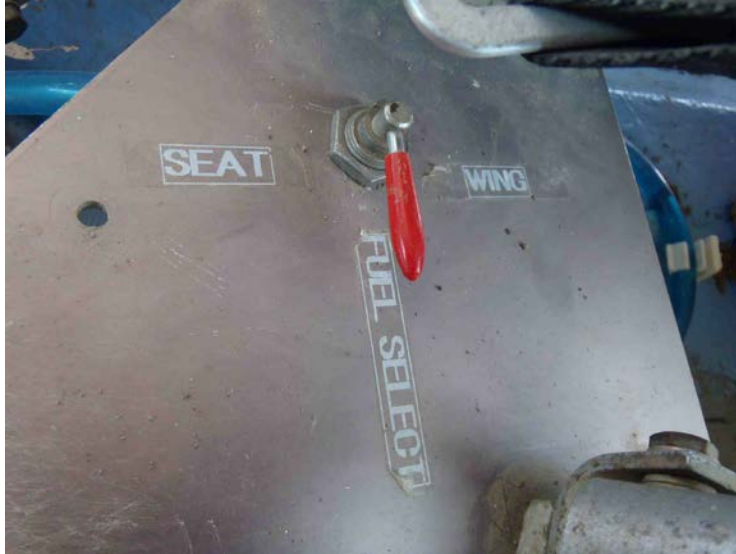
Following recovery, the fuel selector valve was observed in the OFF position (Photo 2), however according to the owner, this had been selected after the airplane was recovered. Movement of fuel between the tanks following the accident was consistent with the valve being set to the WING tank position at that time.

Photo 2 - Fuel Selector Valve

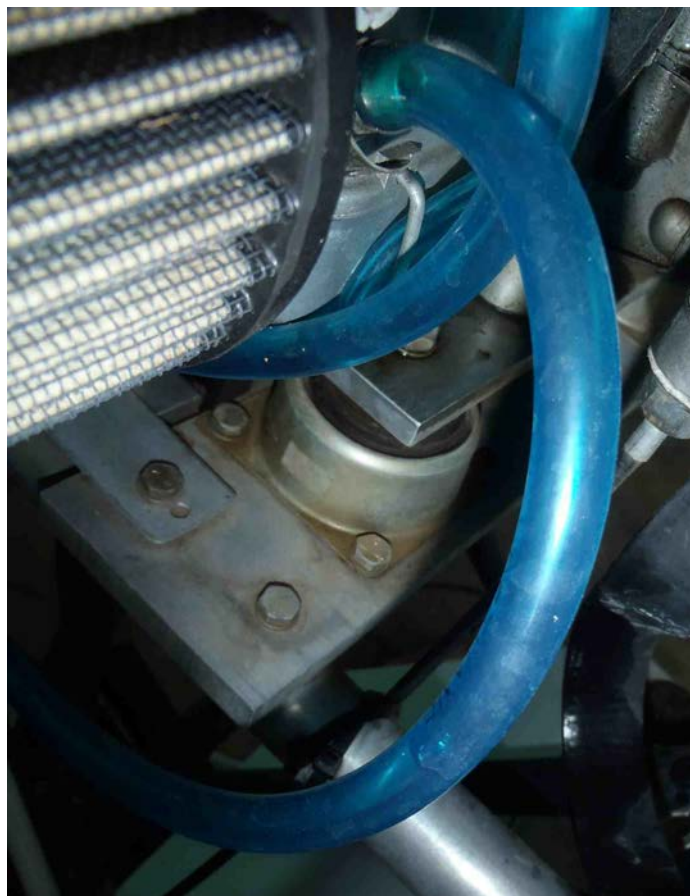
Fuel was observed in all supply lines, from the wing mounted fuel tanks, through to the selector valve, filter, electrical fuel pump, engine driven fuel pump, and carburetors (Photo 3). The main center "seat" fuel tank was empty, along with its fuel lines through to the selector valve. The engine fuel primer was in the closed position, and the single in-line filter contained fuel and appeared free of debris (Photo 4).

Photo 3 - Fuel in Lines

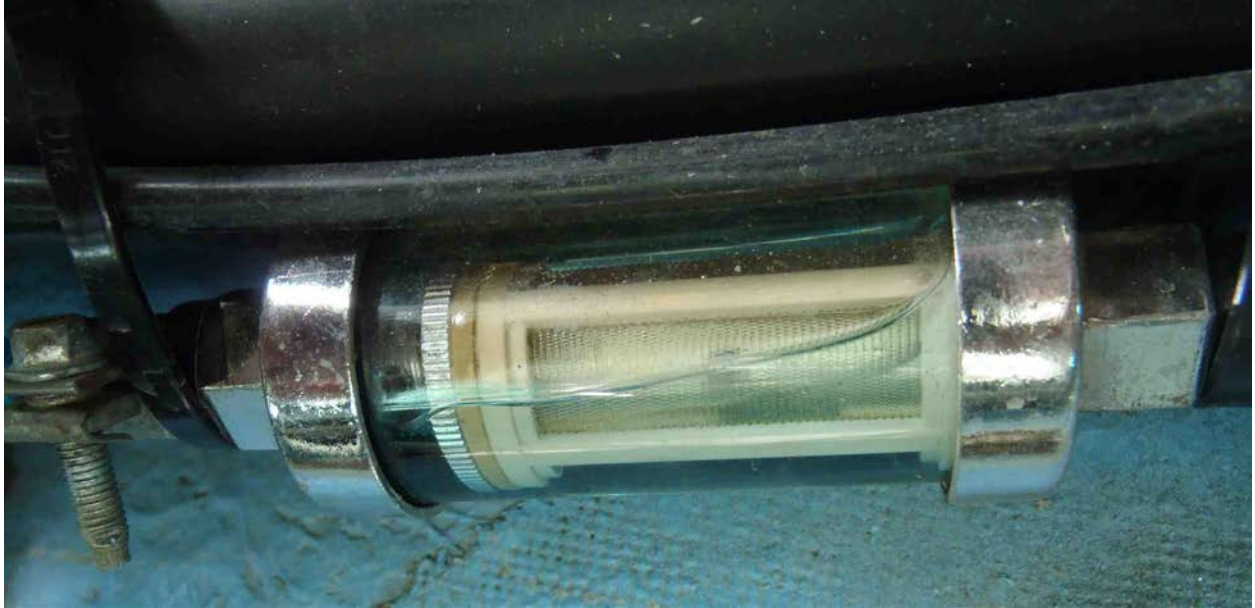
The only fuel filter installed was a plastic-screen type (Photo 4), which was positioned on the "suction" side, just after the selector valve and before both the electrical and engine driven fuel pump. This installation was in deference to the Rotax Installation Manual which required that the filter be installed between the electrical fuel pump and carburetors. The manual also required fuel filters to be installed at each tank, none were located.

Photo 4 - Fuel Filter

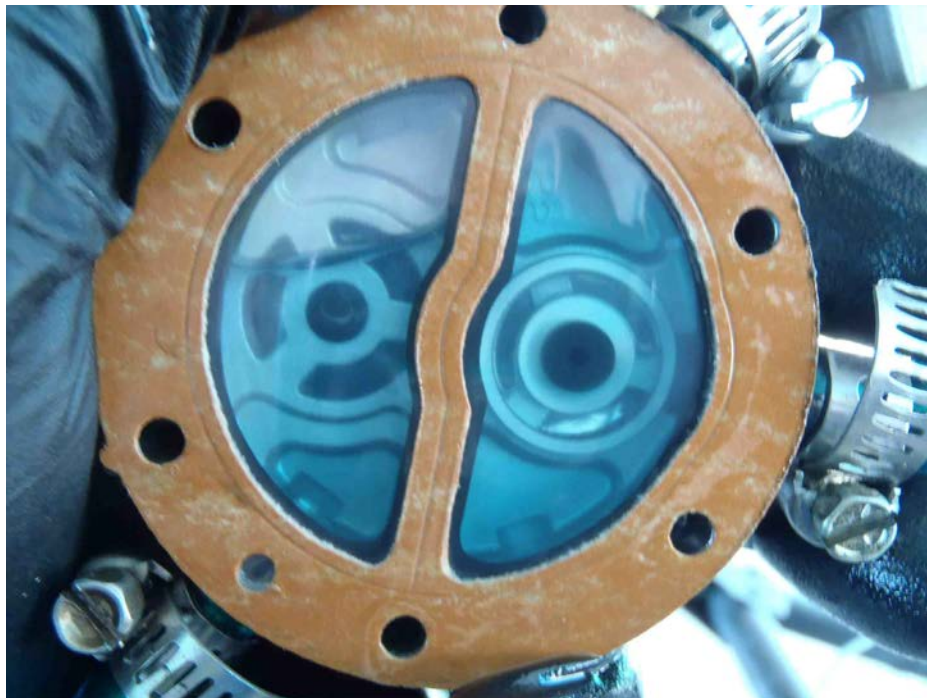
Internal inspection of the engine driven fuel pump revealed that it was almost full with fuel, and all internal seals and membranes were intact (Photo 5). Both carburetor bowls were removed, and the front (magneto side) bowl contained about 1 tablespoon of fuel (Photo 6). The rear bowl was about half-full, and the float appeared to be buoyant (Photo 7). The red sieve sleeves in both carburetors appeared to be crushed along their axis (Photo 8), and the float bracket for the front carburetor hung about 1/32 inch lower than the rear carburetor's float bracket (Photo 9). Neither float bracket was parallel the float chamber as required in the Rotax Repair manual (Photo 10). According to the Rotax representative, the sieve screens purpose was to separate foam/ air bubbles out of the fuel.

Photo 5 - Engine Driven Fuel Pump

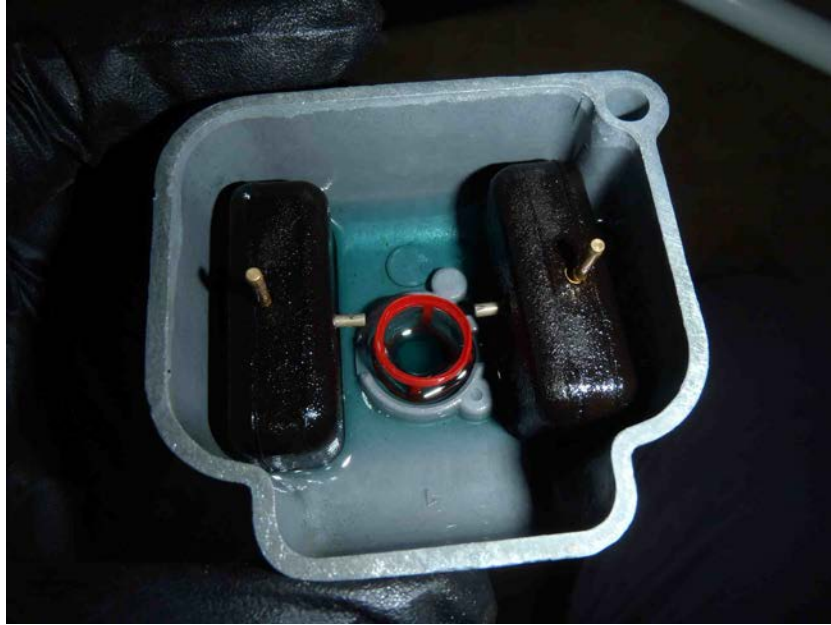
Photo 6 - Front/Magneto Side Carburetor Bowl

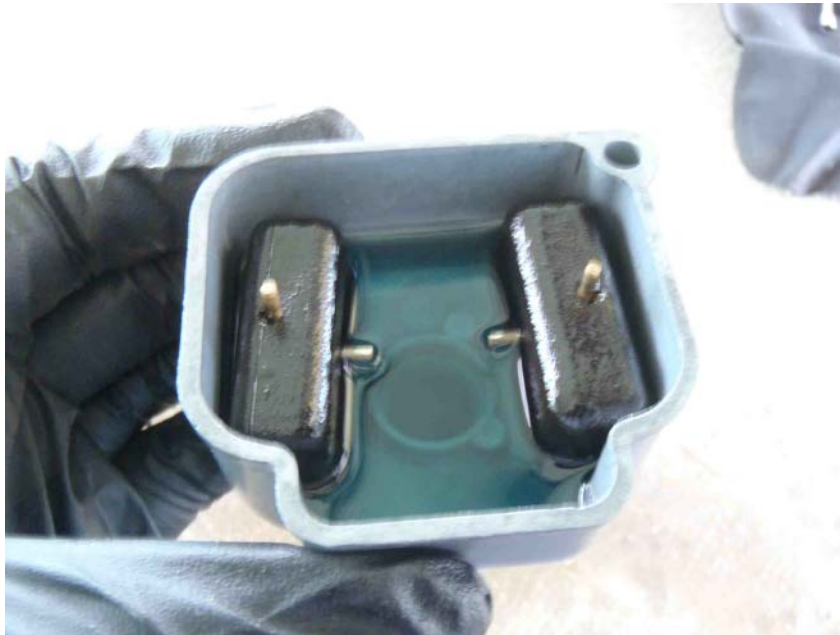
Photo 7 - Rear/Propeller Side Carburetor Bowl

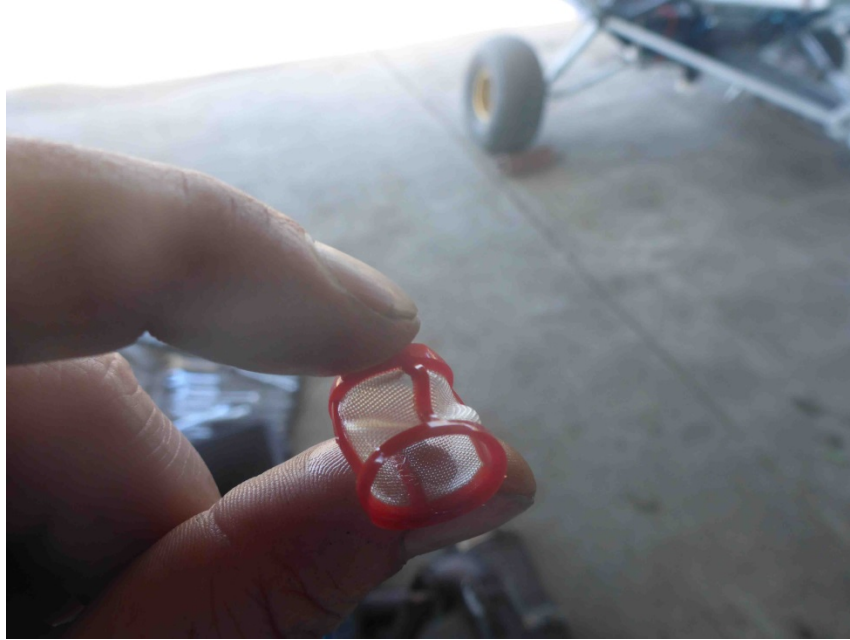
Photo 8 - Sieve Screen

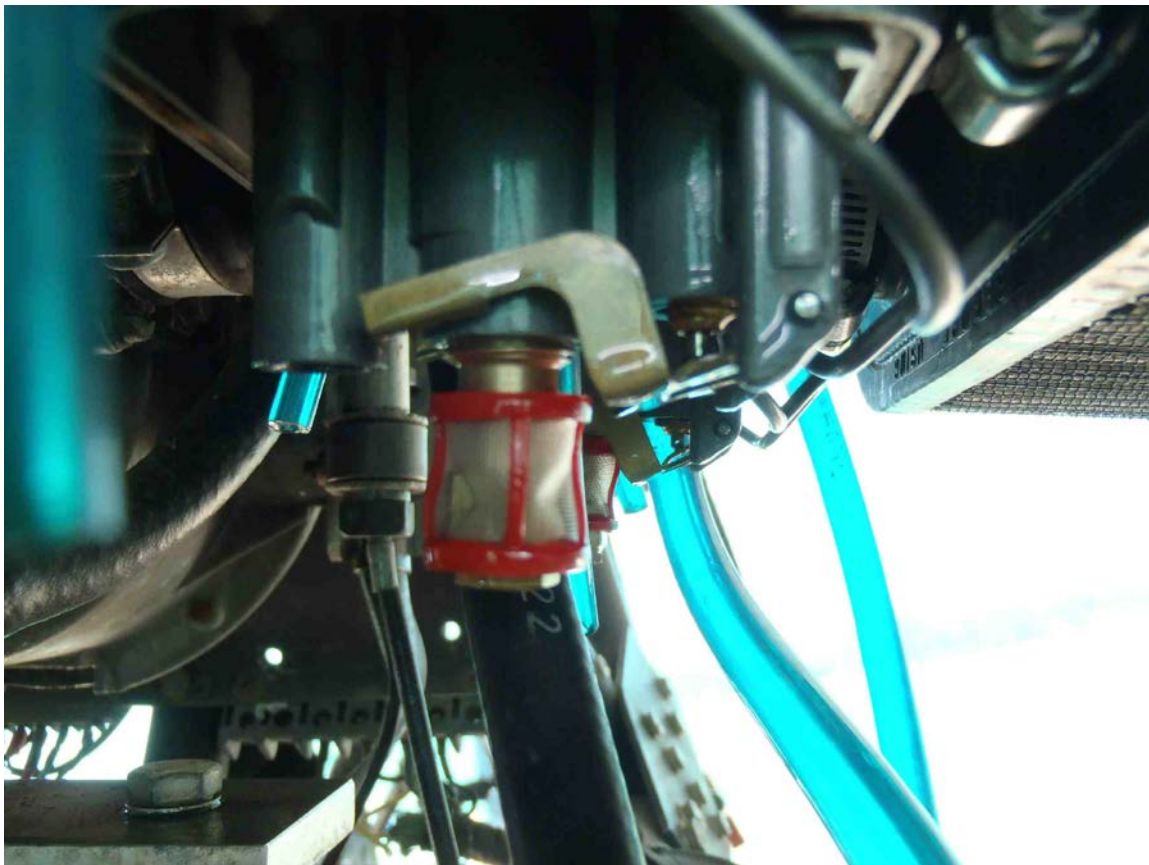
Photo 9 - Carburetor Float Bracket

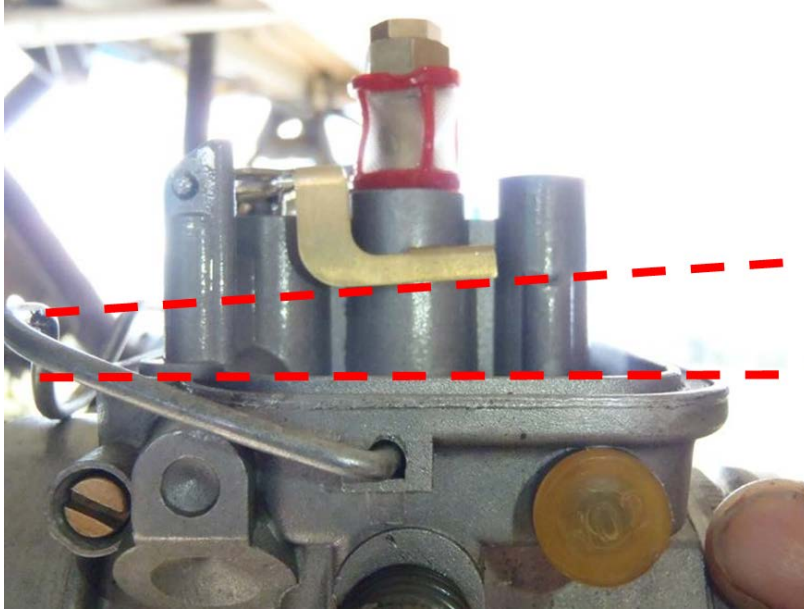
Photo 10 - Float Bracket Compared to Float Chamber

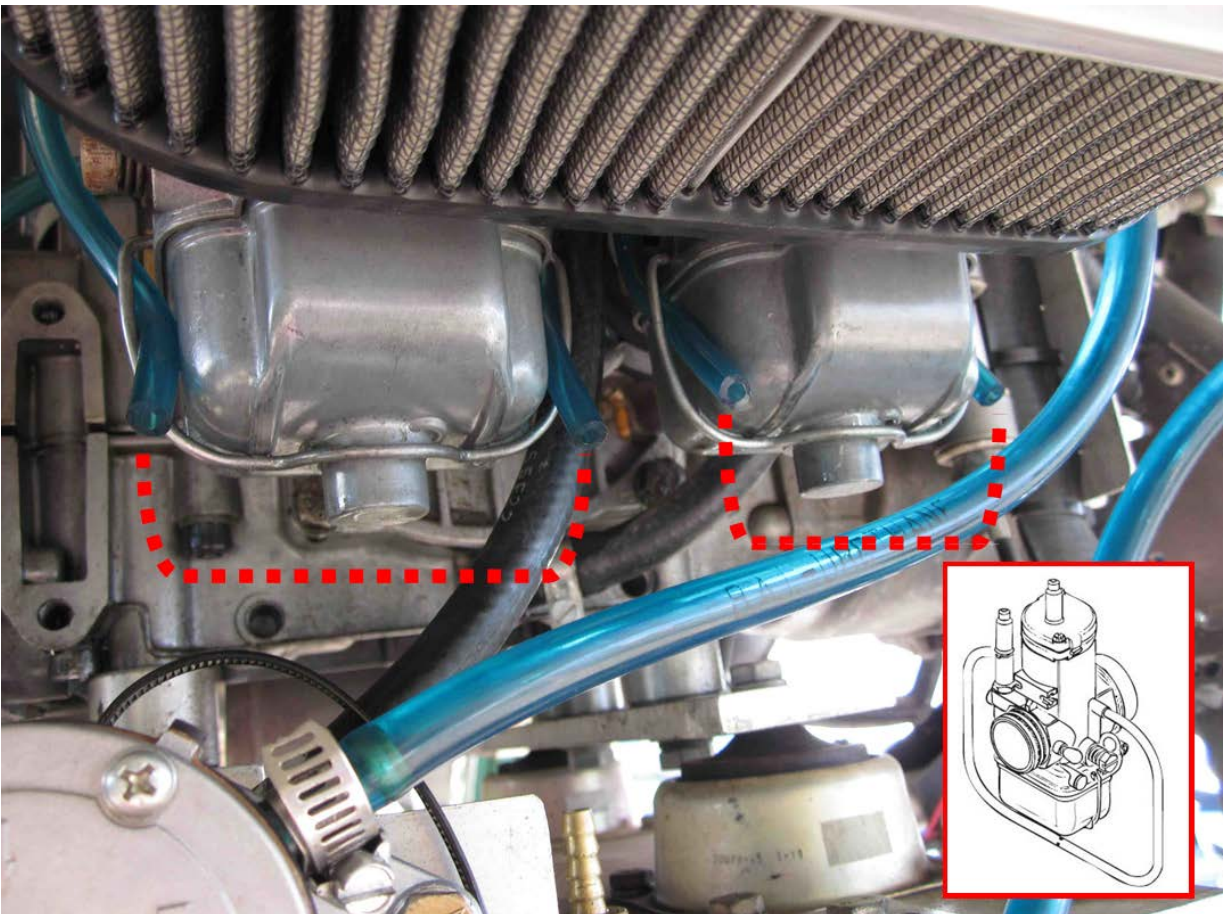
The two carburetor vent pipe fittings for each carburetor were routed directly to open ambient air with plastic tubing, which passed underneath the bowl spring clip, and laterally outwards (Photo 11). According to the Rotax installation and parts manuals, rather than direct venting, each carburetor vent fitting should instead have been directly interconnected to each other with a continuous vent line (Photo 11), containing two small compensation bores. According to the Rotax Installation Manual:

"Equal air pressure conditions must prevail in the vicinity of the carburetor air intake and the carburetor float chamber vent pipes (i.e. the pressure must not be influenced by the propeller air stream). If necessary, the carburetor intake should be shielded against effects of the slipstream by a sheetmetal shield or air intake box, and the carburetor vent pipes should be routed to a calm air zone or connected to a vent chamber."

"The vent duct openings to atmosphere are provided with a hose which prevents ingress of dust and water into the carburetor. Velocity pressure must never act upon venting ducts as it would influence pressure in float chamber, and therefore after the air/fuel mixture."

Photo 11 - Vent Tubes as Found - Versus Exemplar

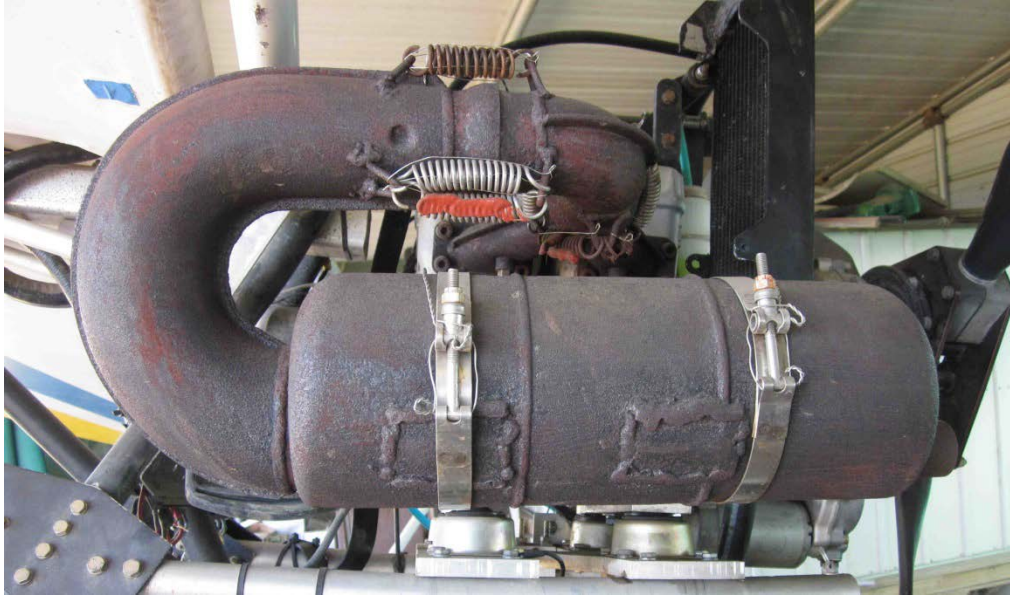
The exhaust muffler remained connected to the manifold, and appeared to be a Rotax original type, although it exhibited heavy corrosion (Photo 12) and was removed for examination. The internal components appeared intact, and nothing sounded loose when it was shaken.

Photo 12 - Muffler

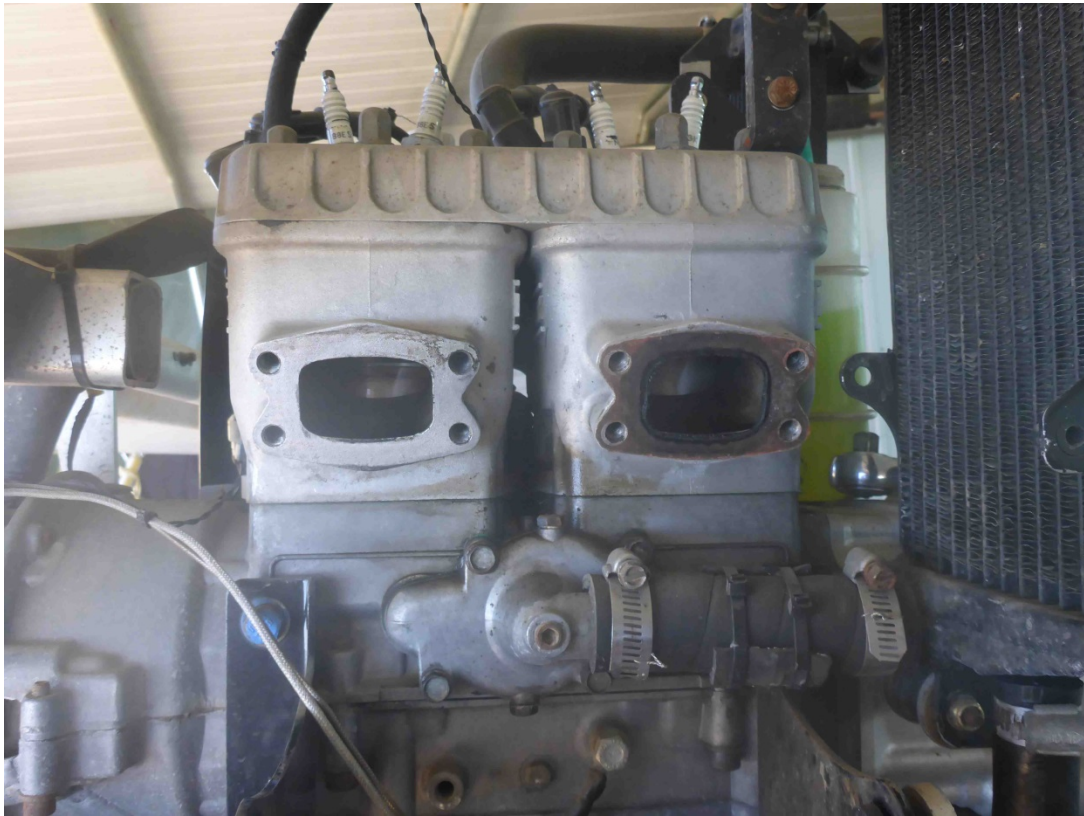
Examination of the piston skirts through the exhaust ports revealed that they were in good condition, with no scratches or indication of seizure (Photo 13). The piston rings were bright and clean with minimal carbon buildup on top of pistons. The engine rotated smoothly by hand at the propeller, and "thumb" was felt at both cylinders. The spark plug gaps were appropriate, and the spark plug electrodes were coated in golden-brown deposits (Photo 14).

Photo 13 - Exhaust Ports

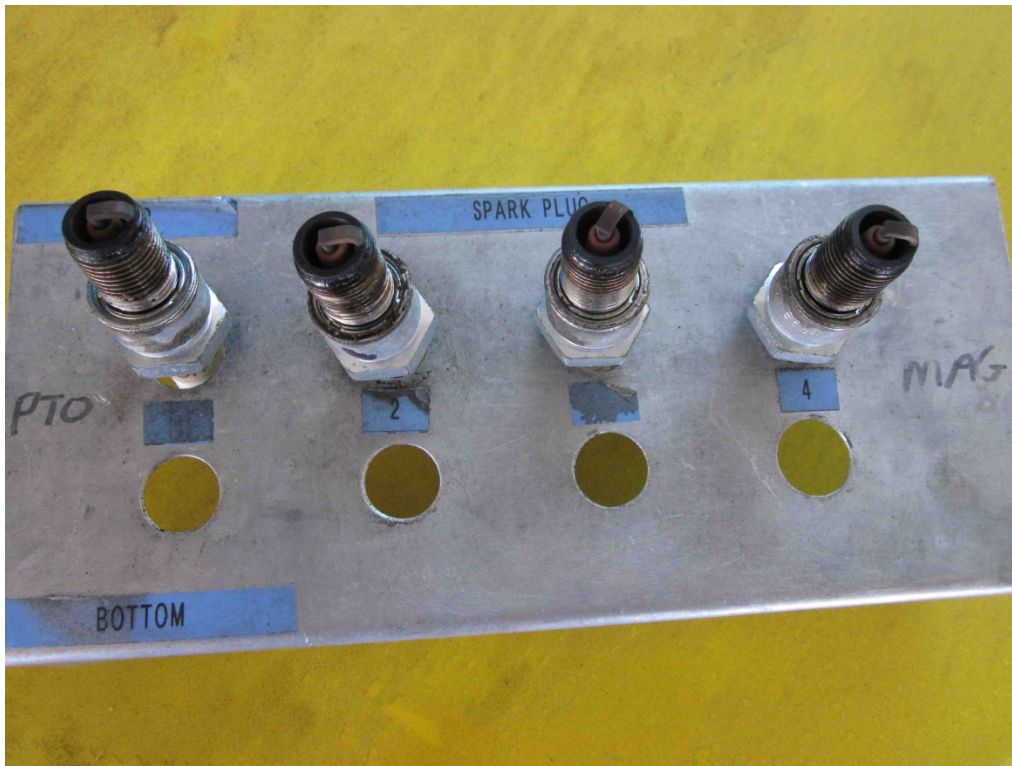
Photo 14 - Spark Plugs

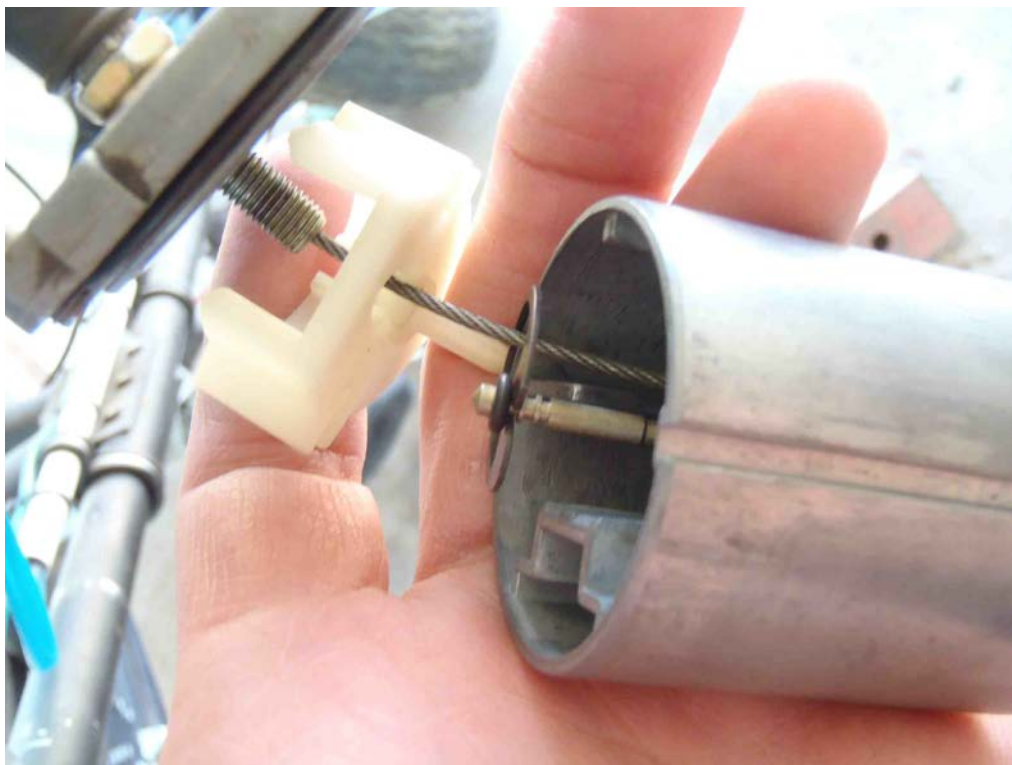
Both main jet orifices were the 158 types, and both were free of obstruction. The carburetor needles were the 11G2 type, which was correct per the Rotax Illustrated Parts Catalogue. Both needle circlips were in the No. 2 position (Photo 15), rather than the factory equipped No. 3 position, which, according to the Rotax representative would result in the engine operating at a leaner mixture. The carburetor plunger walls exhibited light scoring marks. The float needle valve was removed, and appeared pliable and undamaged.

Photo 15 - Needle and Circlip

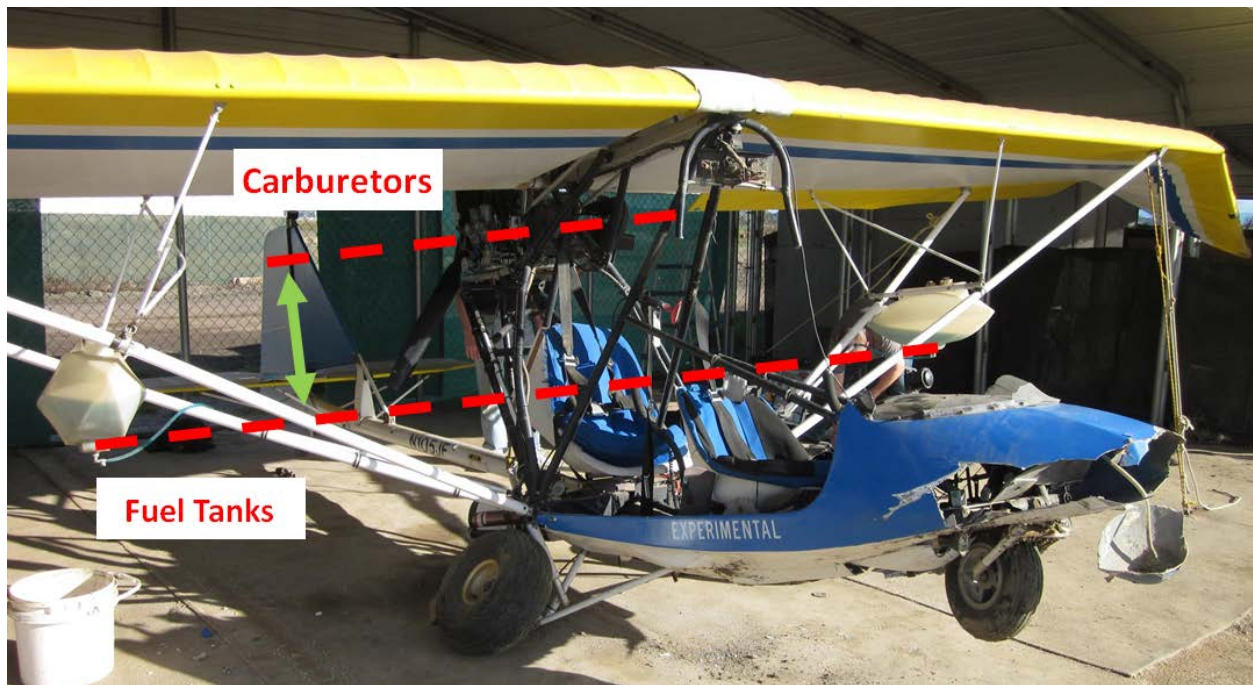
"This section of pipe is under considerable negative pressure when the engine is running hard, and the tiniest flaw in any joint will cause air to be sucked into the system, considerably reducing the capacity of the fuel pump. Air leaks are much more dangerous when the fuel tank is mounted below the fuel pump and carburetor."

Examination revealed that the wing mounted fuel tanks were positioned about 24 inches below the carburetor (Photo 16), and staining was present at the fuel primer handle (Photo 17), indicative of a fuel leak.

Photo 16 - Fuel Tank Position Relative to Carburetors

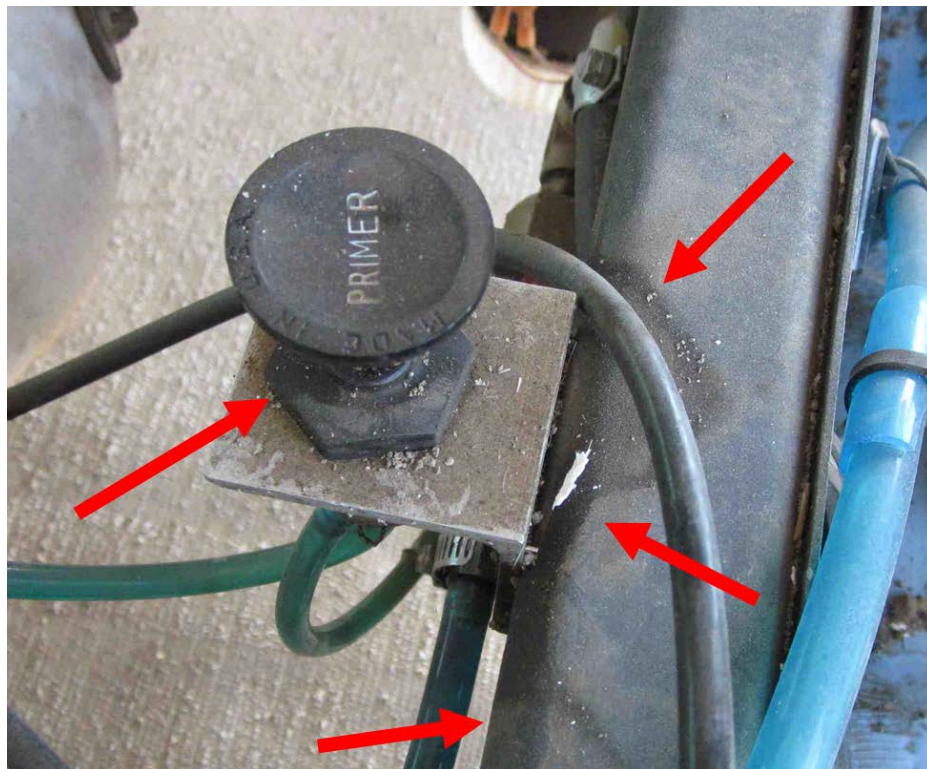
Photo 17 - Primer Valve
