## **NATIONAL TRANSPORTATION SAFETY BOARD**

# **AIRFRAME AND ENGINE EXAMINATION**

**WPR15LA141**

Location: Santa Maria, California  
Date: April 04, 2015  
Aircraft: Piper PA-28R-200, N5469T, Serial #: 28R-7235233  
NTSB IIC: Albert Nixon

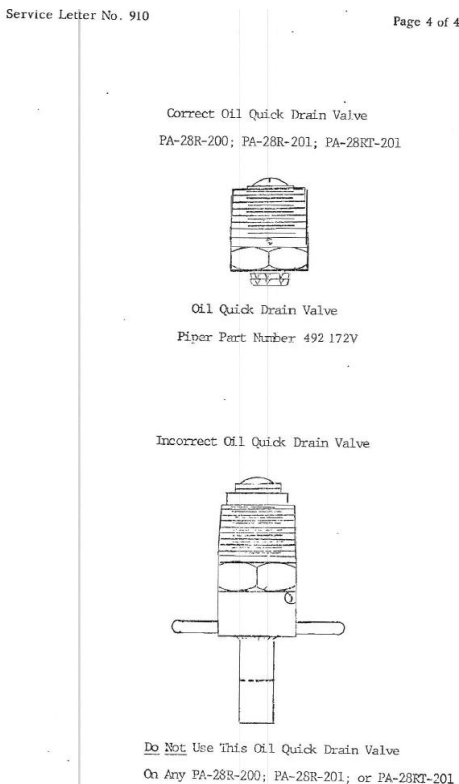
Figure 1: Piper Service Letter 910 pictures of incorrect valve

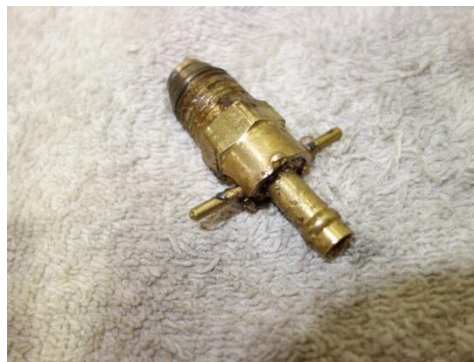
An oil quick drain valve was observed installed. The muffler was removed in order to better observe quick drain valve. The quick drain valve was removed at its part number was a Curtis CCB-37000. Only a small amount of oil drained out, about two ounces. When the nose gear assembly was retracted near its up and locked position, it would strike the oil quick drain valve with its arms. Witness marks were observed on the oil quick drain valve and on the bolt of the nose-gear strut assembly that were consistent with them striking each other.

Figure 2: Installed oil quick drain valve

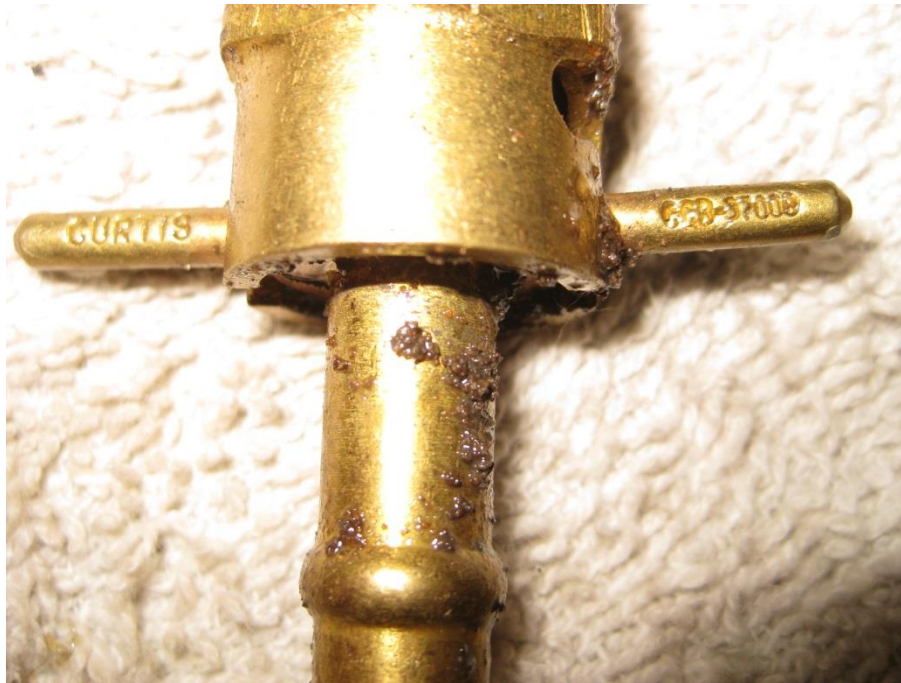
Examination of the recovered airframe and engine was conducted on June 11, 2015 at the Plain Parts Facility, Grove Station, California. The examination of the engine revealed that an incorrect oil quick drain valve was installed.

Figure 3: Installed Oil Quick Drain Valve with part number
