## **NATIONAL TRANSPORTATION SAFETY BOARD**

### **AIRFRAME AND ENGINE EXAM REPORT**

WPR15LA176

Location: Blythe, CA  
Date: June 2, 2015  
Aircraft: Ayres S2R 134, Registration Number: N4018Q, Serial #: 134-021  
NTSB IIC: Zoe Keliher

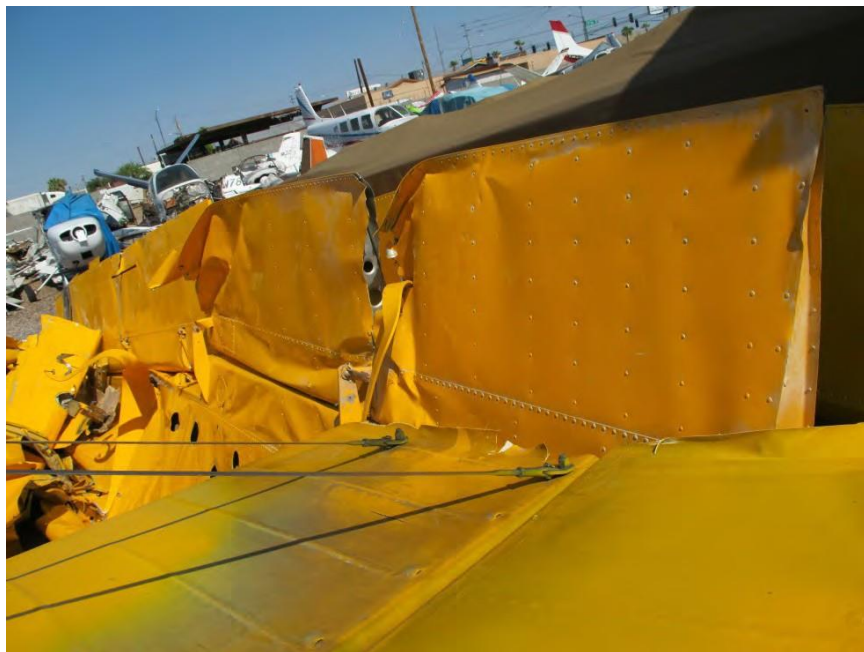
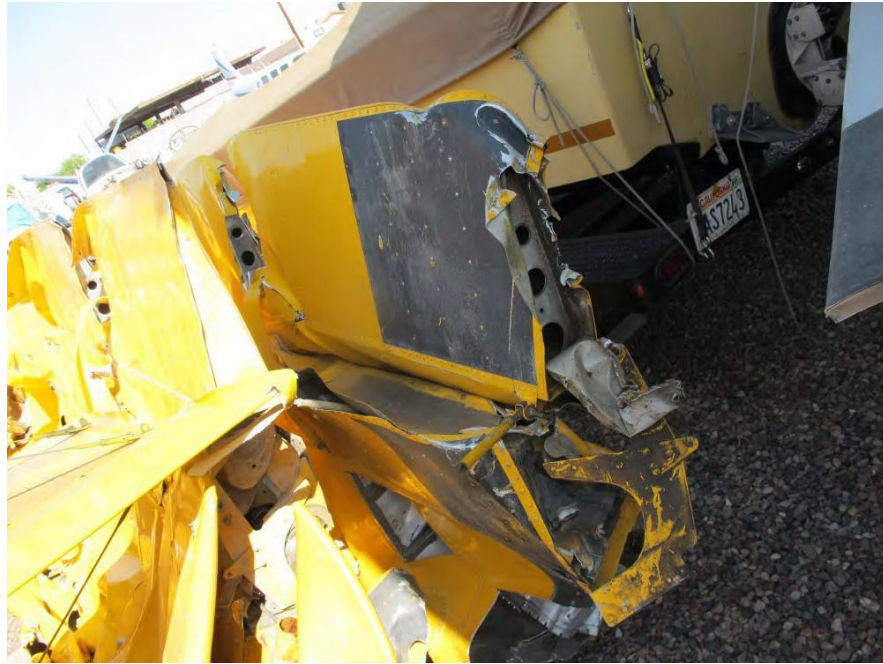
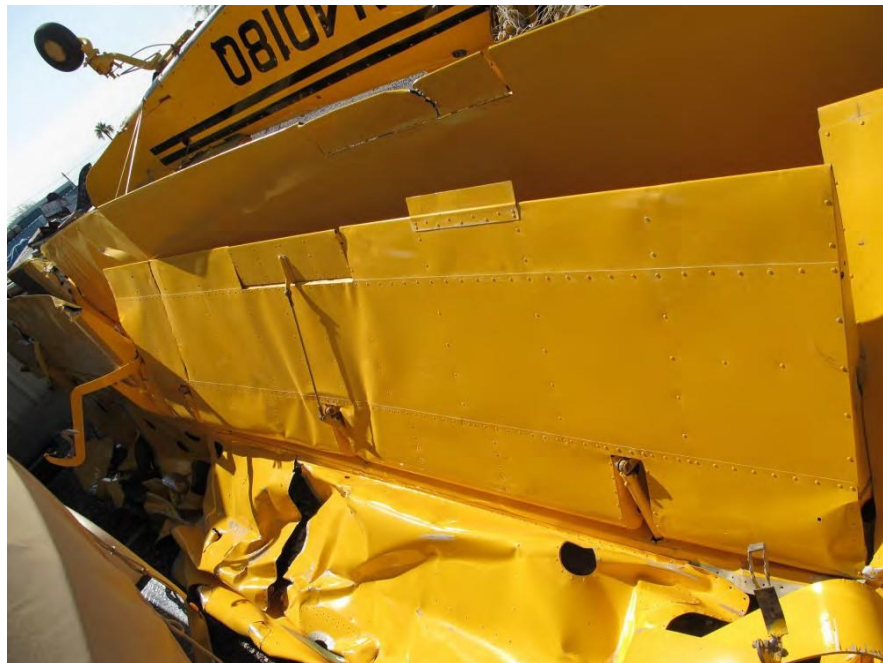
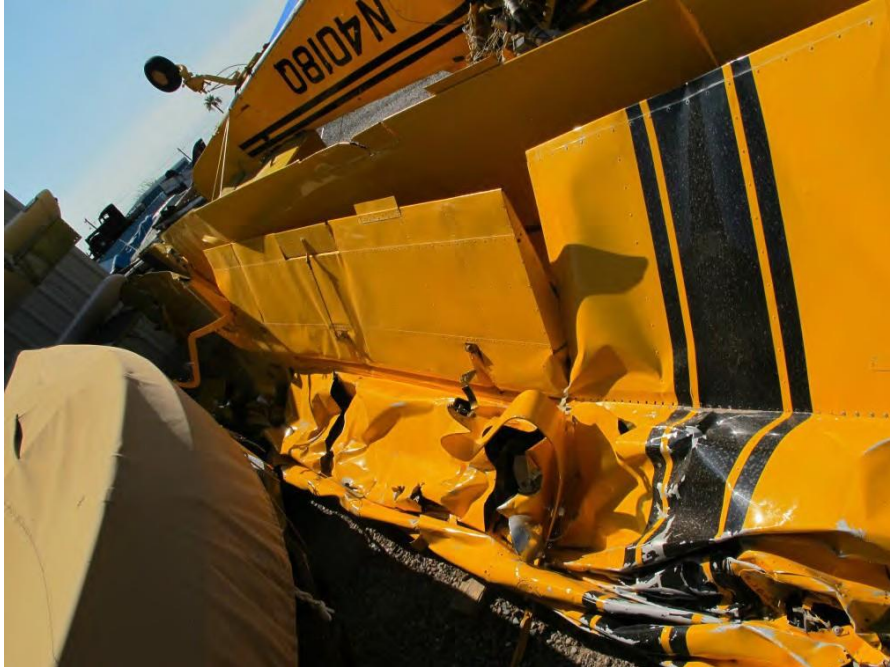
The wings had been removed during recovery. The control surfaces remained attached to the wings. All separation points were along jagged and angular planes. Rod ends were bent at fracture points. The leading edges were crushed aft.

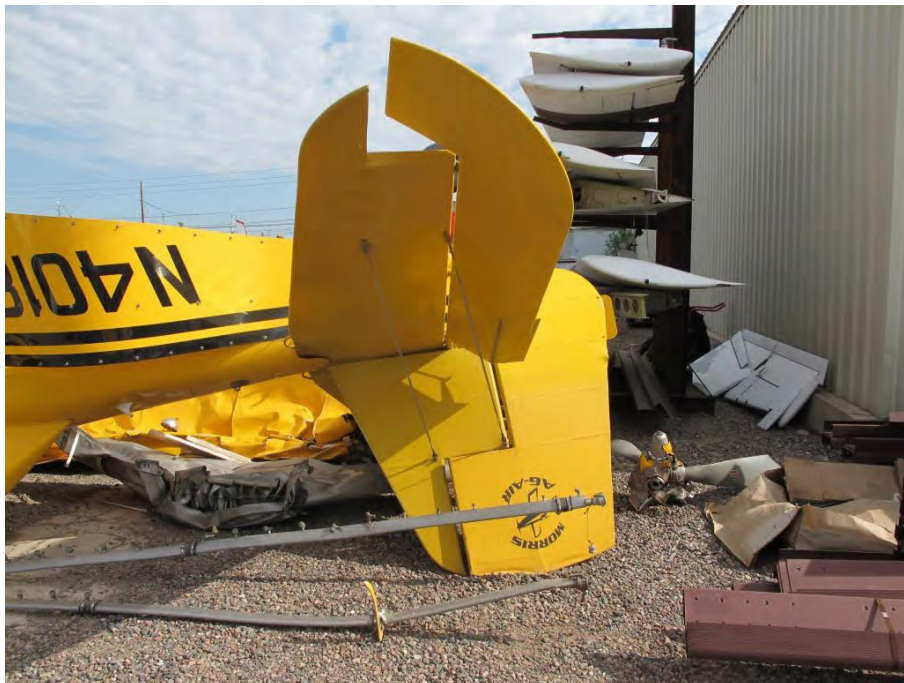
Photo 7 Right Side of Empennage

The empennage remained attached except that the left horizontal stabilizer and elevator were cut at a midpoint for recovery.

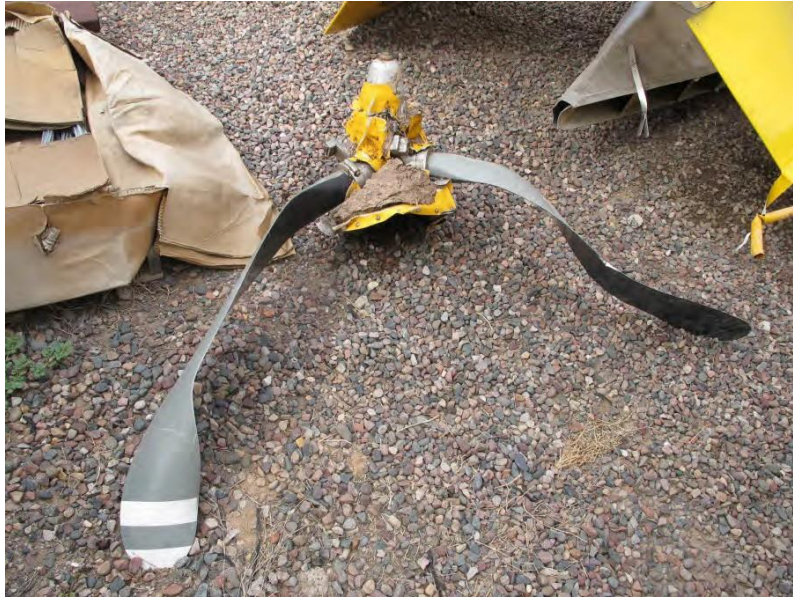
Photo 9 Propeller

The propeller blades that remained attached to the hub were bent and twisted.
