**NATIONAL TRANSPORTATION SAFETY BOARD**

**AIRFRAME AND ENGINE EXAMINATION**

**WPR15LA219**

# Examination Report: N121PT, Garlick Helicopter, UH-1H

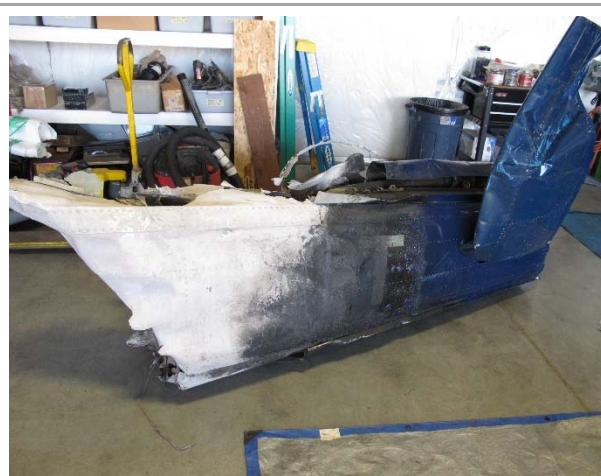
Forward section of the tail boom

- Tail boom had separated aft of the main cabin. Recovery personnel had cut the tail boom in half at mid span.
  - Tail rotor drive shaft had separated near the same location that the boom had separated from the airframe. The drive shaft fracture appeared to be consistent with torsional overload.

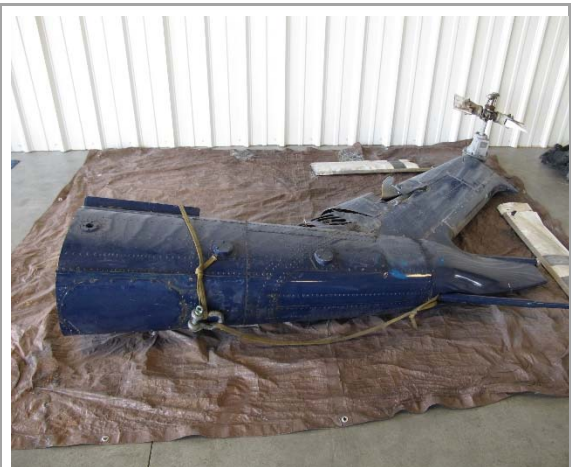
Aft section of the tail boom with tail rotor.

- Tail rotor drive shaft aft of the horizontal stabilizer to the 42-degree gear box, and up to the tail rotor gearbox rotated freely with no binding felt.
- Left horizontal stab was bent upward in a S shape fashion.
- Right horizontal stab outboard 18 inches was curled upwards.
- Tail rotor control cables were present and had been cut by recovery personnel.
- The horizontal stab control push/pull tubes were connected to the horizontal stab and the bell crank located forward of the stab. The forward tube had fractured along the same plane line as the tail boom had separated along.

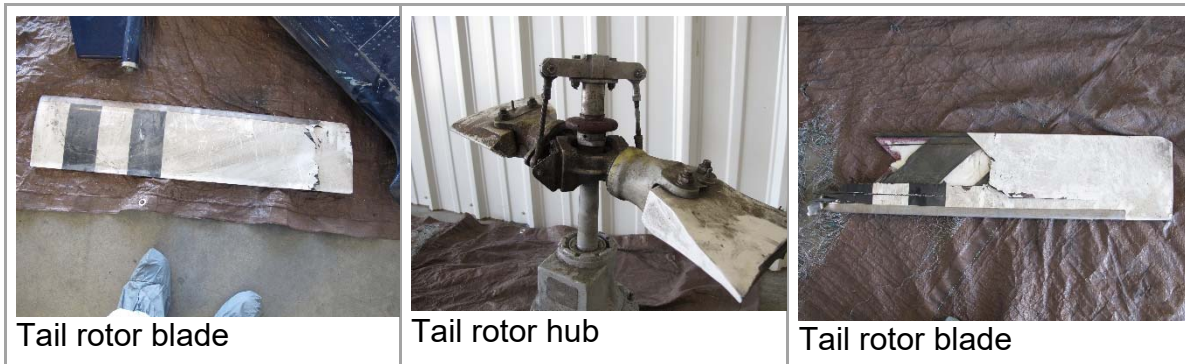
- Tail rotor gearbox contained oil and the tail rotor shaft moved freely. The tail rotor blades had been cut off at the roots by recovery personnel. The leading edge of each blade was straight and no dings, indentations, or chordwise scratching was noted on either blade. Both pitch change links were connected at both ends.

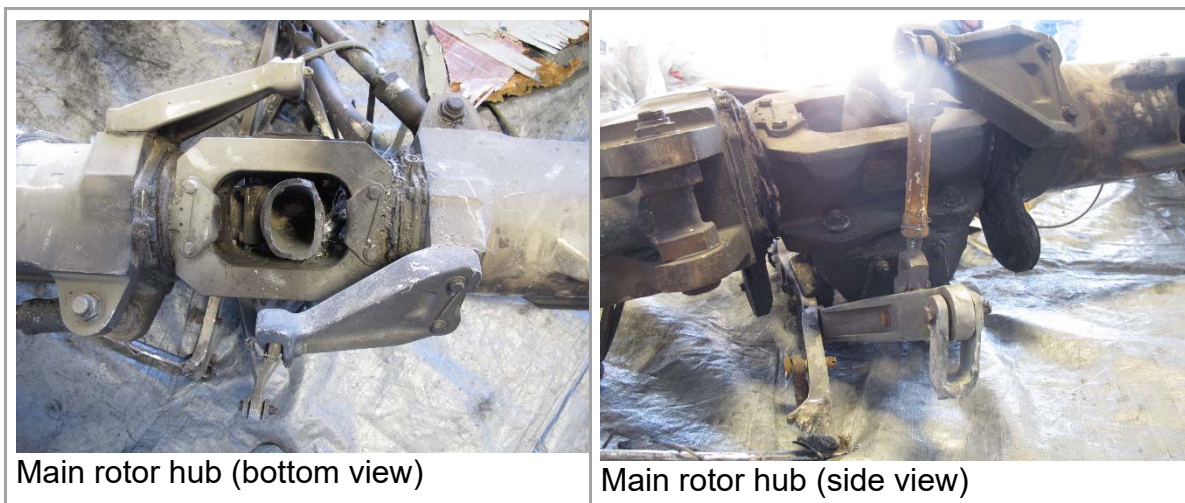
- Main Rotor hub was intact, with blade roots attached to the blade grips. The main rotor mast had separated just below the rotor head with the fracture surface exhibiting 45° shear lips, granular surface, and darkened by soot. The fracture surface was consistent with torsional overload. One balance bar remained attached to the hub, the other was present in the wreckage. All pitch change links

had push/pull tube rod ends attached, however the tubes connecting the rod ends had been destroyed by the fire.

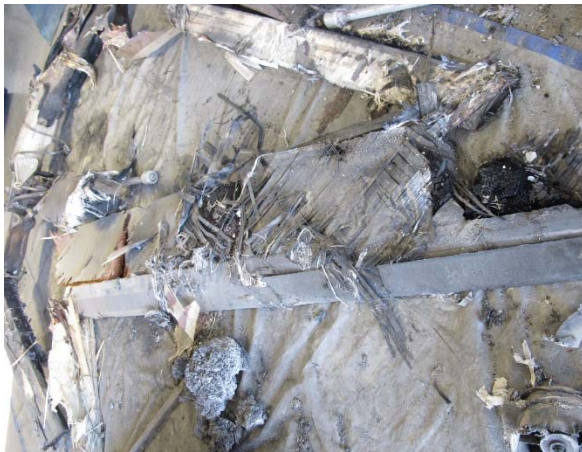
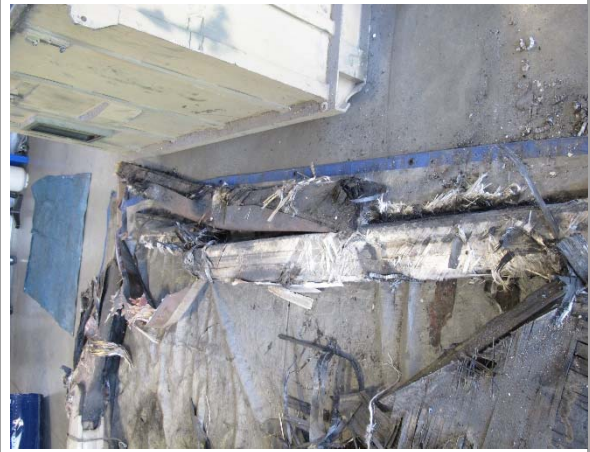
Main rotor blade

- Main rotor blades exhibited heat damage exposing carbon fiber strips. Both rotor blades had been cutoff chordwise about 3 feet outboard of the rotor head blade grips. Portions of both rotor blades had split and separated along the main spar.

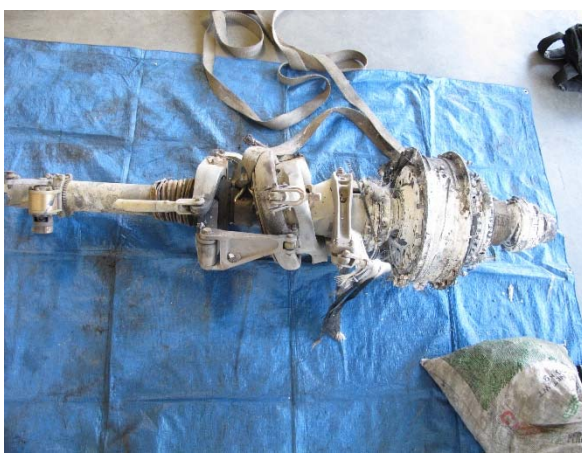
Transmission (overview)

- Main transmission case had been destroyed by fire, exposing the bull gear and planetary gears. The stationary swashplate and rotating swash plate were present above the transmission. One of the 3 horns on the rotating swashplate had been fractured and was not present. The scissors attaching the collective pitch change to the stationary swash plate was attached and connected. The engine drive input and bevel gear was present. The KaFlex coupling on the transmission side was fractured at multiple locations, the associated torque tube end was not present and was not located. The engine side KaFlex coupling and torque tube half was present and exhibited overload fractures.

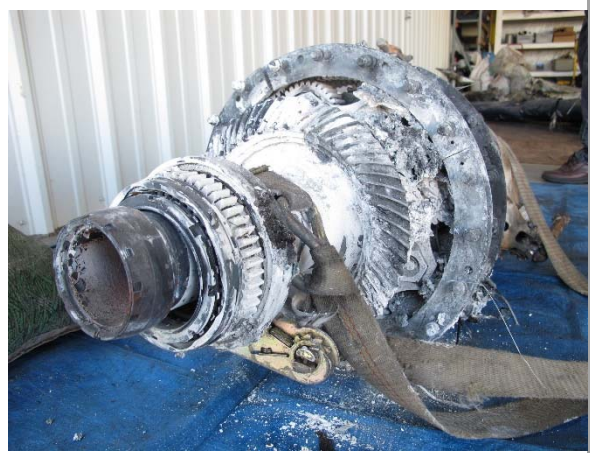
Transmission gearing

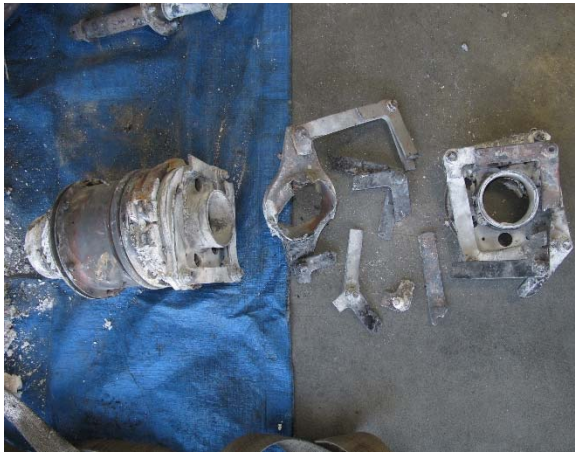
Engine drive input

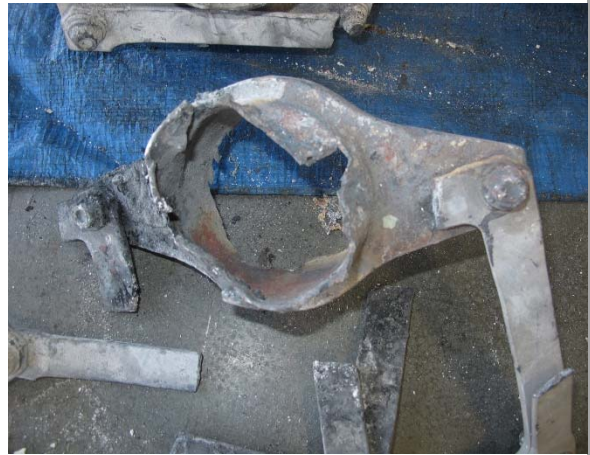
K-flex torque tube

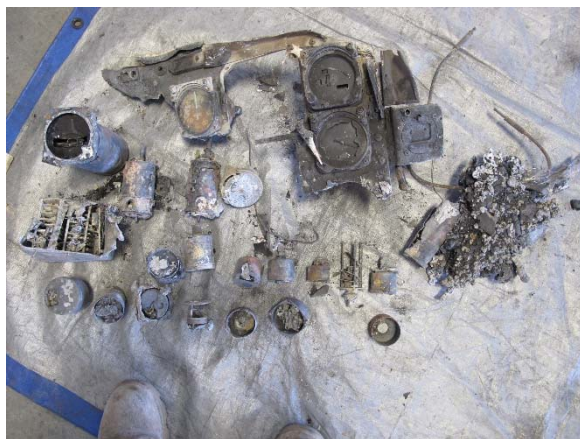
Cockpit instruments

- The cockpit was completely destroyed by fire. The steel cockpit seat frames were present. A number of instruments were also present. The annunciator panel was fire damaged and the front face was destroyed.
  - Turn and bank indicator
  - 2 gyros

- o Airspeed - 0
- o N1 - 4%
- o Altimeter - 5700

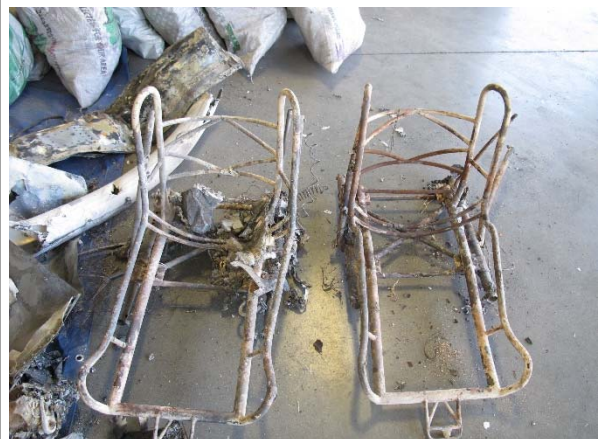
Cockpit seats

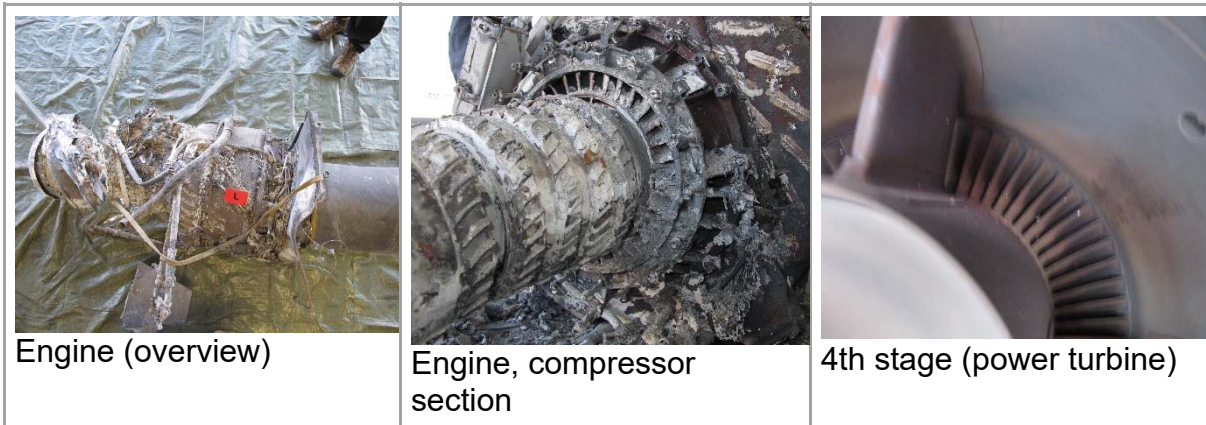
- Per the engine logs, the engine information was as follows:
  - o Engine Model: T53-L-703 (Data plate was not recovered.)
  - o S/N: LE-11448Z
- There was significant thermal damage all around the engine.

- o The air inlet housing was destroyed by fire and was no longer present.
  - o The forward gear reduction housing was destroyed by fire and was no longer present.

- o The axial compressor housings were destroyed by fire and were no longer present.
  - o There was evidence of fire sooting and melted metal on and around the engine.

- The axial compressor rotors and nozzles were exposed and observable.
- All of the axial compressor blades were broken at the root of the rotor for each stage.

- All of the 4<sup>th</sup> stage axial compressor blades were not present in the rotor.
- A few axial compressor blades were found under the engine after removal of the axial compressor nozzle stages.

- All of the axial compressor blades that were found exhibited leading edge damage and bending.
- A quantity of 4 inlet guide vanes (IGVs) were located around the engine wreckage. All exhibited damage consistent with foreign object damage.

- Several vanes of the centrifugal compressor exhibited evidence of leading edge damage and bending opposite the direction of rotation.
- While sifting through the bags of debris recovered at the crash scene the following engine parts were identified:
