# NATIONAL TRANSPORTATION SAFETY BOARD

MATERIALS LABORATORY FACTUAL REPORT

Report No. 16-054

Place : Prichard, Idaho  
Date : July 21, 2015  
Vehicle : Cessna 182Q, N759LV  
NTSB No. : WPR15LA220  
Investigator : Joshua Cawthra, AS-WPR

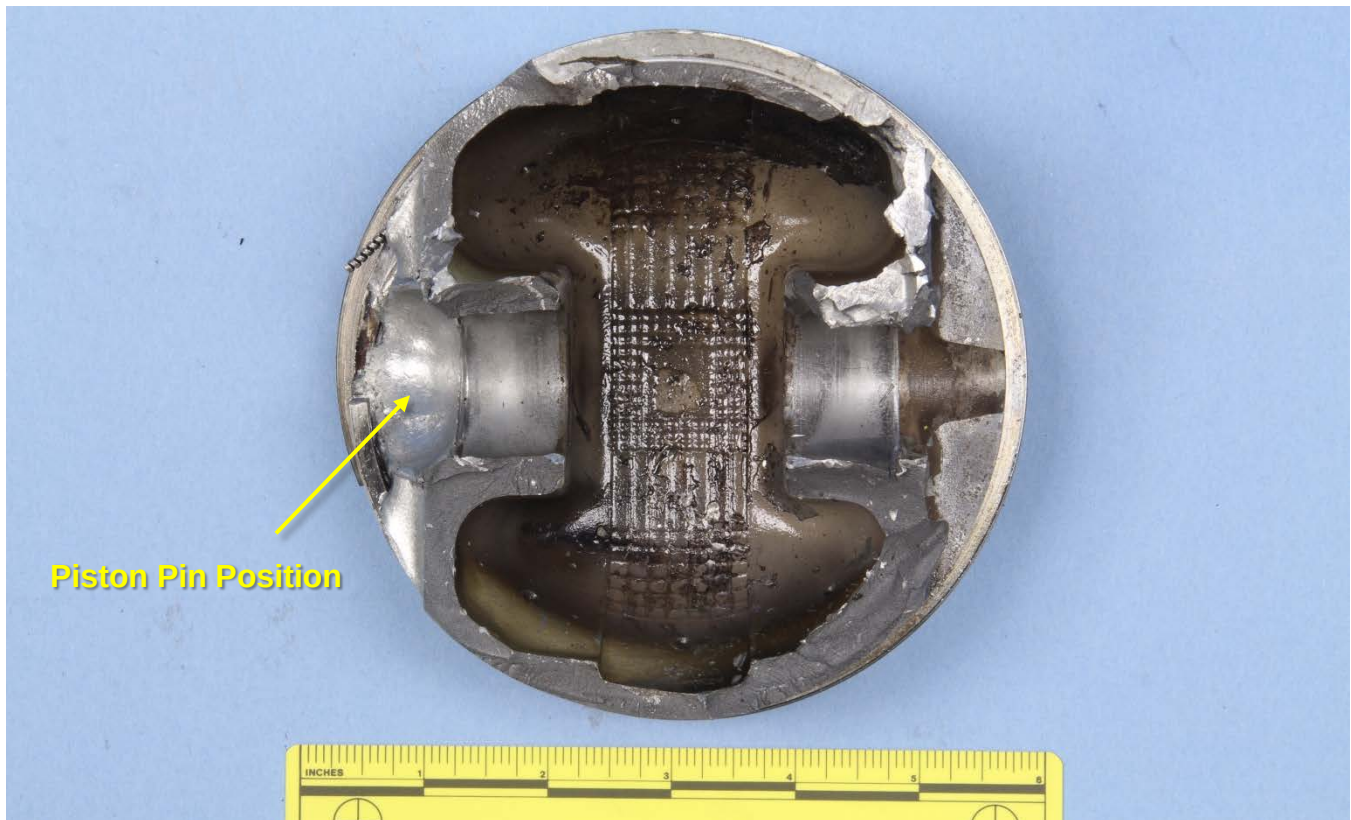
Figure 1 shows the parts submitted to the NTSB Materials Laboratory, as received. Figure 2 illustrates the underside of the piston crown, which had fractured into smaller pieces near the piston pin position. Figure 3 shows the piston crown from the side, illustrating the fracture surface in relation to the piston pin position. The fracture surface exhibited a rough, tortuous appearance along with a dull luster. The fracture surface of the piston crown exhibited river lines and chevron marks consistent with fracture originating at the pin position. The fracture features of the piston crown underside were consistent with overstress failure. No indications of pre-existing cracking or progressive failure were observed on the piston fracture surfaces.

Figure 2 – The underside of the piston crown, as received, showing the fracture surface.

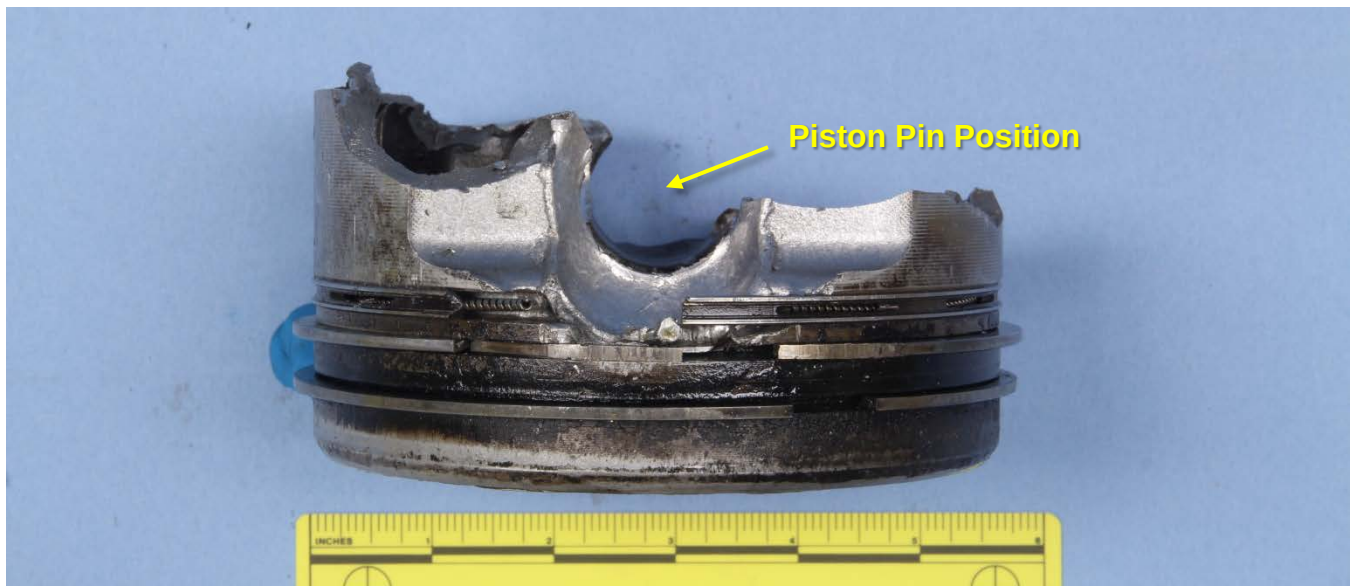
Figure 3 – The piston crown, as viewed from the side along the piston position, as received.

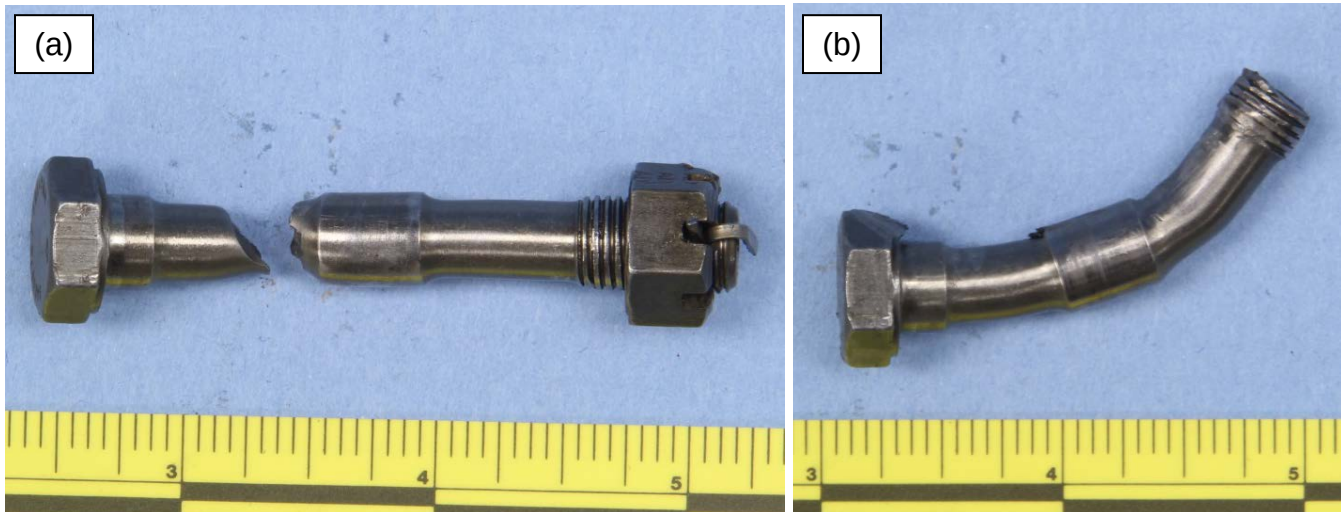
Figure 4 illustrates the two connecting rod bolts as received. The bolt in Figure 4a was received fractured in two halves, exhibiting a 45° slant fracture surface with localized necking adjacent to the fractures. The bolt fracture surface showed a dull luster and rough surface. All of these features were consistent with failure from tensile overstress.

The other bolt is illustrated in Figure 4b. Only one half of the bolt was submitted. This bolt had been bent over, with a relatively flat fracture surface along the bolt threads. This fracture surface also exhibited dull, gray, and rough features. These characteristics were consistent with failure from overstress in bending.

Figure 4 – The two connecting rod bolts, as received. The figures show (a) both halves one bolt and (b) the one half of the other bolt.

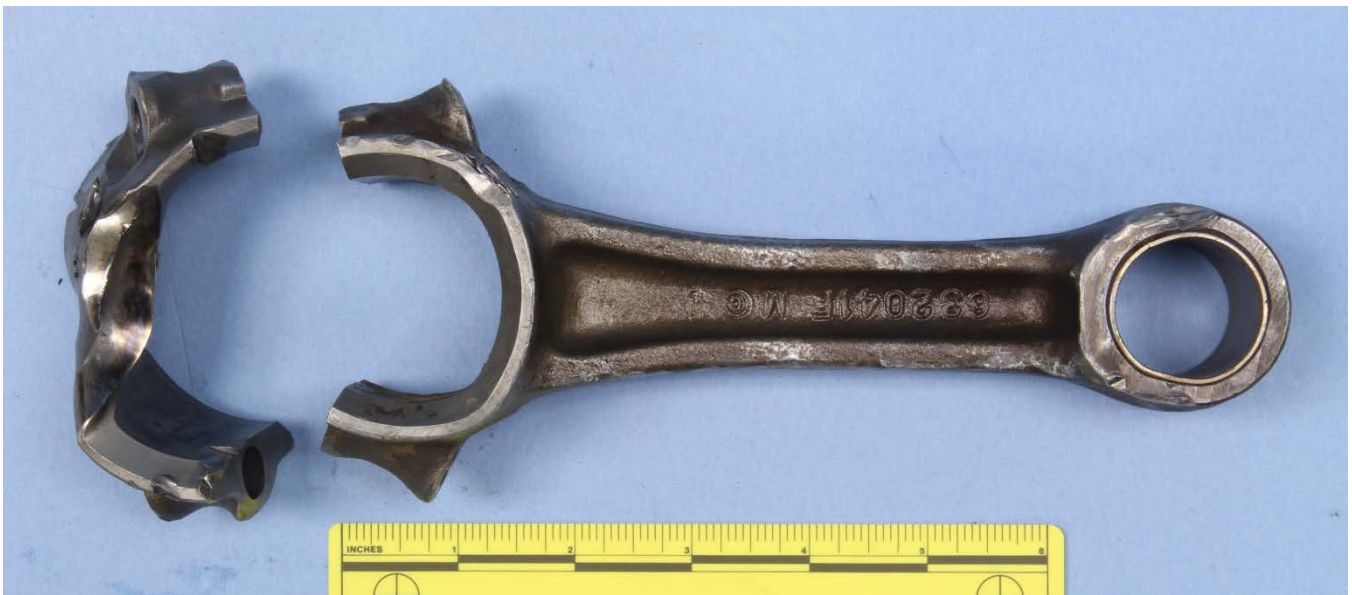
The connecting rod is exhibited in Figure 5. The markings on the connecting rod stated "632041F M ©" on one side and "6" on the other. The connecting rod was generally intact with no indication of cracking, fracture, twisting or gross deformation along the rod. The connecting rod cap is highlighted in Figure 6. The cap exhibited twisting and deformation consistent with batter from impacts with an adjacent object. However, there were no indications consistent with the connecting rod or cap having failed prior to the bolts fracturing.

Figure 5 – The submitted connecting rod, as received.

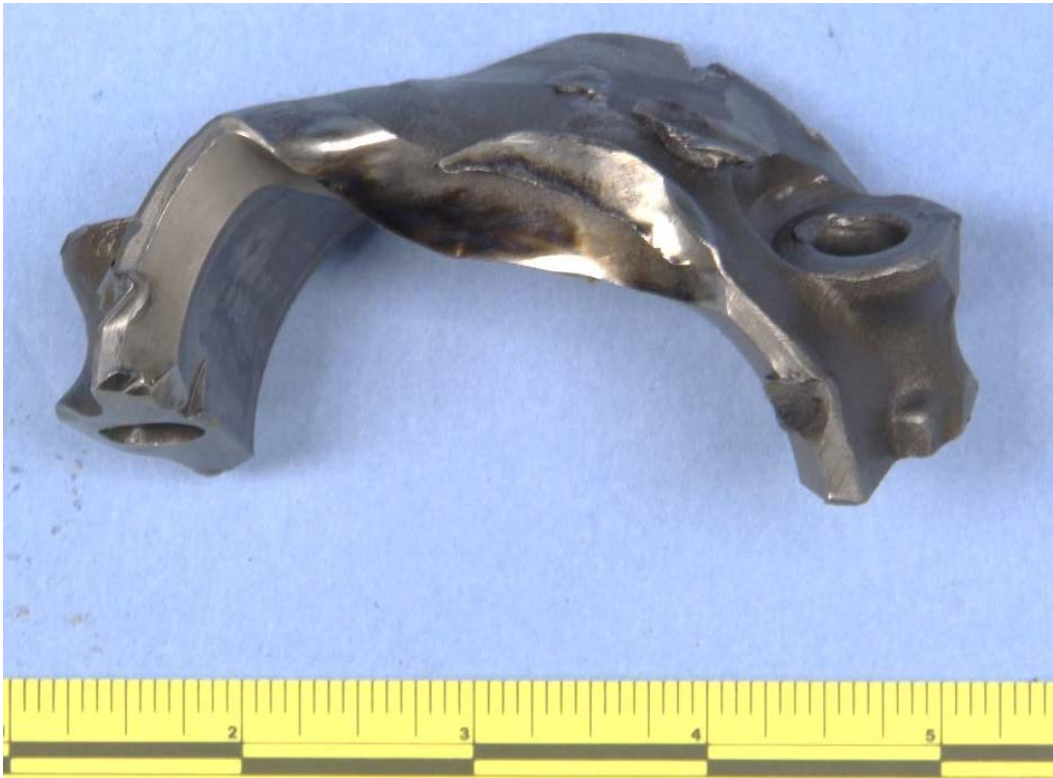
Figure 6 – The connecting rod cap, showing batter and impact damage.

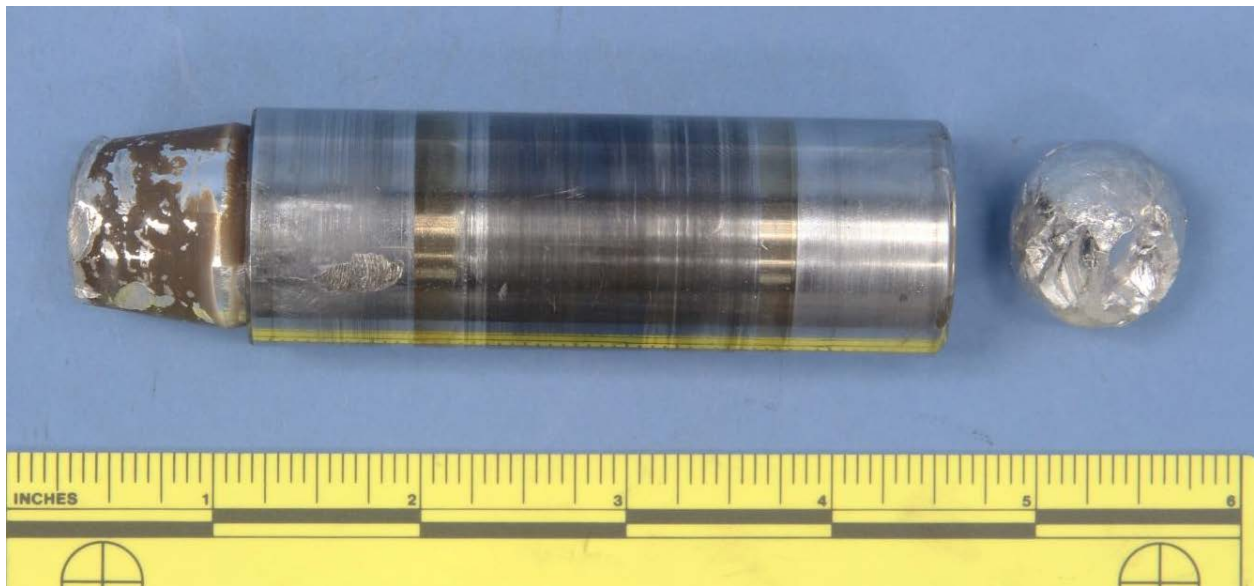
Figure 7 illustrates the piston pin, after degreasing and cleaning. The pin exhibited some wear and impact marks along the barrel. Of note was that one of the tapered piston ends had separated and had become deformed into a spherical shape. Figure 8 through Figure 14 show the fracture surface of this side of the pin. Most of the fracture surface exhibited a shiny luster and general flat shape, consistent with post-fracture batter.

Figure 7 – The piston pin, as received. The left side of the pin exhibited batter on the plug, while the right side plug fragment had separated and been deformed into a spherical shape.

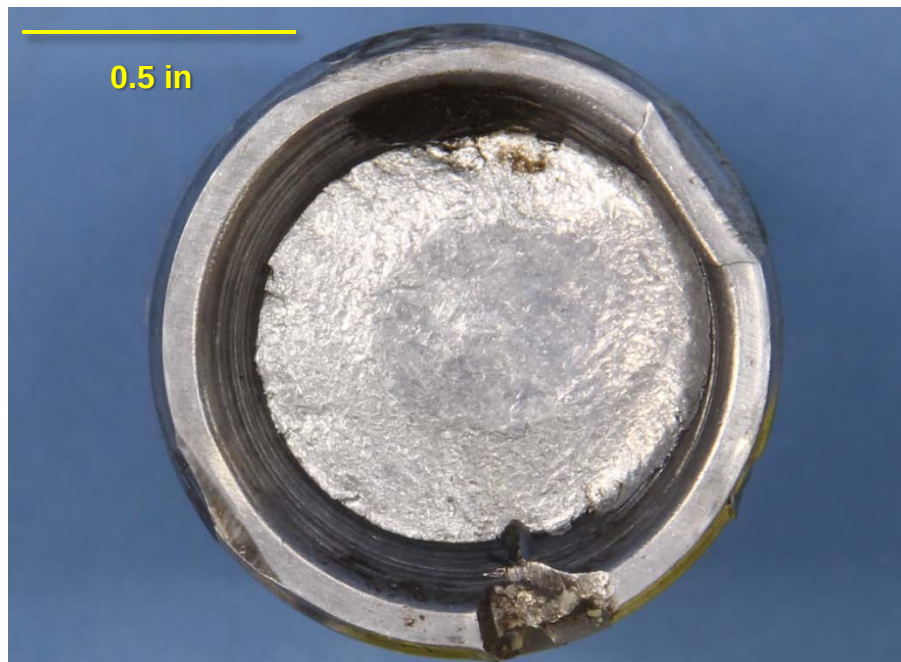
Figure 8 – The right side of the piston pin in Figure 7, showing the fracture surface at the separated plug.

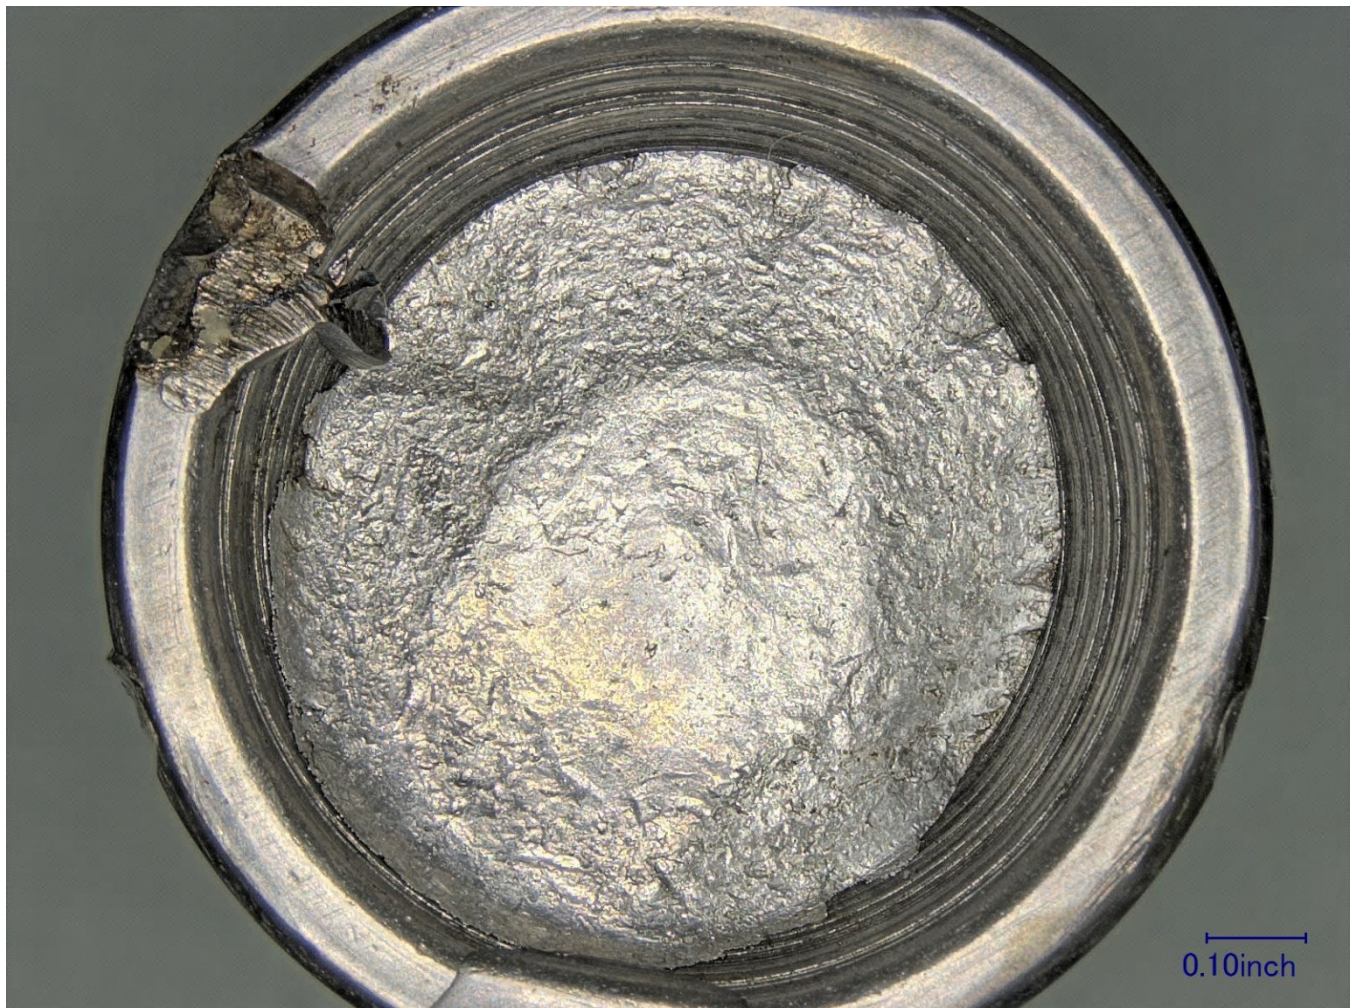
The middle of the pin fracture had a raised, flattened feature, shown in Figure 9. Around the periphery of the fracture surface, adjacent to the barrel of the pin, the fracture surface exhibited ridges consistent with ratchet marks (Figure 10). Ratchet marks are consistent with multiple smaller cracks that coalesce to form a larger crack. Figure 10 and Figure 11 show a less damaged area of the fracture surface, exhibiting crack arrest marks consistent with progressive failure.

Figure 9 – Closer view of the pin fracture surface from Figure 8.

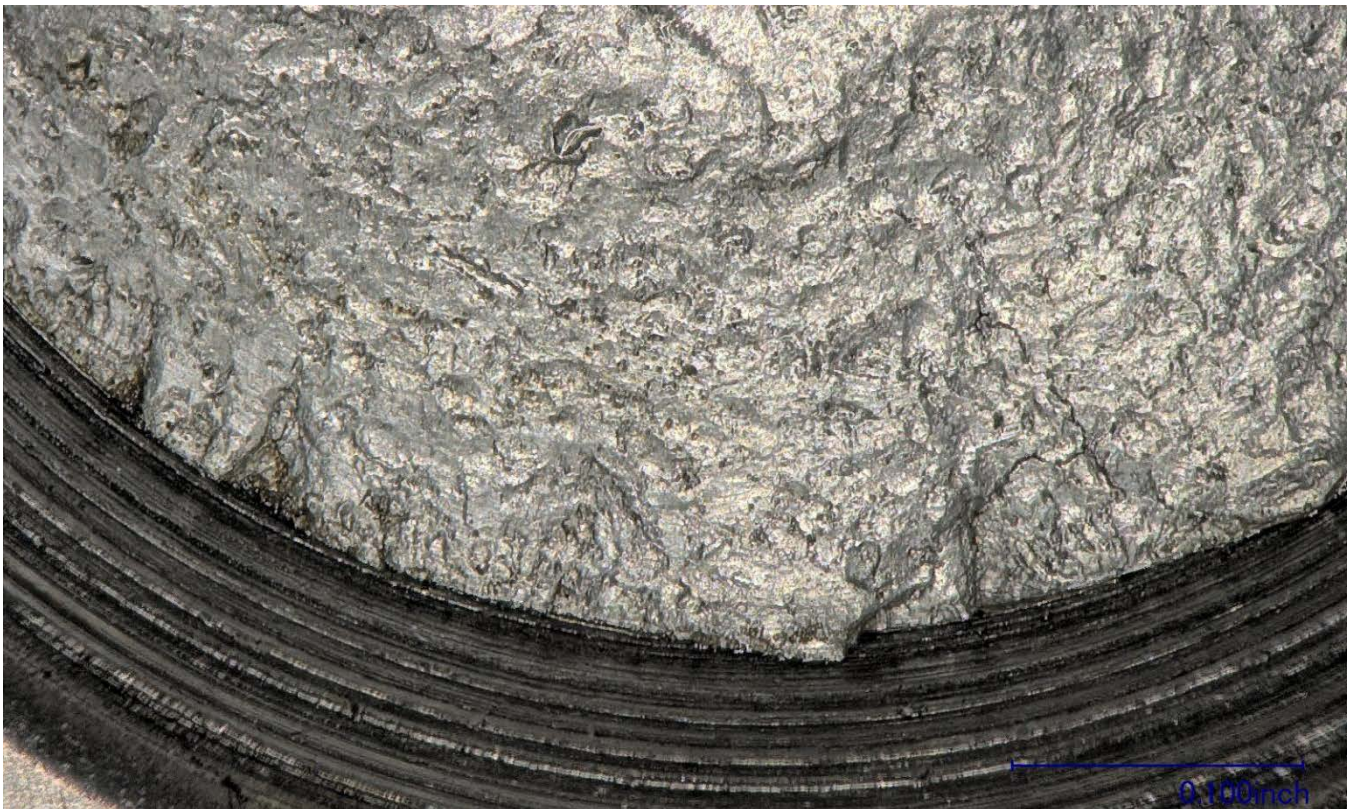
Figure 10 – The lower right side of the pin fracture from Figure 9, showing a small thumbnail crack.

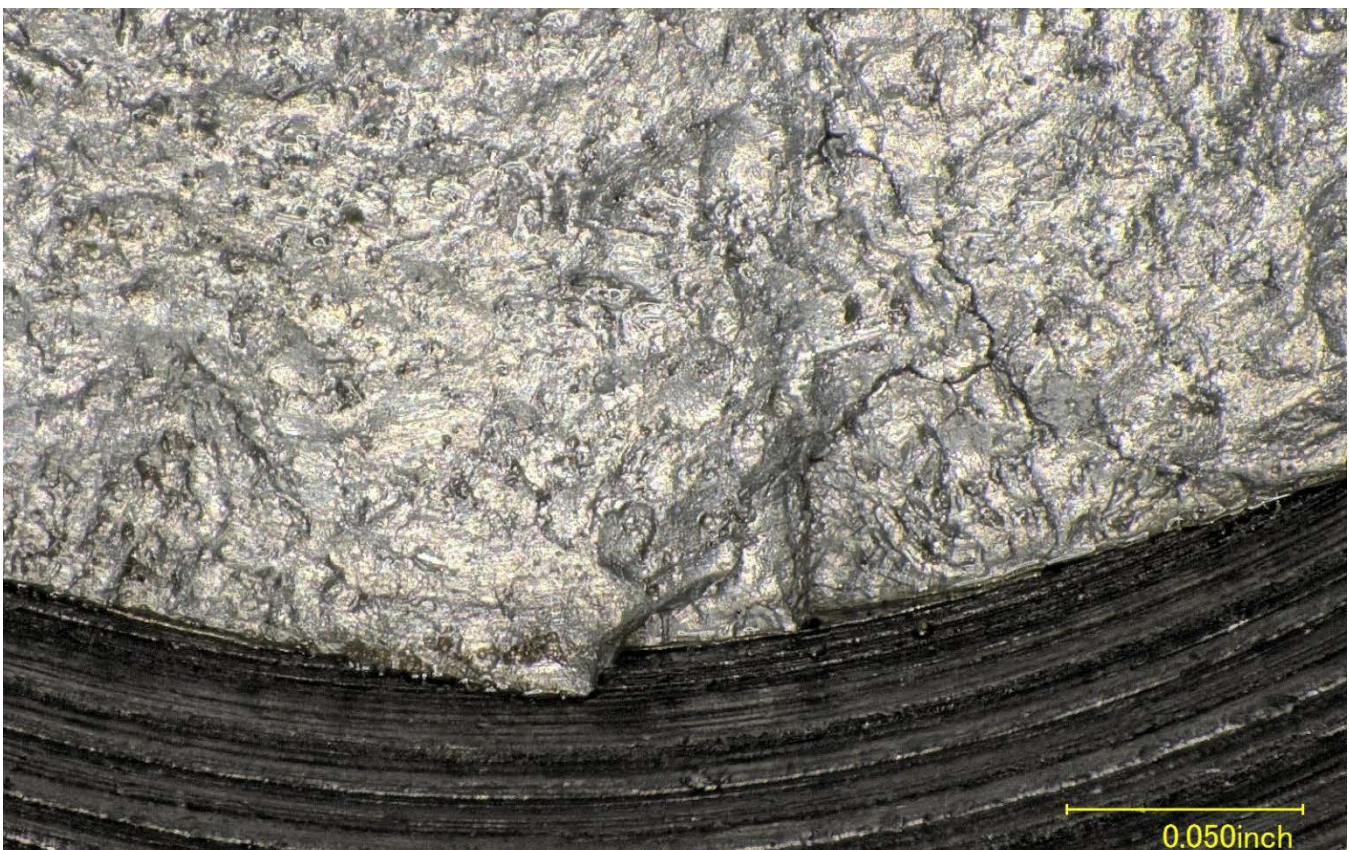
Figure 11 – The small thumbnail crack in Figure 10.

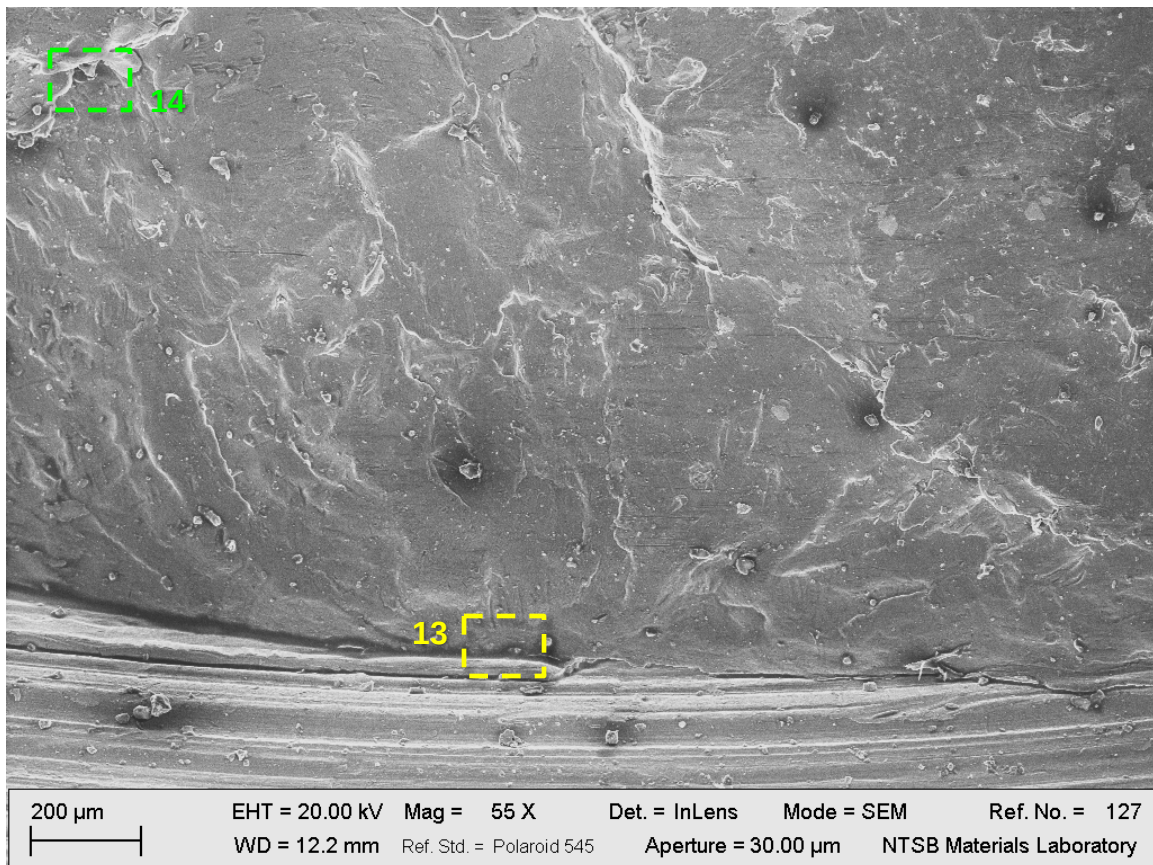
Closer examination of the visible progressive features using a scanning electron microscope (SEM), as shown in Figure 12, revealed striations consistent with fatigue cracking (Figure 13). Examination of the fatigue crack initiation site did not reveal any material or mechanical defects, such as pits, voids, or inclusions (see Figure 14). All of the features of the pin fracture surface were consistent with fatigue cracking initiating around the outside of the pin, with the final fracture along the middle of the pin cross section (the raised, blunted portion).

Figure 12 – Secondary electron (SE) micrograph of the thumbnail crack. The two boxed areas are highlighted in Figure 13 and Figure 14.

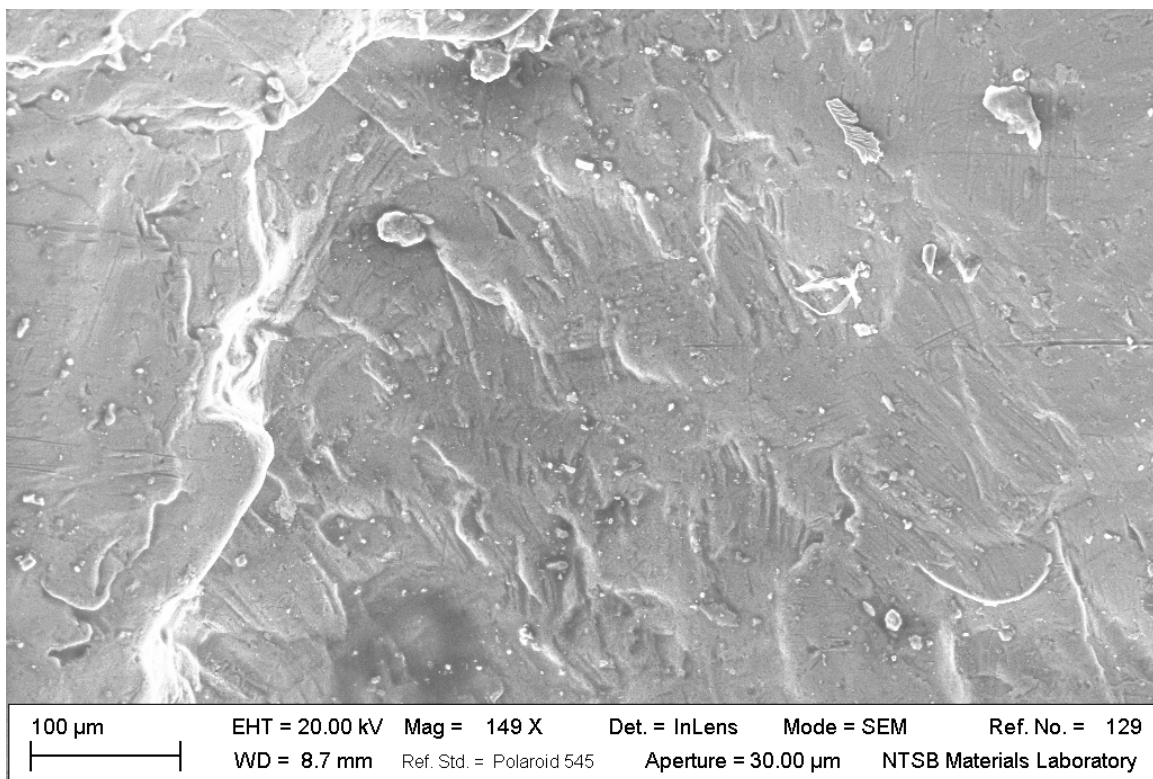
Figure 13 – SE micrograph of the end of the thumbnail crack, showing faint fatigue striations.

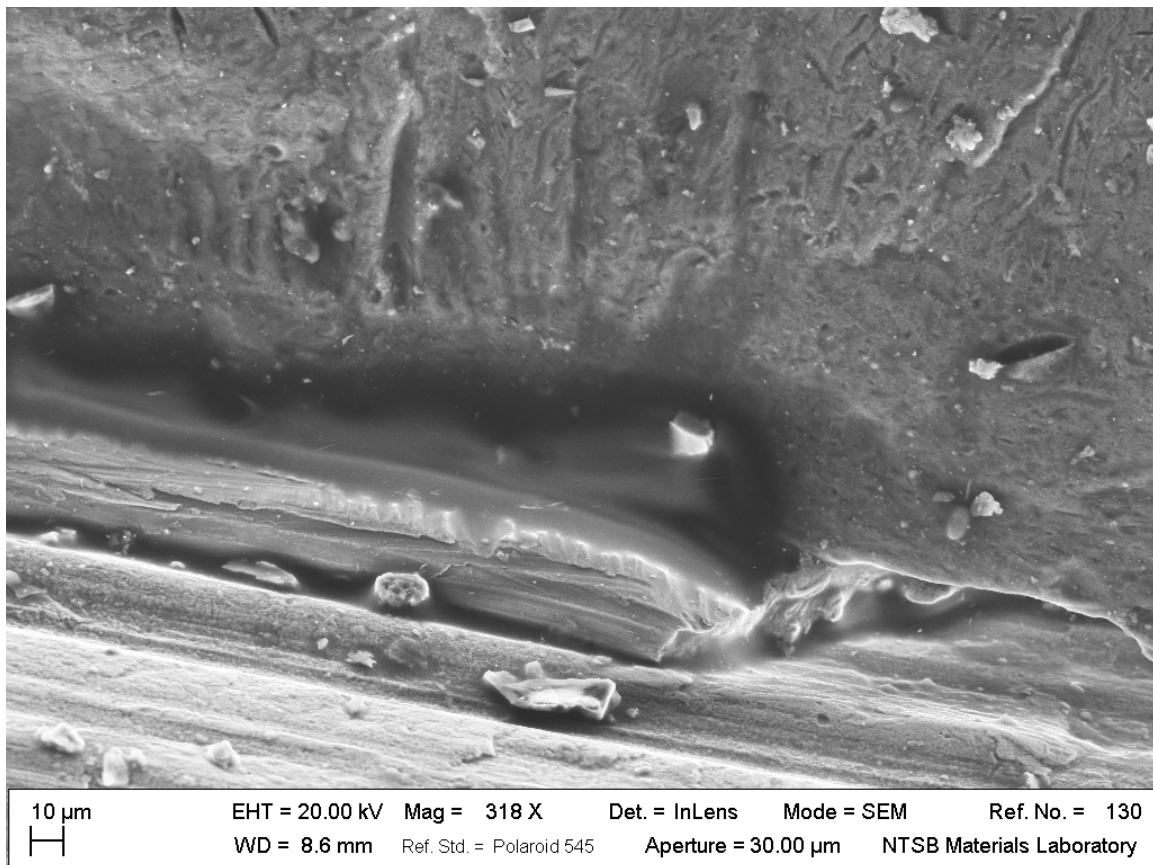
Figure 14 – SE micrograph of the fatigue crack initiation site of the pin thumbnail crack.

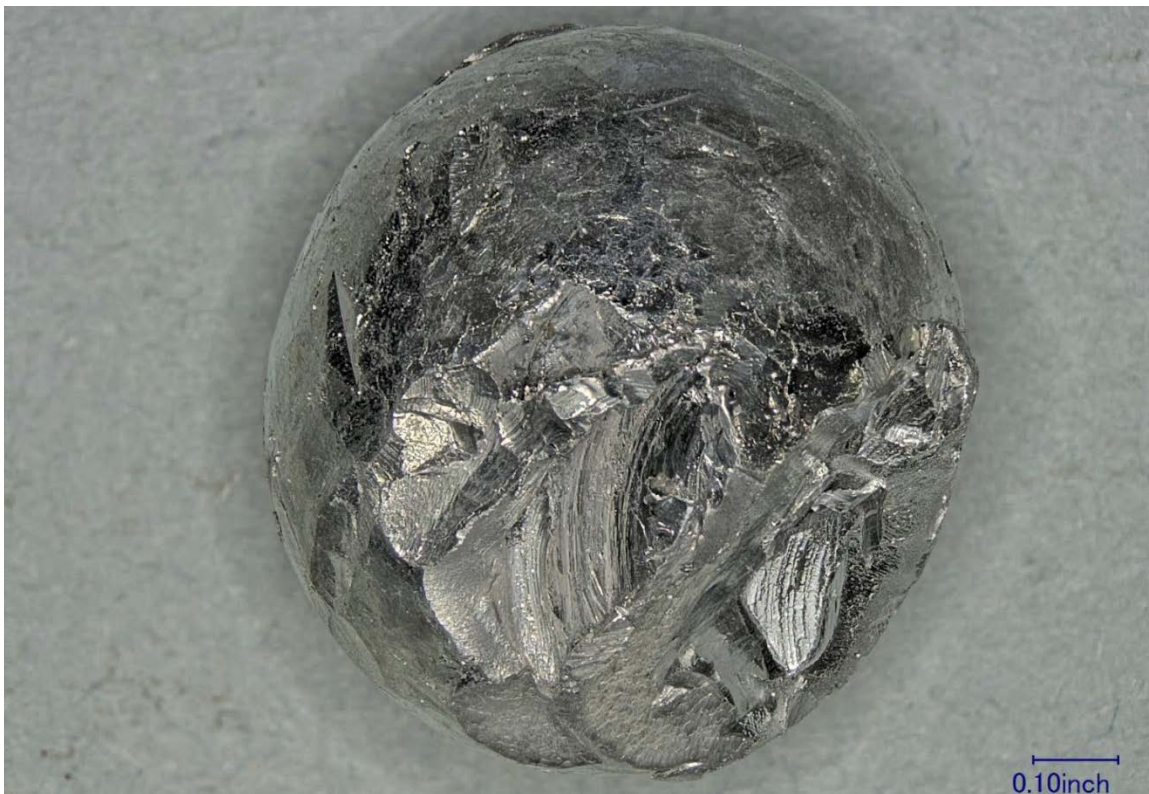
Figure 15 shows the spherical deformed separated portion of the pin. The severe batter on this fragment obscured the features that would conclude fracture information. A circular impression was visible on the spherical fragment, as illustrated in Figure 16. The volume of the spherical pin remnant was consistent with a spherical impression on the underside of the piston crown, depicted by the position of the yellow arrow on Figure 2. This impression occurred after the severe deformation of the now spherical pin fragment.

Figure 15 – The spherical separated pin piece, showing impressions from collisions.

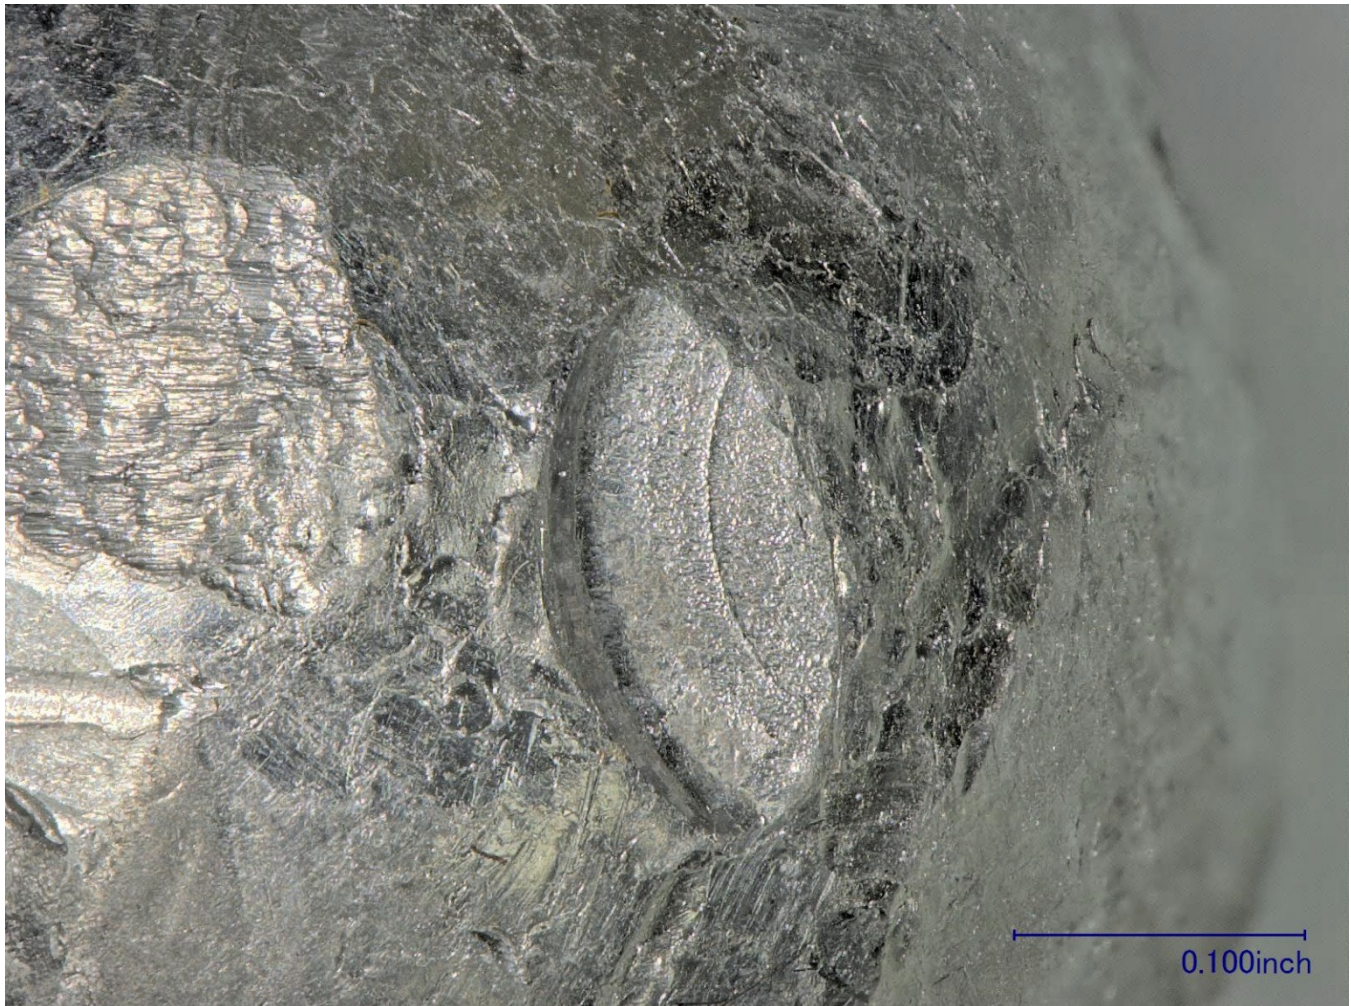
Figure 16 – Closer view of the impact mark on the separated spherical pin piece.
