**NATIONAL TRANSPORTATION SAFETY BOARD**

**MAGNETO SYSTEM EXAMINATION**

**WPR15LA262**

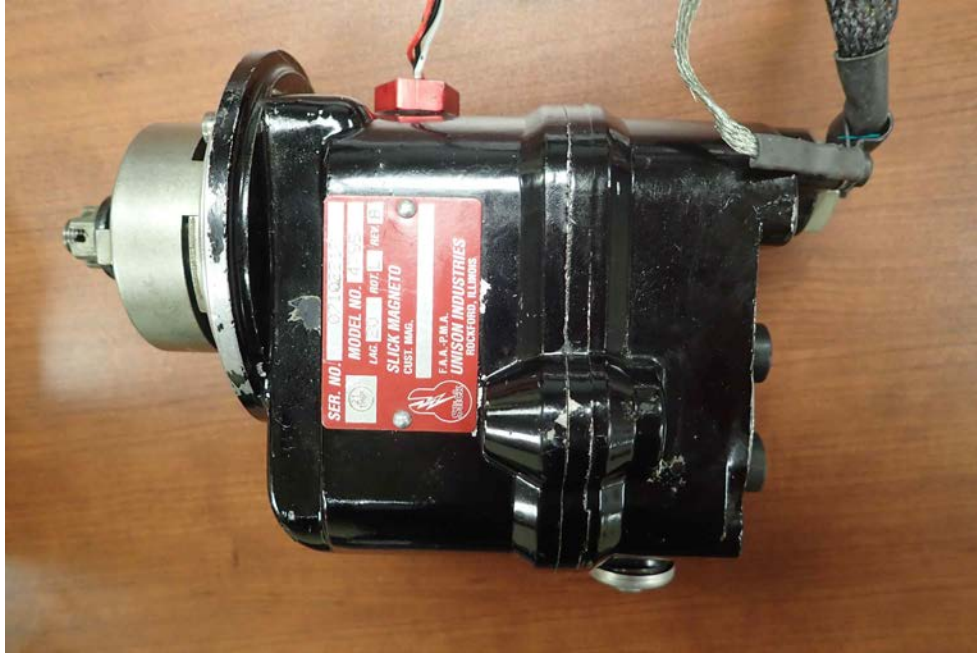
The right magneto case appeared undamaged (Photo 1). The magneto rotated smoothly when turned at geared rotor shaft. The drive gear and wire cap were removed to facilitate installation in the Champion magneto test stand.

Photo 1 - Right Magneto

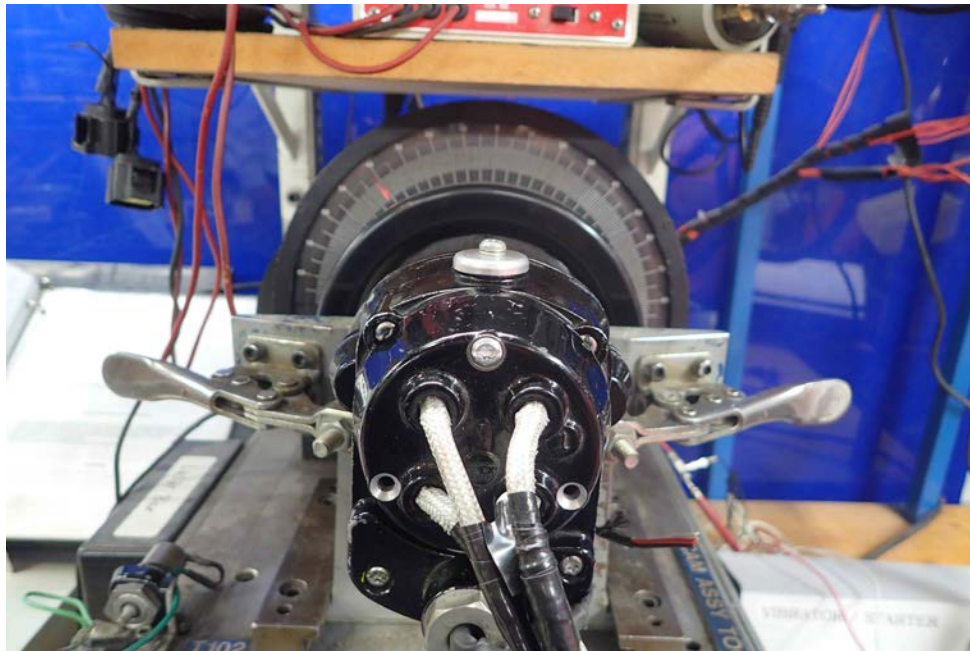
The magneto was installed in the test stand, which was configured for the "Magneto Mode Test", and operated at speeds of between 500 and 2,800 rpm. Sparks were observed intermittently at all four output leads, and the timing gauge indicated that the internal timing was set to 41 degrees, rather than the nominal 25 degrees (Photo 2).

Photo 2 - Right Magneto on Test Stand

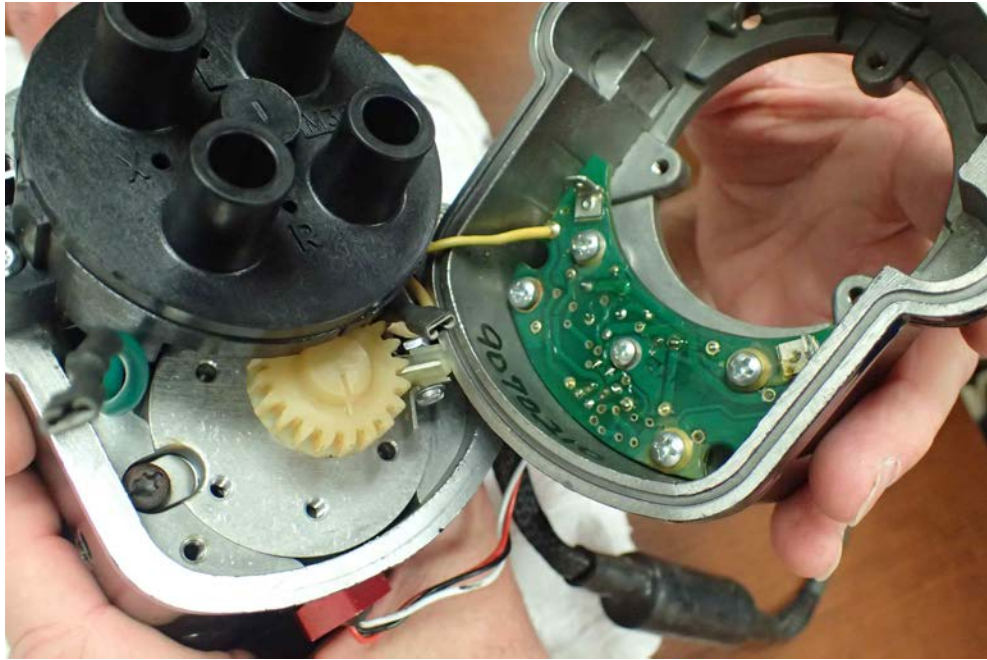
The magneto was then removed from the test stand, and its housing assembly removed. All internal components were intact, clean, and free of indications of arcing (Photo 3).

Photo 3 - Right Magneto

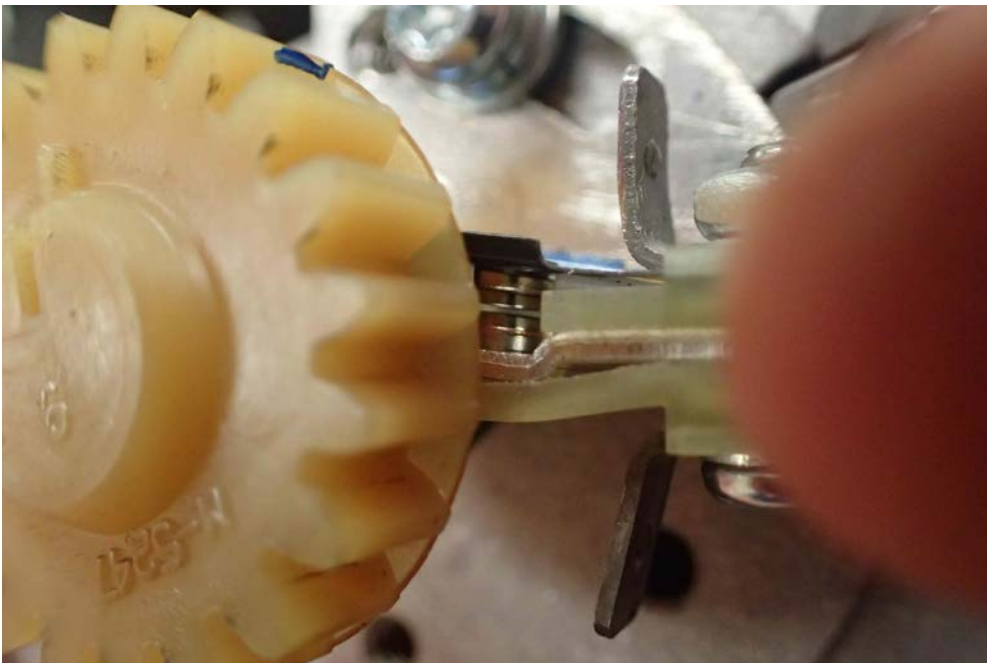
The group then "pinned" the rotor plastic drive gear in the X location, the notches on the rotor and distributor gear did not appear to line up. The pin was removed and the notches were lined up, and the "E" gap was observed in the fully open position, which indicated a timing misconfiguration (Photo 4).

Photo 4 - Right Magneto "E" Gap

The group then adjusted the points visually to the correct timing utilizing an exemplar magneto for reference, and the magneto was again tested on the test stand. It operated in both Lasar and Magneto modes, sparking at all output posts at speeds of between 500 and 2,800 rpm, and the magneto timing gauge indicated 26 degrees.

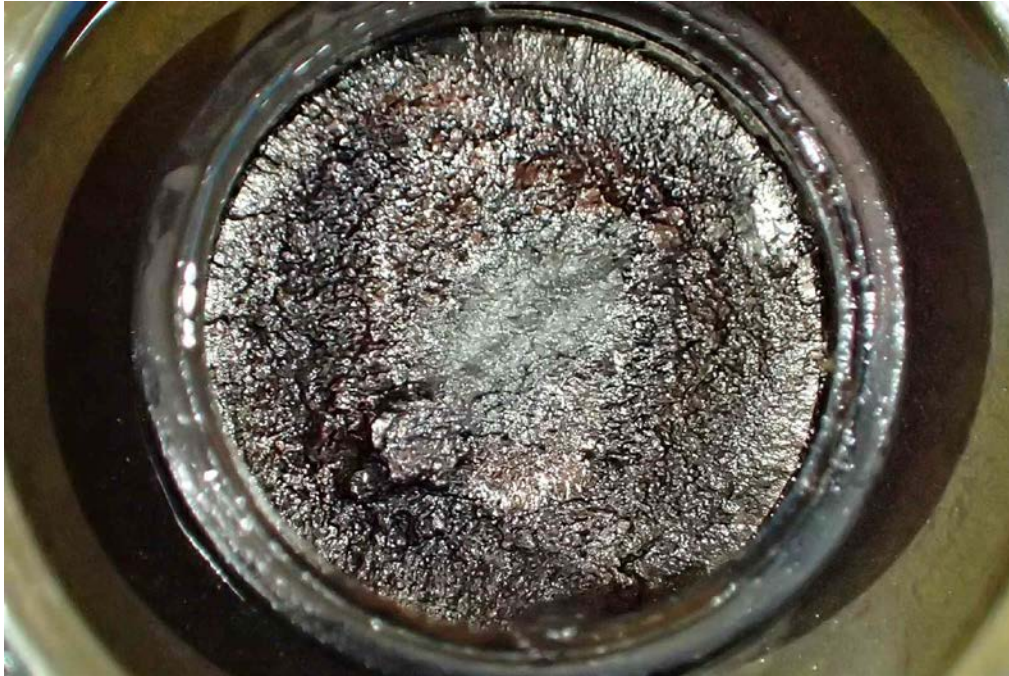
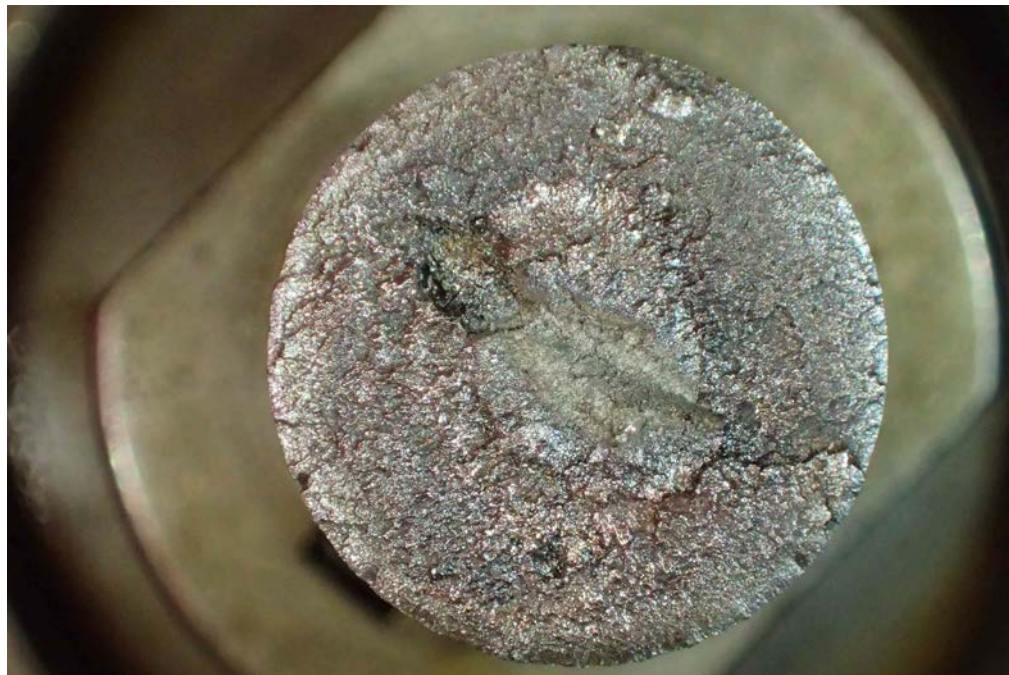
The left magneto case appeared undamaged. The shaft of the drive gear had separated at the input bearing. The fracture surfaces exhibited uniform and granular surface features (Photo 5, 6), with no indication of "beach" marks or propagation lines. All drive gear teeth remained attached; one of the teeth exhibited a 3 mm long gouge to its upper surface (Photo 7), the remaining teeth were intact and undamaged.

Photo 5 - Left Magneto Shaft at Magneto Bearing

Photo 6 - Left Magneto Shaft at Magneto Gear

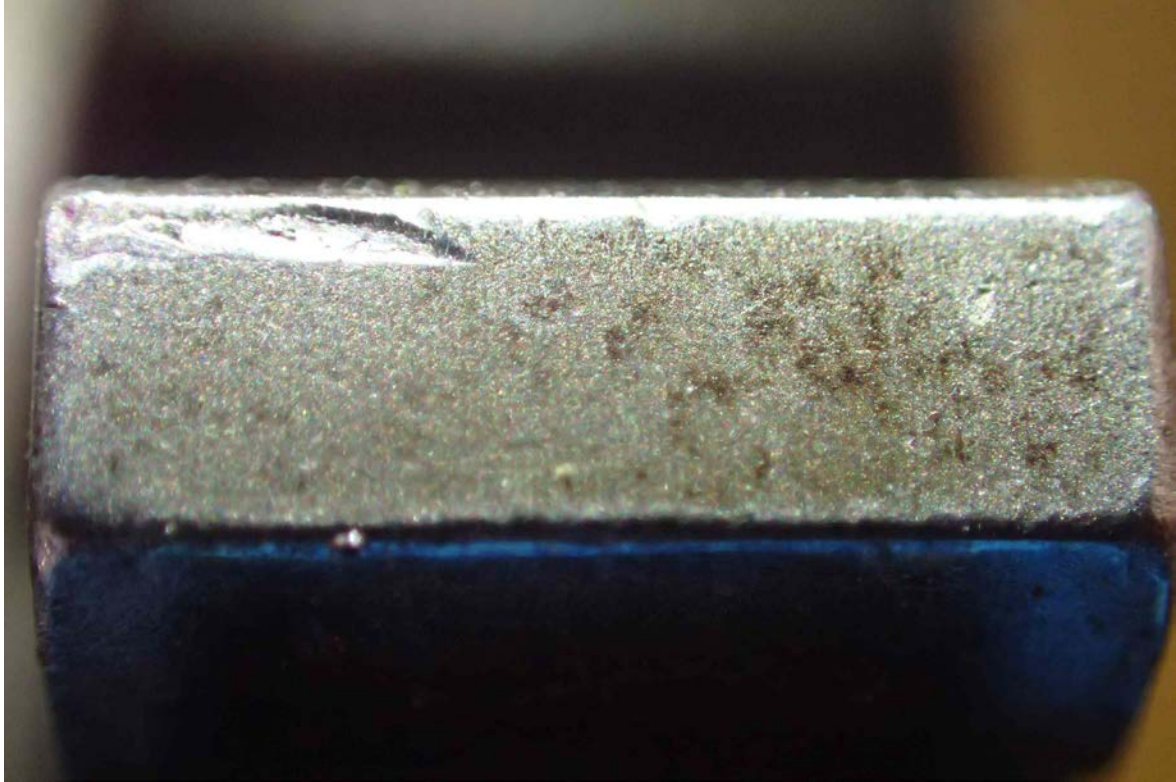
Photo 7 - Left Magneto Drive Gear Tooth Face
